ENGINEERING DIRECTIVE - Defective Material

Issued by the Chief Engineer for Metrolinx

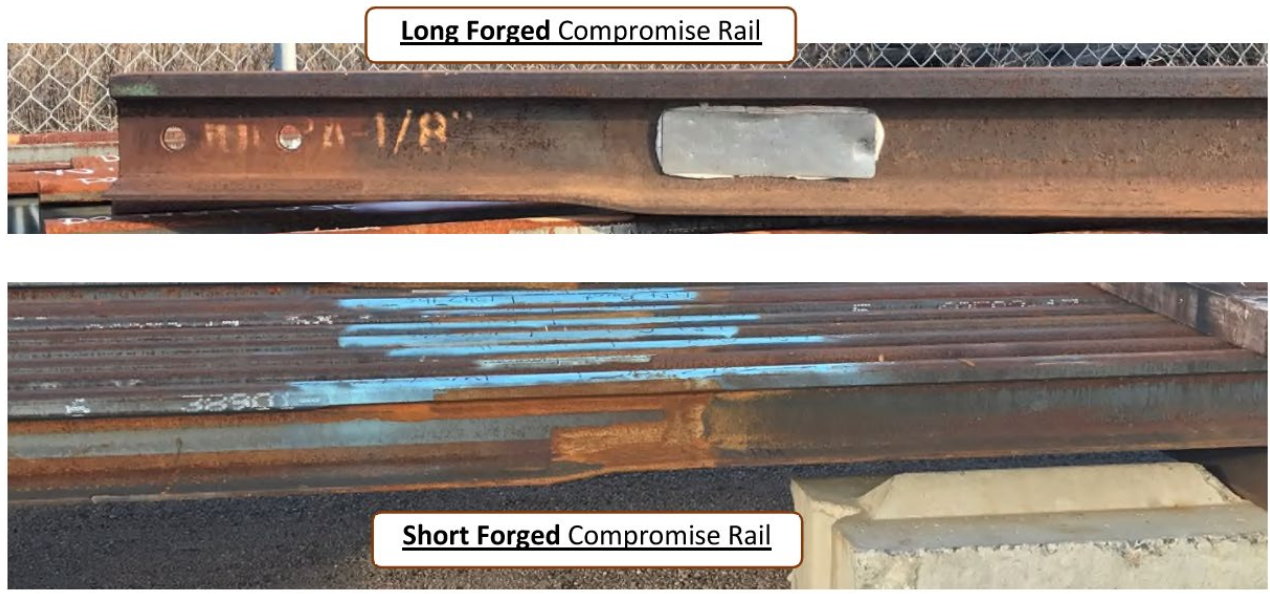
Note: “Long Forged” Compromise rails have a forged section of approximately twenty-two inches. They can be identified by having only a short length of the compromise rail in the smaller rail section. “Short Forged” compromise rails have rail weights that are typically evenly split between the two rail sizes and can continue to be used.

After experiencing several failures across the industry, an investigation was conducted that found long forged compromise rails produced between July 2013 to September 2015 could have a latent defect in the forging. The defect, Insipient Grain Boundary Melting, can result in catastrophic failure of the components particularly after the application of heat experienced through the welding process. The failure mechanism is the development of a horizontal rupture or crack which develops at the weld prior to failing vertically, resulting in a broken rail. A failure of this type occurred on the Metrolinx owned GO Subdivision in August of 2023 within four days of installation of the compromise rail.

Until further notice, due to a higher potential of failure, no Long Forged Compromise Rails manufactured between July 2013 to September 2015 are to be installed in Metrolinx track and/or welded. These rails are to be identified as “scrap” as per the GO Transit Track Standards and disposed of. In addition, no Long Forged Compromise Rails (regardless of manufacture date) are to be installed in Metrolinx track without written approval from the Director, Engineering - Track E&AM.
