## **Overview**

On February 2, 2026, at approximately 08:05, GO 3009 derailed at low speed while operating revenue service westbound near Mile 0.30, within the John Street Interlocking. One (1) coach and one (1) locomotive derailed. There were no injuries to passengers or crew and approximately 108 customers were safely transferred to a rescue train. The derailment caused significant disruption across the GO network during the morning peak rush hour service, with delays of up to 90 minutes.

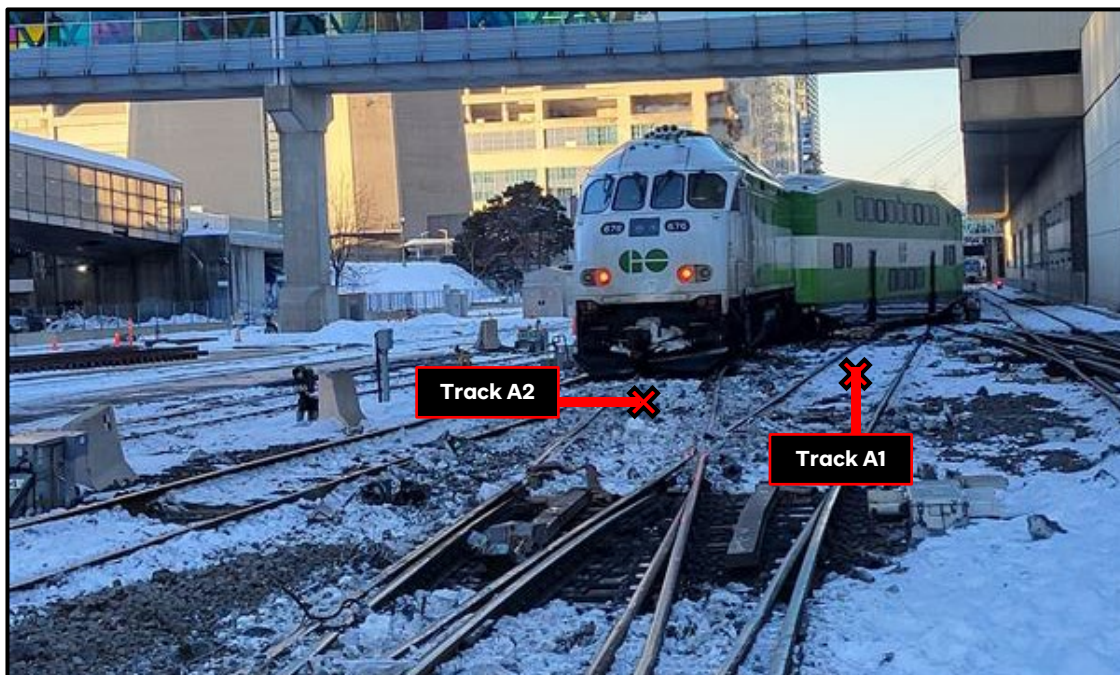
The 12-coach consist was operating with the cab car leading and the locomotive trailing. The coach positioned directly ahead of the locomotive, together with the locomotive itself, derailed. The derailment fouled tracks A1 and A2 and caused damage to the train, to track infrastructure, and to wayside signaling equipment, including a severed signal asset.

**Figure 1: Derailment of GO 3009 within the USRC (Westward View)**
