### **Cultural Heritage Evaluation Report – Islington Avenue Bridge**

**GO Rail Network Electrification TPAP**

**Final Cultural Heritage Evaluation Report:**

**Islington Avenue Bridge**

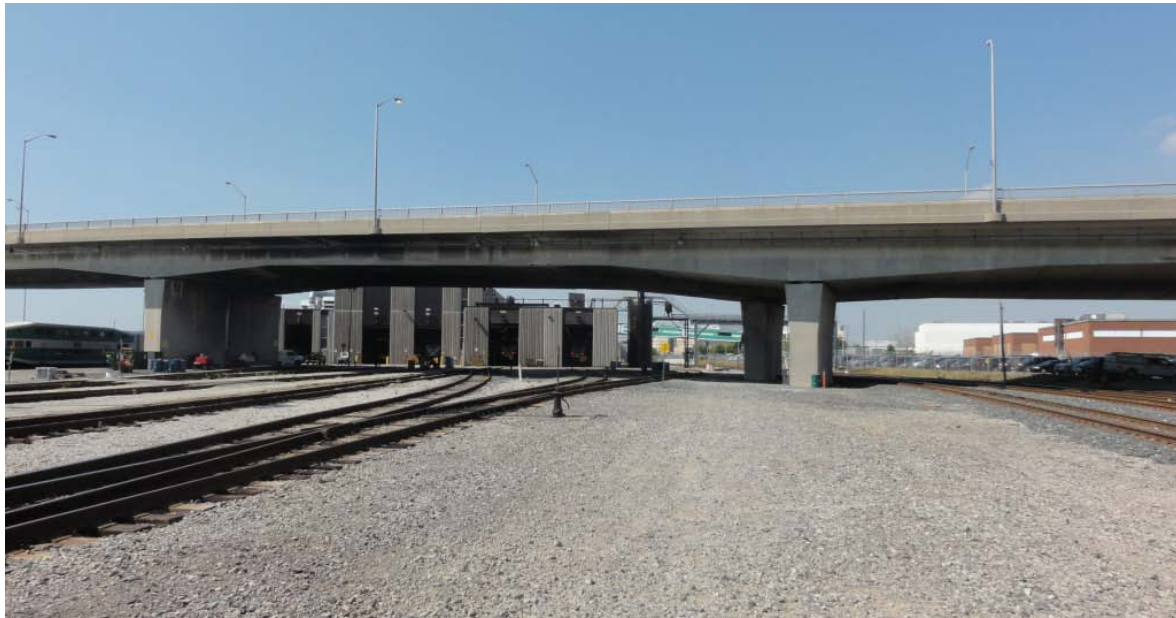
Figure-1-2: East Elevation of the Islington Avenue Bridge

The Islington Avenue Bridge is located at Mile 7.46 of the GO Transit Lakeshore West rail corridor, and is located in the City of Toronto (Figure-1 and Figure 1-2). The bridge is a seven-span, segmental cantilever prestressed concrete structure that carries four lanes of vehicular traffic in a north and south direction over the Willowbrook Maintenance Facility and Via Rail's Toronto Maintenance Facility. The bridge is located within one ownership parcel: PIN 07601-0262. The bridge is currently owned and maintained by the City of Toronto.

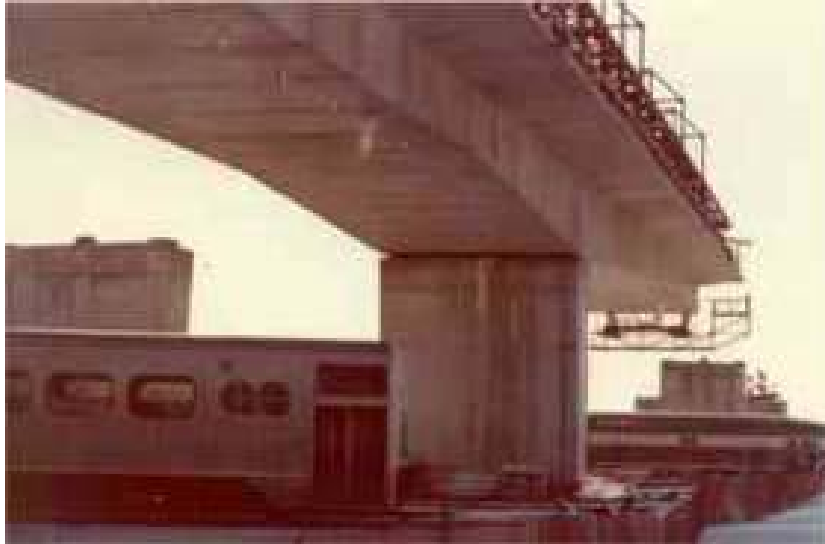
Figure 9-7: Construction of the Islington Avenue Bridge (Planmac Inc.)

The Islington Avenue Bridge was built in 1979 with a unique gantry system to minimize disruption to rail traffic below. It the first segmental bridge to be constructed in a major urban center in North America, and the first segmental bridge to be constructed anywhere in Ontario.

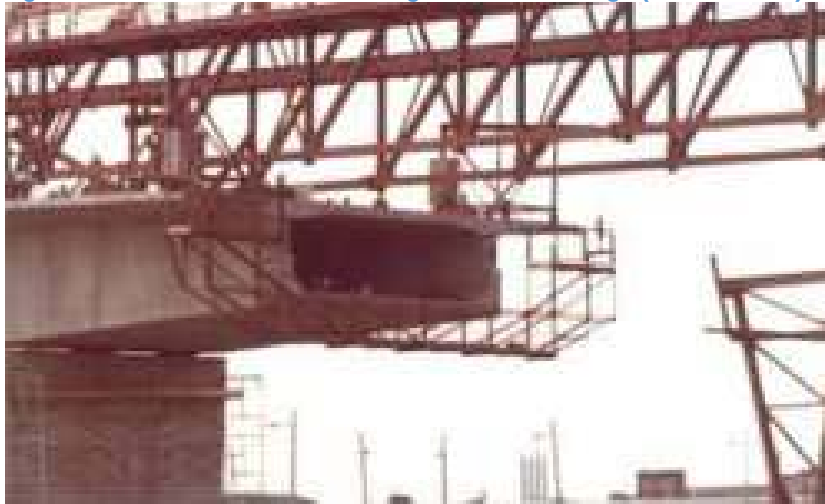
Figure 9-8: Construction of the Islington Avenue Bridge (Planmac Inc.)

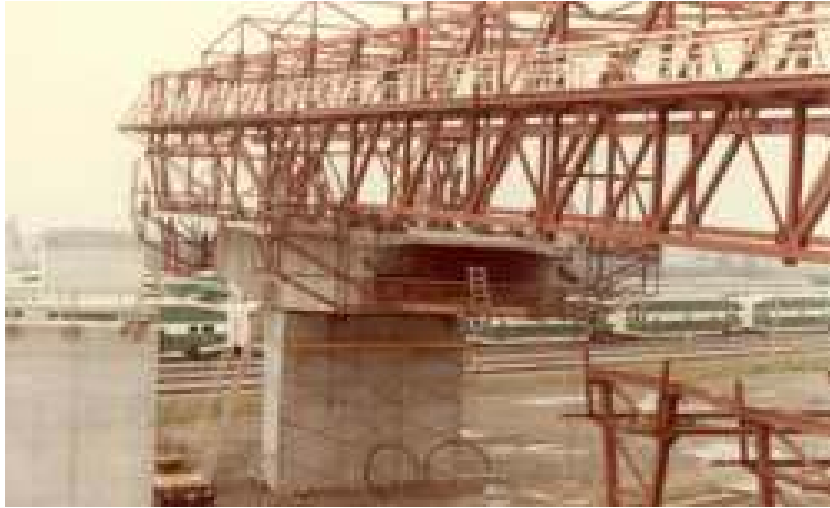
Figure 9-9: Construction of the Islington Avenue Bridge (Planmac Inc.)

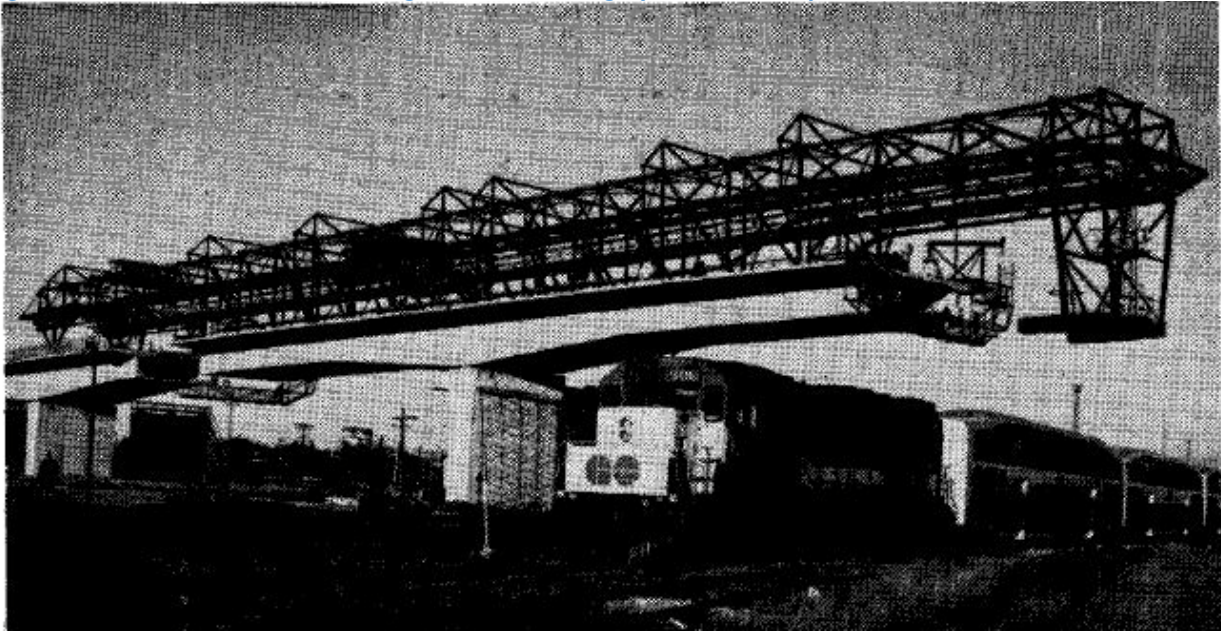
Figure 9-11: Construction of the Islington Avenue Bridge (Lovell 1980:53)

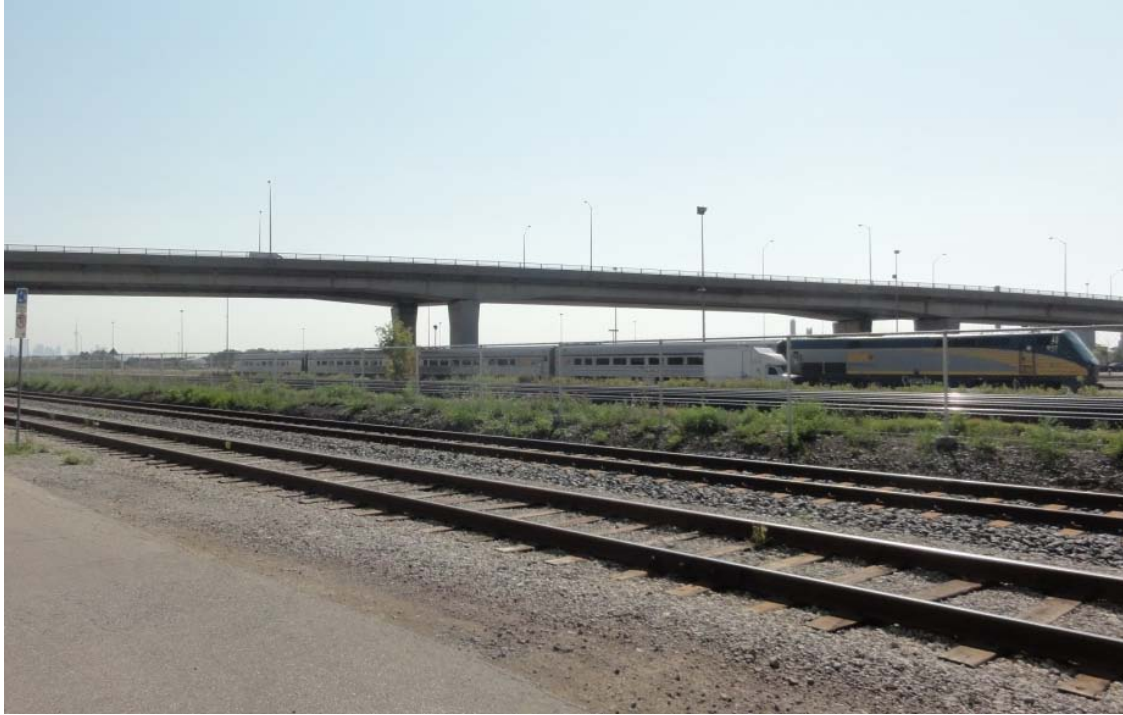
Figure 9-19: View of west elevation, looking southeast from the Willowbrook Maintenance Facility.

The Islington Avenue Bridge consists of an east structure and a west structure, carrying northbound and southbound vehicular traffic, respectively. The bridge features a concrete with asphalt deck that is seven spans in length, supported by six piers consisting of two pillars of reinforced concrete each (Figures 9-19 to 9-22). The individual span lengths are, from south to north, 49 metres, 83 metres, 83 metres, 83 metres, 83 metres, 61 metres, and 49 metres for an overall length of 491 metres. The structure has an overhead clearance of 11.2 metres above the Lakeshore West rail corridor, located in the approximate center of the structure. The piers are affixed to the deck above by means of a large metal bearing (Figure 9-23)

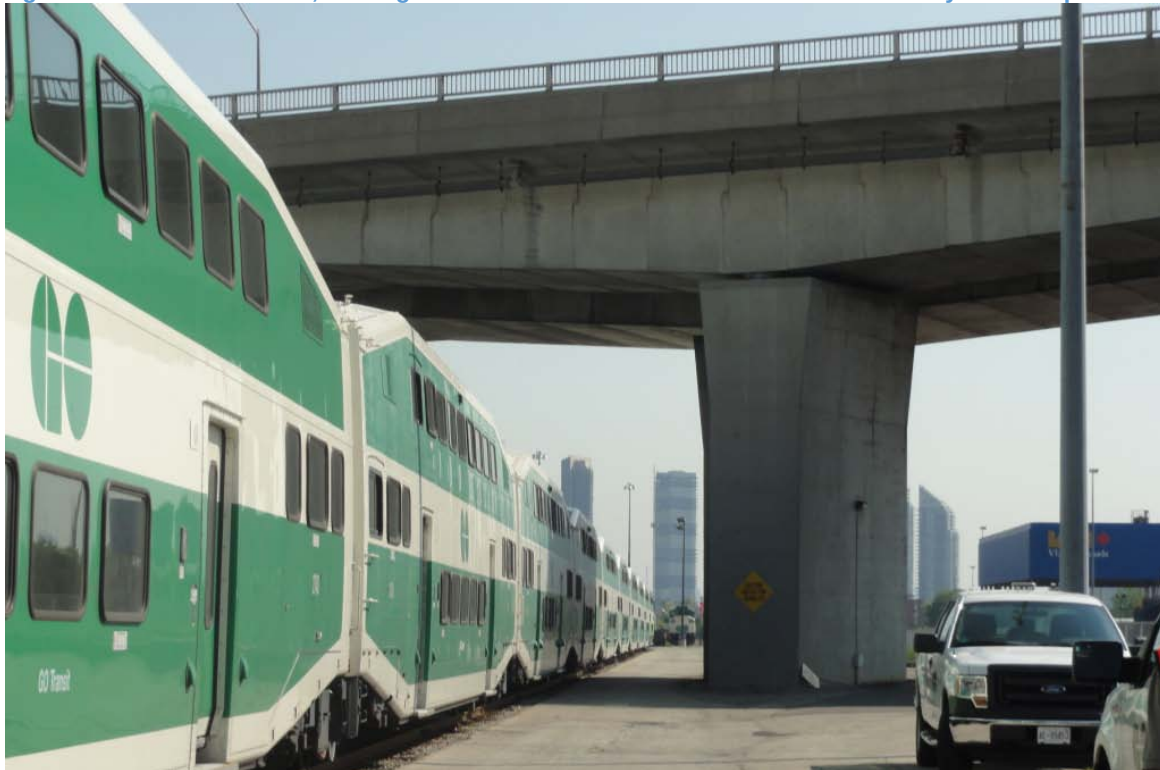
Figure 9-20: West elevation, looking east from the Willowbrook Maintenance Facility towards pier C.

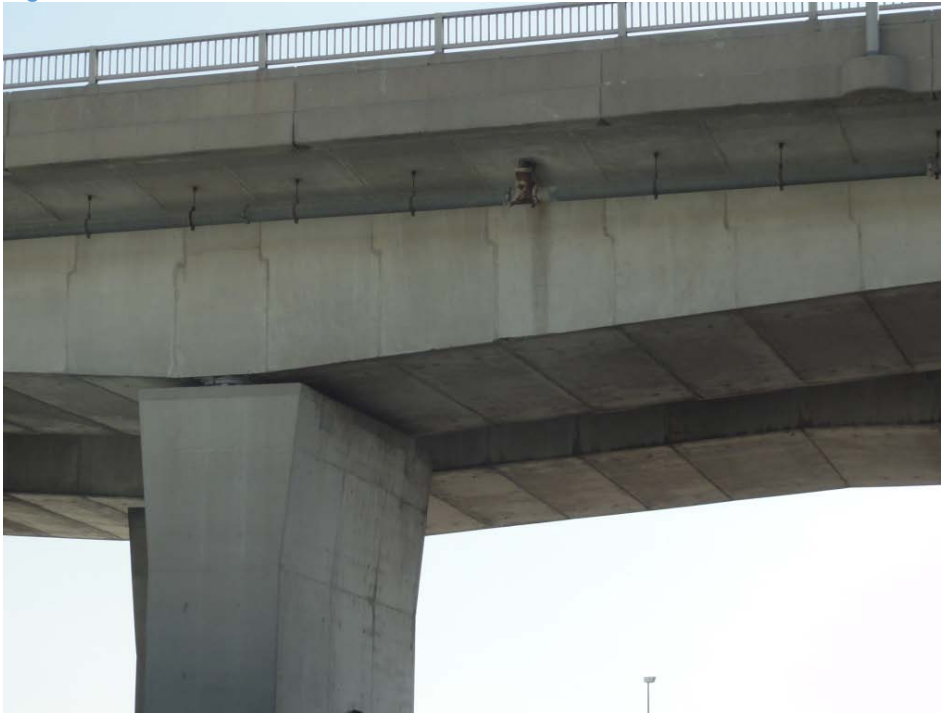
Figure 9-21: Pier and underside of deck, showing individual prestressed precast concrete segments.

tensioned are clearly noted (Figures 9-21 and 9-22). The undersides of several spans are blackened with soot from diesel locomotives passing underneath on the way to the Diesel Service bays in the Willowbrook Maintenance Facility (Figure 9-24). The underside of the deck also supports piping to leading from catch basins to the base of the abutments to drain rainwater of the structure (Figure 9-25).

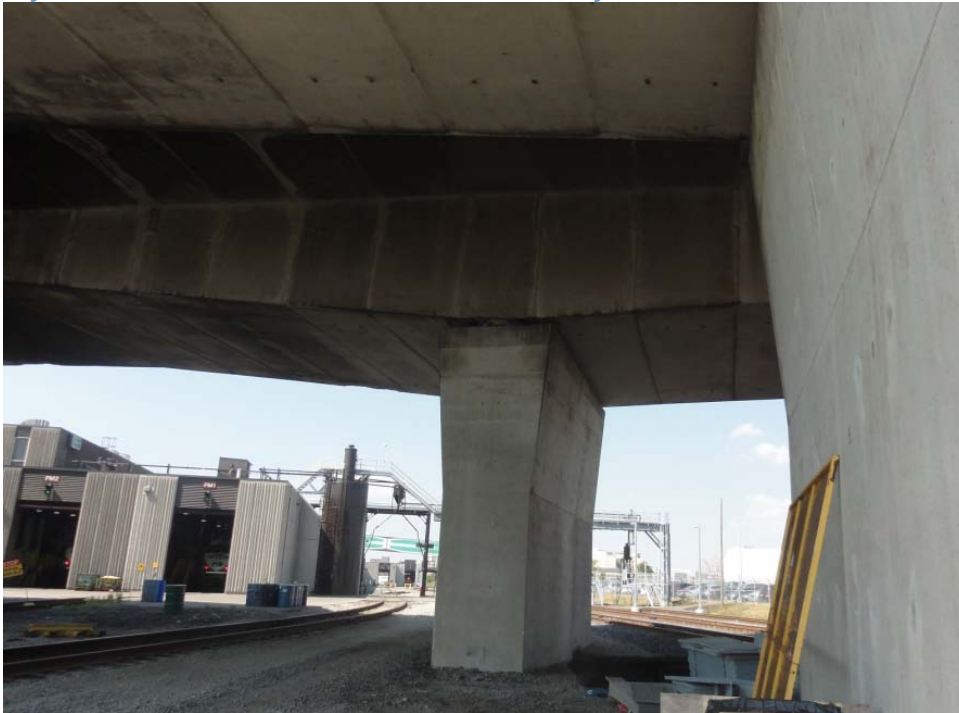
Figure 9-22: Pier A at rear and extreme right, looking west towards Preventative Maintenance Bays 1 and 2 in the Willowbrook Maintenance Facility

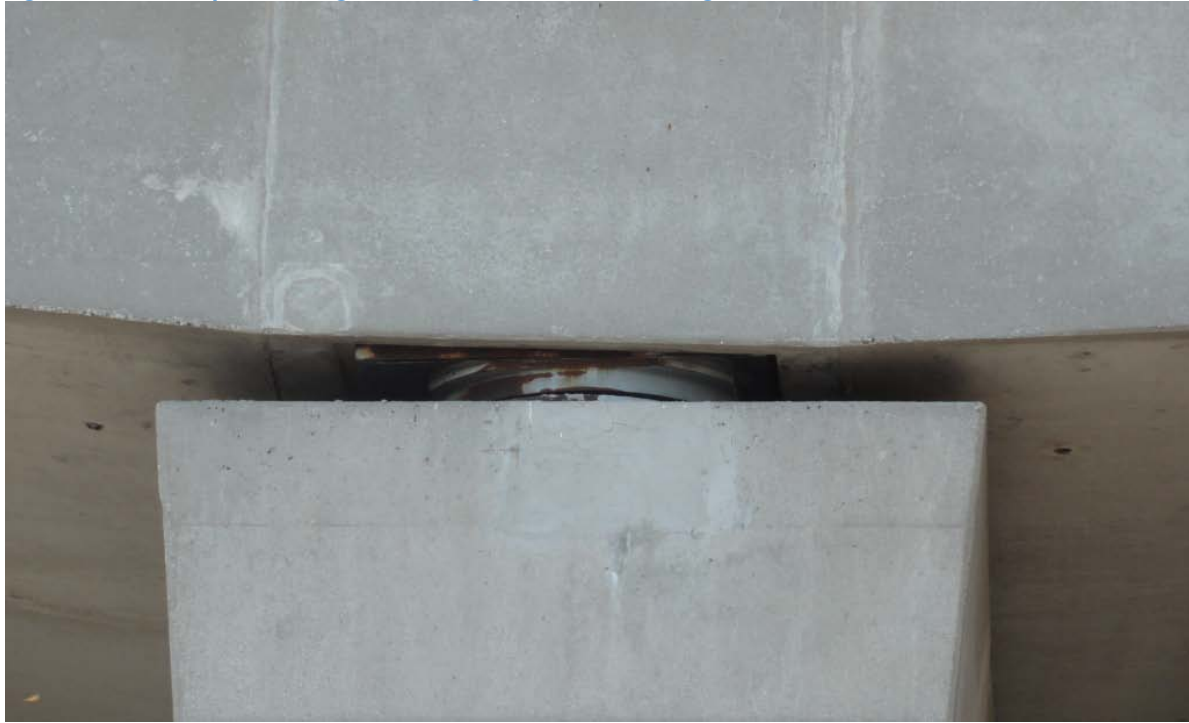
Figure 9-23: Metal pier bearing connecting to the deck, looking west.

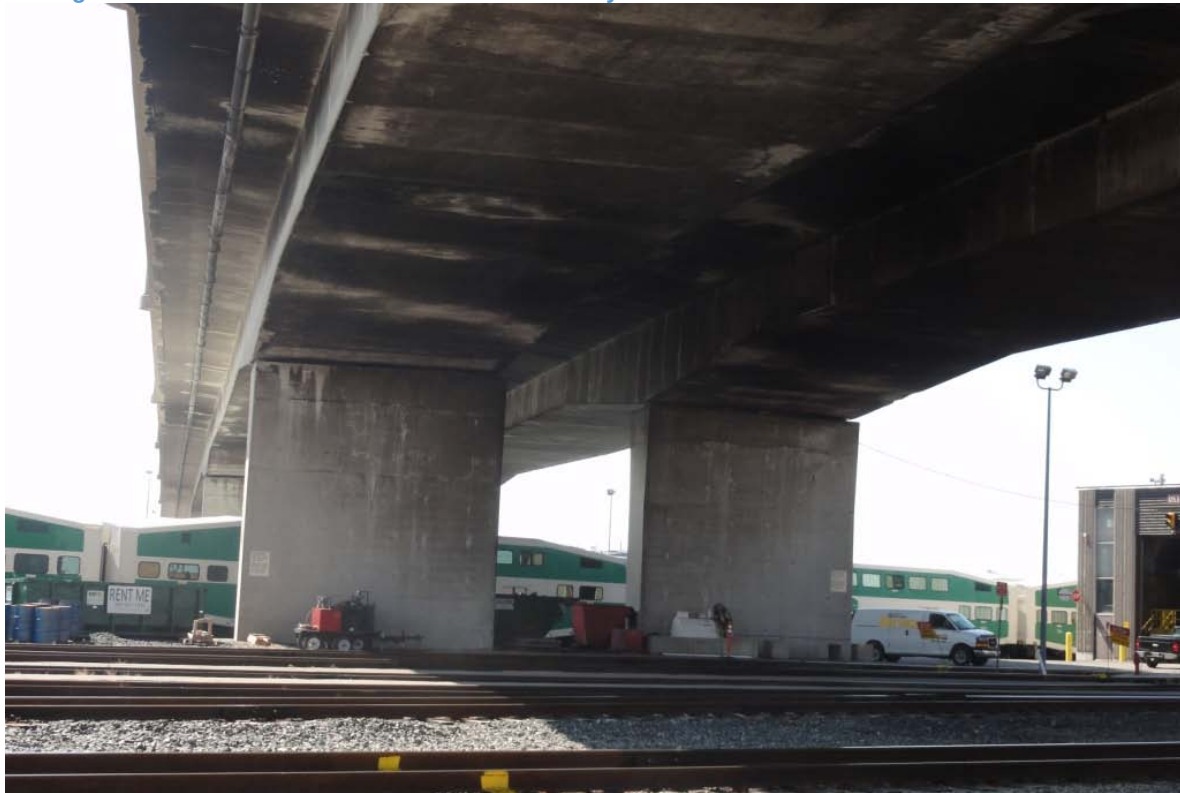
Figure 9-24: Pier B and bridge deck underside showing soot from diesel engines passing underneath, looking south at the Willowbrook Maintenance Facility.

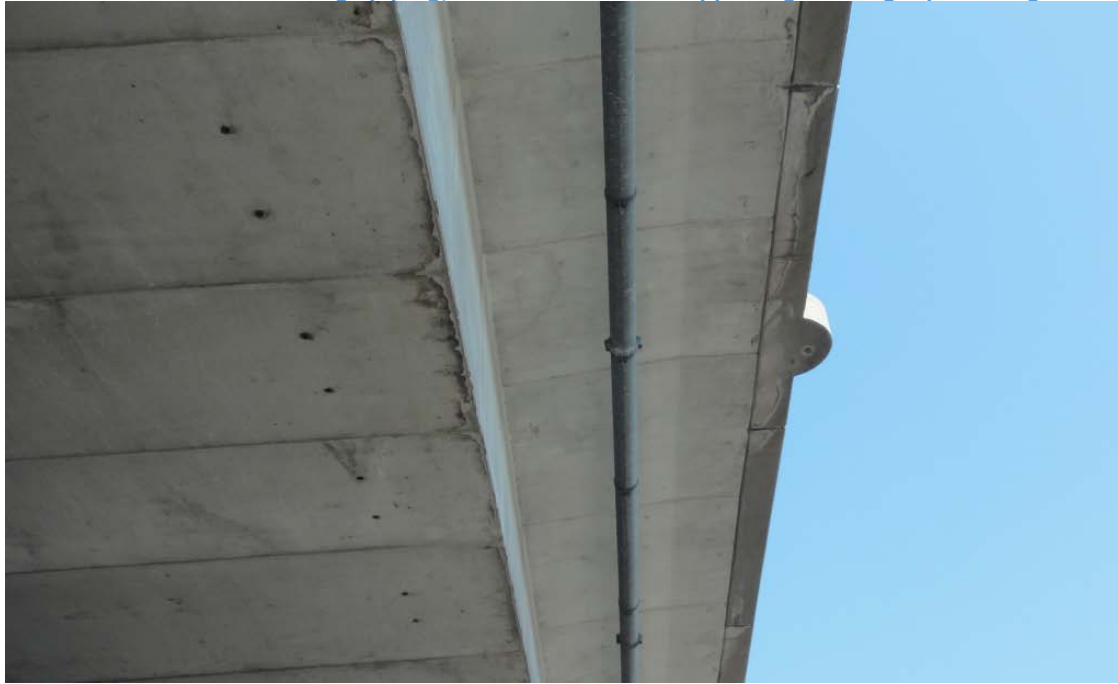
Figure 9-25: Underside of bridge deck with individual precast prestressed concrete segments visible. Note rainwater drainage piping, and concrete base supporting streetlight pole at right.

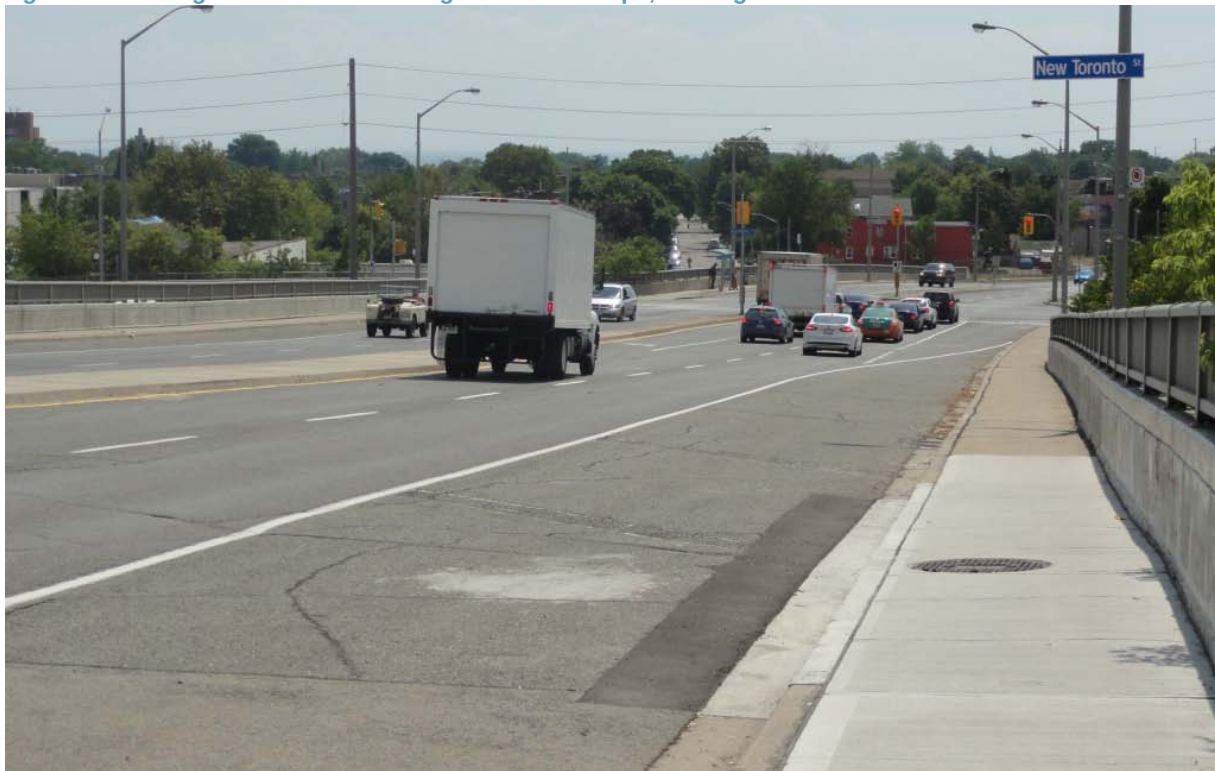
Figure 9-26: Bridge deck demonstrating downward slope, looking south towards New Toronto Street.

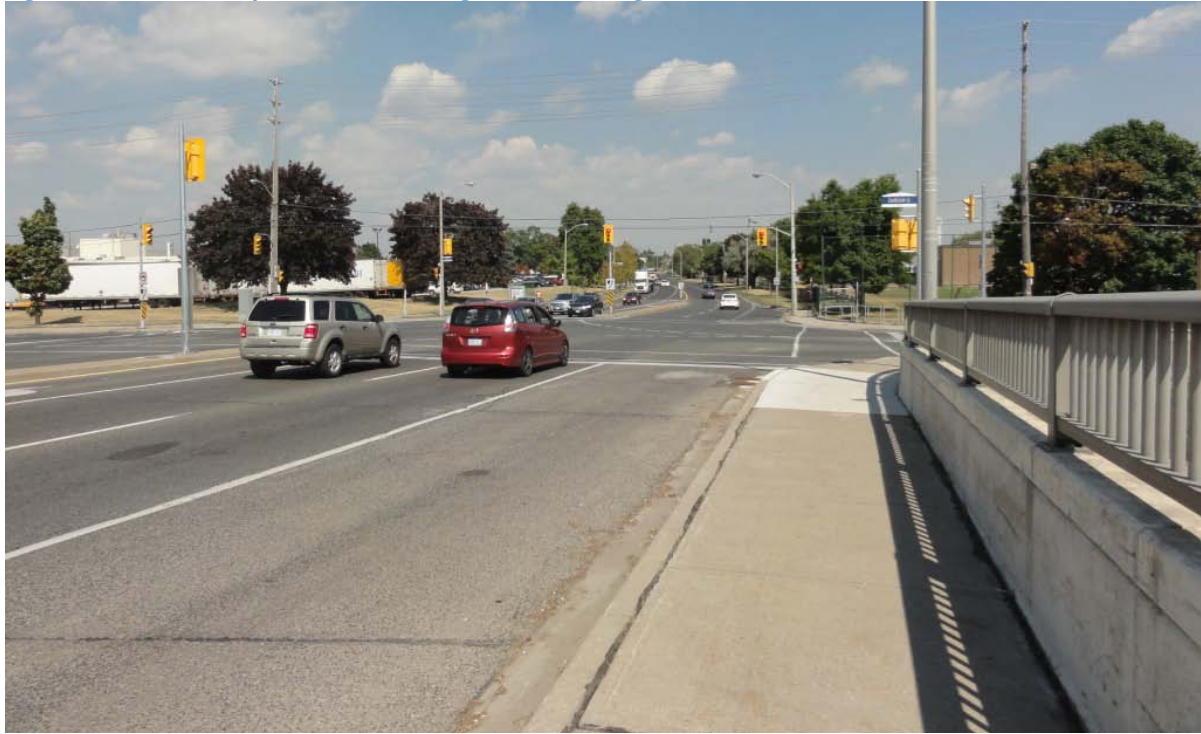
Figure 9-27: Northern portion of the bridge deck, looking north towards Judson Street.

The top of the structure features two lanes with wide curb-lane shoulders to accommodate future expansion of Islington Avenue in each of the northbound and southbound lanes. Southbound traffic is carried on the western structure of the bridge, and is separated from the northbound traffic on the eastern structure by a concrete median (Figures 9-26 and 9-27). The road deck features grated metal catch basins for collecting rainwater, and the whole structure is bound by pedestrian sidewalks and metal railings (Figures 9-28 and 9-29)

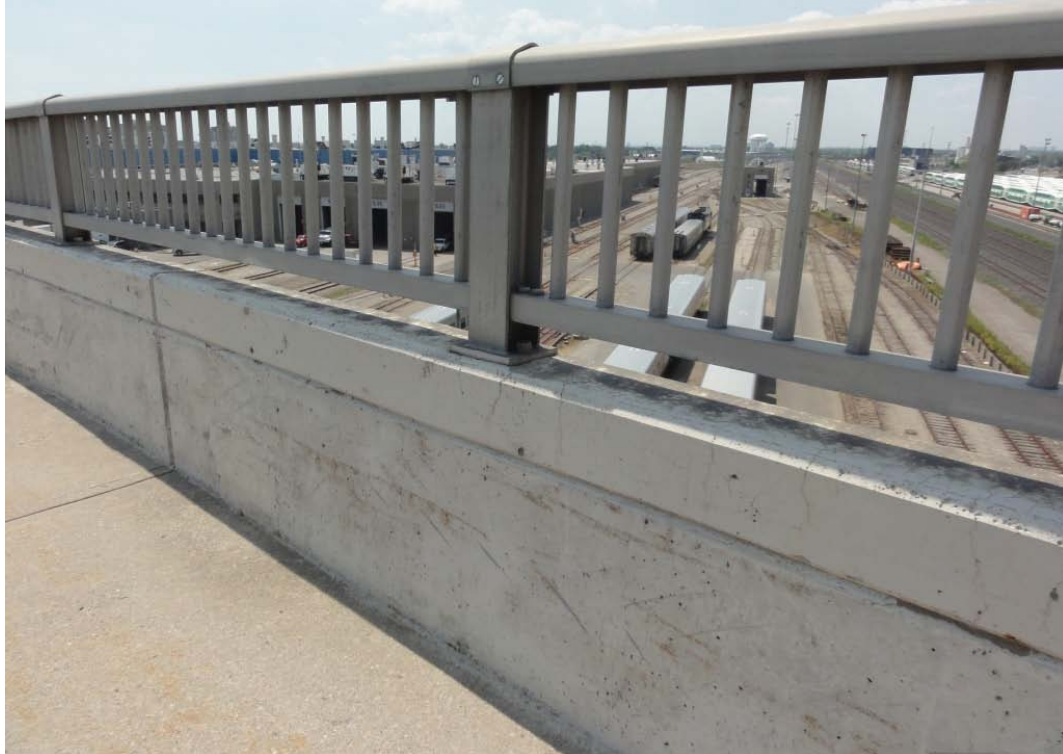
Figure 9-28: Metal railing and pedestrian sidewalk on bridge deck, looking west.

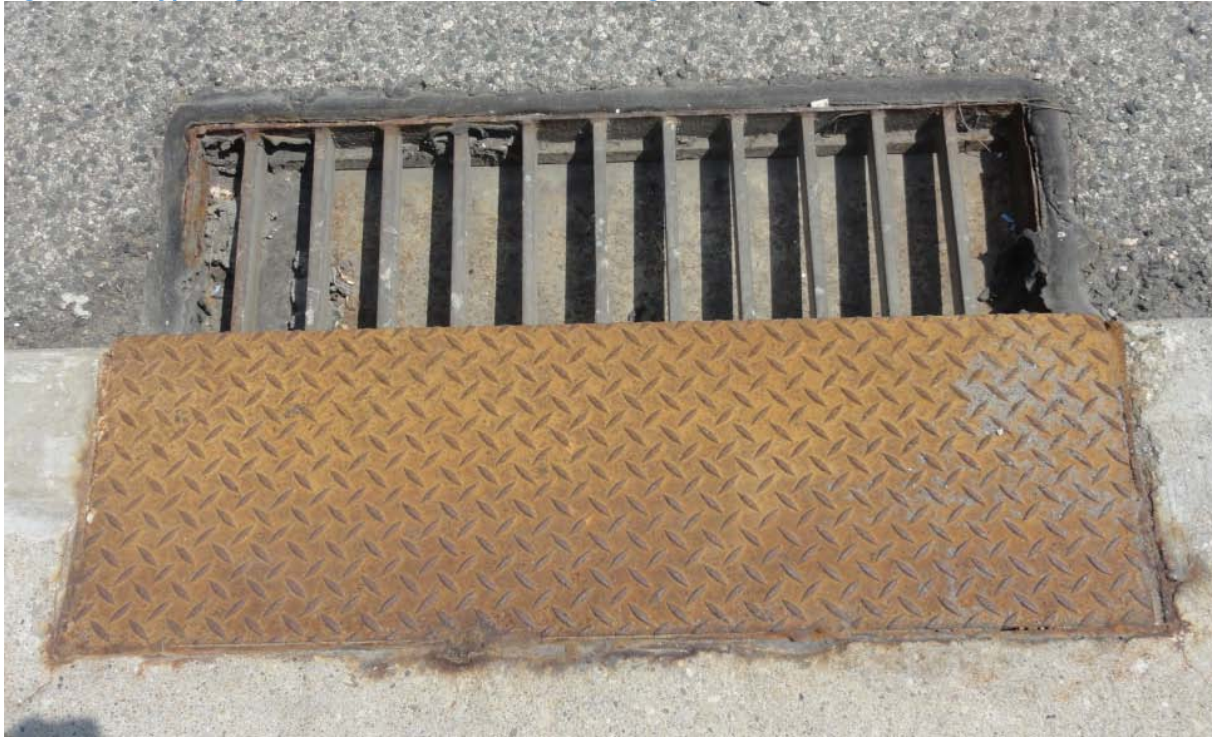
Figure 9-29: Typical grated rainwater catch basin on bridge deck.

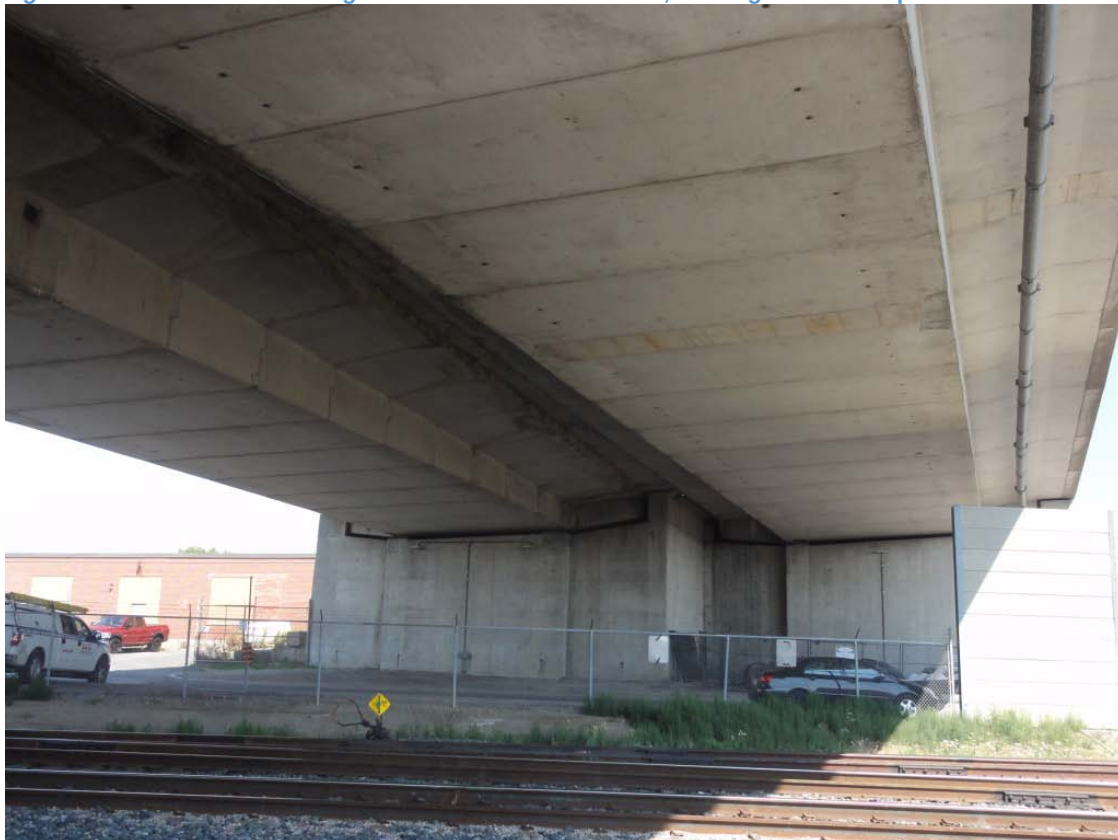
Figure 9-30: Underside of bridge deck and north abutment, looking north from pier B.

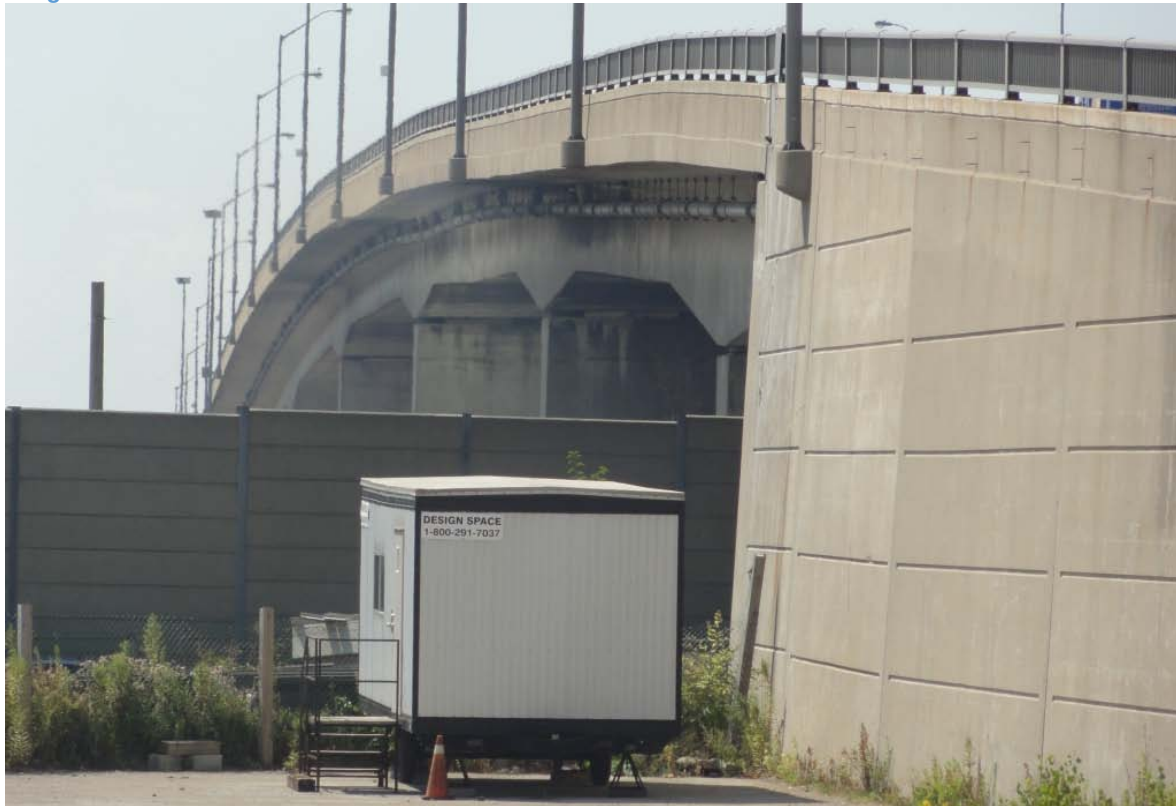
Figure 9-31: East elevation of the bridge, looking south from Judson Street. Note the tall abutment retaining wall at far right where the grade level of Islington Avenue was raised to accommodate the bridge.

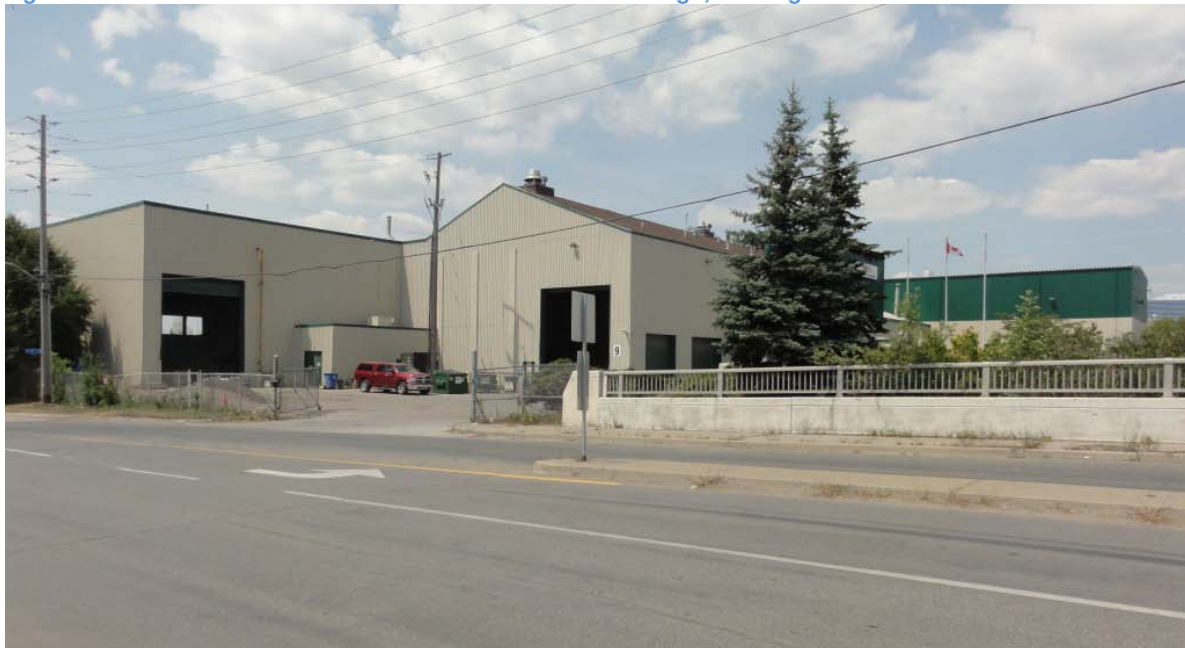
Figure 9-33: Impacts of raising grade level on southern bridge approach, looking west down New Toronto Street from Islington Avenue. Note the tall retaining wall at left and the roof level of the residence compared to street level.

The abutments are reinforced concrete, with the north abutment located approximately 96 metres south of Judson Street, and the south abutment approximately 170 metres north of New Toronto Street (Figure 9-30). In order to achieve the clearance required over the rail corridor, as well as maintain an appropriate slope for vehicular traffic travelling over the bridge, the grade of Islington Avenue was raised by several metres on both the north and south approaches (Figure 9-31). This resulted in dramatic impacts to adjacent structures south of the bridge, where warehouses and residences on the west and east sides of Islington Avenue, south of New Toronto Street had their views and access restricted with the increase in grade level (Figures 9-32 and 9-33).

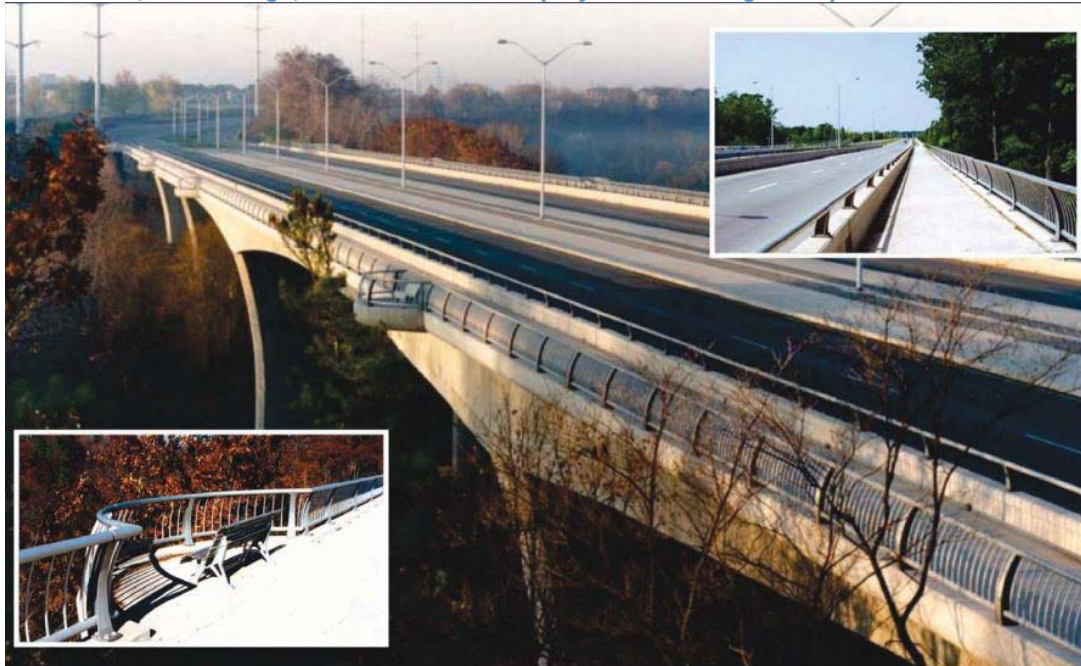
Figure 9-34: Six span precast prestressed concrete Burnhamthorpe Road Bridge over the Credit River, Mississauga, constructed in 1979 (City of Mississauga 2007).

- Burnhamthorpe Road Bridge over the Credit River in the City of Mississauga, constructed in 1979 using segmental construction. This bridge measures 390 metres in length over five spans (City of Mississauga 2007, Chin 2010).
- Fairway Road Bridge over the Grand River in Kitchener-Waterloo, constructed in 2013. This bridge measures 237 metres in length over four spans, and is the first bridge in over 20 years to be constructed using segmental construction in Ontario (Ontario Concrete Awards 2013, Kinnunen 2011).
- Highway 406 over Twelve Mile Creek in St. Catharines, constructed in 1982. This precast concrete box beam structure was post-tensioned in place, and measures 398 metres over six spans (Bassi and Lin 1982, MTO n.d.).

The following images of the Burnhamthorpe Road Bridge over the Credit River, Fairway Road Bridge over the Grand River, and the Highway 406 Bridge over Twelve Mile Creek are included to provide a comparison between like bridges, as well as between the subject bridge and bridges with a comparable overall length (Figures 9-34 to 9-36).

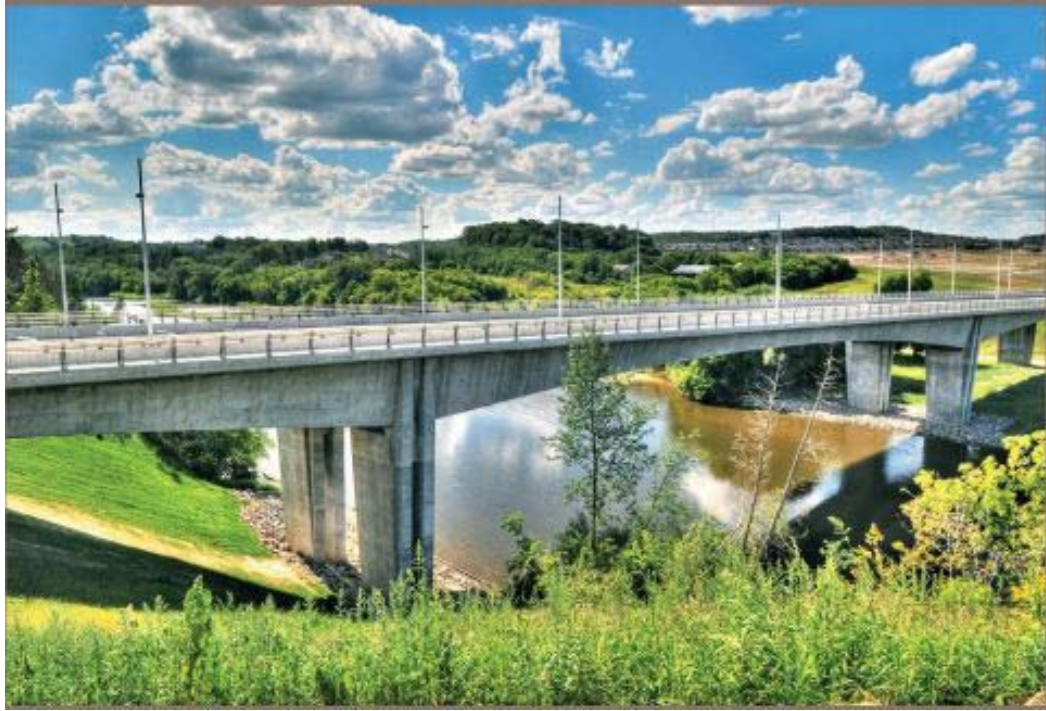
Figure 9-35: Four span precast prestressed concrete Fairway Road Bridge over the Grand River, Kitchener, constructed in 2013 (Ontario Concrete Awards 2013).

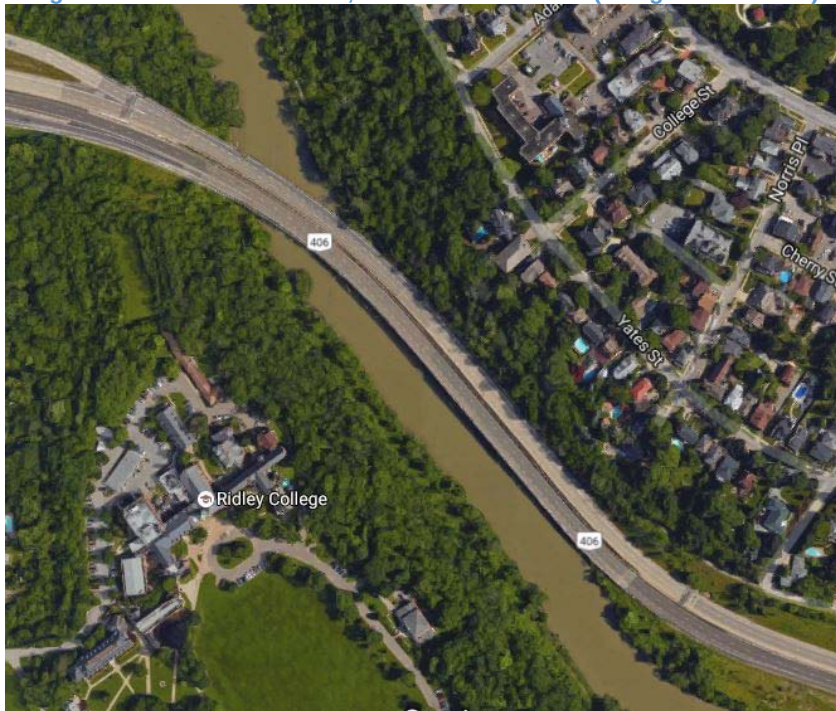
Figure 9-36: Six span post-tensioned segmentally-constructed concrete Highway 406 Bridge over Twelve Mile Creek, constructed in 1982 (Google Earth 2016).
