### **Cultural Heritage Evaluation Report – Willowbrook Maintenance Facility**

**GO Rail Network Electrification TPAP**  
**Final Cultural Heritage Evaluation Report:**  
**Willowbrook Maintenance Facility**

**Metrolinx Electrification Project**

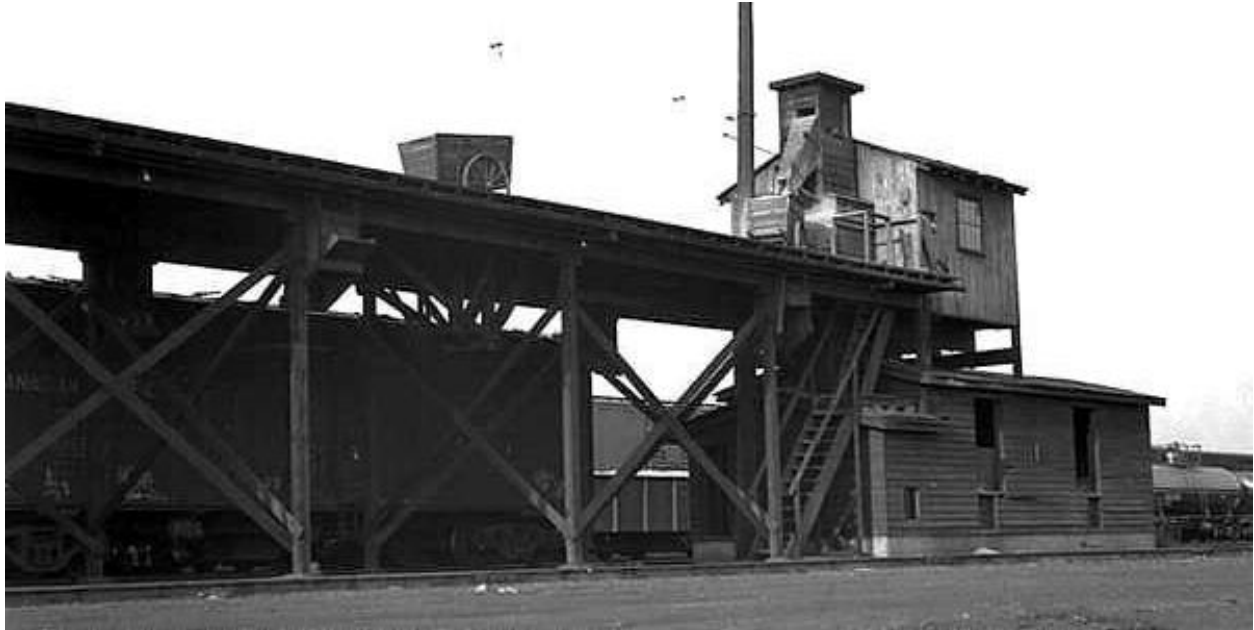
Figure 9-7: CN de-icing facility at Mimico Yard in 1953 (McDonald n.d.)

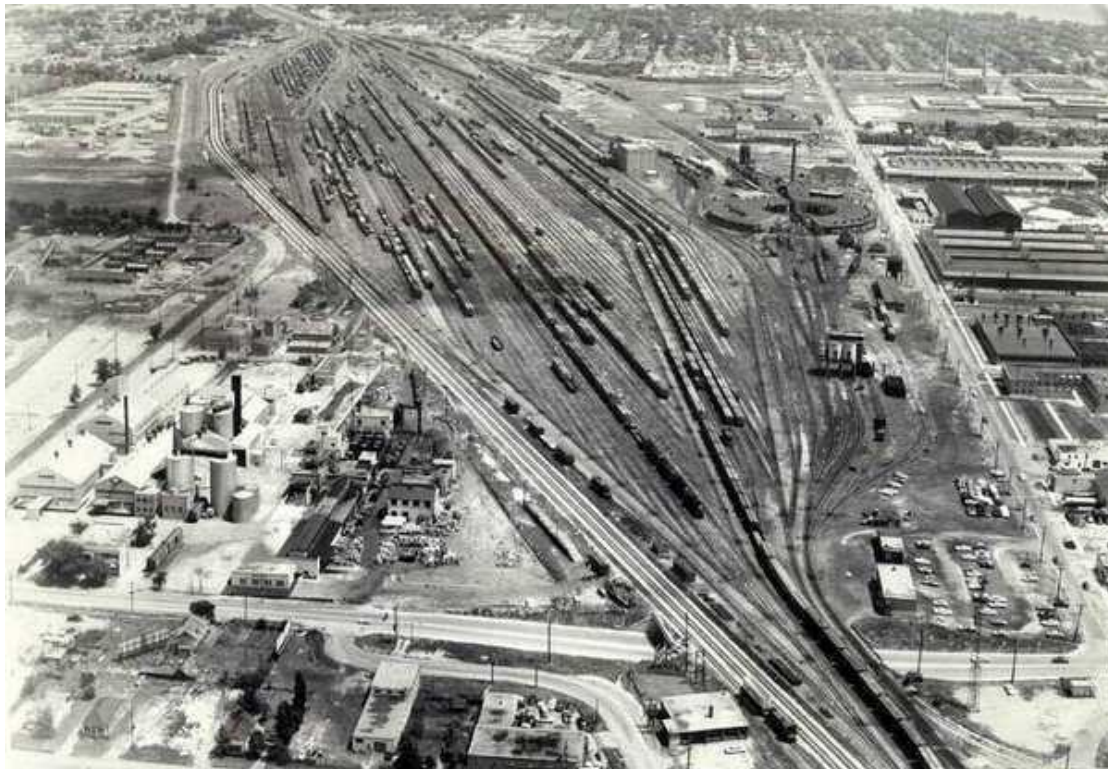
The CNR Mimico Terminal housed three separate railway departments, including the motive power department that operated the roundhouse and serviced steam engines, the car department that repaired freight cars, and the yard and traffic department that schedule and arranged the individual engine and cars into the 'consists' that make up each train. By the mid 1960s the facility was in a state of poor repair, and was in the process of being decommissioned by CNR (Mackenzie 2015). Aerial photography from 1947 demonstrates that the facility had several small structures present in the northwestern portion of the study area, potentially the de-icing facilities depicted in a 1953 archival photograph (Figures 9-2 and 9-7). Additional archival photographs of the facility demonstrate that the structures are difficult to discern due to the large size of trains relative to the structures and the overall scale of the facility (Figures 9-8 and 9-9).

Figure 9-8: CNR Mimico Yard, looking east with Kipling Avenue in foreground, circa 1960s (MacDonald, n.d.)

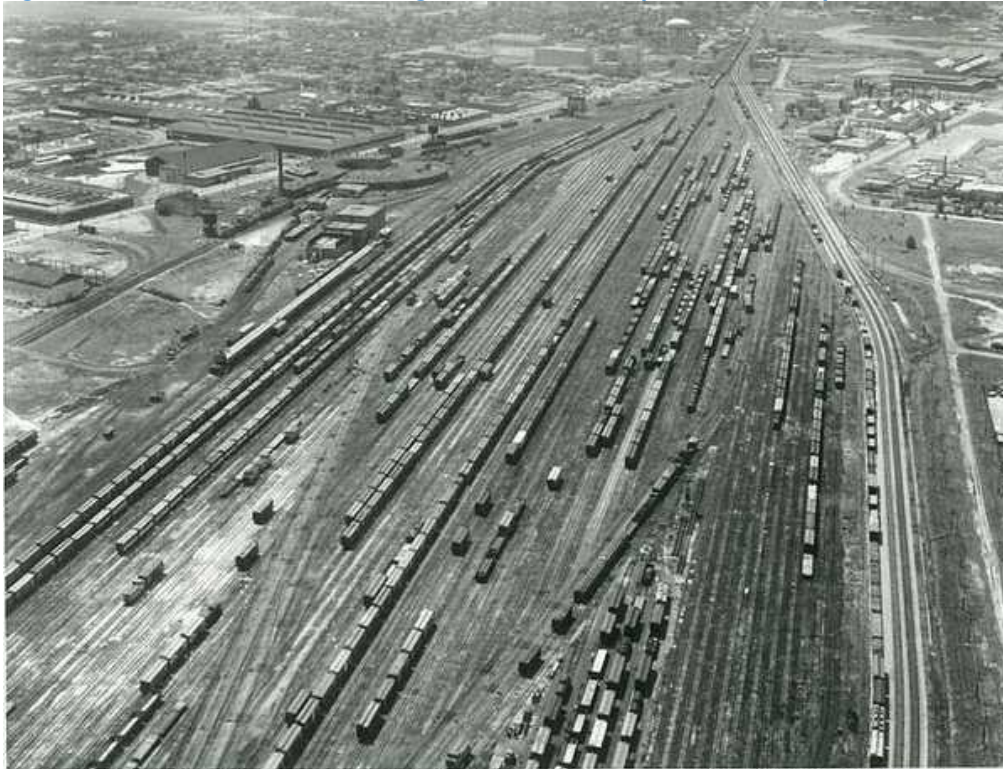
Figure 9-9: CNR Mimico Yard, looking west, circa 1960s (MacDonald n.d.)

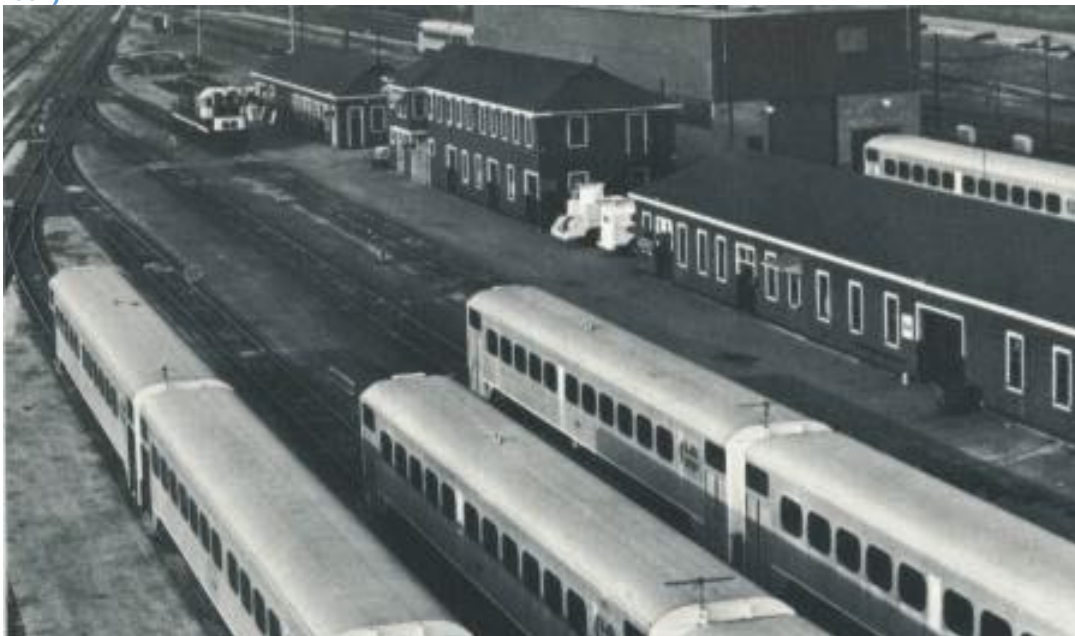
Figure 9-10: Structures in the northeast portion of the facility, looking east, circa 1965 (Sergeant 2004)

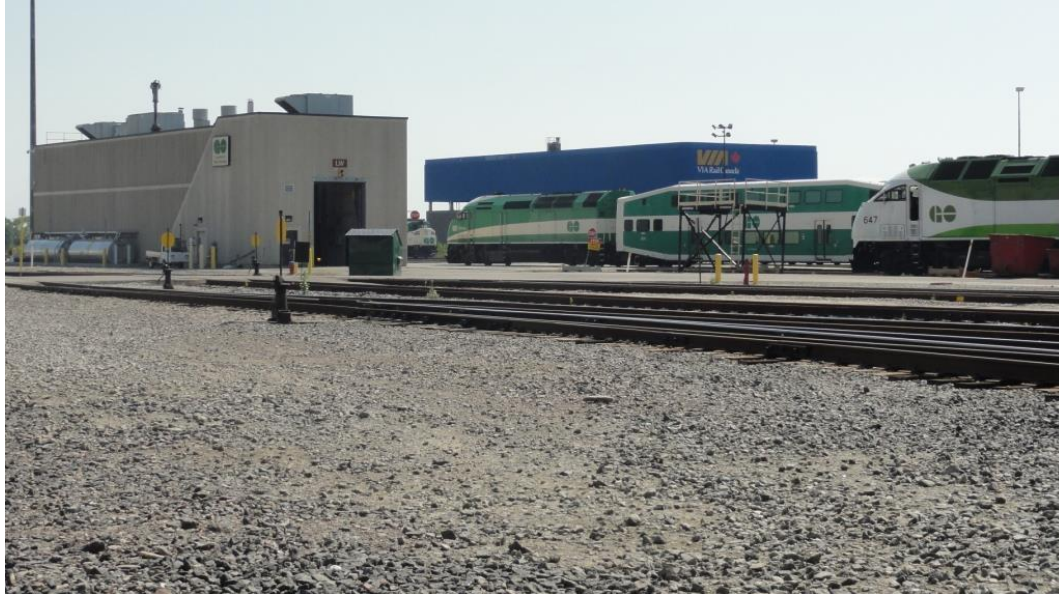
The Willowbrook Maintenance Facility is accessed by a pedestrian overhead bridge south of Judson Street between Magnificent Road and Etona Court, and by several other vehicular access points. The facility includes an array of tracks and switches, and several structures dedicated to a variety of maintenance and repair operations (Figures 9-12 to 9-15).

Figure 9-12: Study area showing Locomotive Wash (LW) building, tracks, and trains, looking southeast. Note the Via Rail maintenance facility at rear center.

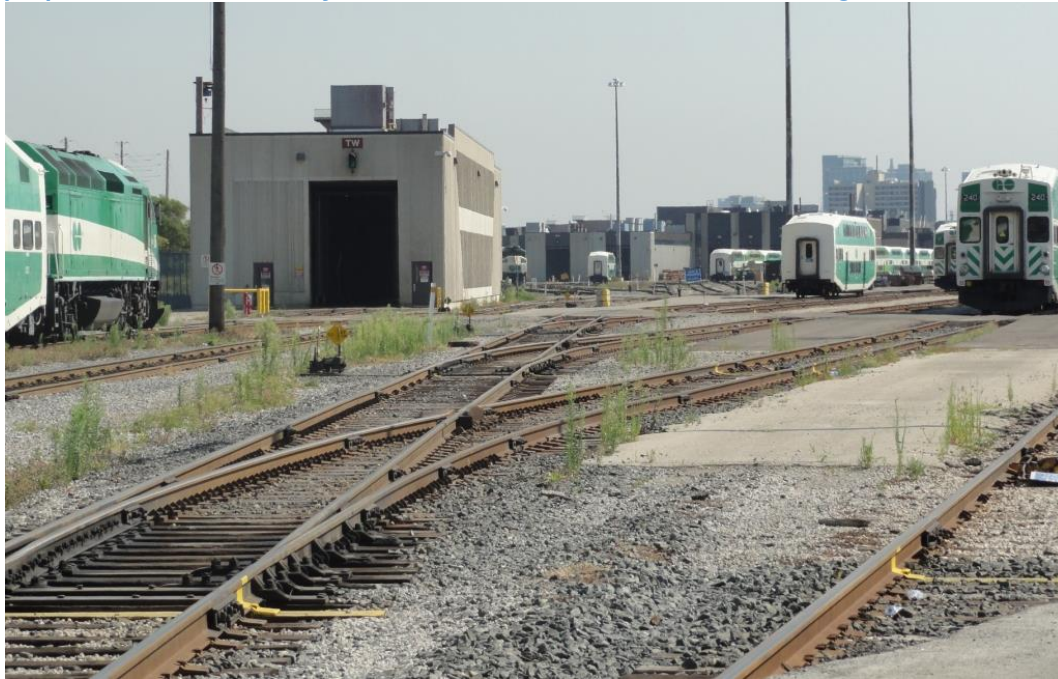
Figure 9-14: Western portion of the study area, looking north east with the Train Washing (TW) structure at left, PM Bays 1 and 2 at center rear, and rail lines in foreground.

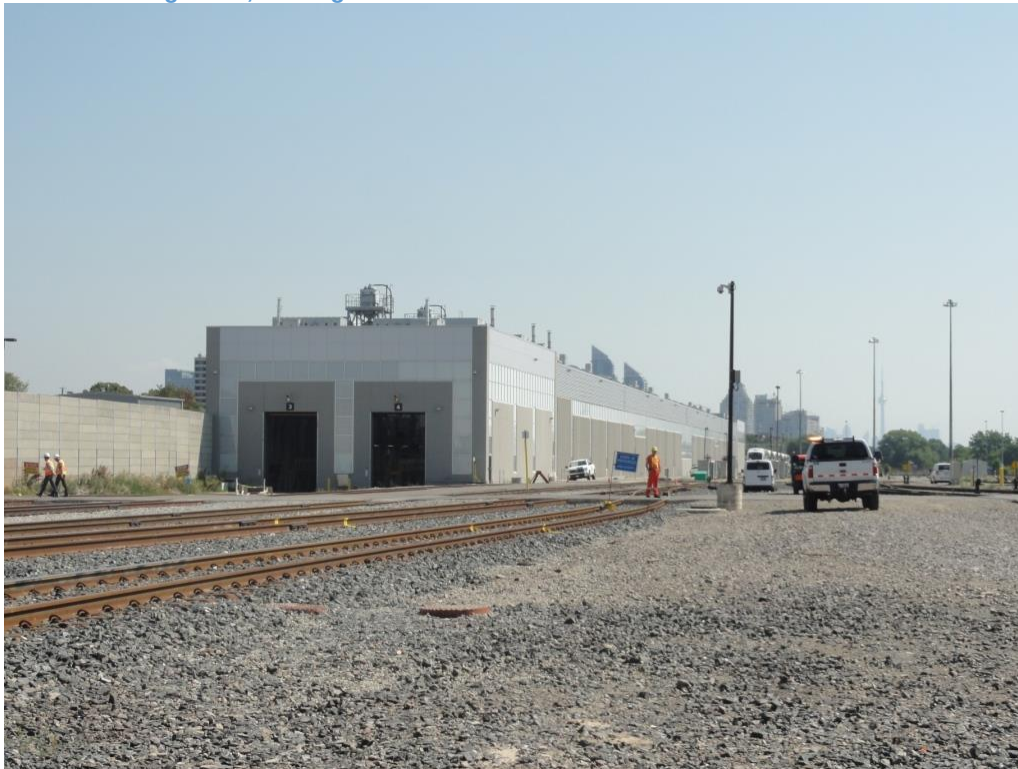
Figure 9-15: Northeast portion of the study area, with PM Bays 3 and 4 at rear and vehicular access in foreground, looking northeast.

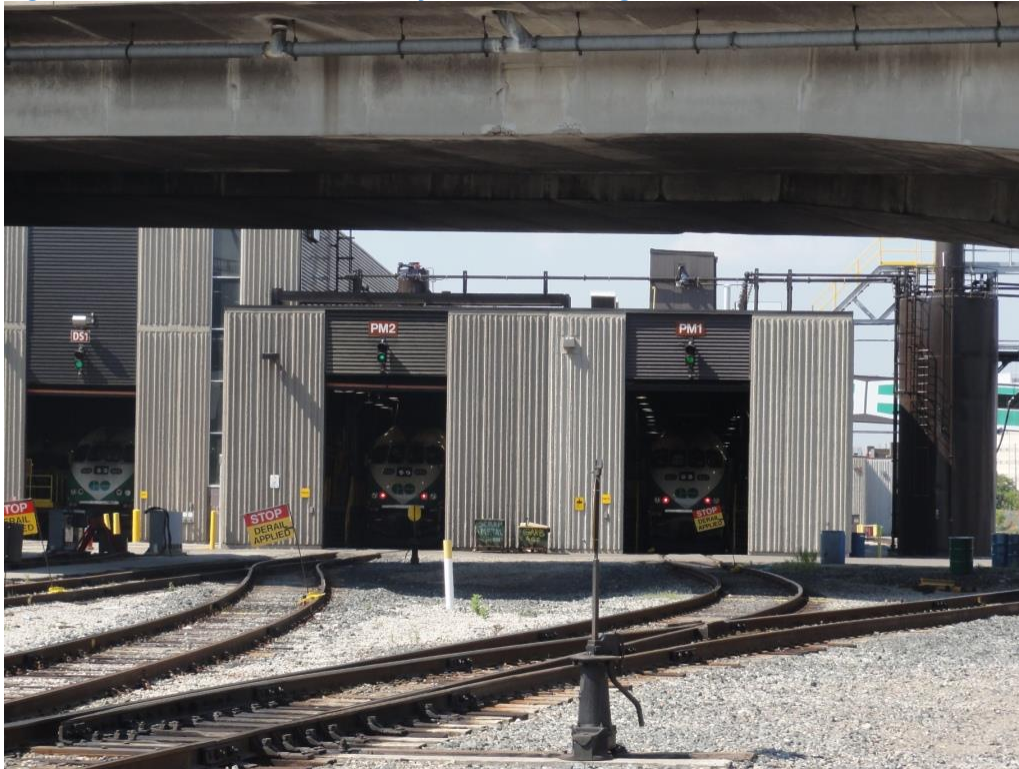
Figure 9-16: East elevation of PM Bays 1 and 2, looking southwest.

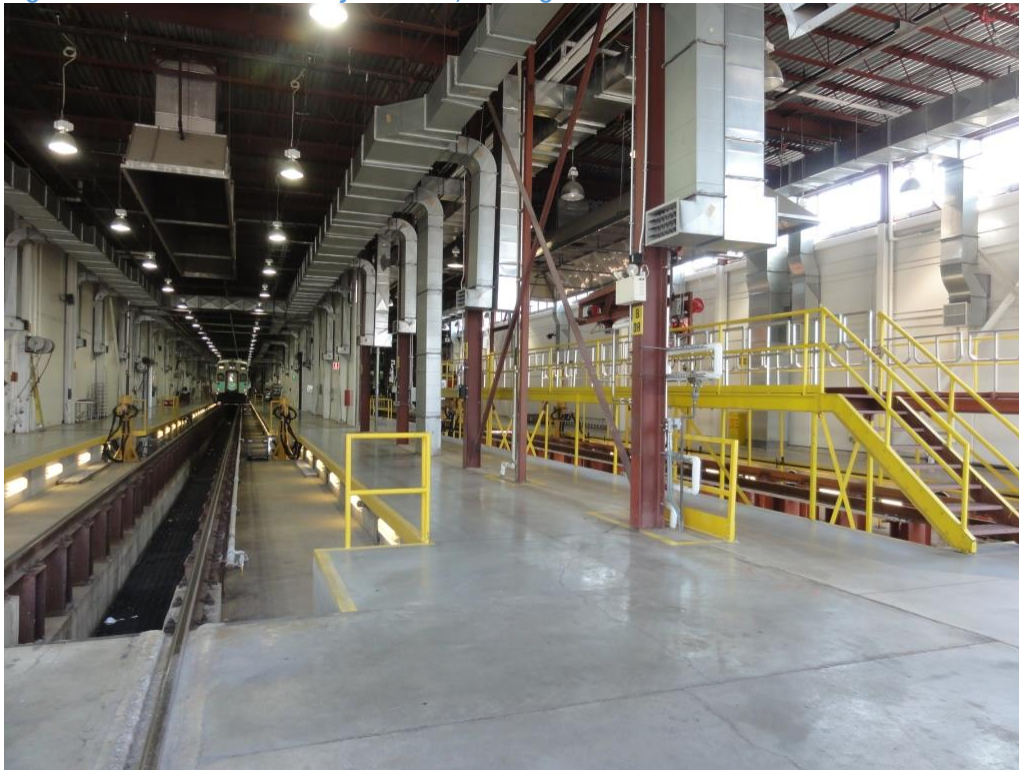
Figure 9-17: Interior of PM Bays 1 and 2, looking northeast.

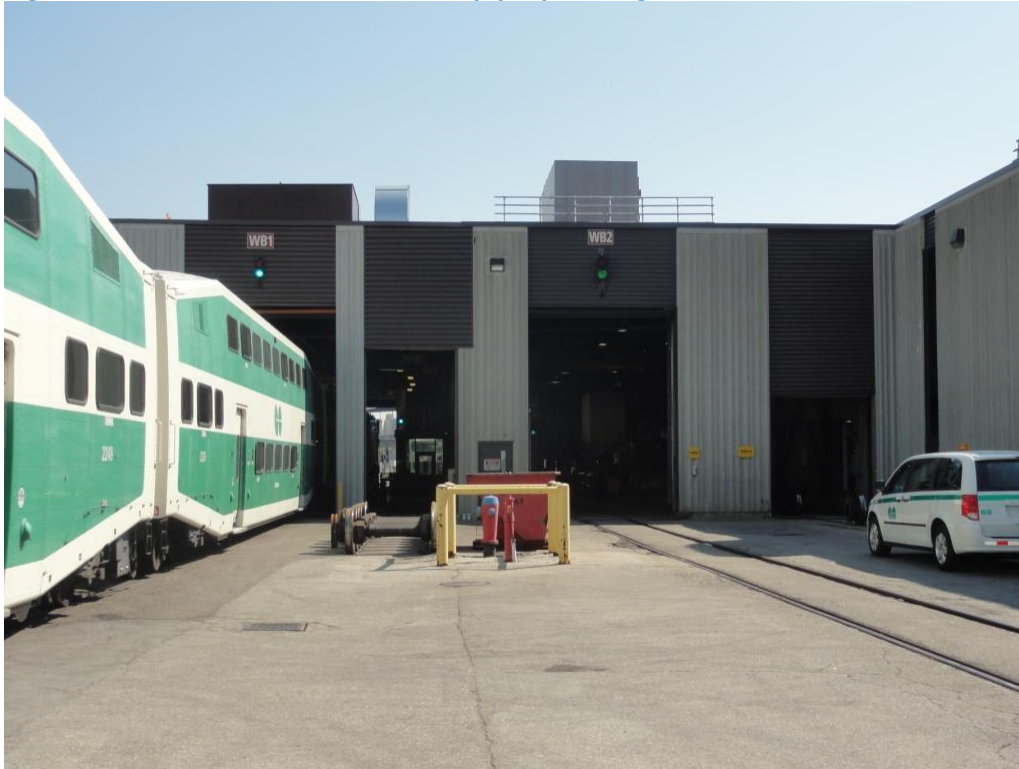
and measures approximately 63 metres in length, 22 metres in width, and is accessed by two rail tracks. The wheel shop is the site of wheel inspections, maintenance, and replacement, and has the ability to mill the wheels back into a perfectly round shape without removing them from the car (Figure 9-18). To the south of PM Bay 2, additional facilities dedicated to the repair of individual passenger coaches and individual diesel engines are located on the west and east ends, respectively. Coach Service (CS) Bays 1-3 are accessed by three tracks from the west, and are the site of scheduled maintenance or repairs to individual passenger coaches deemed too time and labour intensive to be conducted with the coach as part of a consist with a train in one of the Progressive Maintenance Bays (Figure 9-19). Diesel Service (DS) Bays 1-3 similarly are the site of repairs for the diesel engines that have been uncoupled from passenger coaches for individual servicing (Figure 9-20).

Figure 9-18: West elevation of Wheel Shop (WB), looking northeast.

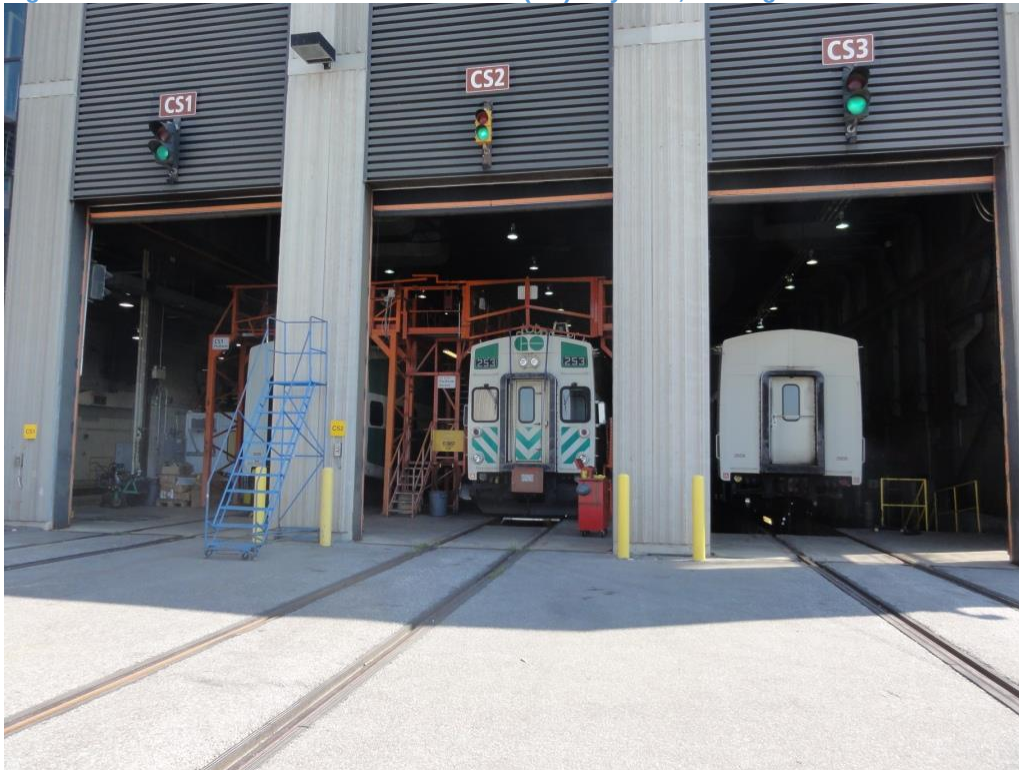
Figure 9-19: West elevation of Coach Service (CS) Bays 1-3, looking northeast.

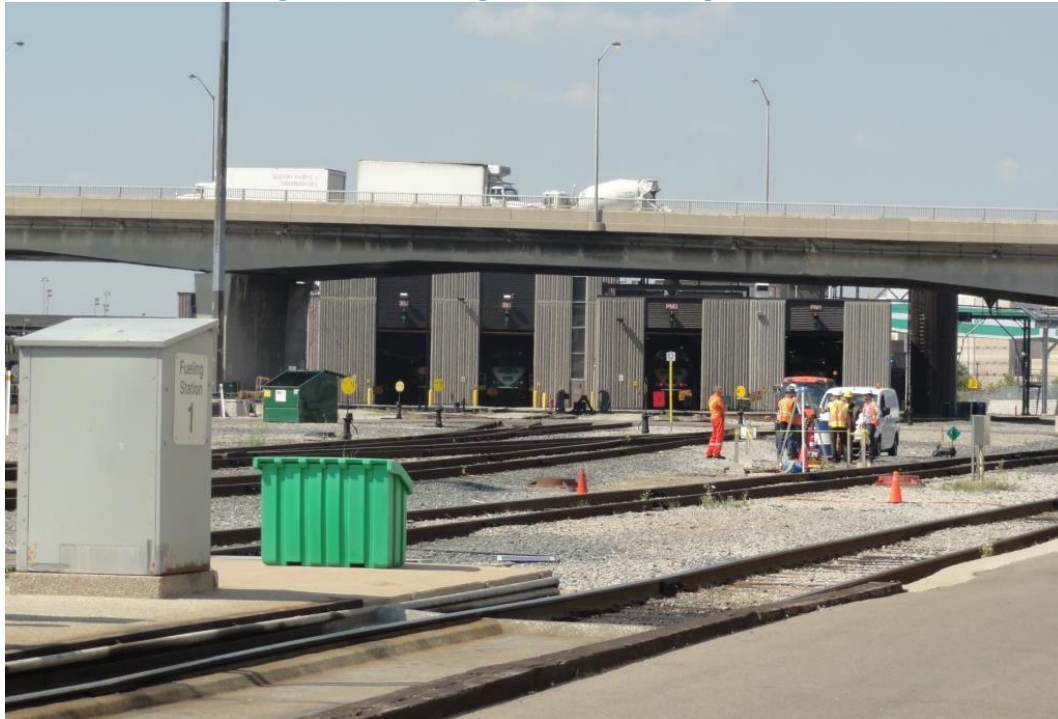
Figure 9-20: East elevation of PM Bays 1 and 2 at rear right, Diesel Service (DS) Bays 1 and 2 at rear left, with the Islington Avenue Bridge overhead, looking southwest.

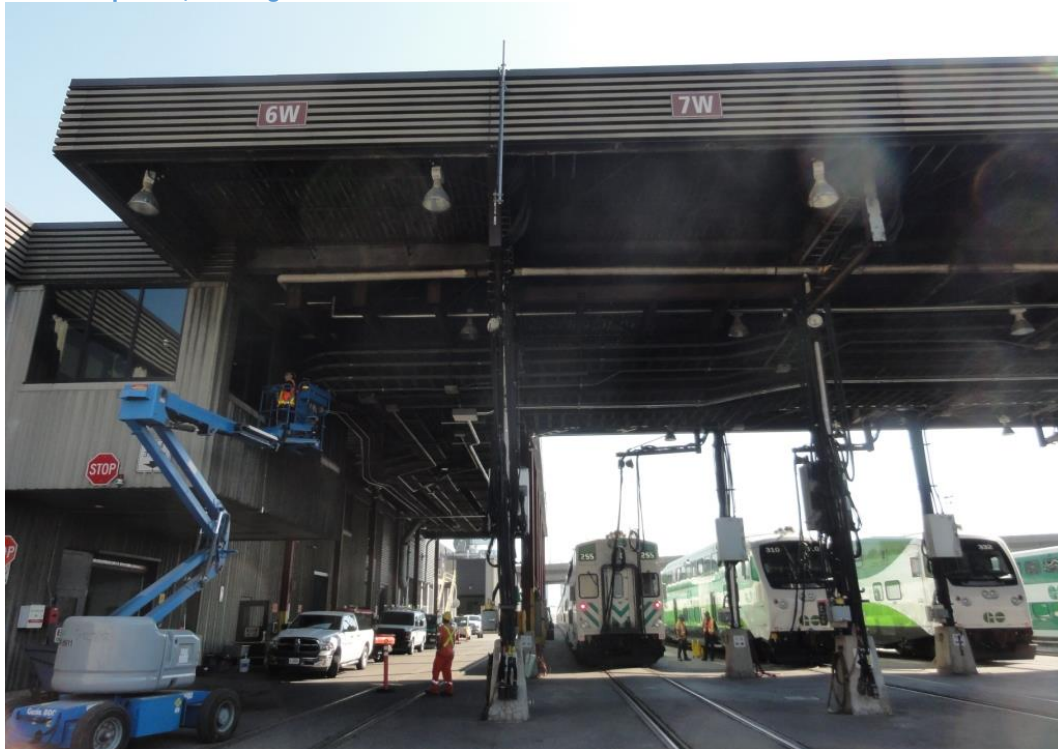
Figure 9-21: Auxiliary power canopy in southern yard, with trains hooked to auxiliary electrical power, looking northeast.

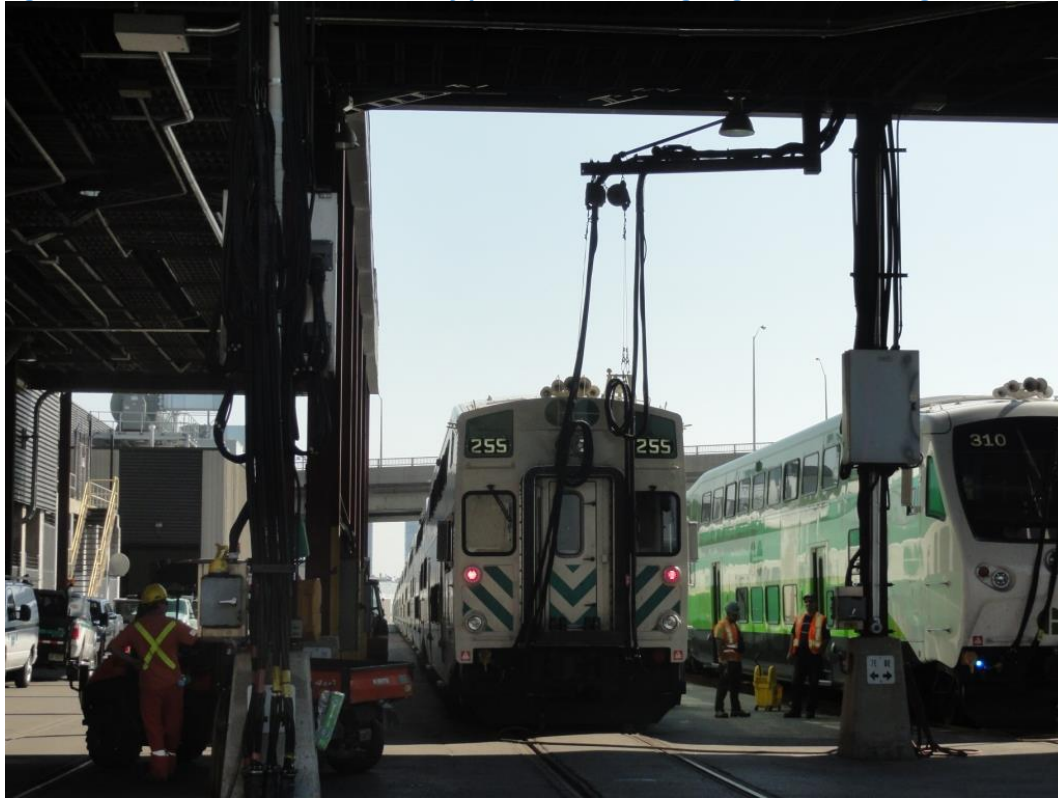
Figure 9-22: Train connected to auxiliary power while undergoing service, looking northeast.

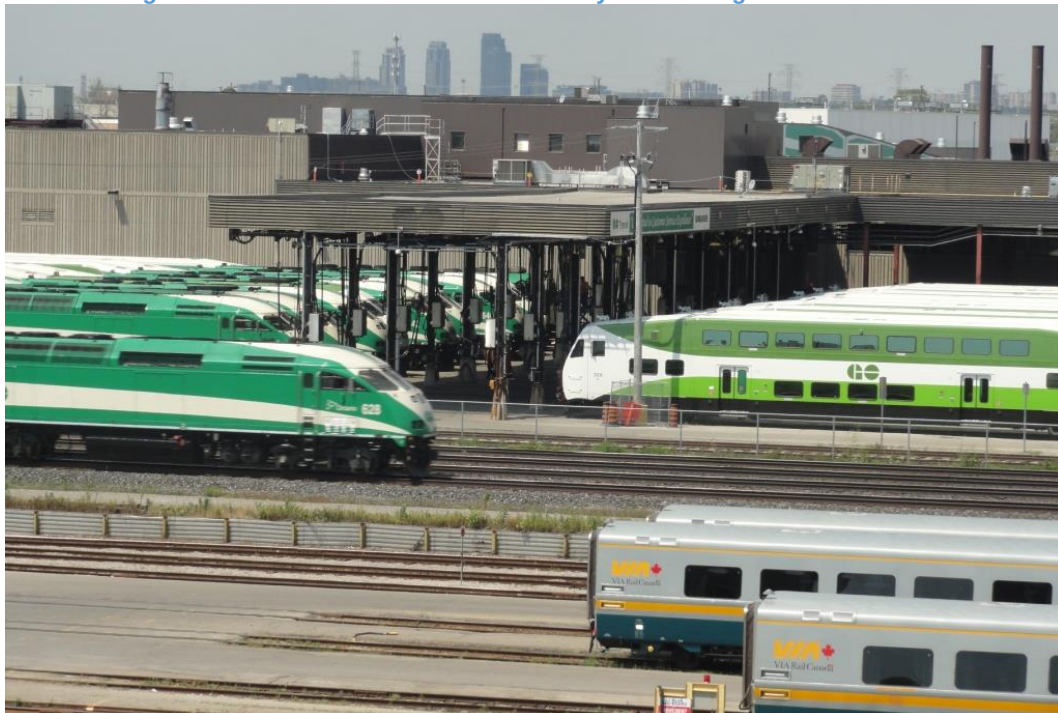
Figure 9-23: Train connected to auxiliary power during short-term storage, with train at left in foreground travelling eastbound on Lakeshore West Line, looking north from the Islington Avenue Bridge. Note the Via Rail maintenance facility in the foreground.

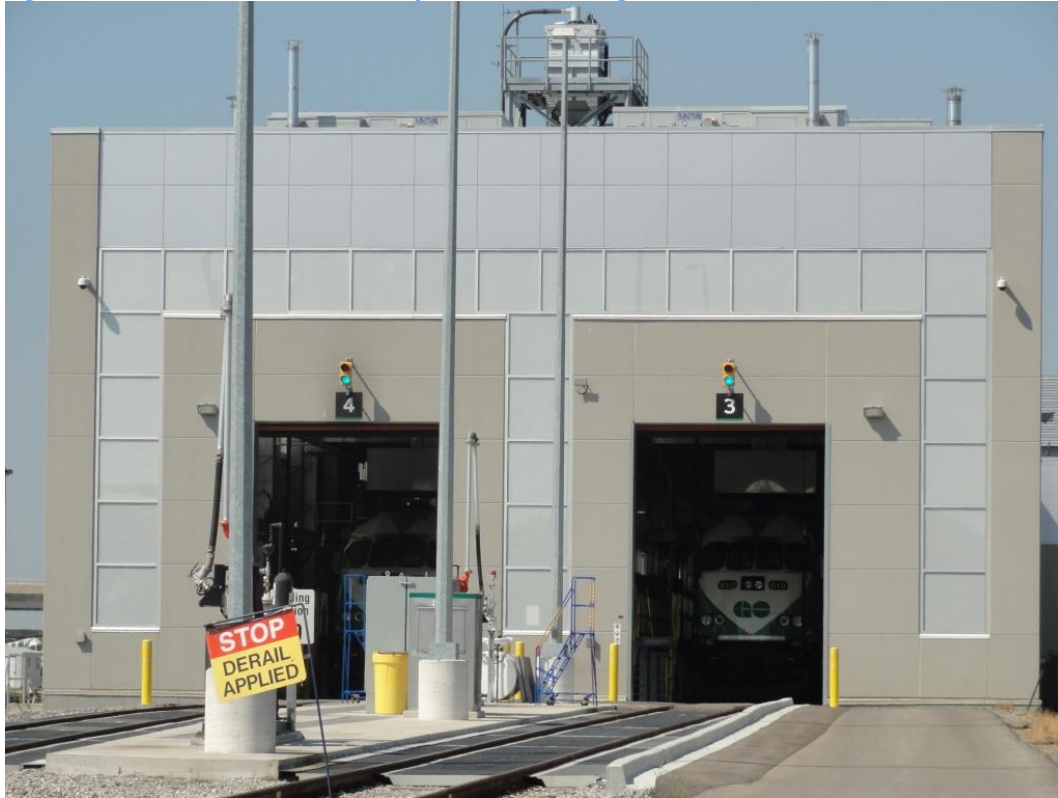
Figure 9-24: East elevation of PM Bays 2 and 4, looking southwest.

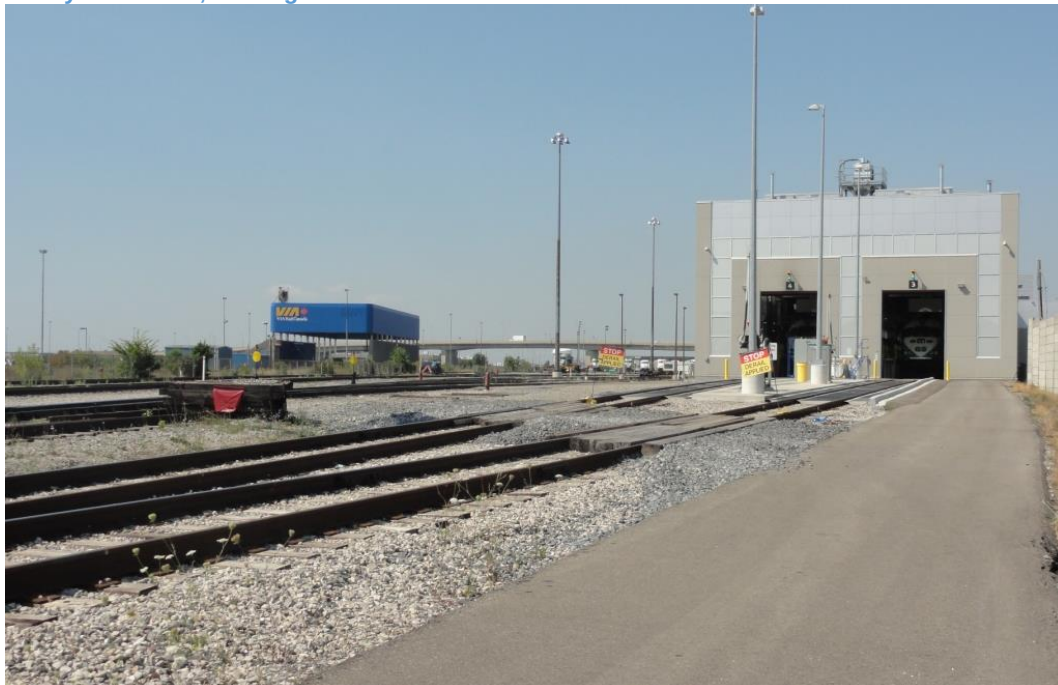
Figure 9-25: Train fueling station leading to PM Bays 3 and 4, with the Via Rail maintenance facility at rear left, looking southwest.

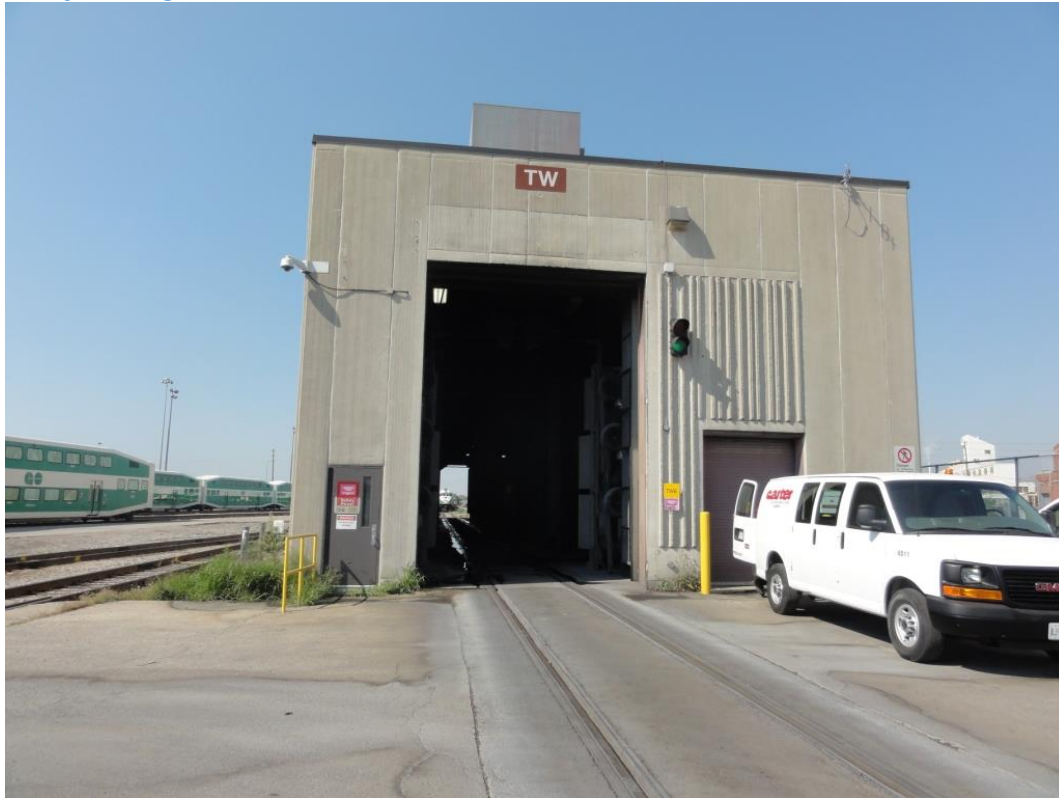
Figure 9-26: East elevation of Train Washing (TW) structure in the southwest portion of the facility, looking southwest.

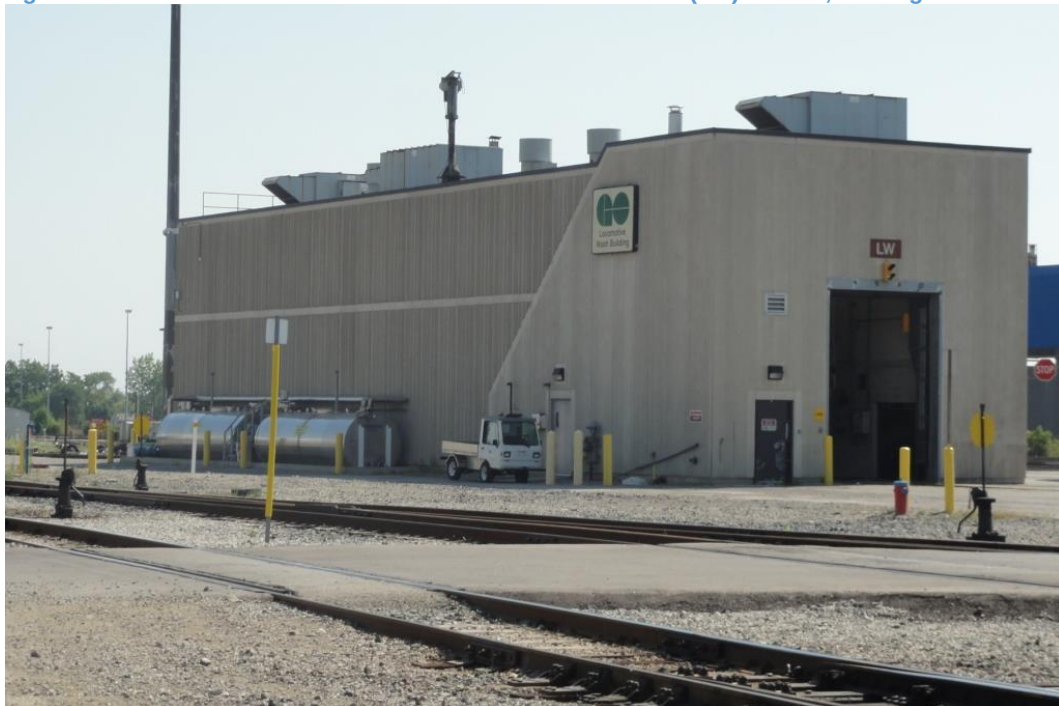
Figure 9-27: North and west elevations of Locomotive Wash (LM) station, looking southeast.

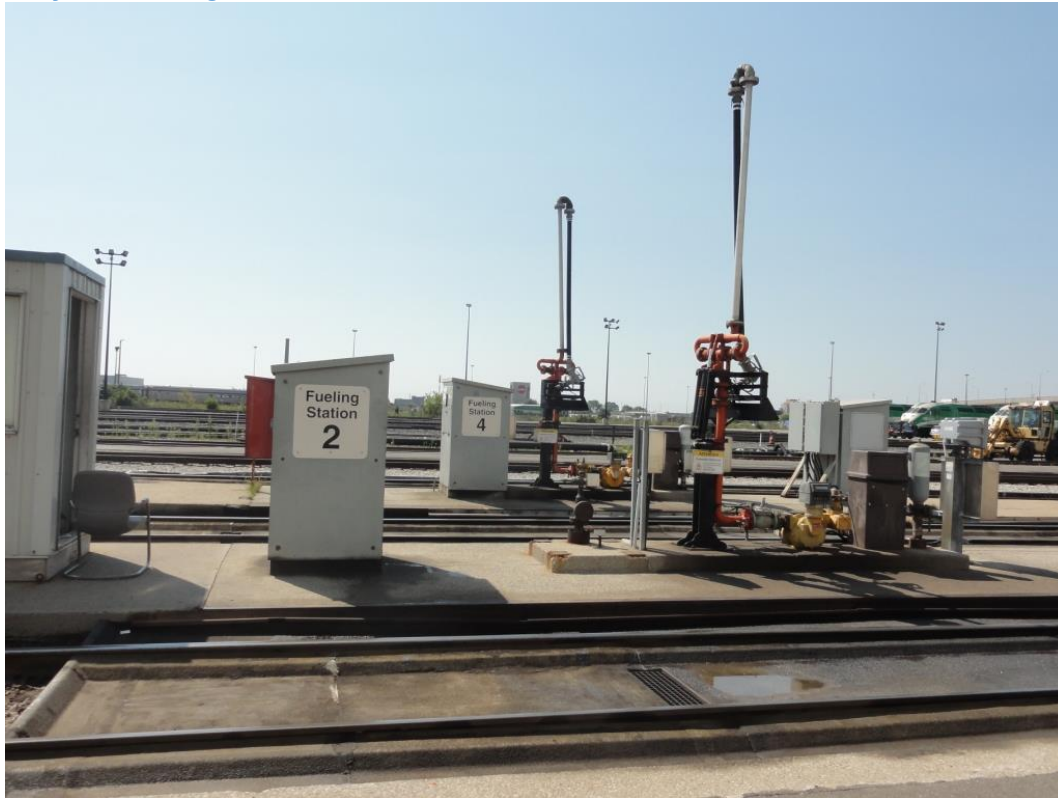
Figure 9-28: Fuelling stations to the east of PM Bays 3 and 4 in the northeast portion of the study area, looking south.

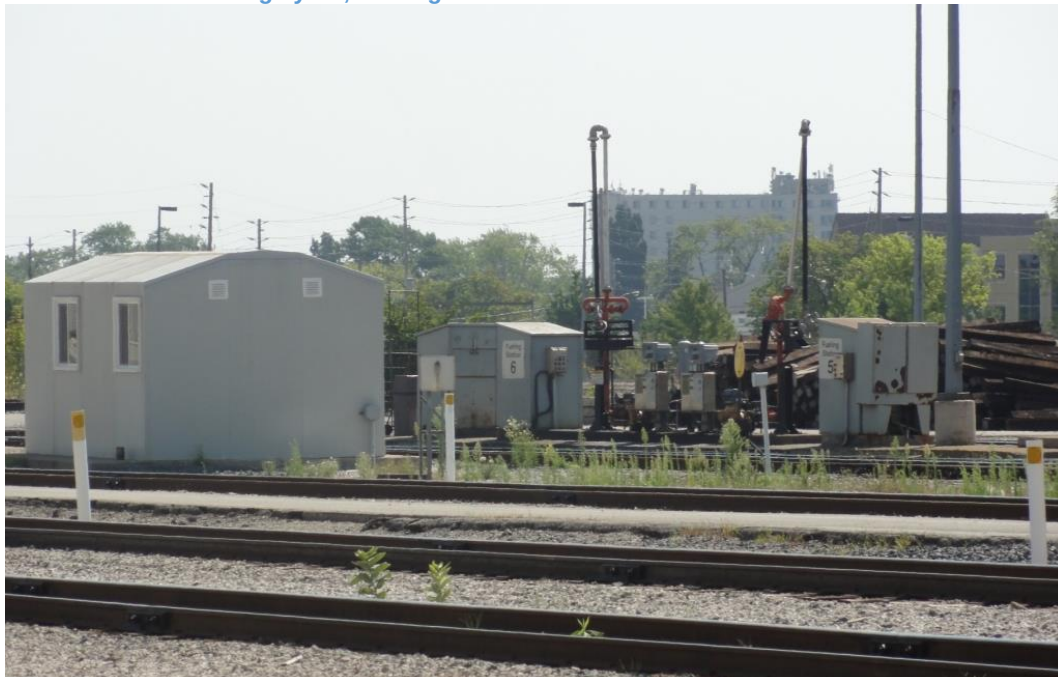
Figure 9-29: Fueling station and ancillary structures in the southern portion of the study area to the east of the storage yard, looking north.

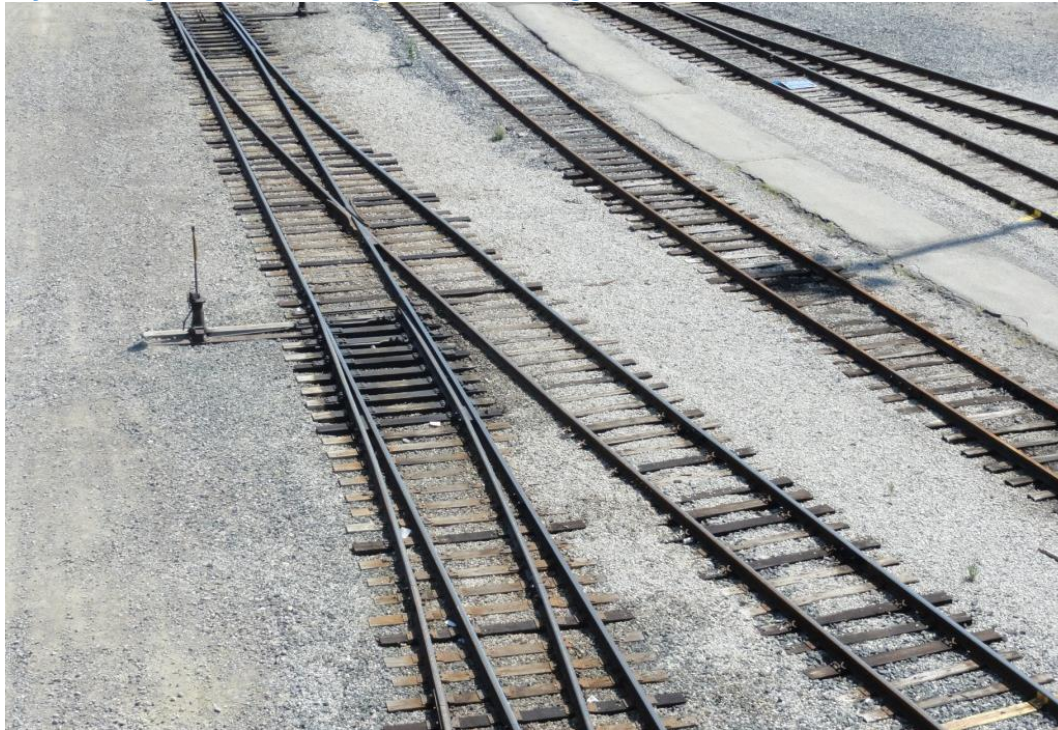
Figure 9-30: Track showing left and right hand turnouts leading to PM Bays 1 and 2 and DS Bays, looking east from the Islington Avenue Bridge.

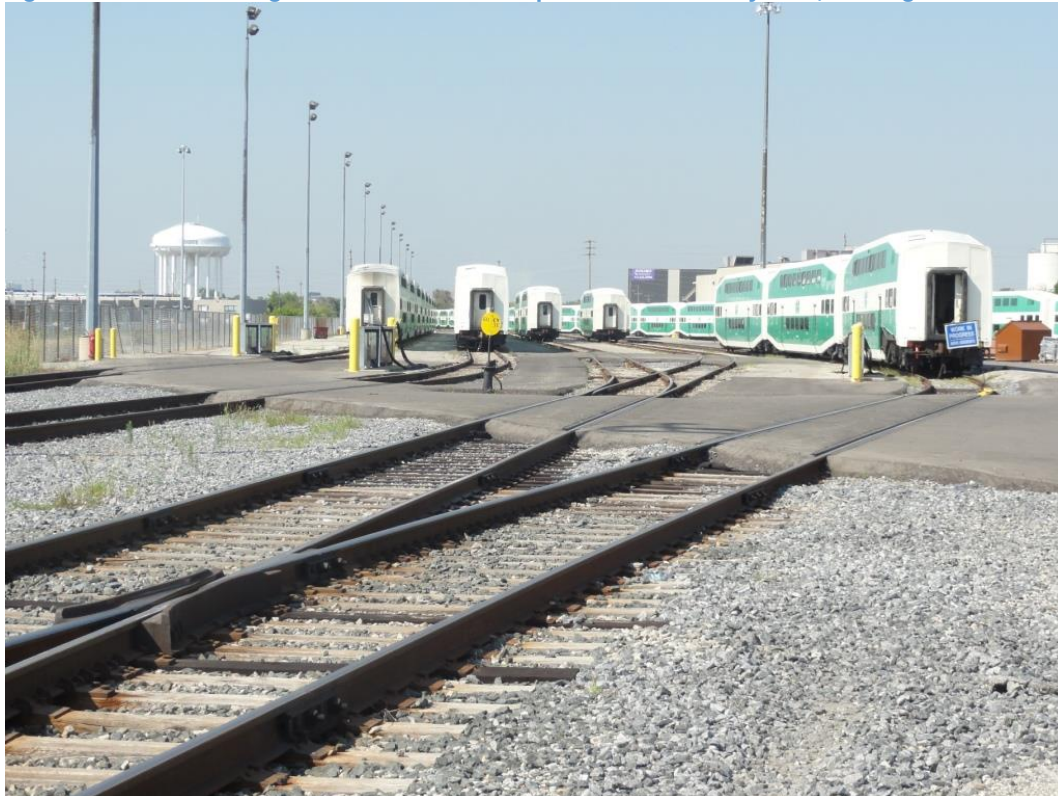
Figure 9-31: Train storage in the southwestern portion of the study area, looking southwest.

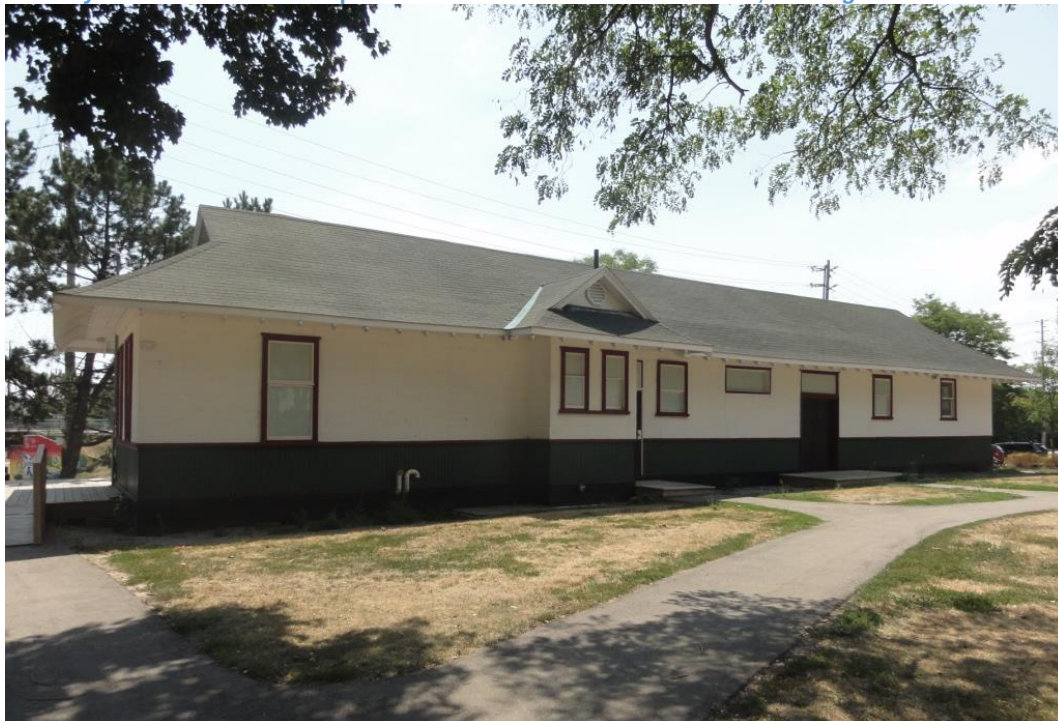
Figure 9-33: Original CNR Mimico Station, relocated to the northwest corner of Judson Street and Royal York Road in anticipation of condominium construction, looking southwest.

developer and relocated to the north side of Judson Street immediately west of Royal York Road, and now serves as a sales center. This station was originally located adjacent to the rail tracks, but was decommissioned with the construction of the extant Mimico GO Station in the late 1960s (Figure 9-33). This relocated CN Mimico Station is Designated under *Part IV* of the *Ontario Heritage Act*, however it is not considered adjacent to the study area, nor are there any anticipated impacts to it from the GO Rail Network TPAP.

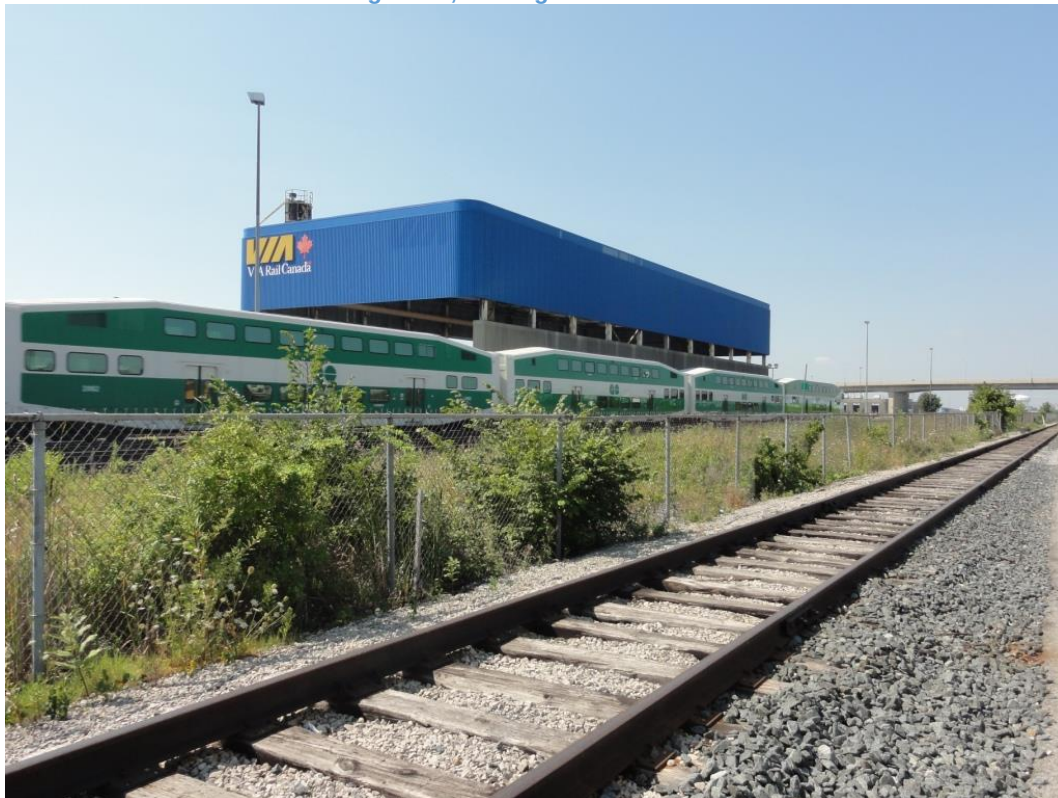
Figure 9-35: Via Rail Toronto Maintenance Center at rear, with train travelling westbound on Lakeshore West Corridor in foreground, looking southwest.

The area adjacent to the Willowbrook Maintenance Facility consists of industrial and commercial establishments to the north, with a residential area north of Judson Street on at the northeast corner of the study area (Figure 9-34). The southern limit of the maintenance facility is bounded primarily by the Lakeshore West Corridor, with the exception of a small portion in the southwest that extends south of the rail line. The Via Toronto Maintenance Center is directly adjacent to the southern study area limit (Figure 9-35).

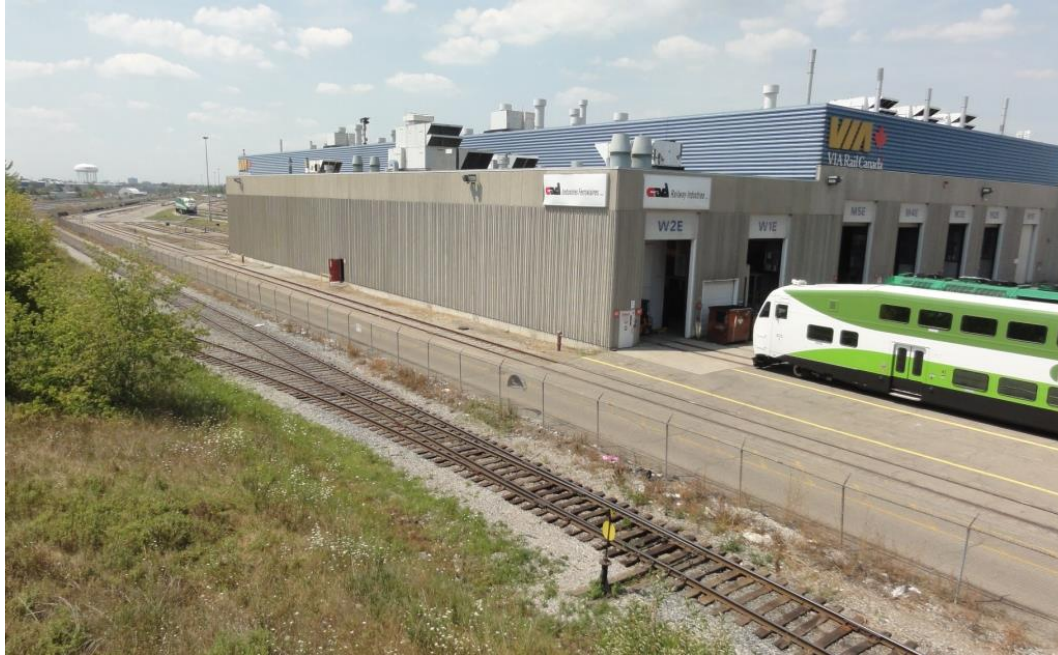
Figure 9-36: Via Rail Toronto Maintenance Facility, looking southwest from the Islington Avenue Bridge.

- Via Rail's Toronto Maintenance Facility- located directly south of the Lakeshore West Rail Corridor, adjacent to the Willowbrook Maintenance Facility (Via Rail n.d.) (Figure 9-37).
- Toronto Transit Commission's (TTC) Davisville Subway Yard, a municipal electrical subway maintenance and storage facility built in 1954 that was the original storage and maintenance yard for the Yonge-University Subway Line (Figure 9-37).
- TTC's Wilson Yard, a municipal electrical subway maintenance and storage facility built in 1978 that was built to accommodate the extra trains needed for the Yonge-University-Spadina Subway Line Extension.
- TTC's Greenwood Yard, a municipal electrical subway maintenance and storage facility built in 1965 that is the main storage and maintenance yard for the Bloor-Danforth Subway Line (Adel and Bow 2015) (Figure 9-38).

Section 9.5 includes images to provide a comparison between like maintenance facilities (Figures 9-36 to 9-38).
