### **Cultural Heritage Evaluation Report – Willowbrook Maintenance Facility**

**GO Rail Network Electrification TPAP**  
**Final Cultural Heritage Evaluation Report:**  
**Willowbrook Maintenance Facility**

**Metrolinx Electrification Project**

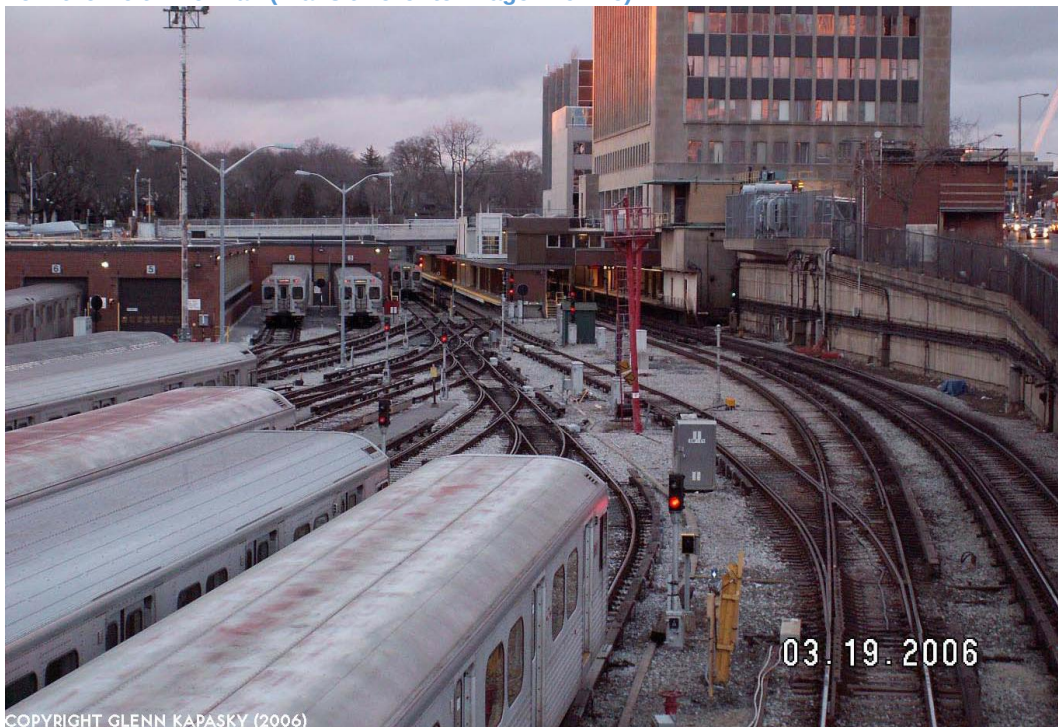
Figure 9-37: Toronto Transit Commission's Davisville Subway Yard in 2006, looking north from the Belt Line Trail (Transit Toronto Image Archive).

- Via Rail's Toronto Maintenance Facility- located directly south of the Lakeshore West Rail Corridor, adjacent to the Willowbrook Maintenance Facility (Via Rail n.d.) (Figure 9-37).
- Toronto Transit Commission's (TTC) Davisville Subway Yard, a municipal electrical subway maintenance and storage facility built in 1954 that was the original storage and maintenance yard for the Yonge-University Subway Line (Figure 9-37).
- TTC's Wilson Yard, a municipal electrical subway maintenance and storage facility built in 1978 that was built to accommodate the extra trains needed for the Yonge-University-Spadina Subway Line Extension.
- TTC's Greenwood Yard, a municipal electrical subway maintenance and storage facility built in 1965 that is the main storage and maintenance yard for the Bloor-Danforth Subway Line (Adel and Bow 2015) (Figure 9-38).

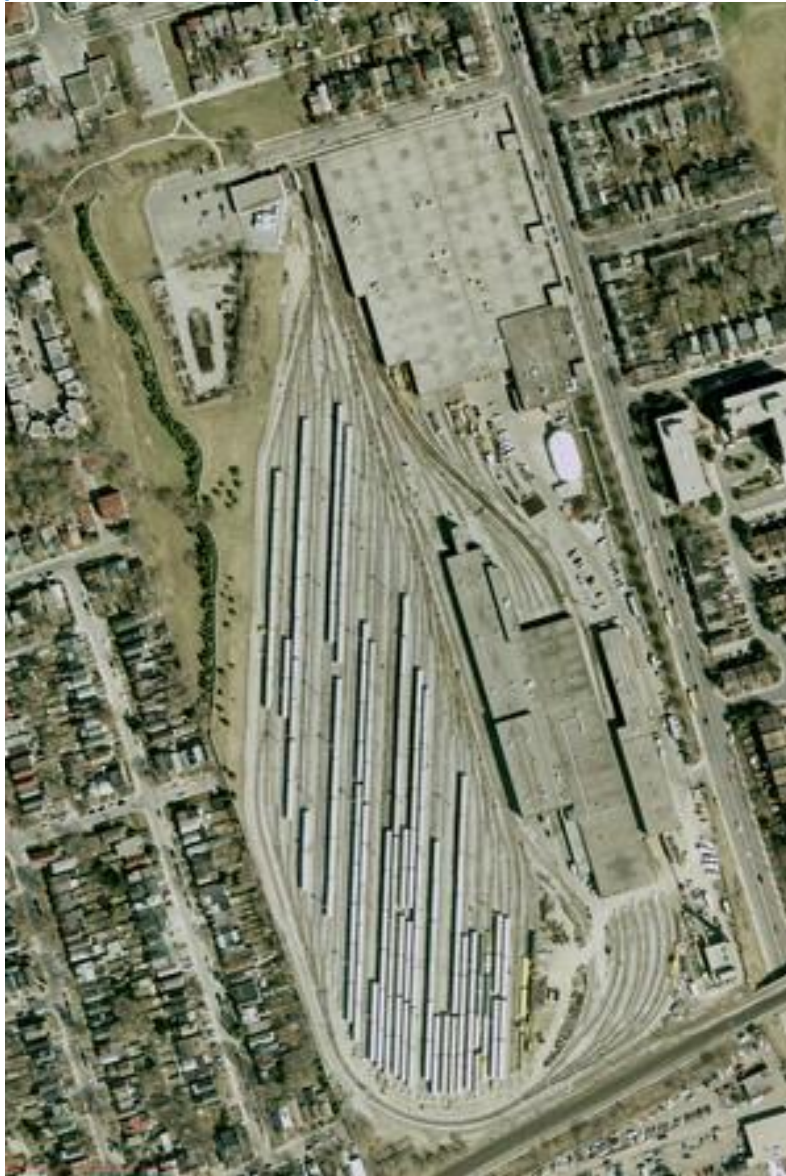
Figure 9-38: TTC's Greenwood Subway Yard from satellite imagery.  
(Transit Adel and Bow 2015)
