**DURHAM-SCARBOROUGH BUS RAPID TRANSIT PROJECT
CULTURAL HERITAGE REPORT – EXISTING CONDITIONS AND PRELIMINARY IMPACT ASSESSMENT
CITY OF TORONTO AND DURHAM REGION, ONTARIO**

ASI File: 18CH-142

October 2019 (Revised June and October 2020;
January, May, November and December 2021; January and February 2022)

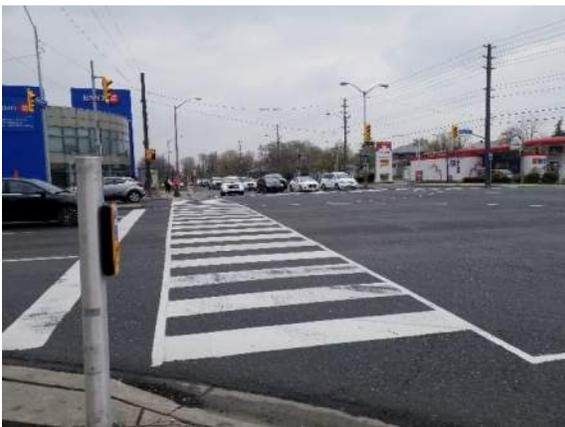
Plate 1: The Project Study Area at the intersection of Ellesmere Road and McCowan Road, looking east.

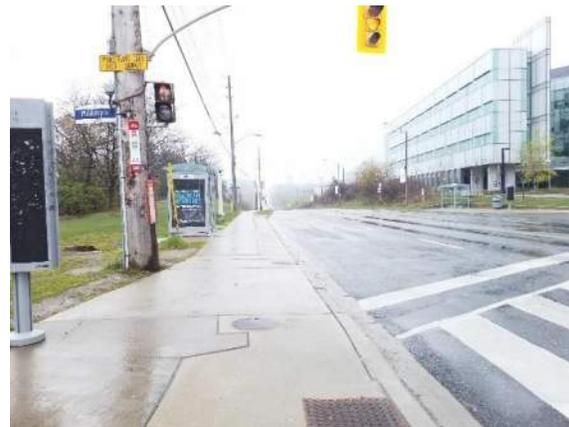
Plate 2: View of the Project Study Area at the intersection of Ellesmere Road and eastern end of Military Trail, looking west towards Highland Creek.

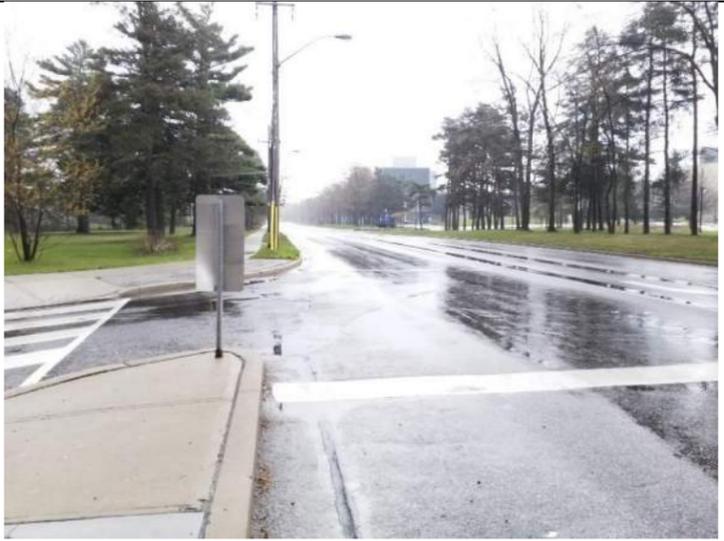
Ref #	Type of Cultural Heritage Resource	Type of Property	Location	Heritage Recognition	Description of Property and Known or Potential CHVI	Photographs/ Digital Image
TO-003	BHR	Residence	3307 Ellesmere Rd, Toronto	Potential BHR - Identified During Desktop/Field Review	<p>Property Description</p> <ul style="list-style-type: none"> - The property features a one-and-a-half storey frame house with a front gable roof and a covered entrance that includes a ramp down to the driveway. - The middle of the roof has a chimney and there is a small attached rear addition that is the same width of the house. - Rectangular lot located on the south side of Ellesmere Road, an early transportation route. - Reflects twentieth-century residential settlement in Scarborough Township. <p>Potential Cultural Heritage Value or Interest and associated heritage attributes This property has the potential to retain historical and contextual value.</p>

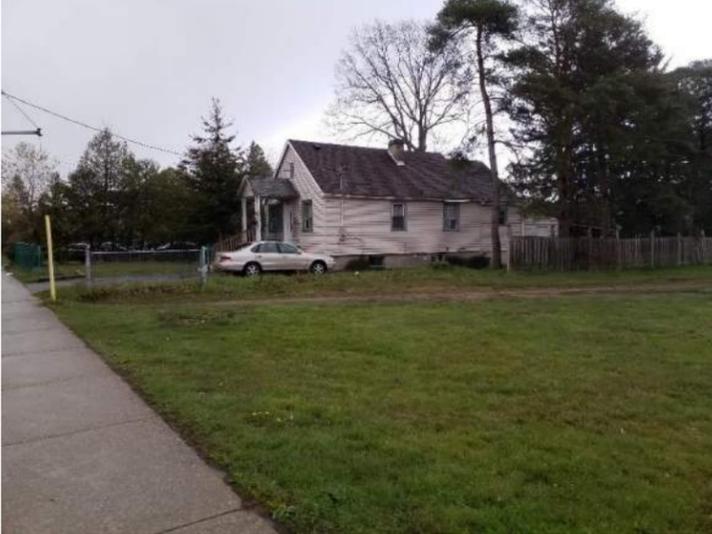
TO-004	BHR	Residence	3344 Ellesmere Rd, Toronto	Potential BHR - Identified During Desktop/Field Review	<p>Property Description</p> <ul style="list-style-type: none"> - The property features a detached one-and-a-half storey frame house with an L shaped footprint. It has a front and side gable roof and a multi-paned bay window to the left of the front entrance. - The house is set close to the road and has a large detached garage located directly behind the house. - Located on the north side of Ellesmere Road, an early transportation route. - It reflects late nineteenth-century settlement on Ellesmere Road in Scarborough Township. <p>Potential Cultural Heritage Value or Interest and associated heritage attributes This property has the potential to retain historical, architectural, and contextual value.</p>

BHR/CHL Reference Number	Address	Required Assessment
TO-004	3344 Ellesmere Rd, Toronto	A CHER is recommended. A CHER has been prepared (ASI 2021b) and this property was found to meet <i>Ontario Regulation 9/06</i> . The property does not have CHVI under <i>Ontario Regulation 10/06</i> . A HIA is recommended in detailed design.
TO-011	3832 Ellesmere, Rd Toronto	A CHER is recommended. A CHER has been prepared (ASI 2021b) and this property was determined to not retain CHVI under <i>Ontario Regulations 9/06 or 10/06</i> .
PK-003	357 Kingston Rd, Pickering	A CHER is recommended. A CHER has been prepared (ASI 2021c) and this property was determined to not retain CHVI under <i>Ontario Regulations 9/06 or 10/06</i> . Note that the CHER determined the correct address for this property is 365 Kingston Road, Pickering.
PK-018	1723 Dunchurch St, Pickering	A CHER is recommended.

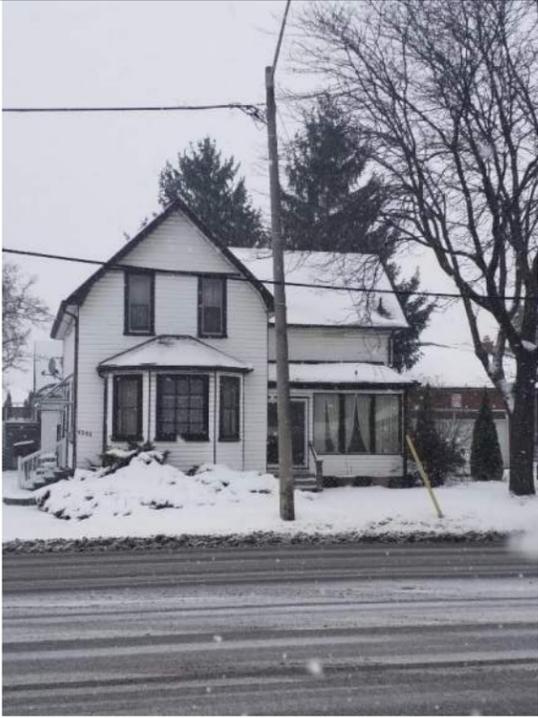
Ref #	Type of Cultural Heritage Resource	Type of Property	Location	Heritage Recognition	Description of Property and Known or Potential CHVI	Photographs/ Digital Image
TO-005	BHR	Church	525 Morrish Rd, Toronto	Potential BHR - Identified During Desktop/Field Review	<p>Property Description</p> <ul style="list-style-type: none"> - The property features the large Byzantine-influenced Ukrainian Orthodox Church of St. Anne, founded in 1958, and a late-twentieth-century residence that forms part of this property. - The church has three towers with domed tops, a high pedimented portico supported by four columns over the front entrance, large central staircase and a large multi-paned arch window above the front doors. - Located east of Morrish Road and north of Ellesmere Road, an early transportation route, set back from the road. - Reflects modern religious establishments along Ellesmere Road in Scarborough Township. <p>Potential Cultural Heritage Value or Interest and associated heritage attributes This property has the potential to retain architectural, and contextual value.</p>

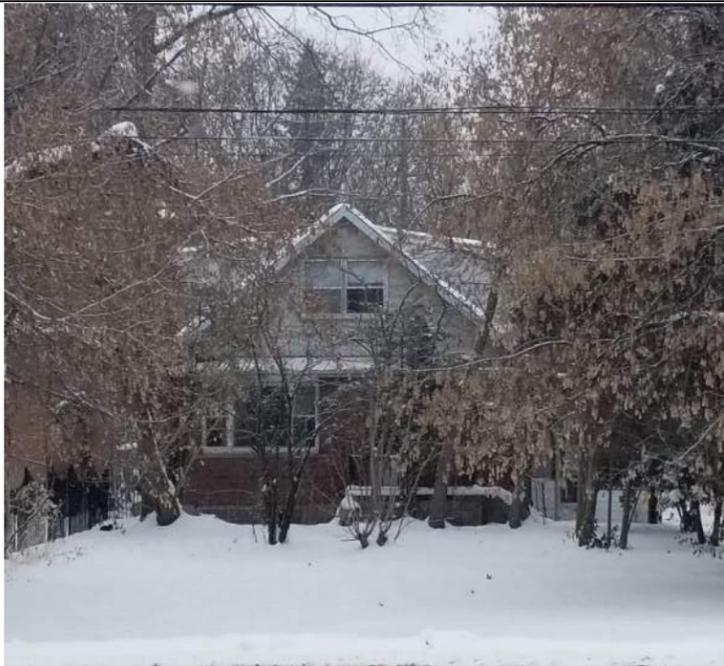
Ref #	Type of Cultural Heritage Resource	Type of Property	Location	Heritage Recognition	Description of Property and Known or Potential CHVI	Photographs/ Digital Image
TO-007	BHR	Residence	3695 Ellesmere Rd, Toronto	Potential BHR - Identified During Desktop/Field Review	<p>Property Description</p> <ul style="list-style-type: none"> - The property features a one-and-a-half storey frame house with gable roof, a small back deck and an enclosed front porch. - The façade and side of the house feature one-over-one pane windows on both levels. - Located on the south side of Ellesmere Road, an early transportation route, set back from the road. - Reflects nineteenth-century settlement in Scarborough Township. <p>Potential Cultural Heritage Value or Interest and associated heritage attributes This property has the potential to retain historical and contextual value.</p>

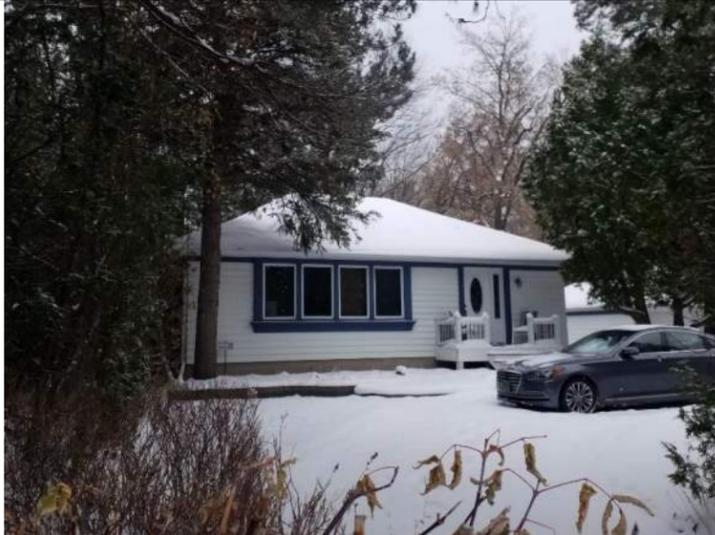
Ref #	Type of Cultural Heritage Resource	Type of Property	Location	Heritage Recognition	Description of Property and Known or Potential CHVI	Photographs/ Digital Image
TO-009	BHR	Residence	103 Deep Dene Dr, Toronto	Potential BHR - Identified During Desktop/Field Review	<p>Property Description</p> <ul style="list-style-type: none"> - The property features a one storey frame house that has a chimney and a multitiered roof with a front gable facing Deep Dene Drive. - The façade is separated into three parts. Two sections have symmetrical, multipaned, rectangular windows. The third section is an entrance way with the same style of windows offset to the left. - Located on a corner lot, south of Ellesmere Road, an early transportation route and on the eastern side of Deep Dene Drive. - It reflects twentieth-century settlement in Scarborough Township. <p>Potential Cultural Heritage Value or Interest and associated heritage attributes This property has the potential to retain historical and contextual value.</p>

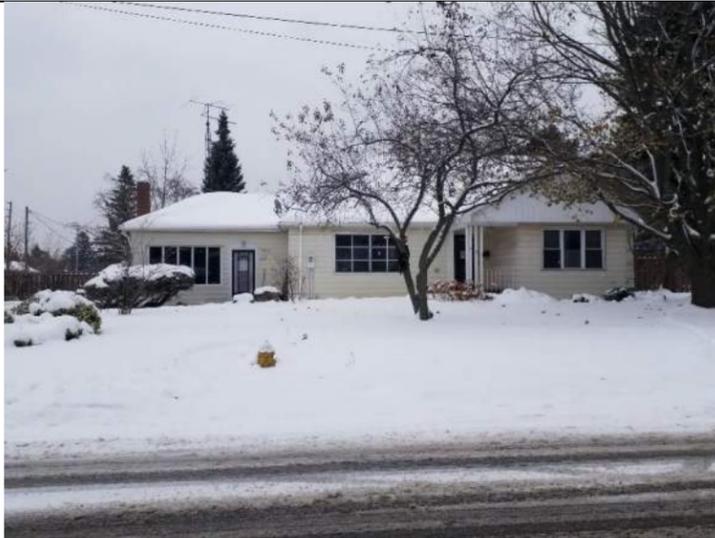
TO-010	BHR	Residence	6 Zaph Ave, Toronto	Potential BHR - Identified During Desktop/Field Review	<p>Property Description</p> <ul style="list-style-type: none"> - The property features a two-and-a-half storey, three-bay frame house with gable roof, wood siding, and Gothic influences. - There are two stone chimneys at the gable ends with a gothic window in the gable dormer above the central entrance on the front elevation. - The front entrance has a covered porch supported by several columns and the first and second storey have one-over-one pane windows. - Located on a corner lot on the north side of Ellesmere Road, an early transportation route, and on the west side of Zaph Avenue (fronting Zaph). - Reflects nineteenth-century settlement in Scarborough Township. <p>Potential Cultural Heritage Value or Interest and associated heritage attributes This property has the potential to retain historical, architectural, and contextual value.</p>

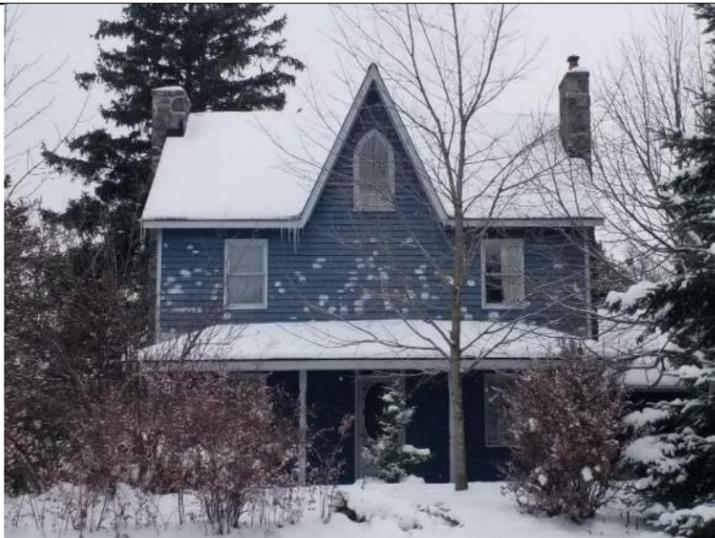
Ref #	Type of Cultural Heritage Resource	Type of Property	Location	Heritage Recognition	Description of Property and Known or Potential CHVI	Photographs/ Digital Image
TO-011	BHR	Residence	3832 Ellesmere, Rd Toronto	Potential BHR - Identified During Desktop/Field Review	<p>Property Description</p> <ul style="list-style-type: none"> - The property features a one storey frame house with an L shaped footprint and an attached garage. - Two chimneys are on opposite sides of the roof. - The garage has a front gable as does the façade of the house. - Rectangular, paneled windows with two toned awnings. - The driveway entrance is flanked by two stone columns. - Located on the north side of Ellesmere Road, an early transportation route. - Reflects early twentieth-century settlement in Scarborough Township. <p>Potential Cultural Heritage Value or Interest and associated heritage attributes This property has the potential to retain historical and contextual value.</p>

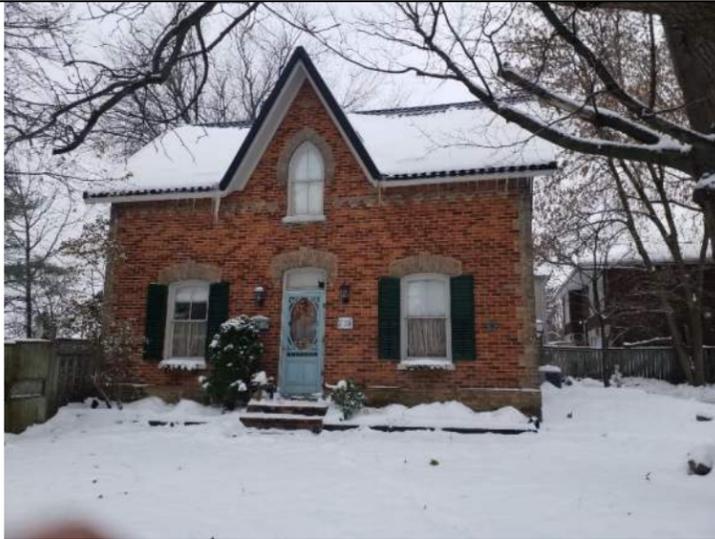
Ref #	Type of Cultural Heritage Resource	Type of Property	Location	Heritage Recognition	Description of Property and Known or Potential CHVI	Photographs/ Digital Image
TO-013	CHL	Church and Residence	6540-6550 Kingston Rd, Toronto	Known CHL - Part IV Designation (By-law #19127)	<p>Property Description</p> <ul style="list-style-type: none"> - The property features a twentieth-century one-and-a-half storey stone house, a brick Church built in 1891 and a single-storey brick church hall built in 1950. - The house has one chimney, one attached single car garage, a side gabled roof and two dormer windows. There are steps up to the entrance which is covered by an awning. - The former church is Gothic Revival, has two front window gables, lancet arch windows and a stone foundation. - Located on the north side of Kingston Road, an early transportation route. - Reflects nineteenth- and twentieth-century settlement and religious activities in Scarborough Township. <p>Known Cultural Heritage Value or Interest under Ontario Regulation 9/06 and associated heritage attributes</p> <p>For additional information, please see the By-Law available at: https://www.heritagetrust.on.ca/en/oha/details?id=2549&backlinkslug=search-results&fields%5Blocation%5D=47%2C410%2C254</p> <p>Physical heritage attributes that support the CHVI include:</p> <ul style="list-style-type: none"> - Brick church with steeply pitched roof, stone foundations, polychromatic brickwork, and arched fenestration and entrances - It is typical of late Victorian simple Canadian Gothic church architecture in rural communities. <p>The historical/associative value that support the CHVI include:</p> <ul style="list-style-type: none"> - The church is the 1891 successor of two mid-nineteenth century Methodist churches in the Highland Creek area

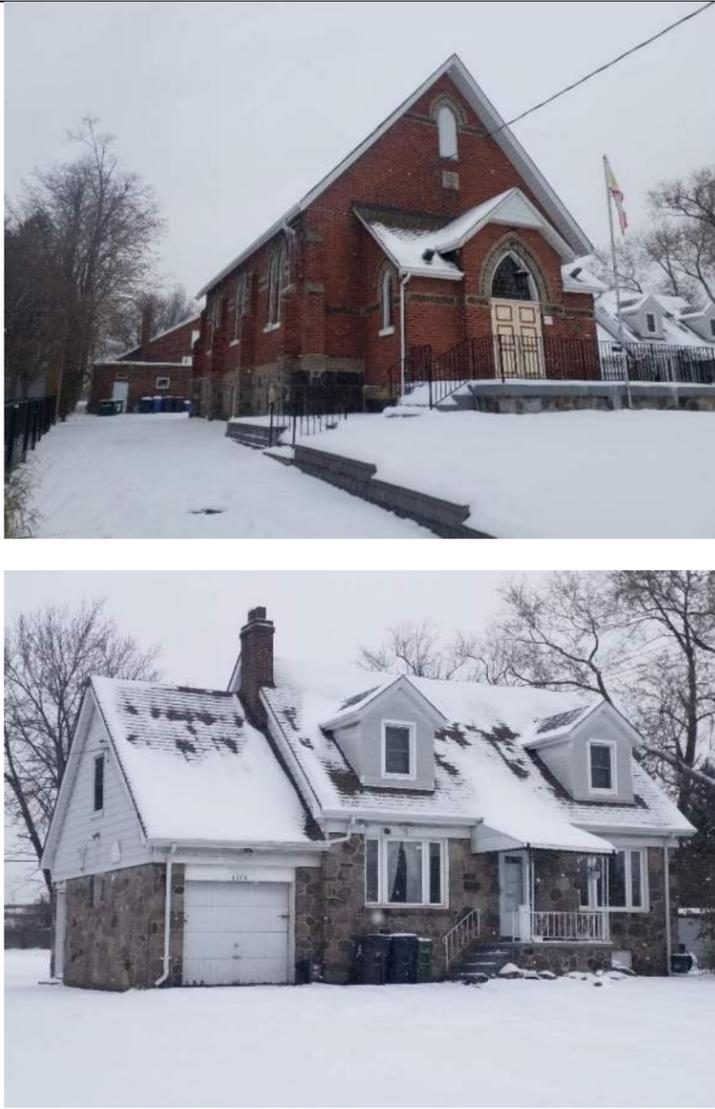
Ref #	Type of Cultural Heritage Resource	Type of Property	Location	Heritage Recognition	Description of Property and Known or Potential CHVI	Photographs/ Digital Image
TO-014	CHL	Park	Rouge National Urban Park, 72 and 98 Old Kingston Rd, Toronto	Known CHL - National Urban Park	<p>Property Description</p> <ul style="list-style-type: none"> - Canada’s first national urban park - The park features a collection of archaeological resources, cultural heritage landscapes, agricultural heritage landscapes, built heritage resources, and cultural traditions communicating the 10,000 years of human presence in this landscape. - In particular, the Bead Hill National Historic Site of Canada is located within the boundaries of Rouge Valley Park in the lower Rouge River Valley in Scarborough, Ontario near the confluence of the Rouge River and the Little Rouge Creek, north of the Project Study Area <ul style="list-style-type: none"> - One of the few remaining seventeenth-century Seneca sites in Canada, it consists of the historic Seneca village and an associated burial area, both dating from the late-seventeenth century, a tree covered midden on the hillside, an Archaic period campsite dating from roughly 3000 BCE, as well as additional burials located on the tip of the point of the tableland, east of the village. <p>Known Cultural Heritage Value or Interest and associated heritage attributes For additional information, please see the By-Law available at: https://www.pc.gc.ca/apps/dfhd/page_nhs_eng.aspx?id=531</p>

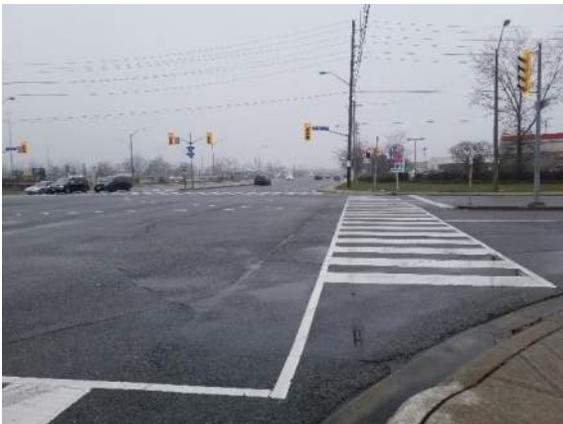
Plate 3: The Project Study Area at the intersection of Kingston Road and Port Union Road, looking southwest.

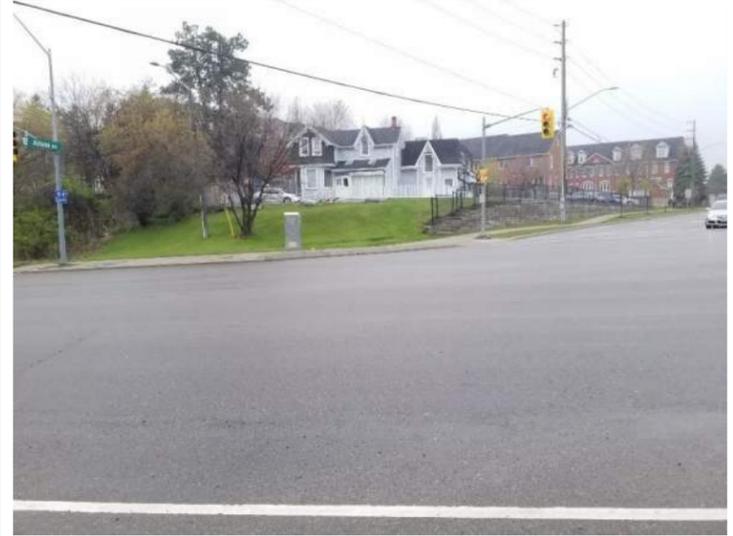
PK-002	BHR	Residence	301 Kingston Rd, Pickering	Potential BHR - Identified During Desktop/Field Review	<p>Property Description</p> <ul style="list-style-type: none"> - The property features a two-storey frame residence in the Georgian style with classical revival elements. The side gable roof features asphalt shingles and a chimney on the east end. The house has a single storey rear addition. - The residence is situated on a rise above the roadway and the property is lined with trees. - Located on the south side of Kingston Road, an early transportation route, set close to the road. - Reflects nineteenth-century settlement along Kingston Road in Pickering Township. <p>Potential Cultural Heritage Value or Interest and associated heritage attributes This property has the potential to retain historical, architectural, and contextual value.</p>

BHR/CHL Reference Number	Address	Required Assessment or Next Steps
		and further consultation with heritage staff at the municipality is recommended.
PK-002	301 Kingston Rd, Pickering	To address indirect impacts, a CHER is recommended to be undertaken as early as possible during detailed design to determine if this potential BHR has CHVI. If the property is determined to have CHVI, an HIA will be undertaken by a qualified person as early as possible in the detailed design phase. It will be developed in consultation with, and submitted for review to, MHSTCI and interested parties including the municipal heritage planner and/or municipal heritage committee and Indigenous Nations, as appropriate. The HIA will discuss the alternatives considered and recommend the alternative to minimize or mitigate adverse effects on the property.
PK-013	1294 Kingston Rd, Pickering	This property currently has received an application for future development. The status of this development should be reviewed during detailed design by a qualified person with recent, relevant heritage experience to determine if impacts have changed and if further cultural heritage work is required.

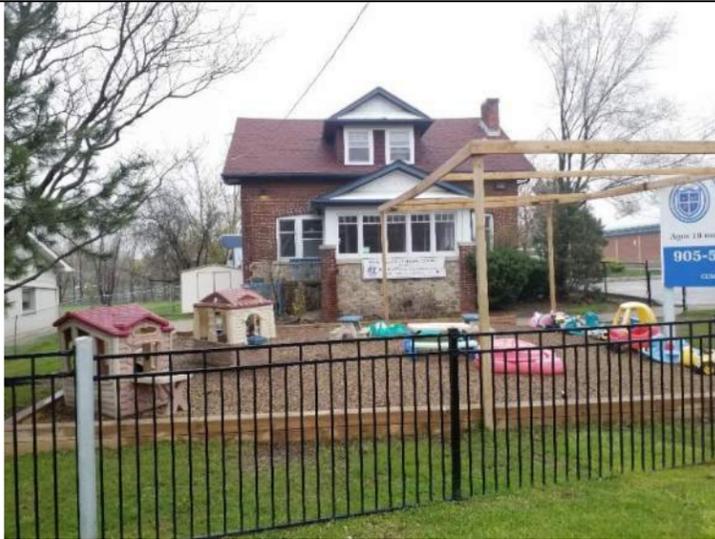
Ref #	Type of Cultural Heritage Resource	Type of Property	Location	Heritage Recognition	Description of Property and Known or Potential CHVI	Photographs/ Digital Image
PK-005	BHR	Residence	422 Kingston Rd, Pickering	Potential BHR - Identified During Desktop/Field Review	<p>Property Description</p> <ul style="list-style-type: none"> - The property features a single-storey frame house with a gable roof, a chimney on the east side, and a covered front entrance. A modern addition has been added to the front façade of the older house. - Located on the north side of Kingston Road, an early transportation route, set back from the road. - Reflects nineteenth-century settlement along Kingston Road in Pickering Township. <p>Potential Cultural Heritage Value or Interest and associated heritage attributes This property has the potential to retain historical, architectural, and contextual value.</p>

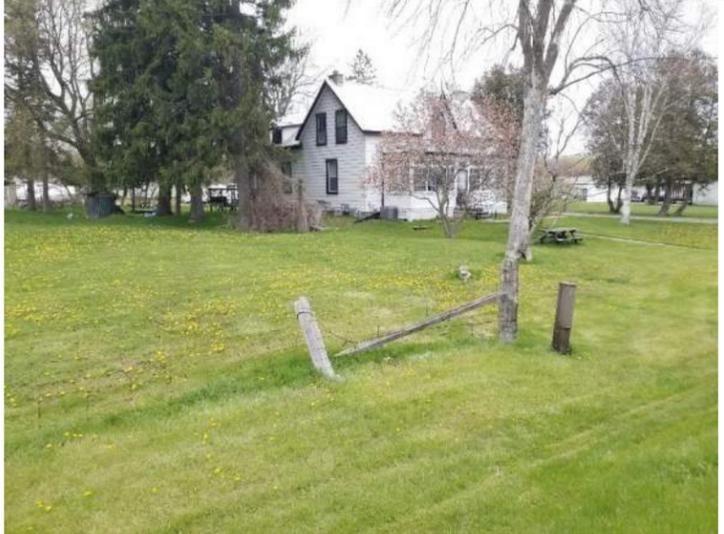
Ref #	Type of Cultural Heritage Resource	Type of Property	Location	Heritage Recognition	Description of Property and Known or Potential CHVI	Photographs/ Digital Image
PK-017	BHR	Residence	1892 Kingston Rd, Pickering	Potential BHR - Identified During Desktop/Field Review	<p>Property Description</p> <ul style="list-style-type: none"> - The property features a one-and-a-half storey Ontario Gothic structure clad in modern siding. The residence has an intersecting gable roof with a lancet window and a small finial. - The property is located on the north side of Kingston Road set back from the road and is immediately west of Notion Road, both early transportation routes. - Reflects nineteenth-century settlement patterns in Pickering Township along Kingston Road. <p>Potential Cultural Heritage Value or Interest and associated heritage attributes This property has the potential to retain historical, architectural, and contextual value.</p>

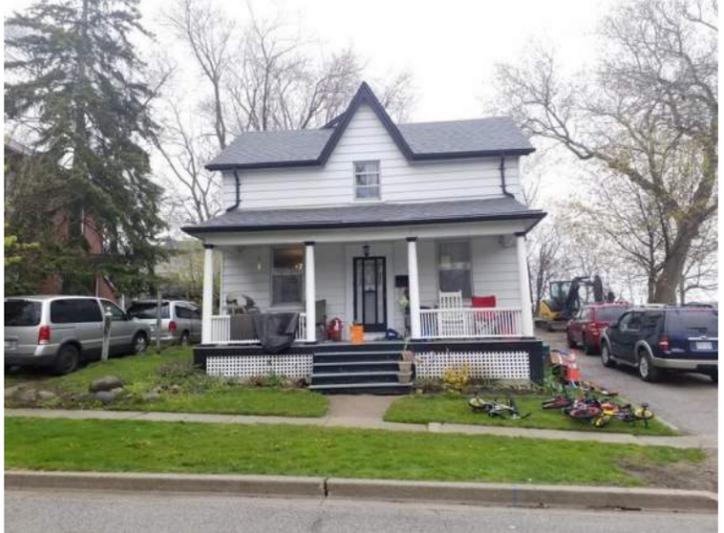
PK-018	BHR	Residence	1723 Dunchurch St, Pickering	Potential BHR - Identified During Desktop/Field Review	<p>Property Description</p> <ul style="list-style-type: none"> - The property features a one-and-a-half storey Ontario Gothic structure clad in modern siding. The residence has an intersecting gable roof and a rear extension and a covered verandah. - The property is located north of Kingston Road and fronts on to Dunchurch St, which does not connect to Kingston Road. - Reflects nineteenth-century settlement patterns in Pickering Township and is associated with the former Dunbarton village area. <p>Potential Cultural Heritage Value or Interest and associated heritage attributes This property has the potential to retain historical, architectural, and contextual value.</p>

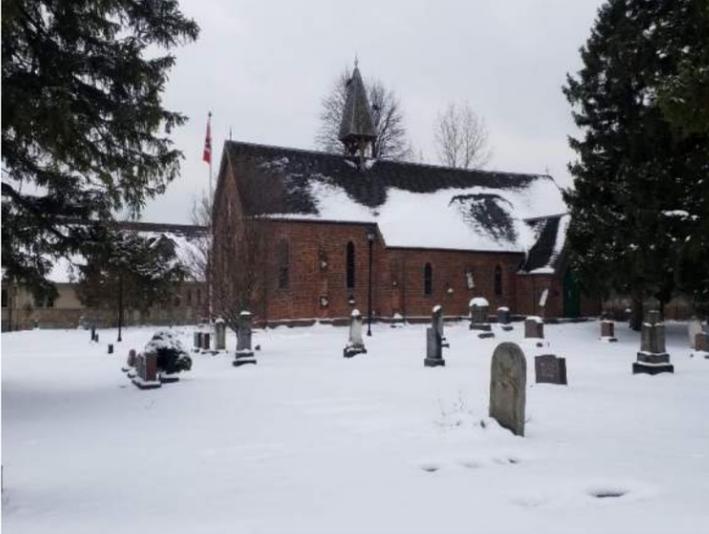
Ref #	Type of Cultural Heritage Resource	Type of Property	Location	Heritage Recognition	Description of Property and Known or Potential CHVI	Photographs/ Digital Image
AJ-004	CHL	Church and Cemetery	77 Randall Dr, Ajax	Known CHL - Part IV Designation (By-law #96-84; 78-2004)	<p>Property Description</p> <ul style="list-style-type: none"> - St. George’s Anglican Church is the oldest church standing in Ajax (Town of Ajax 1984). - The property features an early Gothic Revival church with cemetery, churchyard, and mature trees. - Located on the west side of Randall Drive, south of Kingston Road, an early transportation route, set back from the road. - Reflects nineteenth-century religious and burial practices along Kingston Road in Pickering Township. <p>Known Cultural Heritage Value or Interest under Ontario Regulation 9/06 and associated heritage attributes For additional information, please see the By-Law available at: https://www.heritagetrust.on.ca/en/oha/details?id=292&backlinkslug=search-results&fields%5Bproperty_name%5D=77+Randall+</p> <p>Physical heritage attributes that support the CHVI include:</p> <ul style="list-style-type: none"> - Its Gothic Revival architectural that is typical of a small country church, some of these elements include the following: <ul style="list-style-type: none"> - the angled bricks around windows and doors; - the brick buttresses; - the bell-cote on the roof; - the diamond-shaped leaded windowpanes; - the wooden Gothic-style doors; - the interior walls have been plastered and the lower section wainscoted; - pews have been placed into the walls; and, - a wooden-trussed ceiling supported by wooden arches. <p>The contextual value that support the CHVI include:</p> <ul style="list-style-type: none"> - its proximity to Kingston Road; - its status as a local landmark in the former Pickering Village; and, - the physical relationship between the churchyard with mature trees, the gravestones, and the wrought iron railings (Town of Ajax and Town of Ajax Heritage Advisory Committee 2018a; Town of Ajax 1984).

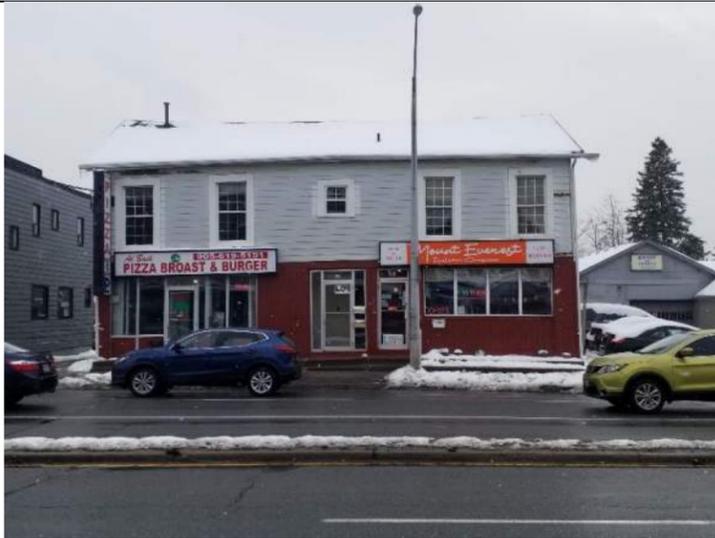
Ref #	Type of Cultural Heritage Resource	Type of Property	Location	Heritage Recognition	Description of Property and Known or Potential CHVI	Photographs/ Digital Image
AJ-007	BHR	Commercial	607-611 Kingston Rd W, Ajax	Potential BHR - Listed on Municipal Heritage Register	<p>Property Description</p> <ul style="list-style-type: none"> - The property features a two-storey, five-bay building with a gable roof. A single-storey addition spans the rear of the building and has a hipped roof. The building reflects an early Georgian commercial structure. The building was constructed as a staging inn when Pickering Village was a popular stop along Kingston Road West between Kingston and Toronto (Town of Ajax and Town of Ajax Heritage Advisory Committee 2018b). - Located on the south side of Kingston Road West, an early transportation route, set close to the road. - Reflects nineteenth-century settlement along Kingston Road West Line in Pickering Village within Pickering Township. <p>Potential Cultural Heritage Value or Interest and associated heritage attributes This property has the potential to retain historical and contextual value.</p>

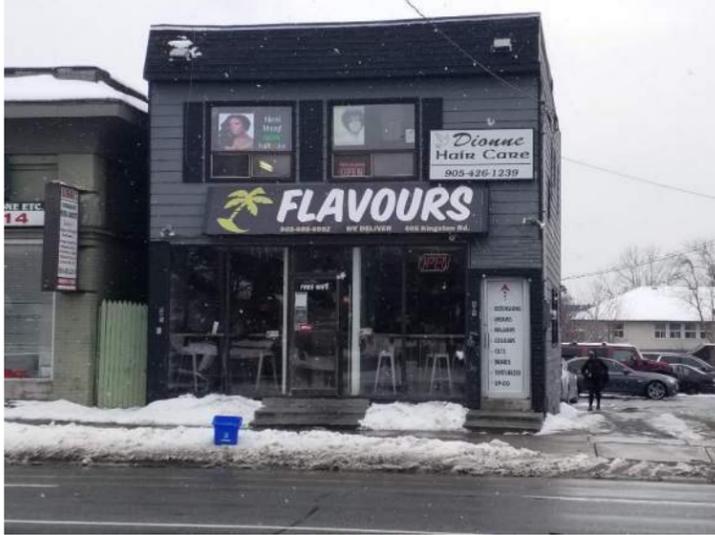
AJ-008	BHR	Commercial	605 Kingston Rd W, Ajax	Potential BHR - Identified During Desktop/Field Review	<p>Property Description</p> <ul style="list-style-type: none"> - The property features a two-storey commercial structure with a flat roof. The building has been heavily altered. - Located on the south side of Kingston Road West, an early transportation route, set close to the road. - Reflects nineteenth-century commercial practices along Kingston Road West in Pickering Village in Pickering Township. <p>Potential Cultural Heritage Value or Interest and associated heritage attributes This property has the potential to retain contextual value.</p>

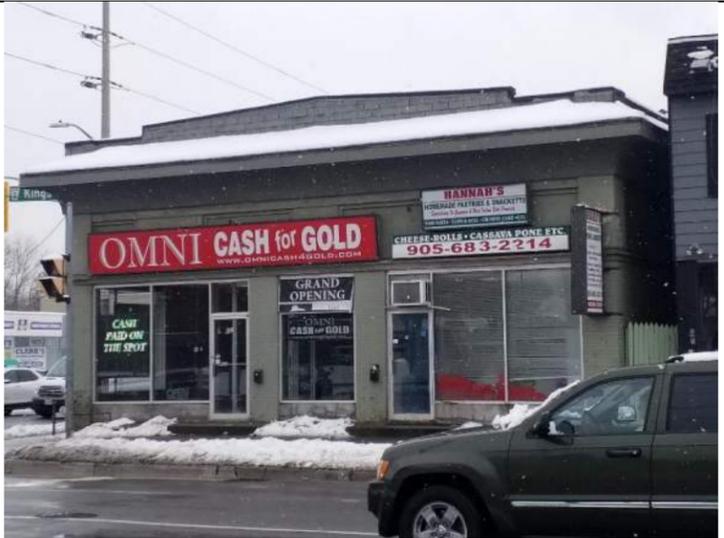
Ref #	Type of Cultural Heritage Resource	Type of Property	Location	Heritage Recognition	Description of Property and Known or Potential CHVI	Photographs/ Digital Image
AJ-009	BHR	Commercial	601 Kingston Rd W, Ajax	Potential BHR - Listed on Municipal Heritage Register	<p>Property Description</p> <ul style="list-style-type: none"> - The property features a single-storey Arts and Crafts-inspired commercial corner building with a flat roof. The roof also has a raised parapet on the Kingston Road façade and sits atop a broad cornice (Town of Ajax and Town of Ajax Heritage Advisory Committee 2018b). - Located on the south side of Kingston Road West, west of Church Street North, both early transportation routes, with a limited front setback. - Reflects early-twentieth-century commercial practices along Kingston Road West in Pickering Village in Pickering Township. <p>Potential Cultural Heritage Value or Interest and associated heritage attributes This property has the potential to retain architectural and contextual value.</p>

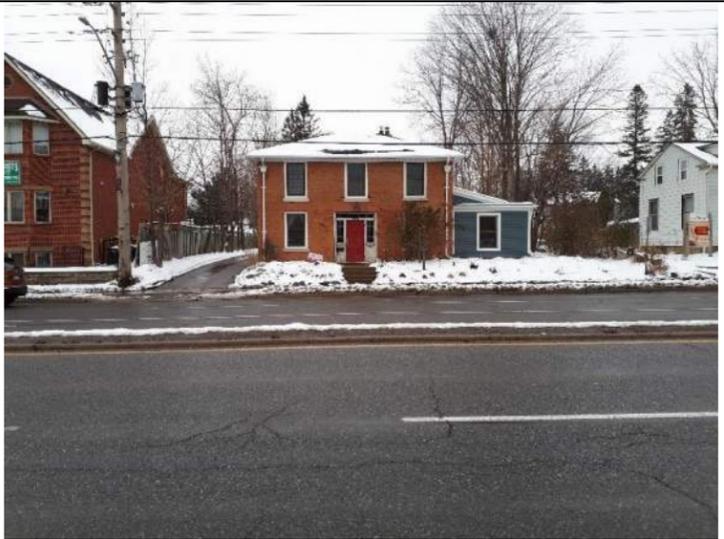
AJ-010	BHR	Commercial	592 Kingston Rd W, Ajax	Known BHR - Part IV Designation (By-law #116-82)	<p>Property Description</p> <ul style="list-style-type: none"> - The property features a two-storey, three-bay Neoclassical residence known as the Davies House, that was constructed in 1842 (Town of Ajax and Town of Ajax Heritage Advisory Committee 2018a). - Located on the north side of Kingston Road West, an early transportation route, with a limited front setback. - Reflects nineteenth-century settlement along Kingston Road West in Pickering Township. <p>Known Cultural Heritage Value or Interest under Ontario Regulation 9/06 and associated heritage attributes For additional information, please see the By-Law available at: https://www.heritagetrust.on.ca/en/oha/details?id=286&backlinkslug=search-results&fields%5Bproperty_name%5D=592+Kingston</p> <p>Physical heritage attributes that support the CHVI include:</p> <ul style="list-style-type: none"> - its Neoclassical shape and form; - the three-bays and hipped roof; - front door, with narrow transom and half side lights; and, - the original wainscoting in the kitchen and the pine floors in the living room

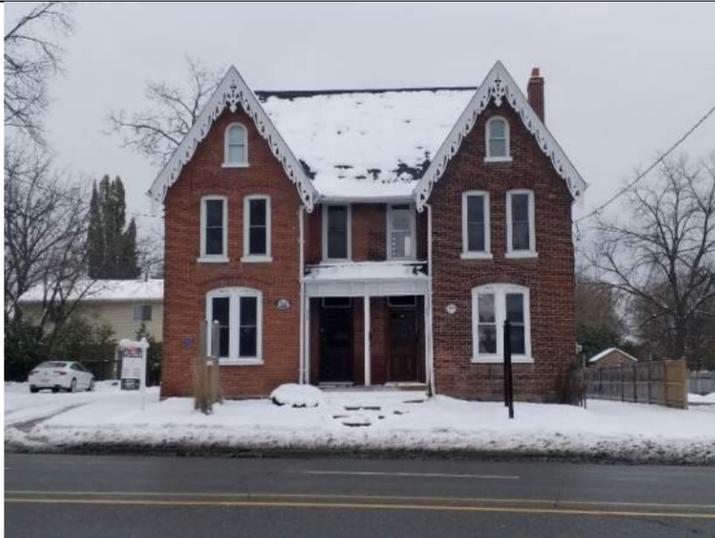
Ref #	Type of Cultural Heritage Resource	Type of Property	Location	Heritage Recognition	Description of Property and Known or Potential CHVI	Photographs/ Digital Image
AJ-015	BHR	Commercial	577 Kingston Rd W, Ajax	Potential BHR - Listed on Municipal Heritage Register	<p>Property Description</p> <ul style="list-style-type: none"> - The property features the western unit of a two-and-a-half storey semi-detached brick residence with a cross-gable roof. The residence is predominately Italianate in style with Gothic influences. The windows are mainly segmental-arch and feature brick hood moulds. - Located on the south side of Kingston Road West, an early transportation route, with a limited front setback. - Reflects nineteenth-century settlement along Kingston Road West in Pickering Township. <p>Potential Cultural Heritage Value or Interest and associated heritage attributes This property has the potential to retain architectural and contextual value.</p>

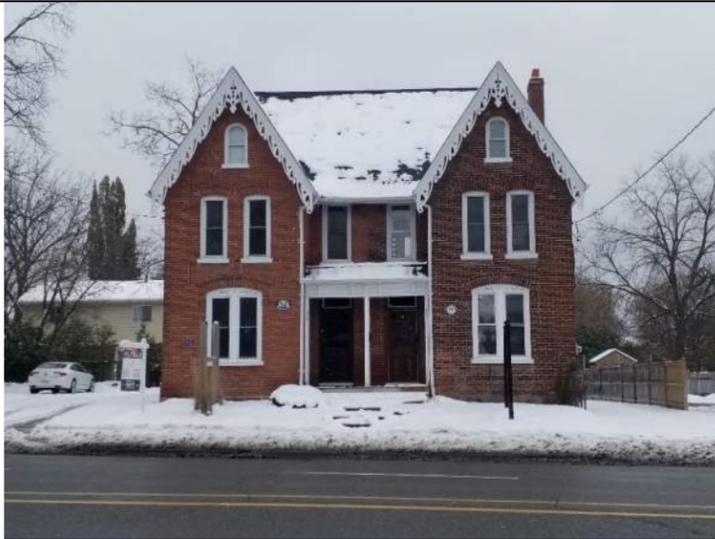
AJ-016	BHR	Commercial	575 Kingston Rd W, Ajax	Potential BHR - Listed on Municipal Heritage Register	<p>Property Description</p> <ul style="list-style-type: none"> - The property features the eastern unit of a two-and-a-half storey semi-detached brick residence with a cross-gable roof. The residence is predominately Italianate in style with Gothic influences. The windows are mainly segmental-arch and feature brick hood moulds. - Located on the south side of Kingston Road West, an early transportation route, with a limited front setback. - Reflects nineteenth-century settlement along Kingston Road West in Pickering Township. <p>Potential Cultural Heritage Value or Interest and associated heritage attributes This property has the potential to retain architectural and contextual value.</p>

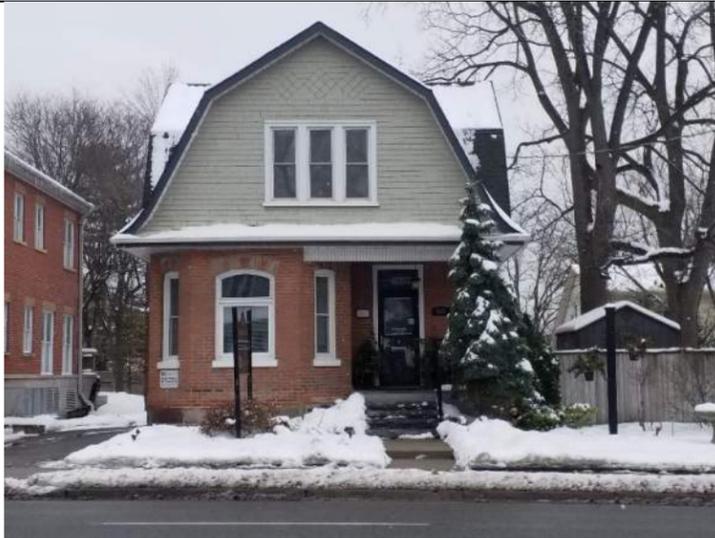
Ref #	Type of Cultural Heritage Resource	Type of Property	Location	Heritage Recognition	Description of Property and Known or Potential CHVI	Photographs/ Digital Image
AJ-019	BHR	Commercial	567 Kingston Rd W, Ajax	Potential BHR - Listed on Municipal Heritage Register	<p>Property Description</p> <ul style="list-style-type: none"> - The property features a one-and-a-half storey Dutch Colonial residence with a bell-cast cross-gambrel roof. It is believed that the house may have been built in an earlier style and the gambrel roof was added later, possibly during the 1920s or 1930s when the Dutch Colonial style came in to popularity (Town of Ajax and Town of Ajax Heritage Advisory Committee 2018b). The front façade features a projecting bay and recessed porch beneath the roof gable. - Located on the south side of Kingston Road West, an early transportation route, with a limited front setback. - Reflects twentieth-century settlement along Kingston Road West in Pickering Township. <p>Potential Cultural Heritage Value or Interest and associated heritage attributes</p> <p>This property has the potential to retain historical, architectural, and contextual value.</p>

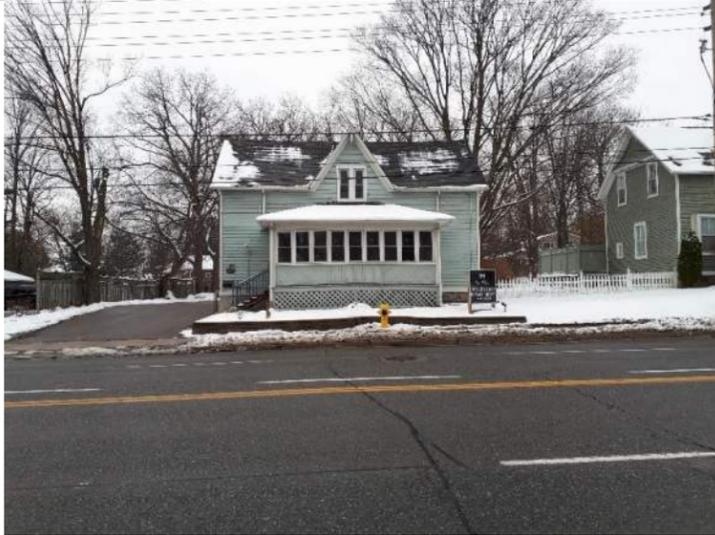
AJ-020	BHR	Commercial	566 Kingston Rd W, Ajax	Known BHR - Part IV Designation (By-law #113-97)	<p>Property Description</p> <ul style="list-style-type: none"> - The property features a one-and-a-half storey frame late Victorian Ontario vernacular residence with a gable roof. The structure has been altered from an earlier single-storey rectangular structure. - Located on the north side of Kingston Road West, an early transportation route, with a limited front setback. - Reflects nineteenth-century settlement along Kingston Road West in Pickering Township. <p>Known Cultural Heritage Value or Interest under Ontario Regulation 9/06 and associated heritage attributes</p> <p>For additional information, please see the By-Law available at: https://www.heritagetrust.on.ca/en/oha/details?id=276&backlinkslug=search-results&fields%5Bproperty_name%5D=566+Kingston</p> <p>Physical heritage attributes that support the CHVI include:</p> <ul style="list-style-type: none"> - its late Victorian Ontario vernacular shape and form; - the tablet window in the front gable; - the original timber framing; and, - the original clapboard and beaded corner boards <p>The contextual value that support the CHVI include:</p> <ul style="list-style-type: none"> - its proximity to Kingston Road West; and - the physical relationship between the house and eight other nineteenth-century residences in a row on the north side of Kingston Road West that are still largely recognizable as such.

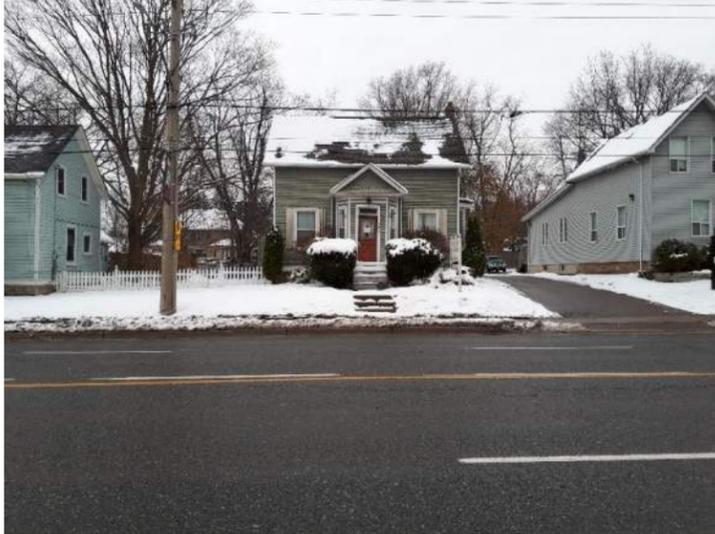
AJ-022	BHR	Commercial	556 Kingston Rd W, Ajax	Potential BHR - Listed on Municipal Heritage Register	<p>Property Description</p> <ul style="list-style-type: none"> - The property features a one-and-a-half storey L-shaped footprint residence with a cross-gable roof with a single-storey rear addition. The former front porch has been enclosed and many of the exterior features have been replaced. The house has a random-laid fieldstone foundation. - Located on the north side of Kingston Road West, an early transportation route, with a limited front setback. - Reflects nineteenth-century settlement along Kingston Road West in Pickering Township. <p>Potential Cultural Heritage Value or Interest and associated heritage attributes This property has the potential to retain architectural and contextual value.</p>

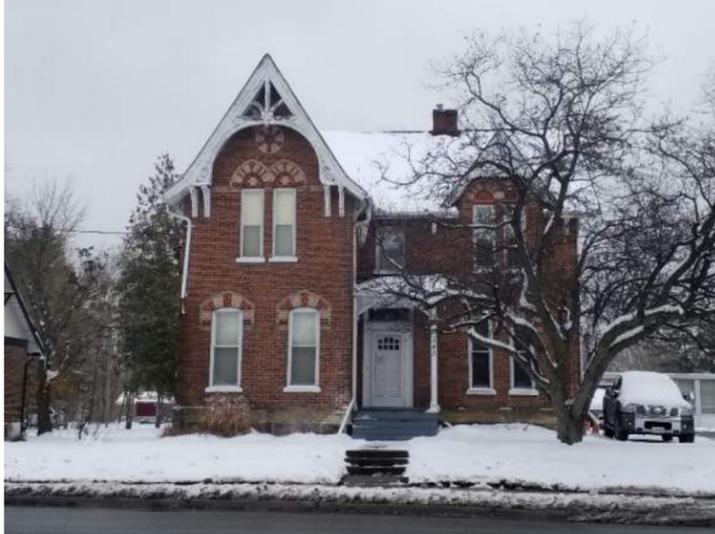
Ref #	Type of Cultural Heritage Resource	Type of Property	Location	Heritage Recognition	Description of Property and Known or Potential CHVI	Photographs/ Digital Image
AJ-023	CHL	Church, Manse and Cemetery	543-549 Kingston Rd W, Ajax	Potential CHL - Listed on Municipal Heritage Register	<p>Property Description</p> <ul style="list-style-type: none"> - The property features a two-storey brick manse with Italianate details, a large brick church, a one-and-a-half storey Gothic Revival house, and a cemetery. - Located on the south side of Kingston Road West, an early transportation route, with a limited front setback. - Reflects nineteenth-century settlement and religious practices along Kingston Road West in Pickering Township. <p>Potential Cultural Heritage Value or Interest and associated heritage attributes</p> <p>This property has the potential to retain historical, architectural, and contextual value.</p>

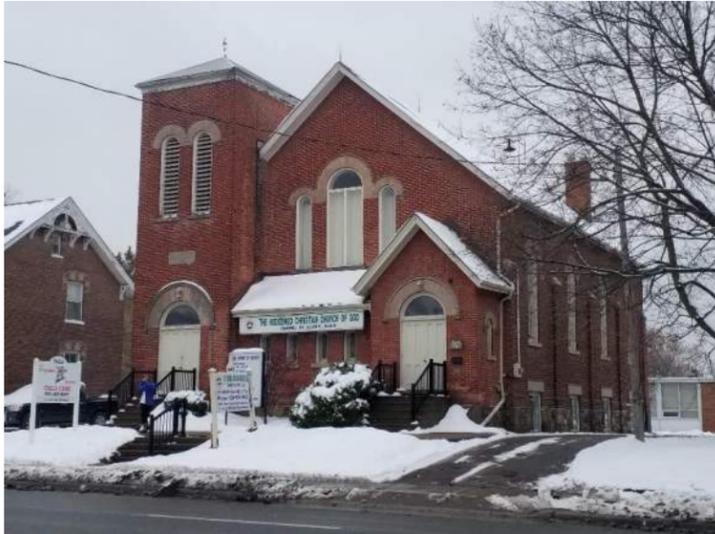
<p>Church</p>

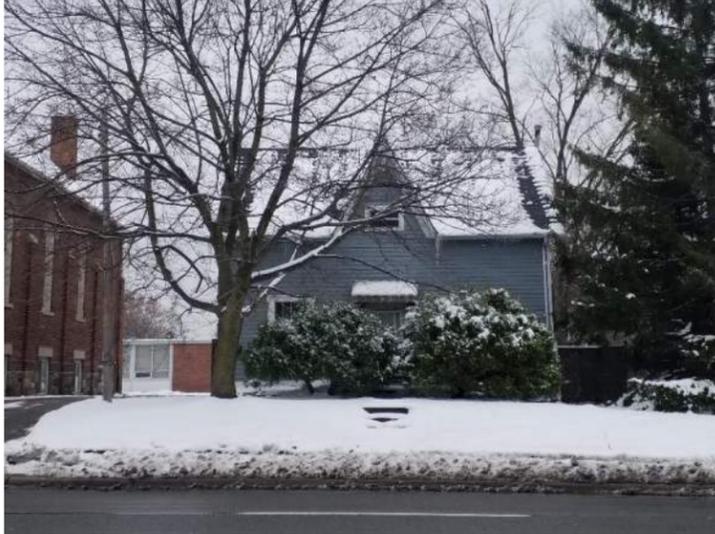
<p data-bbox="2147 822 2371 852">Gothic Revival House</p>
AJ-024	BHR	Residence	539 Kingston Rd W, Ajax	Potential BHR - Listed on Municipal Heritage Register	<p data-bbox="1361 889 1588 915">Property Description</p> <ul data-bbox="1407 919 2119 1165" style="list-style-type: none"> - The property features a one-and-a-half storey brick-clad residence in the Arts and Crafts style with a cross-gable roof and gabled front entrance. The residence features varied fenestration. - Located on the south side of Kingston Road West, an early transportation route, with a limited front setback. - Reflects twentieth-century settlement along Kingston Road West in Pickering Township. <p data-bbox="1361 1201 2085 1255">Potential Cultural Heritage Value or Interest and associated heritage attributes</p> <p data-bbox="1361 1260 2076 1314">This property has the potential to retain architectural and contextual value.</p>

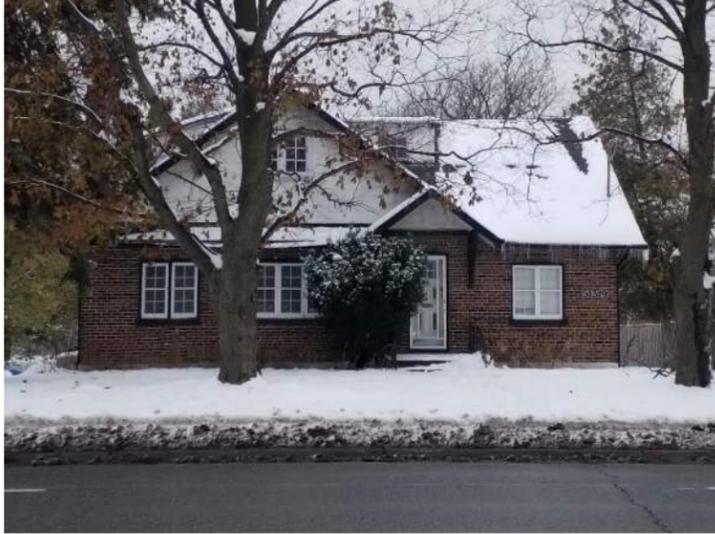
Ref #	Type of Cultural Heritage Resource	Type of Property	Location	Heritage Recognition	Description of Property and Known or Potential CHVI	Photographs/ Digital Image
AJ-025	BHR	Commercial	536 Kingston Rd W, Ajax	Potential BHR - Listed on Municipal Heritage Register	<p>Property Description</p> <ul style="list-style-type: none"> - The property features a single-storey brick residence with a gable roof and an accessibility ramp that wraps around the southeast corner. - Located on the north side of Kingston Road West, an early transportation route, with a limited front setback. - Reflects twentieth-century settlement along Kingston Road West in Pickering Township. <p>Potential Cultural Heritage Value or Interest and associated heritage attributes This property has the potential to retain architectural and contextual value.</p>

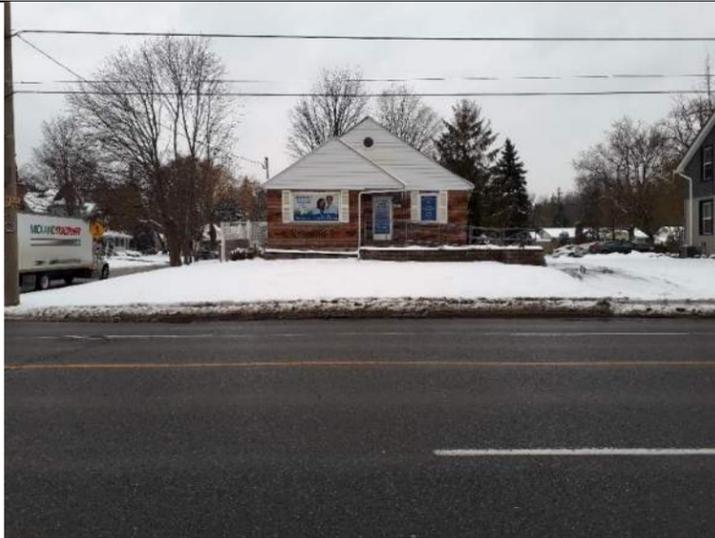
AJ-026	BHR	Residence	531 Kingston Rd W, Ajax	Potential BHR - Listed on Municipal Heritage Register	<p>Property Description</p> <ul style="list-style-type: none"> - The property features a two-storey brick and timber residence with a gable roof and a recessed eastern entry wing. The building combines vernacular Arts and Crafts, and Tudor Revival architectural styles. - Located on the south side of Kingston Road West, an early transportation route, with a limited front setback. - Reflects twentieth-century settlement along Kingston Road West in Pickering Township. <p>Potential Cultural Heritage Value or Interest and associated heritage attributes This property has the potential to retain architectural and contextual value.</p>

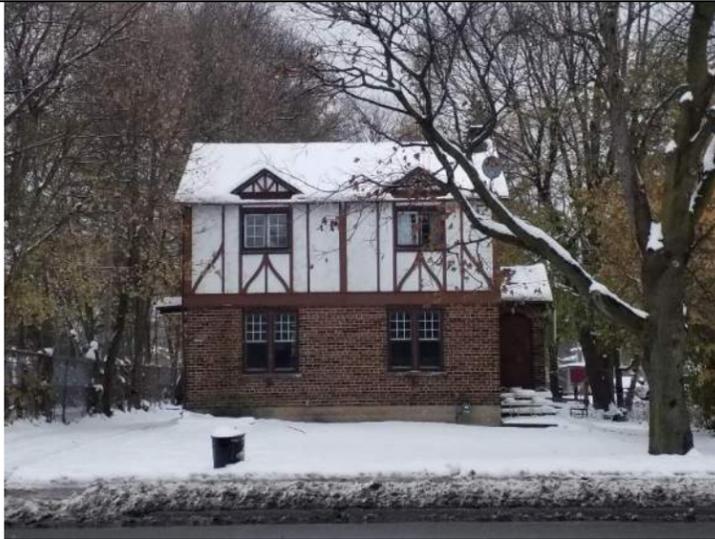
Ref #	Type of Cultural Heritage Resource	Type of Property	Location	Heritage Recognition	Description of Property and Known or Potential CHVI	Photographs/ Digital Image
AJ-027	BHR	Commercial	530 Kingston Rd W, Ajax	Potential BHR - Listed on Municipal Heritage Register	<p>Property Description</p> <ul style="list-style-type: none"> - The property features a one-and-a-half storey, three-bay residence with a gable roof. The front façade features a central gable with a flat-arched window. The first storey has a canted bay window that was a later addition on the east end of the front elevation. Modern siding has been added to the first storey and the upper is clad in board and batten. - Located on the north side of Kingston Road West, an early transportation route, with a limited front setback. - Reflects nineteenth-century settlement along Kingston Road West in Pickering Township. <p>Potential Cultural Heritage Value or Interest and associated heritage attributes This property has the potential to retain architectural and contextual value.</p>

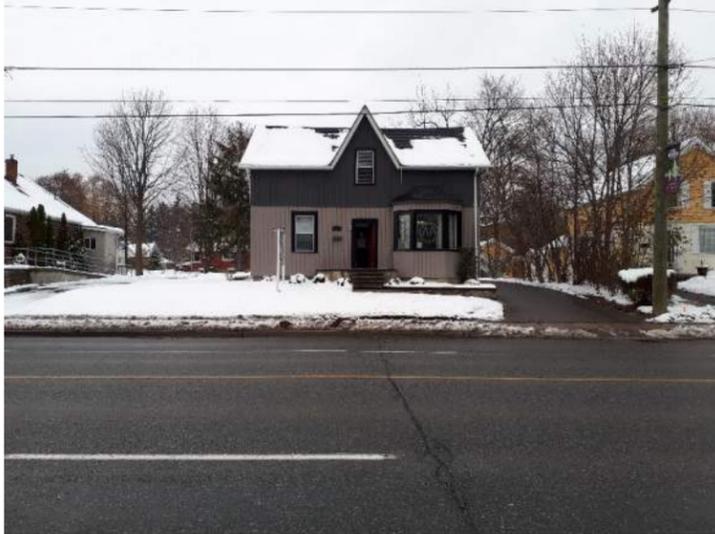
AJ-028	BHR	Commercial	527 Kingston Rd W, Ajax	Potential BHR - Listed on Municipal Heritage Register	<p>Property Description</p> <ul style="list-style-type: none"> - The property features a one-and-a-half storey stucco-clad residence in the Arts and Crafts architectural style with a cross gable roof and gabled entrance projection. The front elevation roofline features two dormers centred above the main entrance. - Located on the south side of Kingston Road West, an early transportation route, with a limited front setback. - Reflects twentieth-century settlement along Kingston Road West in Pickering Township. <p>Potential Cultural Heritage Value or Interest and associated heritage attributes This property has the potential to retain architectural and contextual value.</p>
