**DURHAM-SCARBOROUGH BUS RAPID TRANSIT PROJECT
CULTURAL HERITAGE REPORT – EXISTING CONDITIONS AND PRELIMINARY IMPACT ASSESSMENT
CITY OF TORONTO AND DURHAM REGION, ONTARIO**

ASI File: 18CH-142

October 2019 (Revised June and October 2020;
January, May, November and December 2021; January and February 2022)

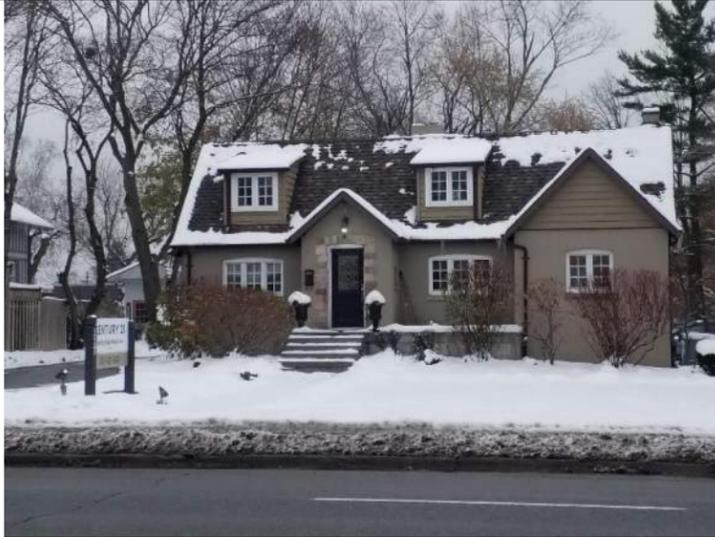
Ref #	Type of Cultural Heritage Resource	Type of Property	Location	Heritage Recognition	Description of Property and Known or Potential CHVI	Photographs/ Digital Image
AJ-029	BHR	Residence	526 Kingston Rd W, Ajax	Potential BHR - Listed on Municipal Heritage Register	<p>Property Description</p> <ul style="list-style-type: none"> - The property features a one-and-a-half storey residence with a gable roof and a rear addition on the east side of the house. The first storey windows have segmental arches. The original massing and fenestration appear unaltered. - Located on the north side of Kingston Road West, an early transportation route, with a limited front setback. - Reflects twentieth-century settlement along Kingston Road West in Pickering Township. <p>Potential Cultural Heritage Value or Interest and associated heritage attributes</p> <p>This property has the potential to retain architectural and contextual value.</p>

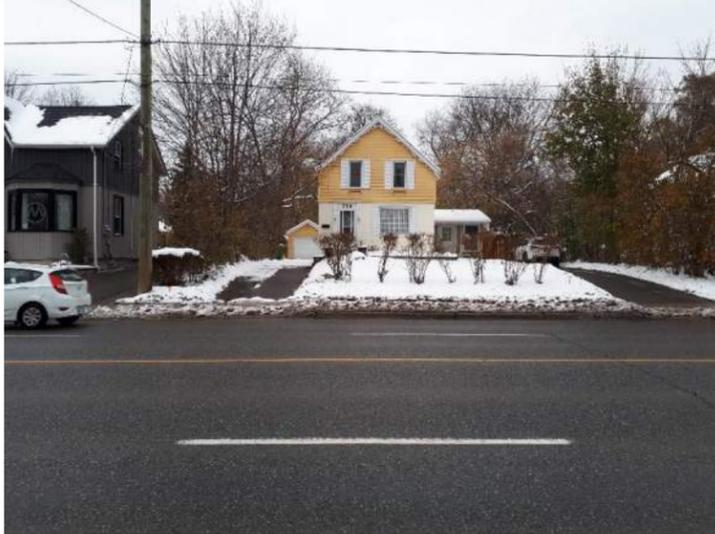
AJ-030	BHR	Residence	519 Kingston Rd W, Ajax	Potential BHR - Listed on Municipal Heritage Register	<p>Property Description</p> <ul style="list-style-type: none"> - The property features a one-and-a-half storey Arts and Crafts style residence with a gable roof. The roof has large dormer windows on both roof slopes. The front porch is recessed beneath the projecting upper storey. - Located on the south side of Kingston Road West, an early transportation route, with a limited front setback. - Reflects twentieth-century settlement along Kingston Road West in Pickering Township. <p>Potential Cultural Heritage Value or Interest and associated heritage attributes</p> <p>This property has the potential to retain architectural and contextual value.</p>

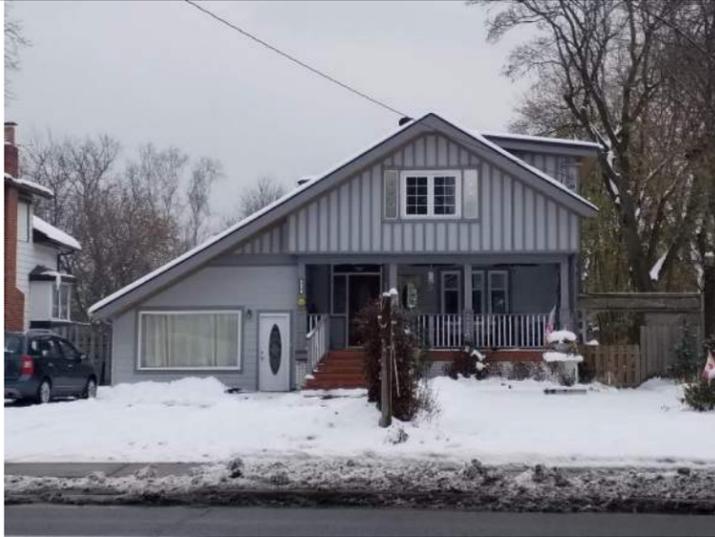
Ref #	Type of Cultural Heritage Resource	Type of Property	Location	Heritage Recognition	Description of Property and Known or Potential CHVI	Photographs/ Digital Image
AJ-031	BHR	Residence	522 Kingston Rd W, Ajax	Potential BHR - Listed on Municipal Heritage Register	<p>Property Description</p> <ul style="list-style-type: none"> - The property features a one-and-a-half storey residence with a gable roof. The residence is of a vernacular design with some Edwardian and Arts and Crafts elements. The massing and fenestration appear unaltered. - Located on the north side of Kingston Road West, an early transportation route, with a limited front setback. - Reflects twentieth-century settlement along Kingston Road West in Pickering Township. <p>Potential Cultural Heritage Value or Interest and associated heritage attributes</p> <p>This property has the potential to retain architectural and contextual value.</p>

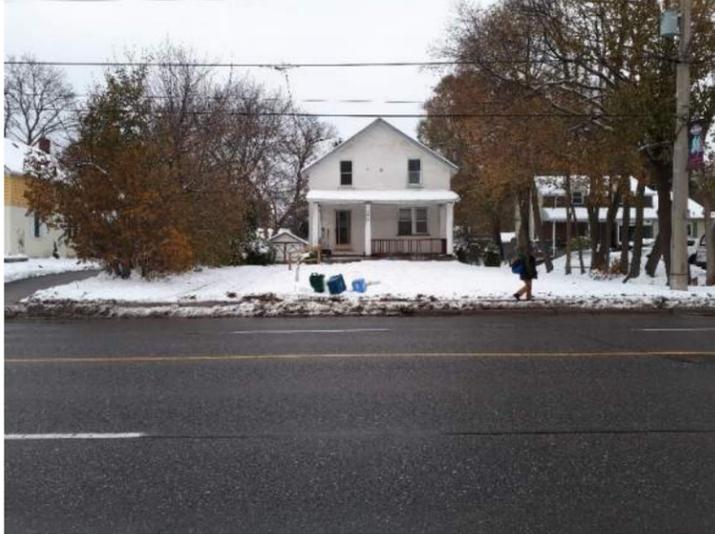
AJ-032	BHR	Residence	515 Kingston Rd W, Ajax	Potential BHR - Listed on Municipal Heritage Register	<p>Property Description</p> <ul style="list-style-type: none"> - The property features a one-and-a-half storey vernacular L-shaped residence with a gable roof. The roof features large dormers on both slopes. The foundation is concrete blocks and has been parged along the front elevation. - Located on the south side of Kingston Road West, an early transportation route, with a limited front setback. - Reflects twentieth-century settlement along Kingston Road West in Pickering Township. <p>Potential Cultural Heritage Value or Interest and associated heritage attributes</p> <p>This property has the potential to retain contextual value.</p>

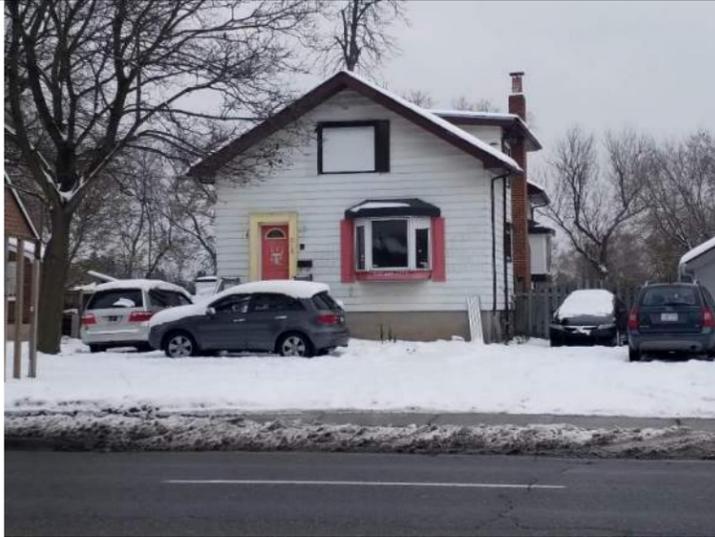
Ref #	Type of Cultural Heritage Resource	Type of Property	Location	Heritage Recognition	Description of Property and Known or Potential CHVI	Photographs/ Digital Image
AJ-033	BHR	Commercial	516 Kingston Rd W, Ajax	Potential BHR - Identified During Desktop/Field Review	<p>Property Description</p> <ul style="list-style-type: none"> - The property features a one-and-a-half storey brick residence with a rectangular footprint and gable roof. The house has two additions on the east side. The roof of the original structure features two dormer windows on the front façade. The building has been converted to commercial use. - Located on the north side of Kingston Road West, an early transportation route, with a limited front setback. - Reflects twentieth-century settlement along Kingston Road West in Pickering Township. <p>Potential Cultural Heritage Value or Interest and associated heritage attributes This property has the potential to retain historical, architectural, and contextual value.</p>

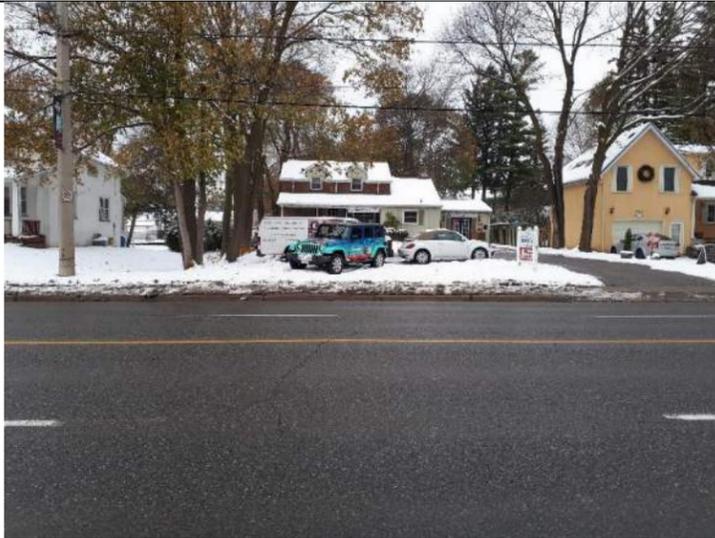
AJ-034	BHR	Residence	511 Kingston Rd W, Ajax	Potential BHR - Listed on Municipal Heritage Register	<p>Property Description</p> <ul style="list-style-type: none"> - The property features a one-and-a-half storey brick residence with a gable roof that is a mixture of the Tudor Revival and Arts and Crafts architectural styles. The house has a recessed eastern wing and a shed-roofed western addition. The entrance on the front façade features an asymmetrical roof and rounded arch opening. - Located on the south side of Kingston Road West, an early transportation route, with a limited front setback. - Reflects twentieth-century settlement along Kingston Road West in Pickering Township. <p>Potential Cultural Heritage Value or Interest and associated heritage attributes This property has the potential to retain architectural and contextual value.</p>

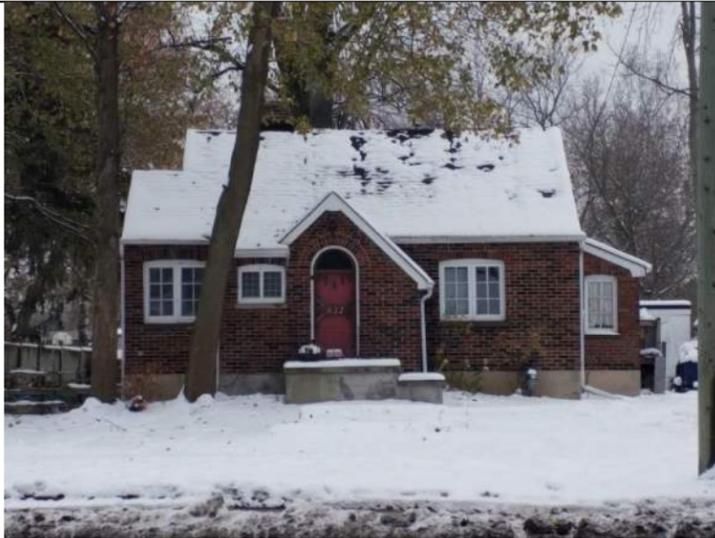
Ref #	Type of Cultural Heritage Resource	Type of Property	Location	Heritage Recognition	Description of Property and Known or Potential CHVI	Photographs/ Digital Image
AJ-035	BHR	Commercial	510 Kingston Rd W, Ajax	Potential BHR - Listed on Municipal Heritage Register	<p>Property Description</p> <ul style="list-style-type: none"> - The property features a one-and-a-half storey vernacular residence with a cross gable roof. The bell-cast roof accommodates a porch at the front and addition at the back. There are large dormers on both roof slopes. The residence has been covered in stucco. - Located on the north side of Kingston Road West, an early transportation route, with a limited front setback. - Reflects twentieth-century settlement along Kingston Road West in Pickering Township. <p>Potential Cultural Heritage Value or Interest and associated heritage attributes</p> <p>This property has the potential to retain architectural and contextual value.</p>

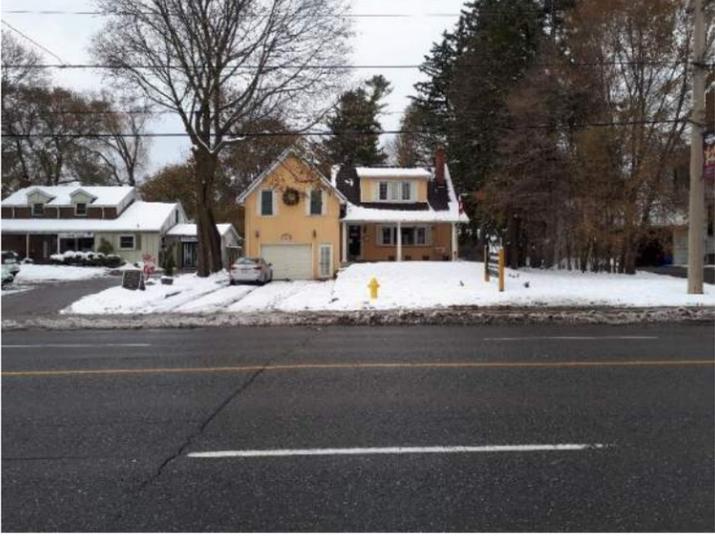
AJ-036	BHR	Residence	505 Kingston Rd W, Ajax	Potential BHR - Listed on Municipal Heritage Register	<p>Property Description</p> <ul style="list-style-type: none"> - The property features a one-and-a-half storey residence with a gable roof and several additions. The residence features Neoclassical elements such as the doorway with entablature, transom, and sidelights. The roof has a dormer and a central chimney. The residence is the earliest known wood-clad building in Ajax. - Located on the south side of Kingston Road West, an early transportation route, with a limited front setback. - Reflects nineteenth-century settlement along Kingston Road West in Pickering Township. <p>Potential Cultural Heritage Value or Interest and associated heritage attributes</p> <p>This property has the potential to retain historical, architectural, and contextual value.</p>

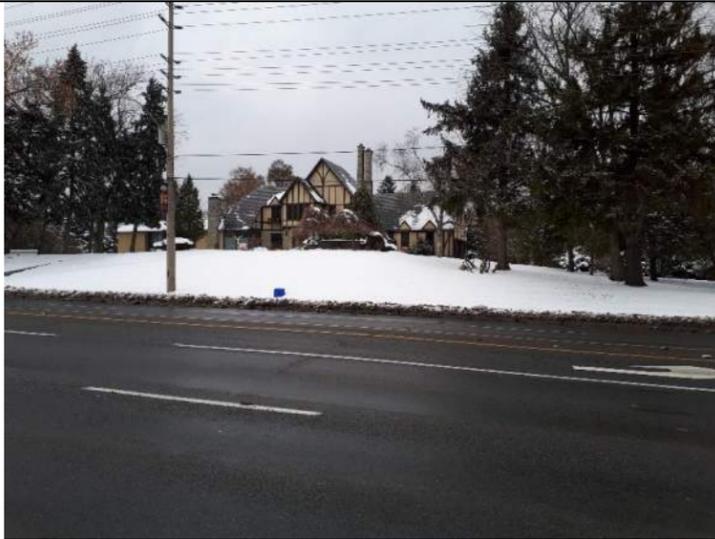
Ref #	Type of Cultural Heritage Resource	Type of Property	Location	Heritage Recognition	Description of Property and Known or Potential CHVI	Photographs/ Digital Image
AJ-047	BHR	Residence	407 Kingston Rd W, Ajax	Potential BHR - Listed on Municipal Heritage Register	<p>Property Description</p> <ul style="list-style-type: none"> - The property features a one-and-a-half storey vernacular brick residence with an L-shaped footprint with cross-gable roof. The house has a rear addition. - Located on the south side of Kingston Road West, an early transportation route, with a limited front setback. - Reflects twentieth-century settlement along Kingston Road West in Pickering Township. <p>Potential Cultural Heritage Value or Interest and associated heritage attributes</p> <p>This property has the potential to retain architectural and contextual value.</p>

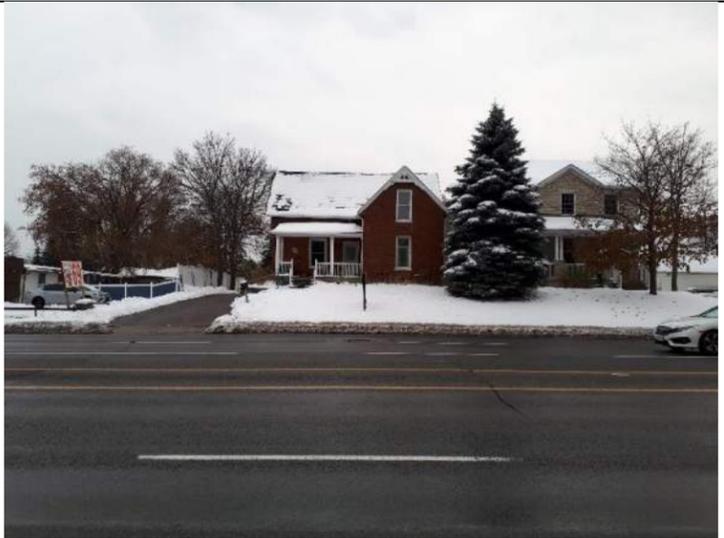
AJ-048	BHR	Commercial	368 Kingston Rd W, Ajax	Potential BHR - Listed on Municipal Heritage Register	<p>Property Description</p> <ul style="list-style-type: none"> - The property features a two-storey Italianate residence with T-shaped footprint with a large rear wing and front porch. The central mass contains a Jerkinhead roof while the remaining portions have gable roofs. The building features dichromatic brickwork with buff as the primary and accented by red brick. - Located on the north side of Kingston Road West, an early transportation route, with a limited front setback. - Reflects nineteenth-century settlement along Kingston Road West in Pickering Township. <p>Potential Cultural Heritage Value or Interest and associated heritage attributes</p> <p>This property has the potential to retain historical, architectural, and contextual value.</p>

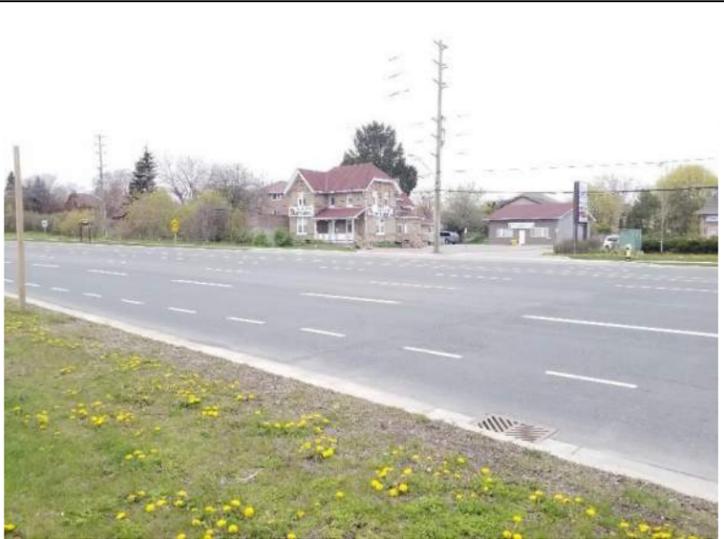
Ref #	Type of Cultural Heritage Resource	Type of Property	Location	Heritage Recognition	Description of Property and Known or Potential CHVI	Photographs/ Digital Image
AJ-049	BHR	Residence	2 Ritchie Ave, Ajax	Potential BHR - Listed on Municipal Heritage Register	<p>Property Description</p> <ul style="list-style-type: none"> - The property features a one-and-a-half storey Gothic Revival residence with a gable roof. A board-and-batten garage has been added to the north of the residence. Original red brick cladding in common bond remain, though much of the exterior has been altered. - Located on the west side of Ritchie Ave south of Kingston Road East, both early transportation routes, set back from the road on a hill overlooking Millers Creek. - Reflects nineteenth-century settlement along Ritchie Avenue in Pickering Township. <p>Potential Cultural Heritage Value or Interest and associated heritage attributes</p> <p>This property has the potential to retain historical, architectural, and contextual value.</p>

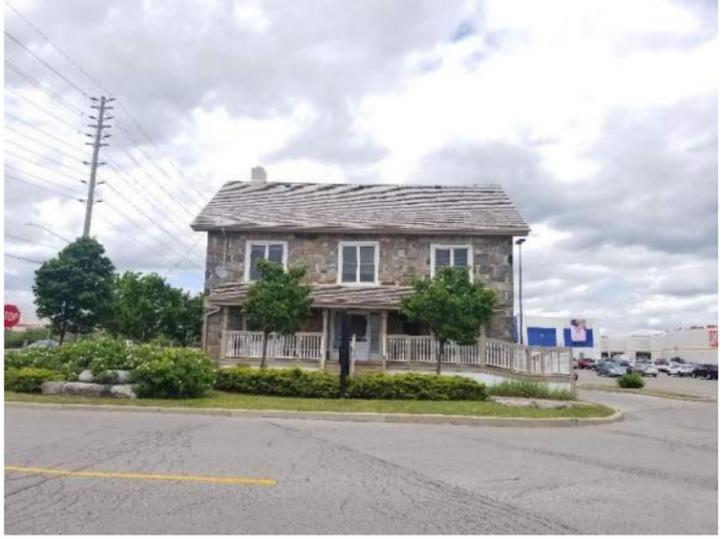
Ref #	Type of Cultural Heritage Resource	Type of Property	Location	Heritage Recognition	Description of Property and Known or Potential CHVI	Photographs/ Digital Image
AJ-051	CHL	Farmstead	380 Kingston Rd E, Ajax	Potential CHL - Listed on Municipal Heritage Register	<p>Property Description</p> <ul style="list-style-type: none"> - The property features a one-and-a-half storey residence constructed in 1935 in the Colonial Revival style; an Edwardian house constructed in 1920; and two large multi-storey barns with gambrel roofs, a long single-storey barn, and two silos. All the structures feature a black and white colour scheme. - The property is associated with the Picov family, pioneers in Quarter Horse racing in Ontario (Town of Ajax and Town of Ajax Heritage Advisory Committee 2018b). - Located on the north side of Kingston Road East, an early transportation route, setback from the road. - Reflects twentieth-century settlement and agricultural practices along Kingston Road East in Pickering Township. <p>Potential Cultural Heritage Value or Interest and associated heritage attributes</p> <p>This property has the potential to retain historical, architectural, and contextual value.</p>

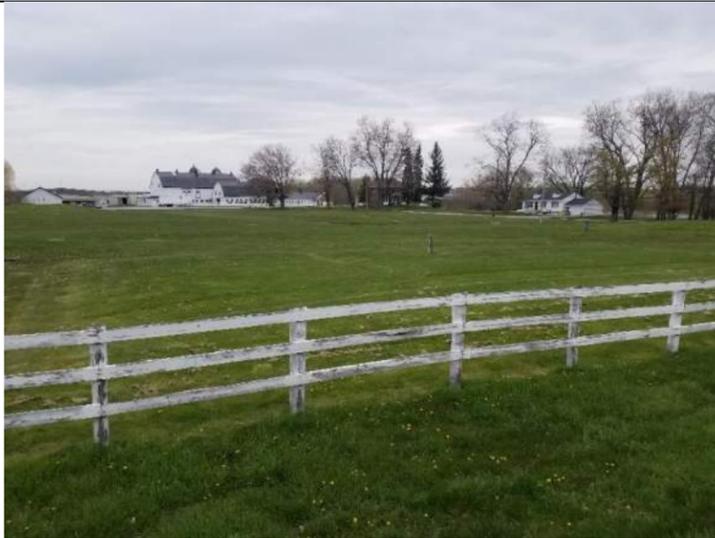
AJ-052	CHL	Cemetery	Kingston Rd E - Hicksite / Brown Quaker Cemetery, Ajax	Known CHL - Part IV Designation (By-law #14-2007)	<p>Property Description</p> <ul style="list-style-type: none"> - The cemetery is known as the Hicksite Cemetery and is one of the oldest graveyards in Ajax. - There are 100 burials and they remain in situ in rows perpendicular to Kingston Road East. - Located on the north side of Kingston Road East, an early transportation route, setback from the road behind a modern house. - Reflects nineteenth-century burial practices along Kingston Road East in Pickering Township. <p>Known Cultural Heritage Value or Interest under Ontario Regulation 9/06 and associated heritage attributes</p> <p>For additional information, please see the By-Law available at: https://www.heritagetrust.on.ca/en/oha/details?id=299&backlinkslug=search-results&fields%5Blocation%5D=7%2C5</p> <p>Physical heritage attributes that support the CHVI include:</p> <ul style="list-style-type: none"> - the original markers and their surviving inscriptions; - the park-like setting with the mature trees along the east and north sides; and, - the original plan and placement of the gravestones.

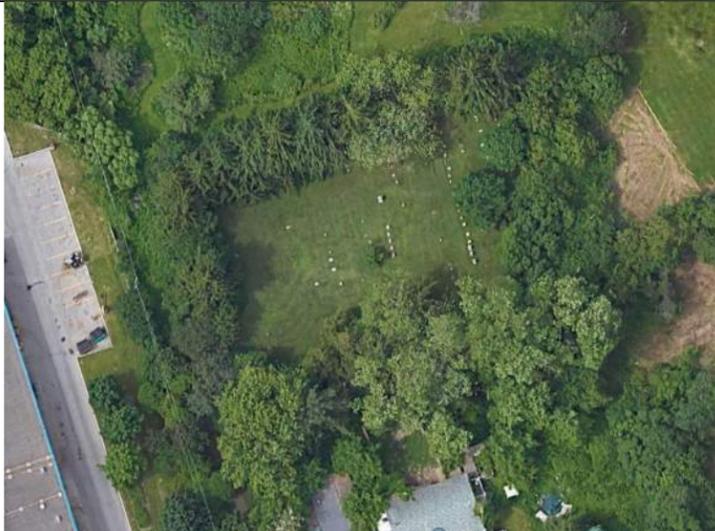
Ref #	Type of Cultural Heritage Resource	Type of Property	Location	Heritage Recognition	Description of Property and Known or Potential CHVI	Photographs/ Digital Image
AJ-053	BHR	School	365 Kingston Rd E, Ajax	Known BHR - Part IV Designation (By-law #148-92; #125-2009)	<p>Property Description</p> <ul style="list-style-type: none"> - The property features a two-storey brick structure, known as the Old Post Inn and was constructed circa 1815. The former inn is constructed in the Loyalist neo-classical design with five-bays and a gable roof with chimneys on the gable ends. A single-storey addition is located on the east side. - Located on the south side of Kingston Road East, an early transportation route, with a limited front setback. - Reflects nineteenth-century settlement along Kingston Road East in Pickering Township. <p>Known Cultural Heritage Value or Interest under Ontario Regulation 9/06 and associated heritage attributes For additional information, please see the By-Law available at: https://www.heritagetrust.on.ca/en/oha/details?id=294&backlinkslug=search-results&fields%5Blocation%5D=7%2C5</p> <p>Physical heritage attributes that support the CHVI include:</p> <ul style="list-style-type: none"> - its Loyalist neo-classic shape and form; - the brick construction and fine structural timberwork; and, - interior features including the bake oven and the folding partition doors on the second floor. <p>The historical/associative value that support the CHVI include:</p> <ul style="list-style-type: none"> - its location along Kingston Road East and use as a staging stop for those travelling along the road.

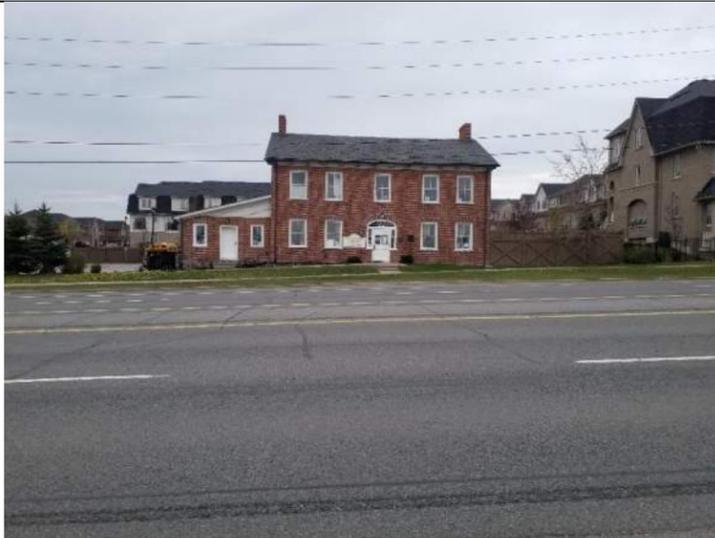
AJ-054	BHR	Mixed Use	462 Kingston Rd E, Ajax	Potential BHR - Listed on Municipal Heritage Register	<p>Property Description</p> <ul style="list-style-type: none"> - The property features a two-storey residence with a rectangular footprint and a slight projection along the east end of the south façade that is accentuated by a cross hip roof. The residence is a unique representation of Edwardian style and is connected with the Picov family, pioneers in Quarter Horse racing in Ontario (Town of Ajax and Town of Ajax Heritage Advisory Committee 2018b). - Located on the north side of Kingston Road East, an early transportation route, setback from the road. - Reflects nineteenth-century settlement along Kingston Road West in Pickering Township. <p>Potential Cultural Heritage Value or Interest and associated heritage attributes This property has the potential to retain historical, architectural, and contextual value.</p>

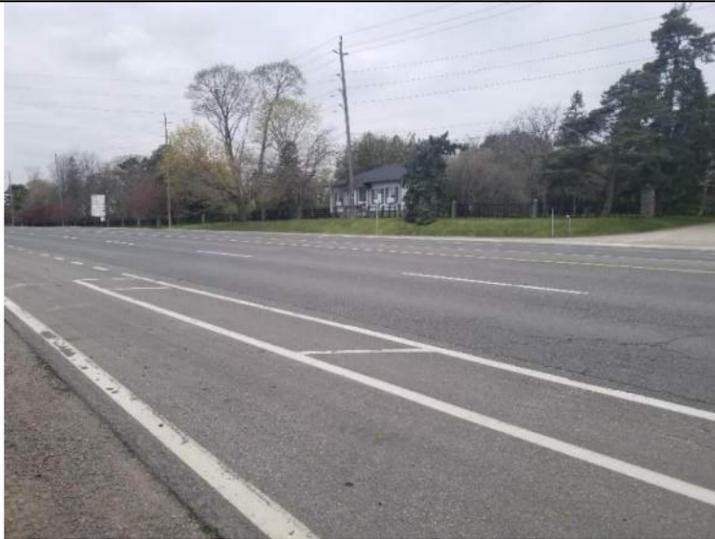
AJ-058	CHL	Farmstead	744 Kingston Rd E and 709 Audley Rd N, Ajax	Potential CHL - Listed on Municipal Heritage Register	<p>Property Description</p> <ul style="list-style-type: none"> - The property features a single-storey Regency cottage that was constructed circa 1835; barns that were constructed in 1927 in the Arts and Crafts style; a 1927 cold storage plant that has the Art Deco scale and massing without ornamentation; and a residence constructed in 1879, that is a two-storey brick structure with a T-shaped footprint with a mixture of Gothic and Italianate architectural elements. - Located on the north side of Kingston Road East, an early transportation route, with a limited front setback. - Reflects nineteenth-century settlement along Kingston Road East in Pickering Township. <p>Potential Cultural Heritage Value or Interest and associated heritage attributes</p> <p>This property has the potential to retain historical, architectural, and contextual value.</p>

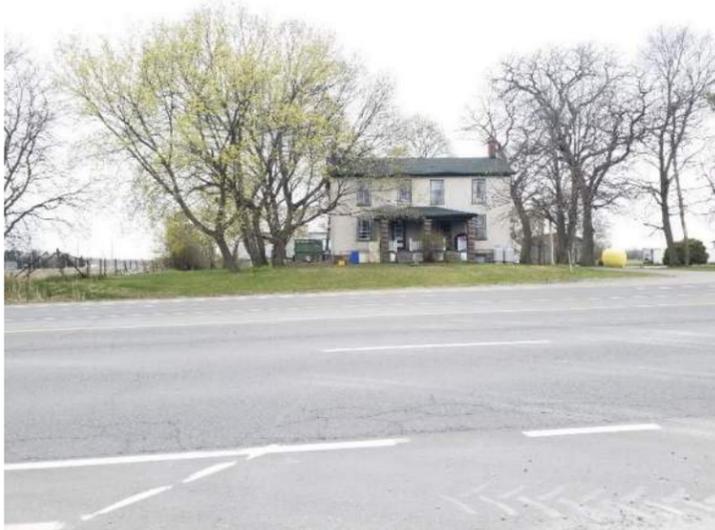
Ref #	Type of Cultural Heritage Resource	Type of Property	Location	Heritage Recognition	Description of Property and Known or Potential CHVI	Photographs/ Digital Image
AJ-059	CHL	Farmstead	775 Kingston Rd E, Ajax	Known CHL – Part IV Designation (By-law #32-2021)	<p>Property Description</p> <ul style="list-style-type: none"> - The property features a two-storey, four-bay, semi-detached Georgian residence with a gable roof and rear addition. A small porch with brick columns provides entrances for the separate units. The windows appear to be original. The foundation is rubble stone and the house also features brick lintels, return eaves, and brick chimneys at the gable ends. South of the residence are agricultural buildings. - Located on the south side of Kingston Road East, an early transportation route, with a limited front setback. - Reflects nineteenth-century settlement along Kingston Road East in Pickering Township. <p>Known Cultural Heritage Value or Interest under Ontario Regulation 9/06 and associated heritage attributes For additional information, please see the By-Law available at: https://imo.ajax.ca/austinproperty</p> <p>The physical/design attributes that support the CHVI include:</p> <ul style="list-style-type: none"> - The property is a unique and early example of an evolved farmstead in Ajax. - The principal building is the c. 1850 Georgian-style residence with twentieth century additions. - A timber-frame gable roof barn, likely constructed in the mid-1800s. - A combined stable and garage dating from 1936. - A one-storey airplane hangar built in 1936. <p>The historical/associative value that support the CHVI include:</p> <ul style="list-style-type: none"> - The association of the property with early Quaker settlement in Pickering Township and the Red Wing Orchards/Stonehaven Farm property. - The property is associated with Nicholas Austin, who likely built the house and was involved with the Hicksite Quakers. - The property is also associated with George McLaughlin, who purchased the property and merged it with the adjacent property on the north side of Kingston Road. <p>The contextual value that support the CHVI include:</p> <ul style="list-style-type: none"> - The property reflects the agricultural character of the Greenbelt along this section of Kingston Road. - The property also maintains visual and historical links with other heritage properties in the area. - The property is also within 2 km of the Hicksite Cemetery, which is the final resting place of many early Quaker families, including the Austins.

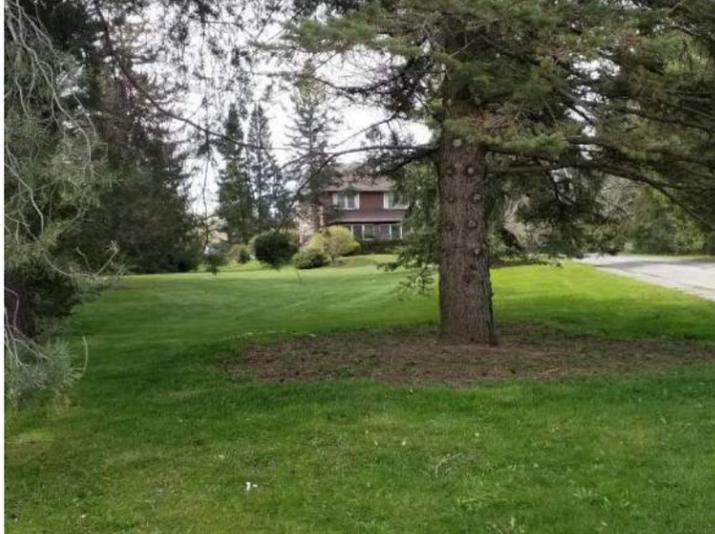
Ref #	Type of Cultural Heritage Resource	Type of Property	Location	Heritage Recognition	Description of Property and Known or Potential CHVI	Photographs/ Digital Image
WI-003	BHR	Residence	925 Dundas St W, Whitby	Potential BHR - Identified During Desktop/Field Review	<p>Property Description</p> <ul style="list-style-type: none"> - The property features a two-storey brick residence with a rectangular footprint, a hipped roof, and a single-storey rear addition. The property also features a garage, an outbuilding, a long driveway, and is lined with trees. - Located on the south side of Dundas Street West, an early transportation route, set back from the road. - Reflects twentieth-century settlement along Dundas Street West in Whitby Township. <p>Potential Cultural Heritage Value or Interest and associated heritage attributes This property has the potential to retain architectural, and contextual value.</p>

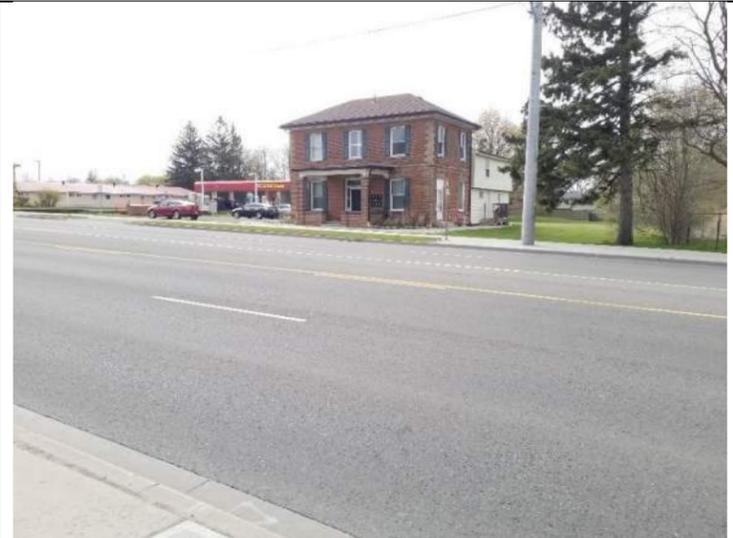
Ref #	Type of Cultural Heritage Resource	Type of Property	Location	Heritage Recognition	Description of Property and Known or Potential CHVI	Photographs/ Digital Image
WI-009	BHR	Residence	859 Dundas St W, Whitby	Potential BHR - Identified During Desktop/Field Review	<p>Property Description</p> <ul style="list-style-type: none"> - The property features a two storey frame residence with a one-and-a-half storey rear addition and a few mature trees on the rear of the parcel. The residence is clad with red brick and features a hipped roof with brackets, buff brick quoining, and covered front porch with brick piers. The rear addition is clad with vinyl siding and features a gable roof. - Located on the south side of Dundas Street West, an early transportation route, set close to the road. - Reflects nineteenth-century settlement along Dundas Street West in Whitby Township. <p>Potential Cultural Heritage Value or Interest and associated heritage attributes</p> <p>This property has the potential to retain historical, architectural, and contextual value.</p>

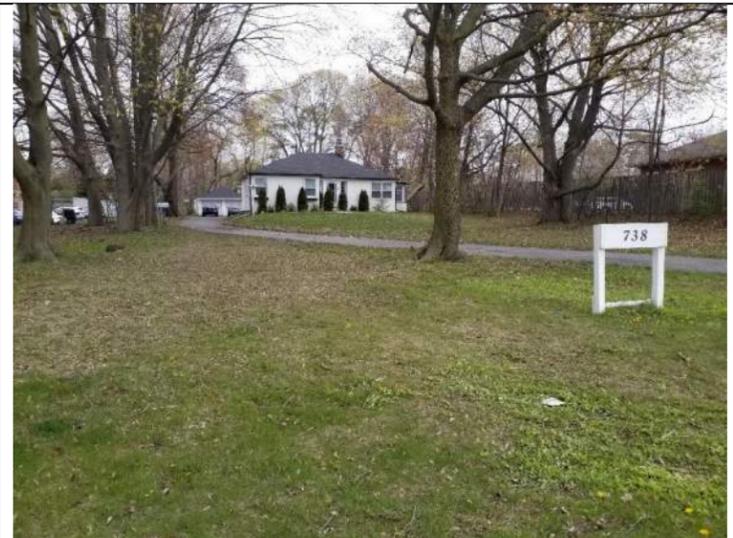
WI-010	BHR	Residence	738 Dundas St W, Whitby	Potential BHR - Identified During Desktop/Field Review	<p>Property Description</p> <ul style="list-style-type: none"> - The property features a one storey frame residence with rear detached garage and mature trees throughout the property. The L-shaped twentieth-century residence features a hipped roof, contemporary stucco, and windows located on the corners of each elevation. - Located on the north side of Dundas Street West, an early transportation route, set back from the road. - Reflects twentieth-century settlement along Dundas Street West in Whitby Township. <p>Potential Cultural Heritage Value or Interest and associated heritage attributes</p> <p>This property has the potential to retain historical, architectural, and contextual value.</p>

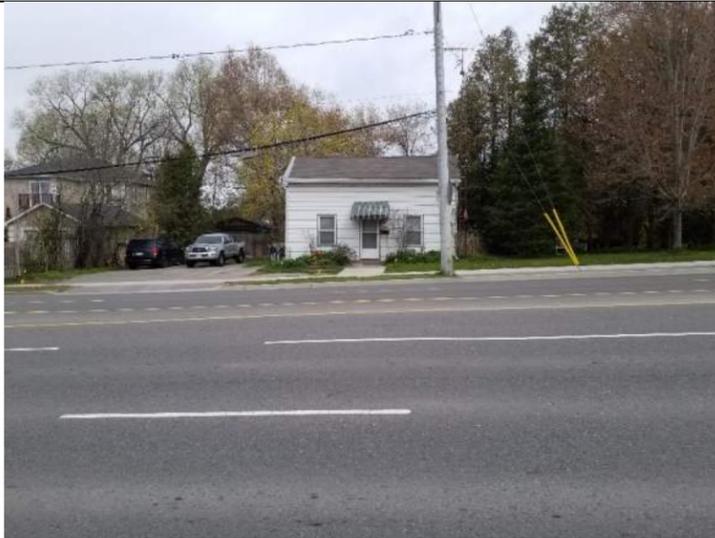
Ref #	Type of Cultural Heritage Resource	Type of Property	Location	Heritage Recognition	Description of Property and Known or Potential CHVI	Photographs/ Digital Image
WI-013	BHR	Residence	708 Dundas St W, Whitby	Potential BHR - Identified During Desktop/Field Review	<p>Property Description</p> <ul style="list-style-type: none"> - The property features a one-and-a-half storey frame residence with rear shed and mature trees throughout the parcel. The residence is clad with vinyl siding and features a side gable roof, symmetrical primary elevation with centre hall plan, and brick chimney on the north elevation. - Located on the north side of Dundas Street West, an early transportation route, set close to the road. - Reflects nineteenth-century settlement along Dundas Street West in Whitby Township. <p>Potential Cultural Heritage Value or Interest and associated heritage attributes This property has the potential to retain historical and contextual value.</p>

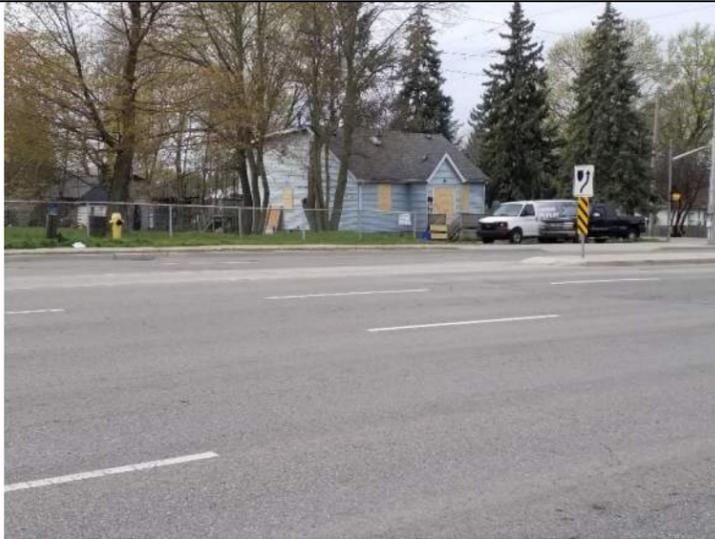
WI-014	BHR	Residence	723 Dundas St W, Whitby	Potential BHR - Identified During Desktop/Field Review	<p>Property Description</p> <ul style="list-style-type: none"> - The property features a one-and-a-half storey frame residence with one-and-a-half storey rear addition and mature trees throughout the parcel. The residence is clad with vinyl siding and features a side gable roof with asymmetrical roof extension on the east elevation, centre hall plan with projected gabled entry on the north elevation and bay window on the west elevation. - Located on the southeast corner of Dundas Street West, an early transportation route, and Annes Street, set close to the road. - Reflects twentieth-century settlement along Dundas Street West in Whitby Township. <p>Potential Cultural Heritage Value or Interest and associated heritage attributes This property has the potential to retain historical and contextual value.</p> <p>Note: This property currently has received approval for future development.</p>

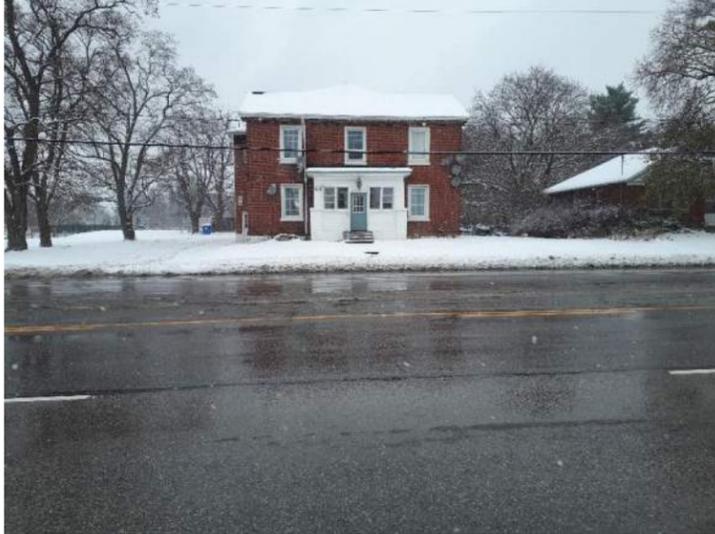
Ref #	Type of Cultural Heritage Resource	Type of Property	Location	Heritage Recognition	Description of Property and Known or Potential CHVI	Photographs/ Digital Image
WI-015	BHR	Residence	610 Dundas St W, Whitby	Potential BHR - Identified During Desktop/Field Review	<p>Property Description</p> <ul style="list-style-type: none"> - The property features a two-and-a-half storey frame residence with several two storey rear additions and rear paved parking with several mature trees lining the parcel. The Georgian style residence is clad with red brick and features a side gable roof with brackets on the original structure with a hipped roof over the rear additions, a parged foundation and enclosed porch addition on the south elevation. - Located on the north side of Dundas Street West, an early transportation route, set close to the road. - Reflects nineteenth-century settlement along Dundas Street West in Whitby Township. <p>Potential Cultural Heritage Value or Interest and associated heritage attributes This property has the potential to retain historical, architectural, and contextual value.</p>

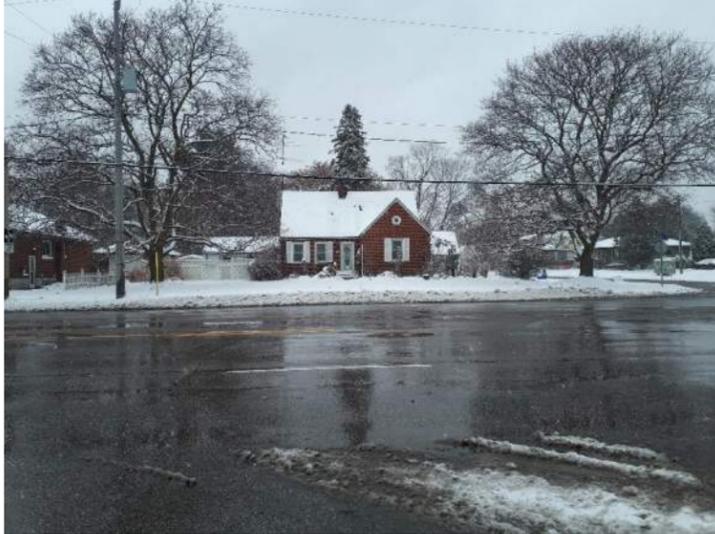
WI-016	BHR	Residence	600 Dundas St W, Whitby	Potential BHR - Identified During Desktop/Field Review	<p>Property Description</p> <ul style="list-style-type: none"> - The property features a one-and-a-half storey frame residence, rear detached garage, shed, and several mature trees. The post-war residence is clad with red brick and features a cross-gable roof with dormers on the north elevation, a central brick chimney and centre hall plan. The gable ends and dormers are clad with vinyl siding. A covered porch connects the residence and garage. - Located on the northwest corner of Dundas Street West, an early transportation route, and Palace Street, and is set close to the road. - Reflects twentieth-century settlement along Dundas Street West in Whitby Township. <p>Potential Cultural Heritage Value or Interest and associated heritage attributes This property has the potential to retain historical, architectural, and contextual value.</p>

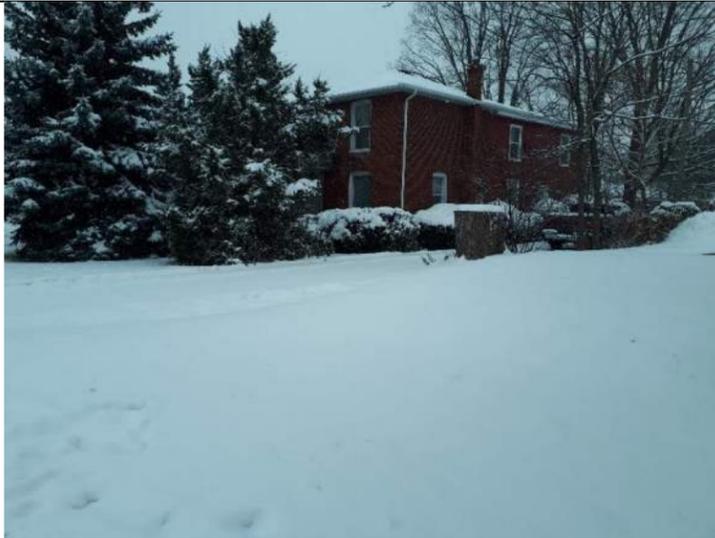
Ref #	Type of Cultural Heritage Resource	Type of Property	Location	Heritage Recognition	Description of Property and Known or Potential CHVI	Photographs/ Digital Image
WI-017	BHR	Residence	504 Dundas St W, Whitby	Potential BHR - Listed on Municipal Heritage Register	<p>Property Description</p> <ul style="list-style-type: none"> - The property features a two-storey brick residence constructed in 1862 with a rear two-storey addition and several mature trees throughout the parcel (Town of Whitby 2017b). The 1862 residence has a rectangular footprint with a hipped roof, side hall plan and brick chimney on the east elevation. The rear addition is clad with vinyl siding and features a flat roof. - Located on the north side of Dundas Street West, an early transportation route, set close to the road. - Reflects twentieth-century settlement along Dundas Street West in Whitby Township. <p>Potential Cultural Heritage Value or Interest and associated heritage attributes This property has the potential to retain historical, architectural, and contextual value.</p>

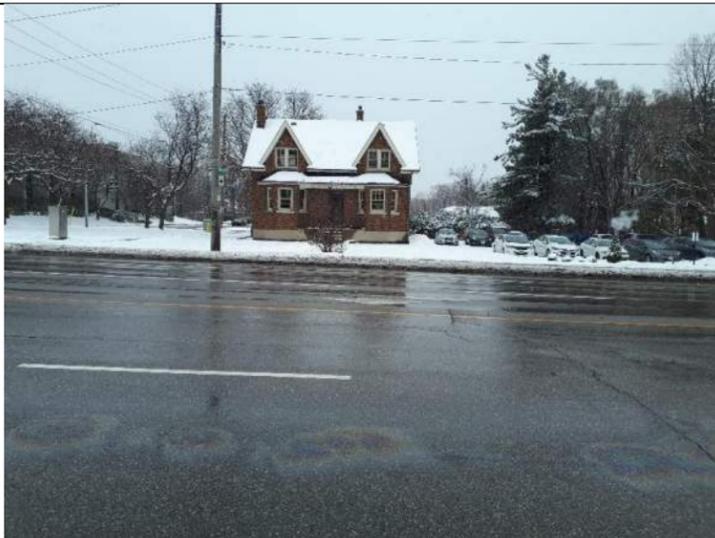
WI-018	BHR	Residence	501 Dundas St W, Whitby	Potential BHR - Identified During Desktop/Field Review	<p>Property Description</p> <ul style="list-style-type: none"> - Known as the Dr. Alva Annes House (Town of Whitby n.d.). - The property features a one-and-a-half storey frame residence with small one storey rear addition with paved parking on the south and west sides of the parcel and several mature trees. The early twentieth century residence is clad with red brick and features a side gable roof with two gables above bay windows on the north elevation and a shed dormer on the south elevation. The small rear addition is clad with vinyl siding. - Located on the southwest corner of Dundas Street West, an early transportation route, and Euclid Street, set close to the road. - Reflects twentieth-century settlement along Dundas Street West in Whitby Township. <p>Potential Cultural Heritage Value or Interest and associated heritage attributes This property has the potential to retain historical, architectural, and contextual value.</p>

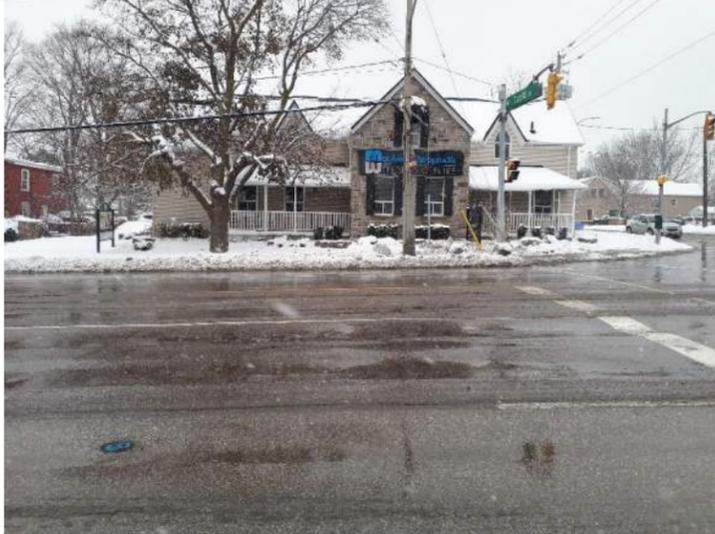
Ref #	Type of Cultural Heritage Resource	Type of Property	Location	Heritage Recognition	Description of Property and Known or Potential CHVI	Photographs/ Digital Image
WI-019	BHR	Commercial	500 Dundas St W, Whitby	Potential BHR - Identified During Desktop/Field Review	<p>Property Description</p> <ul style="list-style-type: none"> - The property features a one-and-a-half storey former residence with one and one-and-a-half storey rear additions and rear paved parking. The Gothic Revival residence has been re-clad with vinyl siding and stone veneer, and features a cross gable roof, symmetrical façade with gable features, and two front porch additions and a rear covered porch addition. - Located on the northwest corner of Dundas Street West, an early transportation route, and Euclid Street, set close to the road. - Reflects twentieth-century settlement along Dundas Street West in Whitby Township. <p>Potential Cultural Heritage Value or Interest and associated heritage attributes This property has the potential to retain historical, architectural, and contextual value.</p>

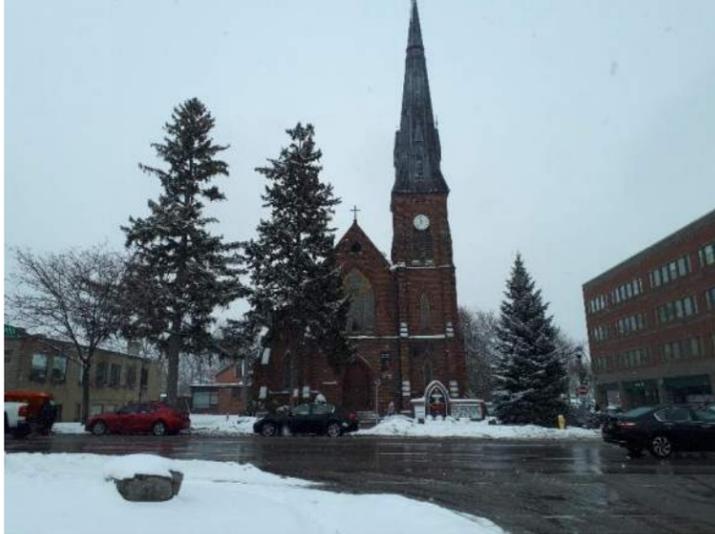
WI-020	BHR	Church	300 Dundas St W, Whitby	Potential BHR - Listed on Municipal Heritage Register This property is also included in the Perry's Plan Neighbourhood Proposed Heritage Conservation District (WI-066)	<p>Property Description</p> <ul style="list-style-type: none"> - The property features a Gothic Revival church constructed between 1865-1866, designed by Toronto architect Henry Langley. The church has been re-built after three fires. - Located on the north side of Dundas Street West, an early transportation route, set close to the road. - Reflects nineteenth-century religious practices along Dundas Street West in Whitby Township. <p>Potential Cultural Heritage Value or Interest and associated heritage attributes This property has the potential to retain historical, architectural, and contextual value.</p>

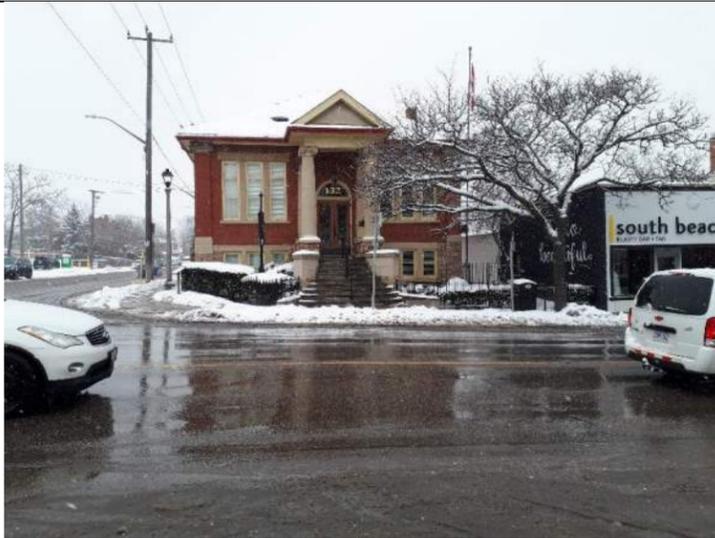
Ref #	Type of Cultural Heritage Resource	Type of Property	Location	Heritage Recognition	Description of Property and Known or Potential CHVI	Photographs/ Digital Image
WI-021	BHR	Commercial	132 Dundas St W, Whitby	<p>Known BHR - Part IV Designation (By-law #1813-85)</p> <p>This property is also included in the Four Corners Proposed Heritage Conservation District (WI-065)</p>	<p>Property Description</p> <ul style="list-style-type: none"> - The property features a single-storey commercial building. The former library in the Beaux Arts Classical design was constructed in 1913 by the Whitby Library Board and was financed by the Carnegie Foundation. The Ontario County Old Girls' Association donated the land. The building was used as the library until 1973. It features red brick, a hipped roof, stone foundation, and pedimented front entry porch supported by ionic columns and approached by stairs (Town of Whitby 2017a). - Located on the northeast corner of Dundas Street West, an early transportation route, and Byron Street N, set close to the road. - Reflects twentieth-century educational practices along Dundas Street West in Whitby Township. <p>Known Cultural Heritage Value or Interest under Ontario Regulation 9/06 and associated heritage attributes For additional information, please see the By-Law available at: https://www.heritagetrust.on.ca/en/oha/details?id=7171&backlinkslug=search-results&fields%5Baddress%5D=132+Dundas+</p> <p>Physical heritage attributes that support the CHVI include:</p> <ul style="list-style-type: none"> - its Beaux Arts Classical shape and form; and, - its monument of scale without the use of expensive materials <p>The historical/associative value that support the CHVI include:</p> <ul style="list-style-type: none"> - its use as the Town's library from opening in 1914 until 1973; and, - its association with the Whitby Library Board, the Carnegie Foundation, and the Ontario County Old Girls' Association.

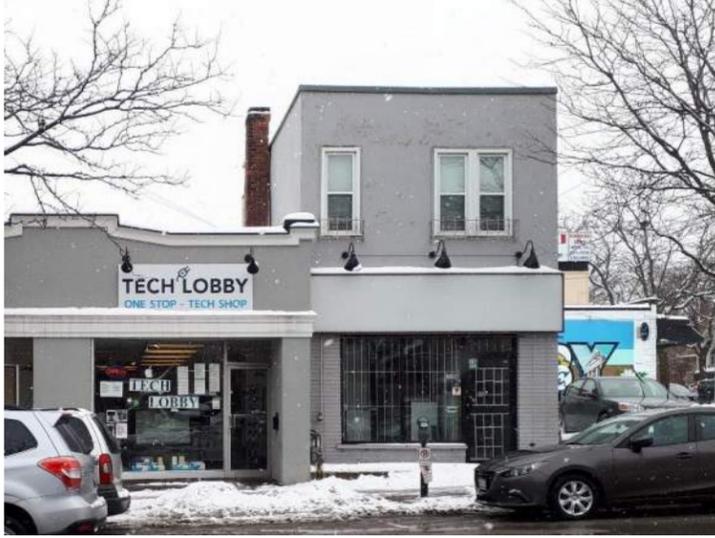
WI-022	BHR	Commercial	115 Dundas St W, Whitby	<p>Potential BHR - Identified During Desktop/Field Review</p> <p>This property is also included in the Four Corners Proposed Heritage Conservation District (WI-065)</p>	<p>Property Description</p> <ul style="list-style-type: none"> - The property features a two-storey commercial building constructed in 1916 and formerly known as the W.F. Disney's Implement Building (Town of Whitby n.d.). The early twentieth-century building is surfaced with contemporary stucco and features a flat roof with parapet walls. The storefront on the north elevation has been altered with the addition of brick (painted) cladding, replacement windows and contemporary signage. The windows openings on the second storey are asymmetrical. - Located on the southeast corner of Dundas Street West, an early transportation route, and Byron Street S, set close to the road. - Reflects twentieth-century commercial practices along Dundas Street West in Whitby Township. <p>Potential Cultural Heritage Value or Interest and associated heritage attributes This property has the potential to retain contextual value.</p>

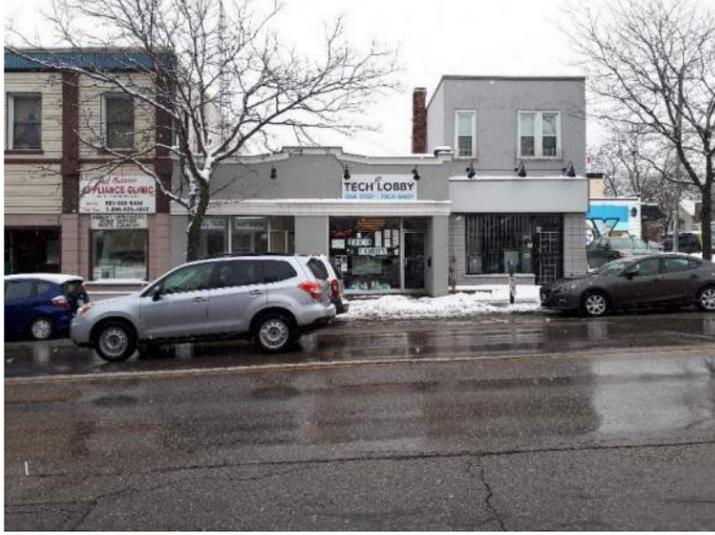
WI-024	BHR	Commercial	113 Dundas St W, Whitby	<p>Potential BHR - Identified During Desktop/Field Review</p> <p>This property is also included in the Four Corners Proposed Heritage Conservation District (WI-065)</p>	<p>Property Description</p> <ul style="list-style-type: none"> - The property features a one storey commercial building with one storey rear addition, small grass lawn and paved parking the in the rear. The early twentieth-century building has a rectangular footprint, flat roof, and parapet. The front façade has been stuccoed and has two large windows with an entrance at the western end of the façade. - Located on the south side of Dundas Street West, an early transportation route, set close to the road. - Reflects twentieth-century commercial practices along Dundas Street West in Whitby Township. <p>Potential Cultural Heritage Value or Interest and associated heritage attributes This property has the potential to retain contextual value.</p>

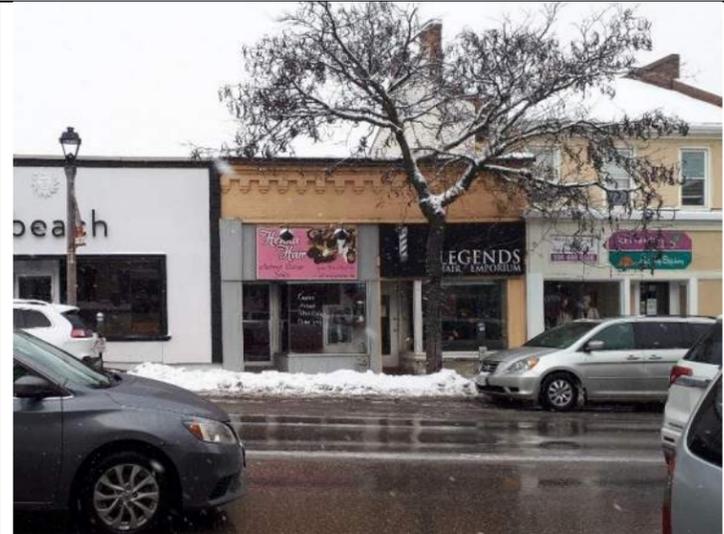
Ref #	Type of Cultural Heritage Resource	Type of Property	Location	Heritage Recognition	Description of Property and Known or Potential CHVI	Photographs/ Digital Image
WI-025	BHR	Commercial	128 Dundas St W, Whitby	<p>Potential BHR - Identified During Desktop/Field Review</p> <p>This property is also included in the Four Corners Proposed Heritage Conservation District (WI-065)</p>	<p>Property Description</p> <ul style="list-style-type: none"> - (On the left) The property features a single-storey commercial building formerly known as Bryan’s Block (Town of Whitby n.d.). The early twentieth-century building has a rectangular footprint, flat roof with parapet on the south elevation. The east and west elevations share party walls with the neighbouring commercial buildings. The north elevation has painted brick veneer with brick detailing ornamenting the cornice and large window openings and entrance framed with vertical aluminum siding below. - Located on the north side of Dundas Street West, an early transportation route, set close to the road. - Reflects twentieth-century commercial practices along Dundas Street West in Whitby Township. <p>Potential Cultural Heritage Value or Interest and associated heritage attributes</p> <p>This property has the potential to retain architectural and contextual value.</p>
