**DURHAM-SCARBOROUGH BUS RAPID TRANSIT PROJECT
CULTURAL HERITAGE REPORT – EXISTING CONDITIONS AND PRELIMINARY IMPACT ASSESSMENT
CITY OF TORONTO AND DURHAM REGION, ONTARIO**

ASI File: 18CH-142

October 2019 (Revised June and October 2020;
January, May, November and December 2021; January and February 2022)

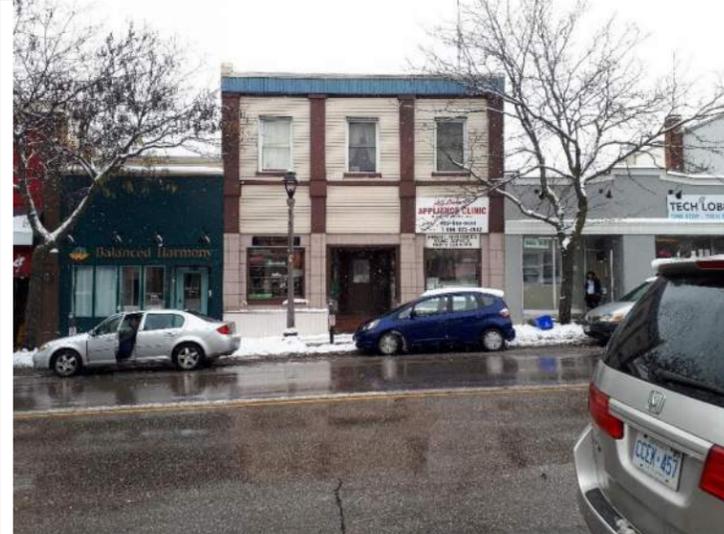
WI-026	BHR	Commercial	111 Dundas St W, Whitby	<p>Potential BHR - Identified During Desktop/Field Review</p> <p>This property is also included in the Four Corners Proposed Heritage Conservation District (WI-065)</p>	<p>Property Description</p> <ul style="list-style-type: none"> - The property features a two-storey commercial building constructed in 1888 and formerly known as the Deverll’s Warehouse (Town of Whitby n.d.). The 1888 commercial building has a rectangular footprint and flat roof with parapet walls. The north elevation is divided into three bays and features large display windows and entrance on the street level and a single double hung window within each bay on the second storey. The elevation has been altered through the addition of vinyl siding and ceramic tile. The east and west elevations share party walls with the neighbouring commercial buildings. - Located on the south side of Dundas Street West, an early transportation route, set close to the road. - Reflects nineteenth-century commercial practices along Dundas Street West in Whitby Township. <p>Potential Cultural Heritage Value or Interest and associated heritage attributes</p> <p>This property has the potential to retain architectural and contextual value.</p>

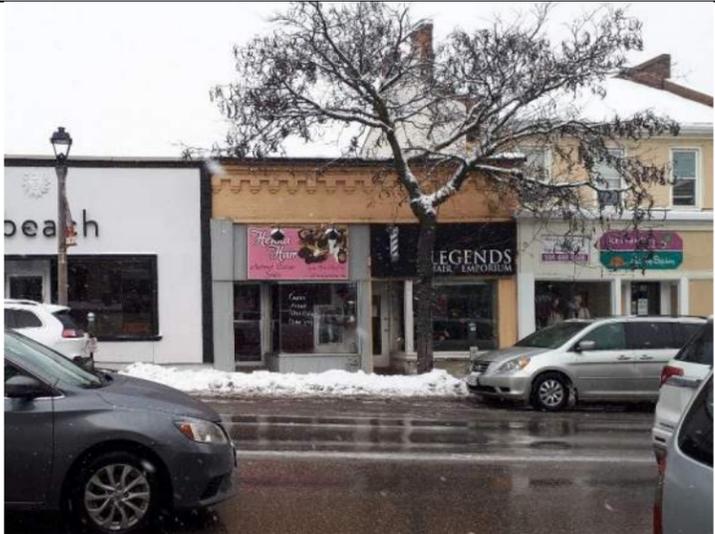
Ref #	Type of Cultural Heritage Resource	Type of Property	Location	Heritage Recognition	Description of Property and Known or Potential CHVI	Photographs/ Digital Image
WI-027	BHR	Commercial	126 Dundas St W, Whitby	<p>Potential BHR - Identified During Desktop/Field Review</p> <p>This property is also included in the Four Corners Proposed Heritage Conservation District (WI-065)</p>	<p>Property Description</p> <ul style="list-style-type: none"> - (On the right) The property features a single-storey commercial building formerly known as Bryan’s Block (Town of Whitby n.d.). The property features a one storey commercial building with paved parking the in the rear. The early twentieth-century building has a rectangular footprint, flat roof with parapet on the south elevation. The east and west elevations share party walls with the neighbouring commercial buildings. The north elevation has painted brick veneer with brick detailing ornamenting the cornice and large window openings and entrance framed with vertical aluminum siding below. - Located on the north side of Dundas Street West, an early transportation route, set close to the road. - Reflects twentieth-century commercial practices along Dundas Street West in Whitby Township. <p>Potential Cultural Heritage Value or Interest and associated heritage attributes</p> <p>This property has the potential to retain architectural and contextual value.</p>

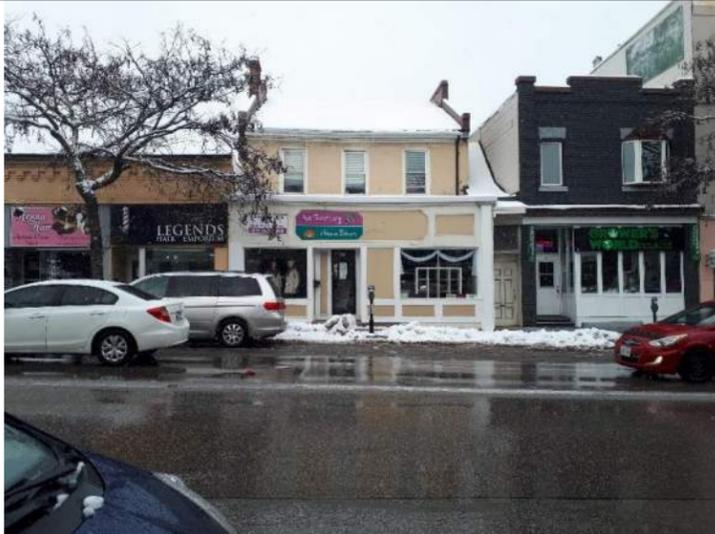
WI-028	BHR	Commercial	124 Dundas St W, Whitby	<p>Potential BHR - Listed on Municipal Heritage Register</p> <p>This property is also included in the Four Corners Proposed Heritage Conservation District (WI-065)</p>	<p>Property Description</p> <ul style="list-style-type: none"> - The property features a two-storey commercial building constructed in 1850 and formerly known as the Carleton Lynde’s Block (Town of Whitby n.d.). The Georgian style commercial building features a side gable roof with parapet walls along the gable end and symmetrical façade. A one storey flat roof addition has been added to the street-facing elevation and has large windows and an entrance with plywood cladding. A covered external stair is located on the side of the structure leading to the former residence. The two storey rear addition has a flat roof and contemporary siding. - Located on the north side of Dundas Street West, an early transportation route, set close to the road. - Reflects nineteenth-century commercial practices along Dundas Street West in Whitby Township. <p>Potential Cultural Heritage Value or Interest and associated heritage attributes</p> <p>This property has the potential to retain historical, architectural, and contextual value.</p>

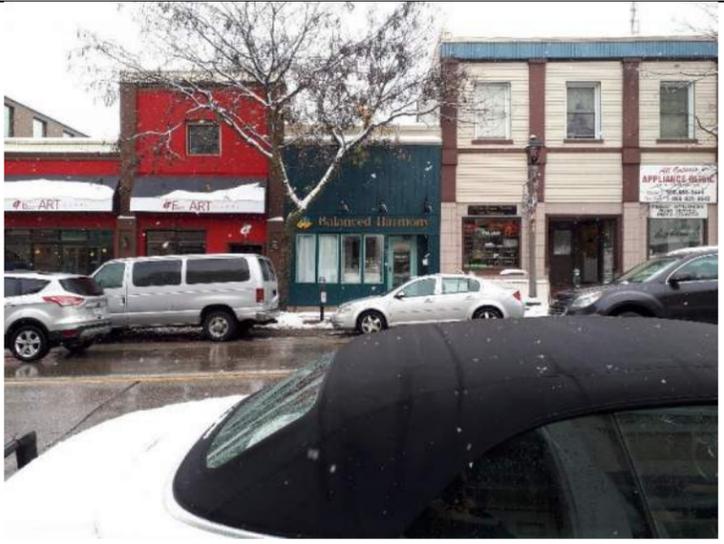
Ref #	Type of Cultural Heritage Resource	Type of Property	Location	Heritage Recognition	Description of Property and Known or Potential CHVI	Photographs/ Digital Image
WI-029	BHR	Commercial	109 Dundas St W, Whitby	<p>Potential BHR - Identified During Desktop/Field Review</p> <p>This property is also included in the Four Corners Proposed Heritage Conservation District (WI-065)</p>	<p>Property Description</p> <ul style="list-style-type: none"> - The late nineteenth-century building has a rectangular footprint, a rear addition, and shares a party wall with its neighbouring properties. The exterior has been clad in board-and-batten siding. Windows extend the length of the front façade with an entryway at the western end. - Located on the south side of Dundas Street West, an early transportation route, set close to the road. - Reflects nineteenth-century commercial practices along Dundas Street West in Whitby Township. <p>Potential Cultural Heritage Value or Interest and associated heritage attributes</p> <p>This property has the potential to retain contextual value.</p>

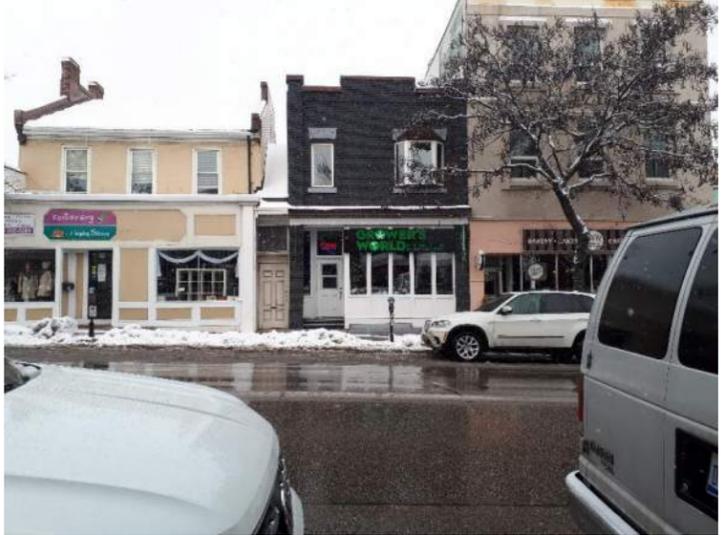
WI-030	BHR	Commercial	120 Dundas St W, Whitby	<p>Potential BHR - Identified During Desktop/Field Review</p> <p>This property is also included in the Four Corners Proposed Heritage Conservation District (WI-065)</p>	<p>Property Description</p> <ul style="list-style-type: none"> - The property features a two-storey commercial building, constructed in 1920 and formerly known as the Anthony Bandel Butcher Shop (Town of Whitby n.d.). The early twentieth-century painted brick building features a flat roof with modestly decorative brickwork on the parapet wall. The storefront on the south elevation has retained the storefront wood lintel however the entry door and windows have been replaced and the surrounding frame re-clad with wood. The windows openings on the second storey are asymmetrical. Vinyl siding has been added to the exposed section of the west elevation, and the remaining portion as well as the east elevation share party walls with the neighbouring structures. - Located on the north side of Dundas Street West, an early transportation route, set close to the road. - Reflects twentieth-century commercial practices along Dundas Street West in Whitby Township. <p>Potential Cultural Heritage Value or Interest and associated heritage attributes</p> <p>This property has the potential to retain architectural and contextual value.</p>

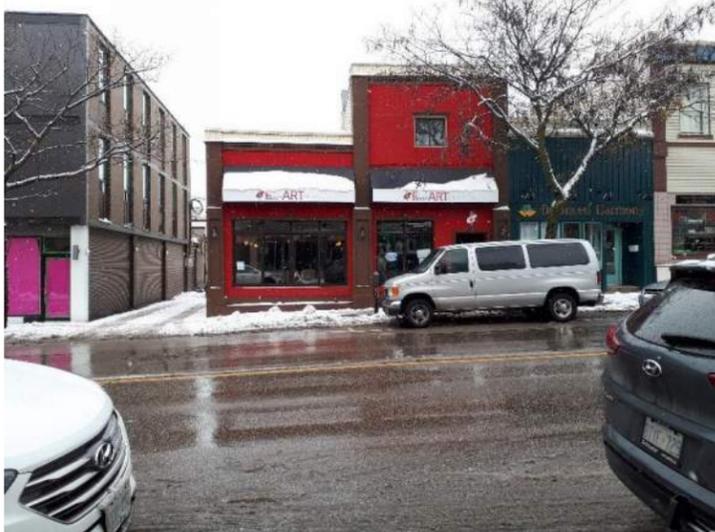
WI-032	BHR	Commercial	116 Dundas St W, Whitby	<p>Potential BHR - Listed on Municipal Heritage Register</p> <p>This property is also included in the Four Corners Proposed Heritage Conservation District (WI-065)</p>	<p>Property Description</p> <ul style="list-style-type: none"> - The property features a three-storey commercial building constructed in 1853 and formerly known as Arnall’s Block (Town of Whitby 2017b). The nineteenth-century building has a one storey rear addition and features a flat roof with parapet walls and concrete foundation. The north elevation has a symmetrical arrangement with entrances flanking large display windows on the first storey and even placement of window openings on the second and third storeys. The north elevation has been surfaced with contemporary stucco. The east and west elevations share party walls with the neighbouring commercial buildings. - Located on the north side of Dundas Street West, an early transportation route, set close to the road. - Reflects nineteenth-century commercial practices along Dundas Street West in Whitby Township. <p>Potential Cultural Heritage Value or Interest and associated heritage attributes</p> <p>This property has the potential to retain contextual value.</p>

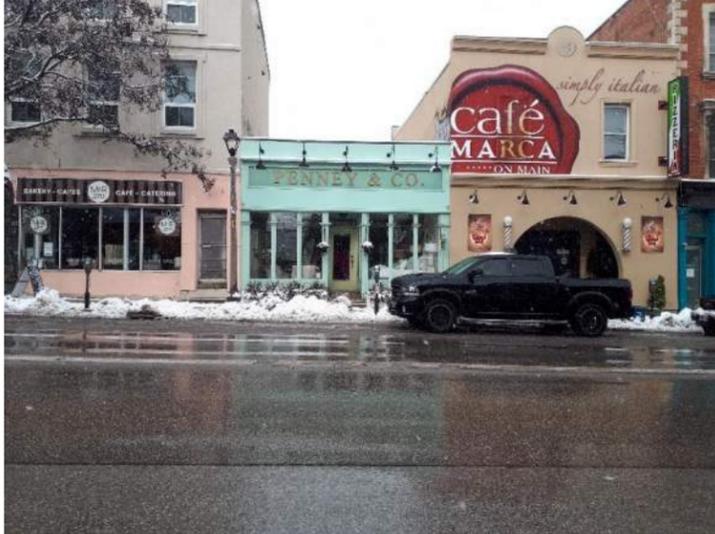
Ref #	Type of Cultural Heritage Resource	Type of Property	Location	Heritage Recognition	Description of Property and Known or Potential CHVI	Photographs/ Digital Image
WI-033	BHR	Commercial	114 Dundas St W, Whitby	<p>Potential BHR - Identified During Desktop/Field Review</p> <p>This property is also included in the Four Corners Proposed Heritage Conservation District (WI-065)</p>	<p>Property Description</p> <ul style="list-style-type: none"> - The property features a single-storey commercial building formerly known as the David Mathison Block, constructed in 1922 (Town of Whitby n.d.; Town of Whitby 2016). The building has a rectangular footprint, a flat roof, a rear addition, and shares a party wall with its neighbouring properties. The front façade features windows flanking a recessed entryway. - Located on the north side of Dundas Street West, an early transportation route, set close to the road. - Reflects twentieth-century commercial practices along Dundas Street West in Whitby Township. <p>Potential Cultural Heritage Value or Interest and associated heritage attributes</p> <p>This property has the potential to retain architectural and contextual value.</p>

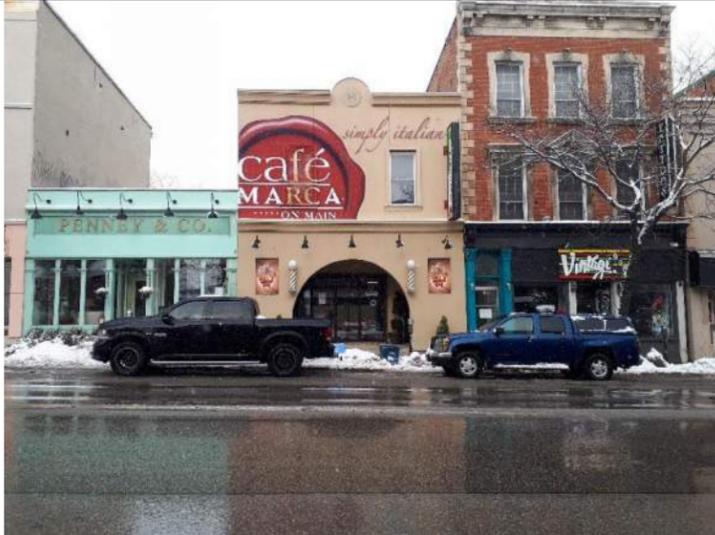
WI-034	BHR	Mixed Use	110 Dundas St W, Whitby	<p>Potential BHR - Identified During Desktop/Field Review</p> <p>This property is also included in the Four Corners Proposed Heritage Conservation District (WI-065)</p>	<p>Property Description</p> <ul style="list-style-type: none"> - The property features a two-storey commercial building constructed circa 1904 and formerly known as the E.R. Blow Block (Town of Whitby n.d.). The building has a rectangular footprint and flat roof with parapet walls. The north elevation is symmetrically arranged and features a large rounded arch opening that provides access to a portico with large display windows and entrance set back. The second storey features two symmetrically placed double-hung windows and a contemporary moulded cornice. The elevation has been resurfaced with contemporary stucco. The east and west elevations share party walls with the neighbouring commercial buildings. - Located on the north side of Dundas Street West, an early transportation route, set close to the road. - Reflects twentieth-century commercial practices along Dundas Street West in Whitby Township. <p>Potential Cultural Heritage Value or Interest and associated heritage attributes</p> <p>This property has the potential to retain contextual value.</p>

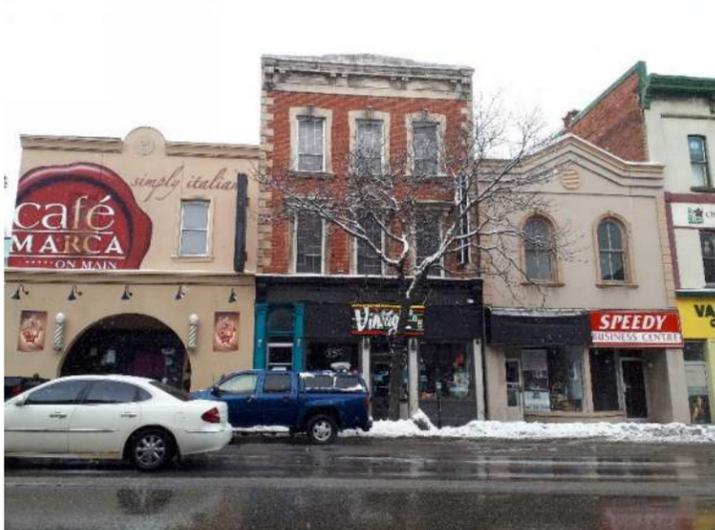
Ref #	Type of Cultural Heritage Resource	Type of Property	Location	Heritage Recognition	Description of Property and Known or Potential CHVI	Photographs/ Digital Image
WI-035	BHR	Mixed Use	106-108 Dundas St W, Whitby	<p>Potential BHR - Listed on Municipal Heritage Register</p> <p>This property is also included in the Four Corners Proposed Heritage Conservation District (WI-065)</p>	<p>Property Description</p> <ul style="list-style-type: none"> - The property features a three-storey dichromatic brick commercial building constructed in 1860 with two rear additions, formerly known as the Joel Bigelow Block. The building has a rectangular footprint, flat roof with parapet and shares a party wall with its neighbouring properties. The entryway and storefront window openings are contemporary window replacements and signage on the first storey. The second and third storeys features symmetrical window openings and ornamental brickwork such as quoining, window hoods and dentils. The street-facing parapet has an ornamental cornice. - Located on the north side of Dundas Street West, an early transportation route, set close to the road. - Reflects nineteenth-century commercial practices along Dundas Street West in Whitby Township. <p>Potential Cultural Heritage Value or Interest and associated heritage attributes</p> <p>This property has the potential to retain historical, architectural, and contextual value.</p>

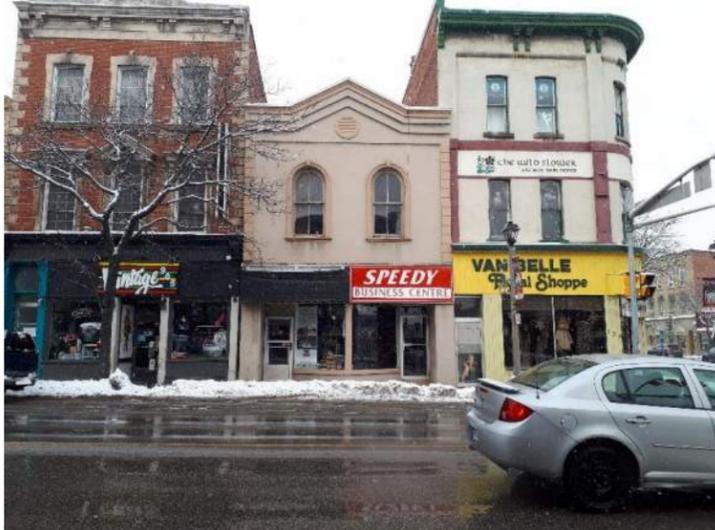
WI-036	BHR	Commercial	104 Dundas St W, Whitby	<p>Potential BHR - Identified During Desktop/Field Review</p> <p>This property is also included in the Four Corners Proposed Heritage Conservation District (WI-065)</p>	<p>Property Description</p> <ul style="list-style-type: none"> - The property features a two-storey commercial building constructed in 1873, formerly known as the Richard Francis Block (Town of Whitby n.d.). The property features a two storey commercial building with one storey rear addition. The nineteenth-century building has a rectangular footprint and flat roof with pointed parapet wall. The south elevation has been surfaced with contemporary stucco and features a symmetrical arrangement with large, angle display windows that form a point in the centre of the façade and lead to the setback entrances on the out edges. The second storey features two rounded arch windows. Window surrounds and quoining are articulated with the contemporary stucco. The east and west elevations share party walls with the neighbouring commercial buildings. - Located on the north side of Dundas Street West, an early transportation route, set close to the road. - Reflects nineteenth-century commercial practices along Dundas Street West in Whitby Township. <p>Potential Cultural Heritage Value or Interest and associated heritage attributes</p> <p>This property has the potential to retain historical, architectural, and contextual value.</p>

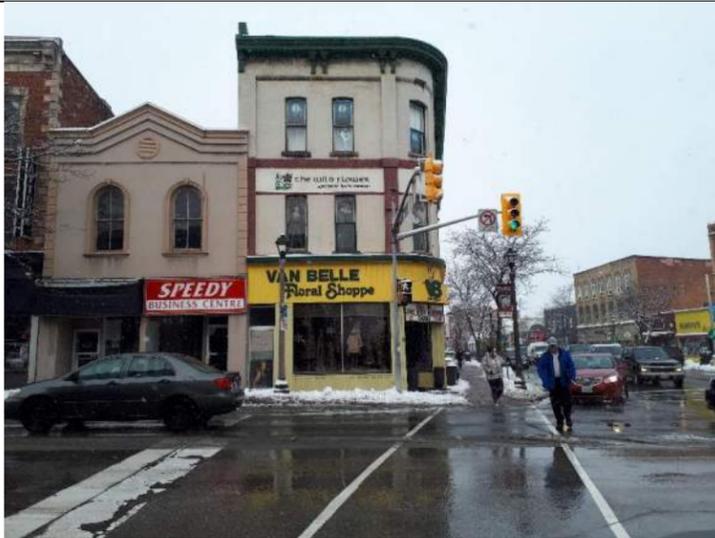
Ref #	Type of Cultural Heritage Resource	Type of Property	Location	Heritage Recognition	Description of Property and Known or Potential CHVI	Photographs/ Digital Image
WI-037	BHR	Mixed Use	100 Dundas St W, Whitby	<p>Potential BHR - Identified During Desktop/Field Review</p> <p>This property is also included in the Four Corners Proposed Heritage Conservation District (WI-065)</p>	<p>Property Description</p> <ul style="list-style-type: none"> - The property features a three-storey commercial building, constructed between 1871-1873 and was known as Gerrie's Block (Town of Whitby n.d.). The property features a three storey corner commercial building that fills the property parcel with a date stone that reads "1828". The building features a rounded southeast corner and flat roof with parapet walls. The first storey contains several storefront openings and has been clad with vertical aluminum siding. The second and third stories have been surfaced with contemporary stucco and features pilasters that extend from the storefront lintel to the pressed metal cornice with coupled brackets. - Located on the northwest side of Dundas Street West, an early transportation route, and Brock Street S, set close to the road. - Reflects nineteenth-century commercial practices along Dundas Street West in Whitby Township. <p>Potential Cultural Heritage Value or Interest and associated heritage attributes</p> <p>This property has the potential to retain historical, architectural, and contextual value.</p>

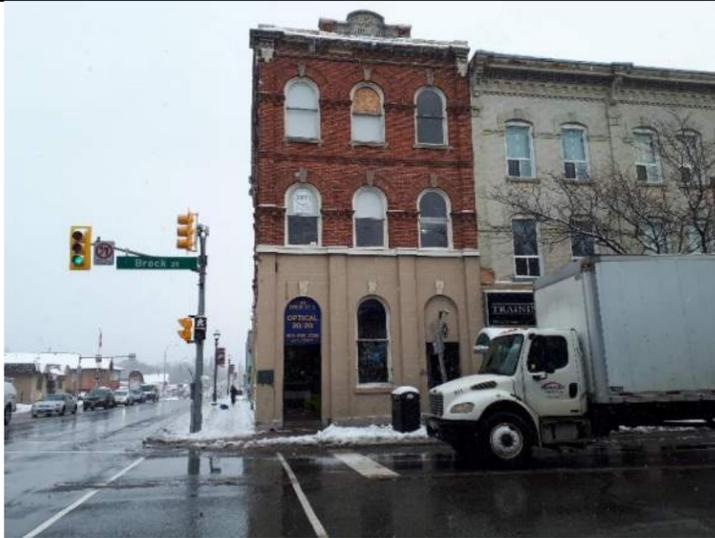
WI-038	BHR	Commercial	101 Brock St S, Whitby	<p>Potential BHR - Listed on Municipal Heritage Register</p> <p>This property is also included in the Four Corners Proposed Heritage Conservation District (WI-065)</p>	<p>Property Description</p> <ul style="list-style-type: none"> - The property features a three-storey brick commercial building with a single-storey rear addition, constructed in 1874-1875, had been constructed for the Dominion Bank. The building has a rectangular footprint, flat roof with parapet and shares a party wall with its neighbouring properties. The dichromatic brick building features arched windows on each storey and an arched entryway. The first storey has been stuccoed. Both the western and northern elevation decorated parapets with "1874 Dominion Bank". The building has ornamental brickwork such as quoining, window hoods and dentils. - Located on the south side of Dundas Street West, an early transportation route, set close to the road. - Reflects nineteenth-century commercial practices along Dundas Street West in Whitby Township. <p>Potential Cultural Heritage Value or Interest and associated heritage attributes</p> <p>This property has the potential to retain historical, architectural, and contextual value.</p>

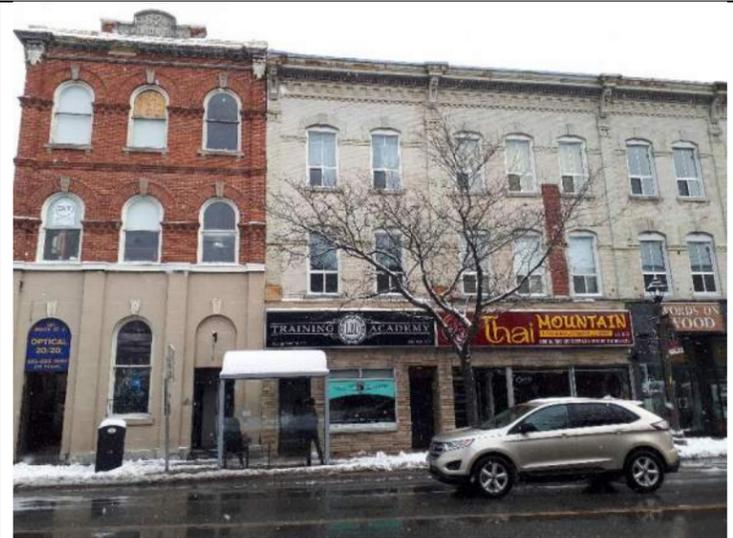
Ref #	Type of Cultural Heritage Resource	Type of Property	Location	Heritage Recognition	Description of Property and Known or Potential CHVI	Photographs/ Digital Image
WI-039	BHR	Commercial	107 Brock St S, Whitby	<p>Potential BHR - Listed on Municipal Heritage Register</p> <p>This property is also included in the Four Corners Proposed Heritage Conservation District (WI-065)</p>	<p>Property Description</p> <ul style="list-style-type: none"> - The property features a three-storey commercial building constructed in 1878, formerly known as Watson’s Block. The building has a rectangular footprint and shares a party wall with its neighbouring properties. The building has brick segmental arch windows and ornamental brickwork such as dentils and cornice. - Located on the east side of Brock Street South to the south of Dundas Street East, both early transportation routes, set close to the road. - Reflects nineteenth-century commercial practices along Dundas Street West in Whitby Township. <p>Potential Cultural Heritage Value or Interest and associated heritage attributes This property has the potential to retain historical, architectural, and contextual value.</p>

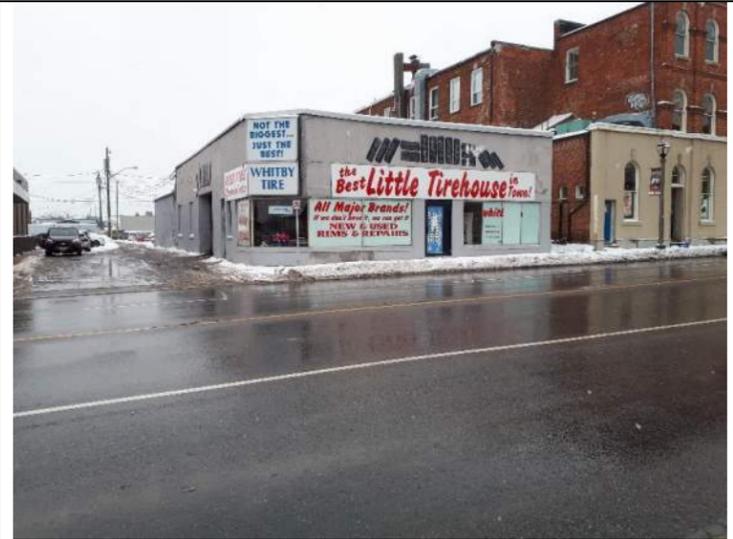
WI-040	BHR	Commercial	103 Dundas St E, Whitby	<p>Potential BHR - Identified During Desktop/Field Review</p> <p>This property is also included in the Four Corners Proposed Heritage Conservation District (WI-065)</p>	<p>Property Description</p> <ul style="list-style-type: none"> - The property features a single-storey garage that was constructed in 1916 and was formerly the Central Garage, and the Davidson Motor Company Ltd. (Town of Whitby n.d.). - Located on the south side of Dundas Street East, an early transportation route, set close to the road. - Reflects twentieth-century commercial practices along Dundas Street East in Whitby Township. <p>Potential Cultural Heritage Value or Interest and associated heritage attributes This property has the potential to retain historical and contextual value.</p>

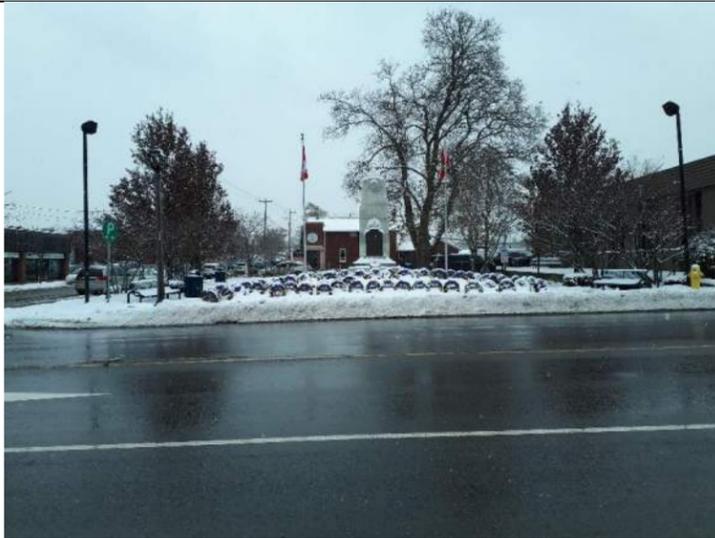
Ref #	Type of Cultural Heritage Resource	Type of Property	Location	Heritage Recognition	Description of Property and Known or Potential CHVI	Photographs/ Digital Image
WI-041	CHL	Park	111 Dundas St E, Whitby	Potential CHL - Identified During Desktop/Field Review	<p>Property Description</p> <ul style="list-style-type: none"> - The property features pedestrian pathways, benches, manicured gardens, and a war memorial in the centre of the park grounds. - Located on the south side of Dundas Street East, an early transportation route, set close to the road. - Reflects twentieth-century memorial practices along Dundas Street East in Whitby Township. <p>Potential Cultural Heritage Value or Interest and associated heritage attributes This property has the potential to retain architectural, historical and contextual value.</p>

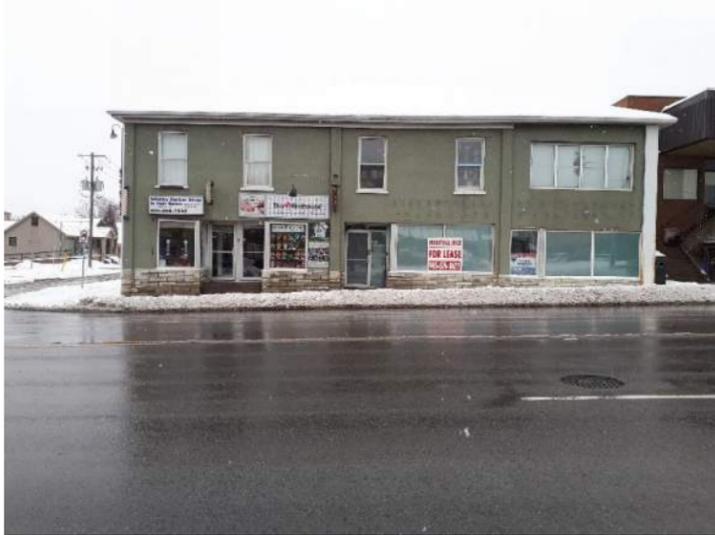
WI-042	BHR	Mixed Use	215 Dundas St E, Whitby	Potential BHR - Listed on Municipal Heritage Register	<p>Property Description</p> <ul style="list-style-type: none"> - The property features a two-storey mixed use building, constructed in 1921 with a hipped roof. The exterior of the building has been heavily altered. - Located on the south side of Dundas Street East, an early transportation route, set close to the road. - Reflects twentieth-century commercial practices along Dundas Street East in Whitby Township. <p>Potential Cultural Heritage Value or Interest and associated heritage attributes This property has the potential to retain contextual value.</p>

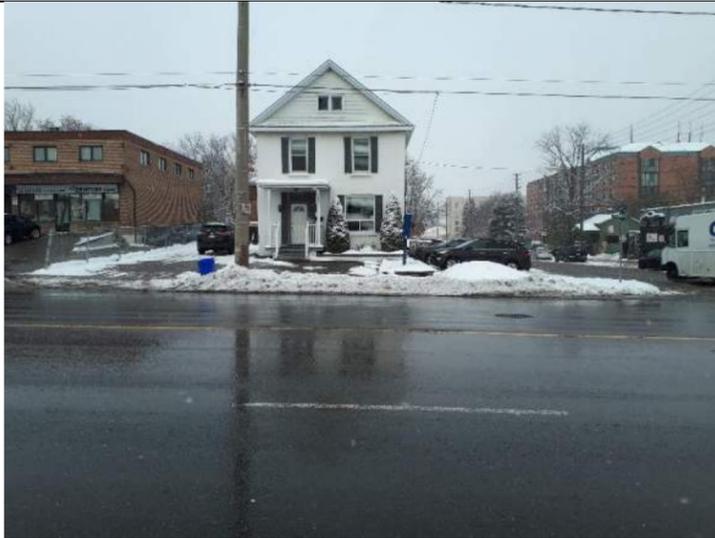
Ref #	Type of Cultural Heritage Resource	Type of Property	Location	Heritage Recognition	Description of Property and Known or Potential CHVI	Photographs/ Digital Image
WI-043	BHR	Mixed Use	218 Dundas St E, Whitby	Potential BHR - Identified During Desktop/Field Review	<p>Property Description</p> <ul style="list-style-type: none"> - The property features a two-and-a-half storey Edwardian residence with a rectangular footprint and a covered front entrance. - Located on the north side of Dundas Street East, an early transportation route, set close to the road. - Reflects twentieth-century settlement along Dundas Street East in Whitby Township. <p>Potential Cultural Heritage Value or Interest and associated heritage attributes</p> <p>This property has the potential to retain architectural and contextual value.</p>

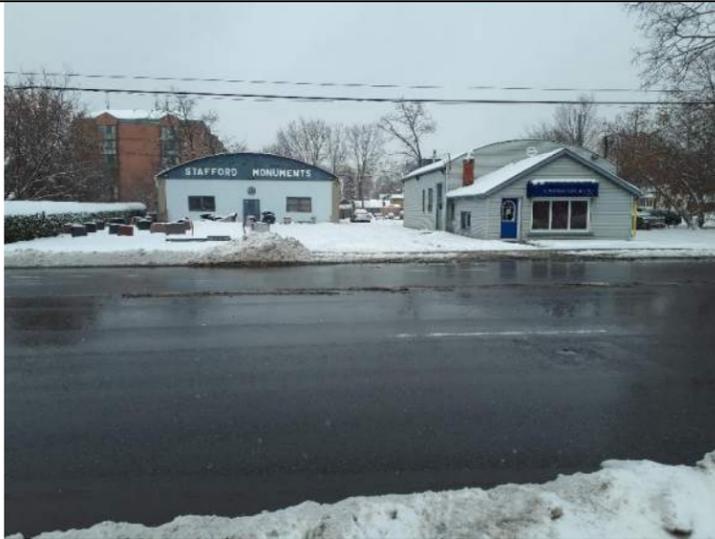
WI-044	BHR	Commercial	318 Dundas St E, Whitby	Potential BHR - Listed on Municipal Heritage Register	<p>Property Description</p> <ul style="list-style-type: none"> - The property features two single-storey commercial buildings for the Stafford Monuments business. A family-owned and operated business in Whitby for over 70 years (Stafford Monuments Ltd. n.d.). - Located on the north side of Dundas Street East, an early transportation route, set close to the road. - Reflects twentieth-century commercial practices along Dundas Street East in Whitby Township. <p>Potential Cultural Heritage Value or Interest and associated heritage attributes</p> <p>This property has the potential to retain historical, architectural, and contextual value.</p>

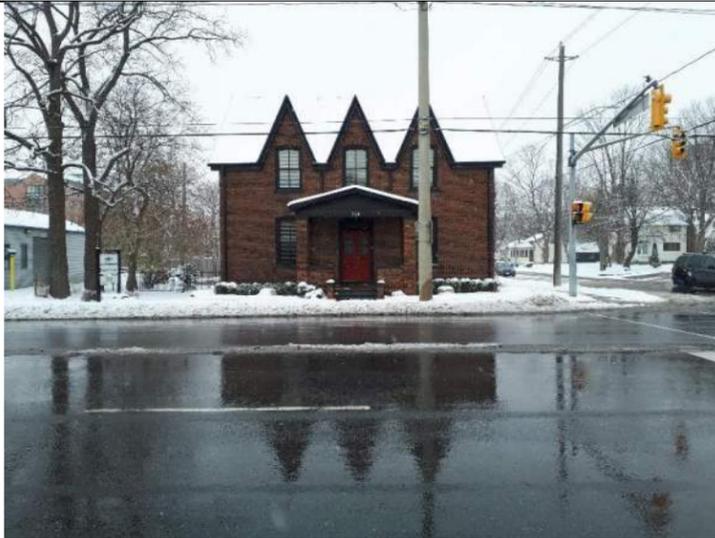
WI-046	BHR	Residence	425 Dundas St E, Whitby	Potential BHR - Listed on Municipal Heritage Register	<p>Property Description</p> <ul style="list-style-type: none"> - The property features a two-storey Italianate brick residence constructed in 1859, formerly known as the William Burns House and Pugsley Manor. The residence house features a hipped roof and dichromatic brickwork with a decorative enclosed front porch. The residence has a modern additions at the rear and east elevations. - Located on the south side of Dundas Street East, an early transportation route, set close to the road. - Reflects nineteenth-century settlement along Dundas Street East in Whitby Township. <p>Potential Cultural Heritage Value or Interest and associated heritage attributes This property has the potential to retain historical, architectural, and contextual value.</p>

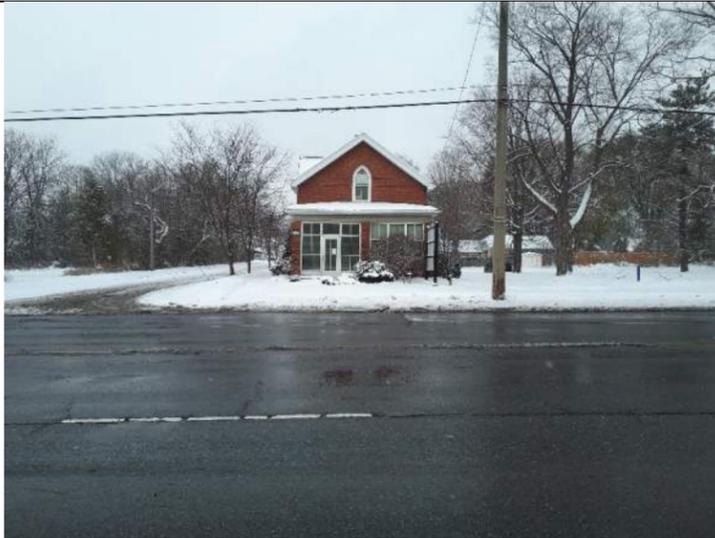
Ref #	Type of Cultural Heritage Resource	Type of Property	Location	Heritage Recognition	Description of Property and Known or Potential CHVI	Photographs/ Digital Image
WI-047	BHR	Commercial	500 Dundas St E, Whitby	Potential BHR - Formerly Listed on Municipal Heritage Register; Commemorative Feature	<p>Property Description</p> <ul style="list-style-type: none"> - The property features a one-and-a-half storey brick residence constructed in 1840 with an addition in 1878, formerly known as the Jonathan Wolfenden House. The house features a rectangular footprint with later rear additions, a gable roof, and central second-storey window. The front porch has been enclosed. - Located on the north side of Dundas Street East, an early transportation route, set close to the road. - Reflects nineteenth-century settlement along Dundas Street East in Whitby Township. <p>Potential Cultural Heritage Value or Interest and associated heritage attributes This property has the potential to retain architectural and contextual value.</p> <p>Note: This property currently has received approval for future development. Further, staff has advised that there is a commemorative component to the future development.</p>

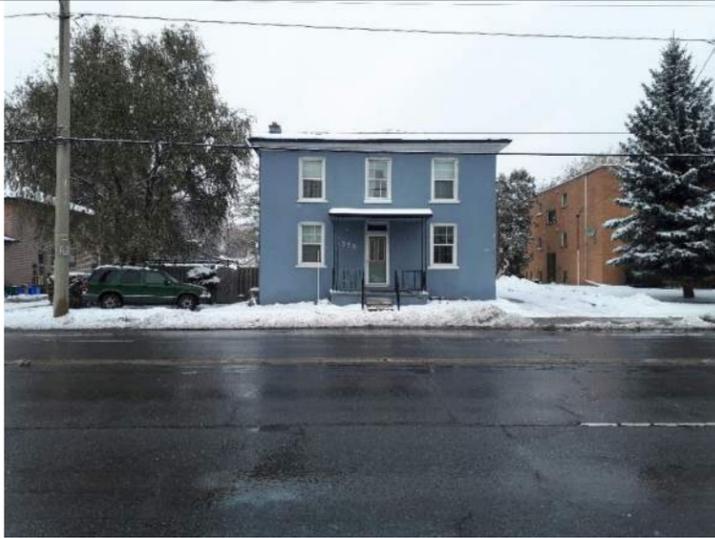
WI-048	BHR	Residence	528 Dundas St E, Whitby	Potential BHR - Listed on Municipal Heritage Register	<p>Property Description</p> <ul style="list-style-type: none"> - The property features a two-storey, three bay residence constructed in circa 1900. The house has a gable roof and symmetrical windows flanking the covered front entrance. - Located on the north side of Dundas Street East, an early transportation route, set close to the road. - Reflects nineteenth-century settlement along Dundas Street East in Whitby Township. <p>Potential Cultural Heritage Value or Interest and associated heritage attributes This property has the potential to retain architectural and contextual value.</p>

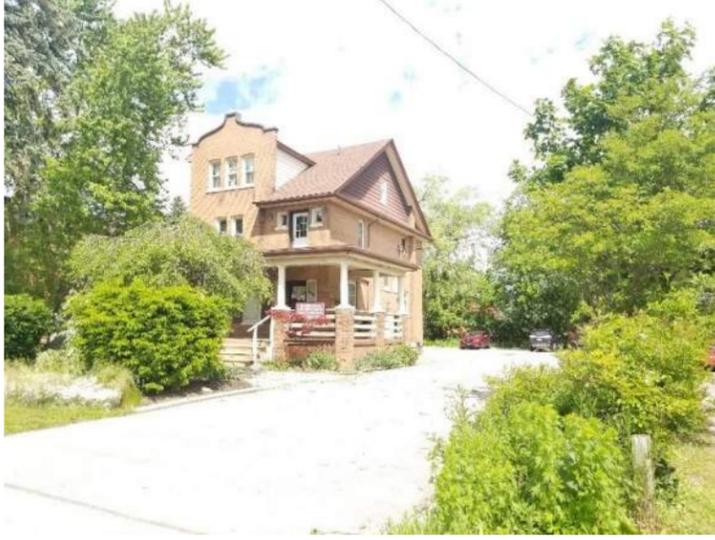
Ref #	Type of Cultural Heritage Resource	Type of Property	Location	Heritage Recognition	Description of Property and Known or Potential CHVI	Photographs/ Digital Image
WI-049	BHR	Commercial	540 Dundas St E, Whitby	Potential BHR - Identified During Desktop/Field Review	<p>Property Description</p> <ul style="list-style-type: none"> - The property features a two-and-a-half storey early-twentieth-century brick residence with a gable roof and a projecting Flemish gable on the front façade. The house also features a wrap-around porch and varied fenestration. - Located on the north side of Dundas Street East, an early transportation route, set close to the road. - Reflects twentieth-century settlement along Dundas Street East in Whitby Township. <p>Potential Cultural Heritage Value or Interest and associated heritage attributes This property has the potential to retain architectural and contextual value.</p>

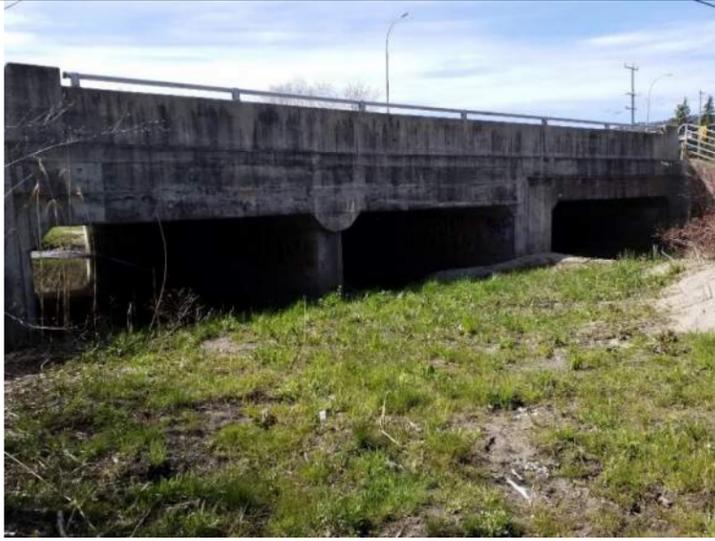
WI-050	BHR	Bridge	Structure 14, Pringle Creek, Whitby	Potential BHR - Identified During Desktop/Field Review	<p>Property Description</p> <ul style="list-style-type: none"> - The property features a three-span rigid frame concrete bridge with concrete abutments. - Date of construction is unknown. - Located over Pringle Creek along Dundas Street East, east of Garden Street, both early transportation routes. - Reflects twentieth-century transportation practices along Dundas Street East in Whitby Township. <p>Potential Cultural Heritage Value or Interest and associated heritage attributes This property has the potential to retain architectural and contextual value.</p>

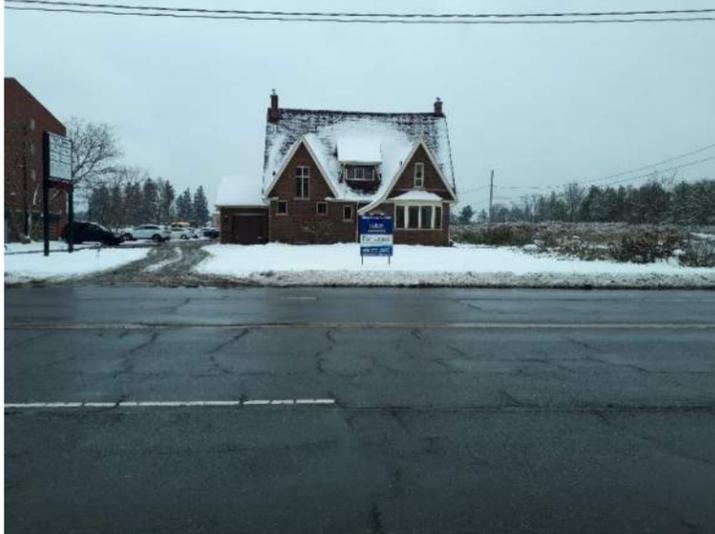
Ref #	Type of Cultural Heritage Resource	Type of Property	Location	Heritage Recognition	Description of Property and Known or Potential CHVI	Photographs/ Digital Image
WI-051	BHR	Commercial	519 Dundas St E, Whitby	Known BHR - Part IV Designation (By-law #2739-89)	<p>Property Description</p> <ul style="list-style-type: none"> - The property features a one-and-a-half storey brick residence constructed in 1928, formerly known as the Donald Wilson House (Town of Whitby 1989). The Craftsman style house with elements of English cottage revival has a steeply pitched gable roof with two gables along the front roof slope with a dormer window in between. The front entrance is off-centre and a bay window is located on the west side of the front façade. The house also features varying types of windows. - Located on the south side of Dundas Street East, an early transportation route, set close to the road. - Reflects twentieth-century settlement along Dundas Street East in Whitby Township. <p>Known Cultural Heritage Value or Interest under Ontario Regulation 9/06 and associated heritage attributes For additional information, please see the By-Law available at: https://www.heritagetrust.on.ca/en/oha/details?id=7284&backlinkslug=search-results&fields%5Blocation%5D=7%2C435</p> <p>Physical heritage attributes that support the CHVI include:</p> <ul style="list-style-type: none"> - The Craftsman and English cottage revival brick house; - The prominent and sweeping gables; - Leaded glazing; and, - Consistent interior detailing of mahogany panelling and woodwork throughout the house.

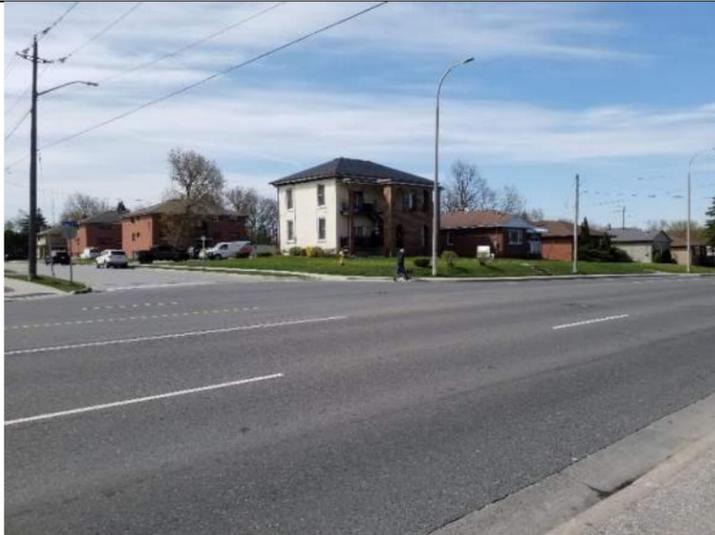
WI-052	BHR	Residence	839 Dundas St E, Whitby	Potential BHR - Identified During Desktop/Field Review	<p>Property Description</p> <ul style="list-style-type: none"> - The property features a two-storey brick residence with a hipped roof. An external staircase and a brick screen with window and door-shaped openings has been added to the front façade. Some windows appear original on the western elevation. - Located on the south side of Dundas Street East, an early transportation route, set close to the road. - Reflects nineteenth-century settlement along Dundas Street East in Whitby Township. <p>Potential Cultural Heritage Value or Interest and associated heritage attributes This property has the potential to retain architectural and contextual value.</p>

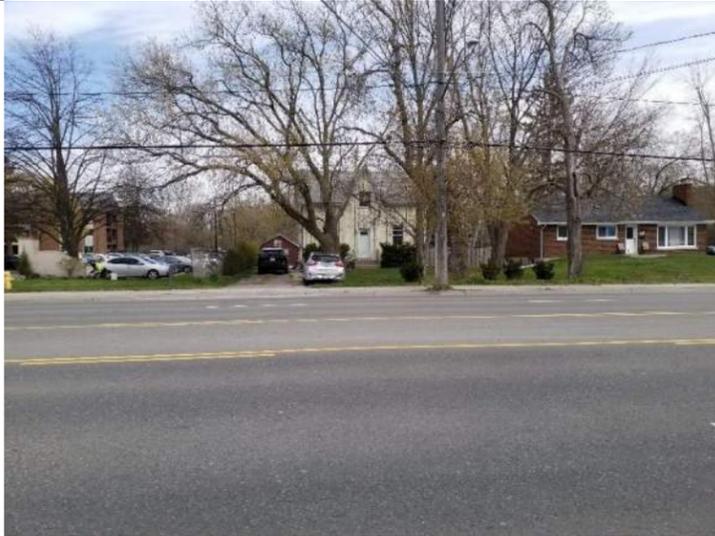
Ref #	Type of Cultural Heritage Resource	Type of Property	Location	Heritage Recognition	Description of Property and Known or Potential CHVI	Photographs/ Digital Image
WI-053	BHR	Residence	944 Dundas St E, Whitby	Potential BHR - Identified During Desktop/Field Review	<p>Property Description</p> <ul style="list-style-type: none"> - The property features a one-and-a-half storey Ontario Gothic residence with a gable roof and central gable. The front entrance is flanked by symmetrical windows. The house has been clad in siding. - Located on the north side of Dundas Street East, an early transportation route, set close to the road. - Reflects nineteenth-century settlement along Dundas Street East in Whitby Township. <p>Potential Cultural Heritage Value or Interest and associated heritage attributes</p> <p>This property has the potential to retain architectural and contextual value.</p>

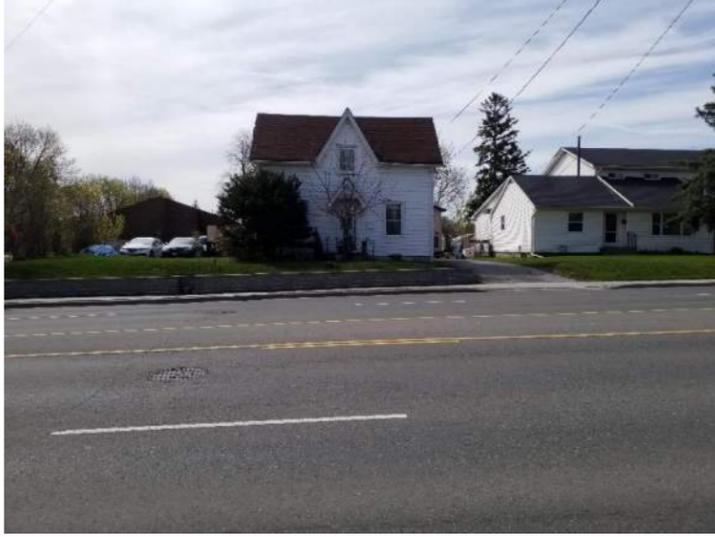
WI-054	BHR	Residence	991 Dundas St E, Whitby	Potential BHR - Identified During Desktop/Field Review	<p>Property Description</p> <ul style="list-style-type: none"> - The property features a one-and-a-half storey Ontario Gothic residence with a gable roof and central gable. The covered front entrance is flanked by symmetrical windows. The house has been clad in siding. - Located on the south side of Dundas Street East, an early transportation route, set close to the road. - Reflects nineteenth-century settlement along Dundas Street East in Whitby Township. <p>Potential Cultural Heritage Value or Interest and associated heritage attributes</p> <p>This property has the potential to retain architectural and contextual value.</p>

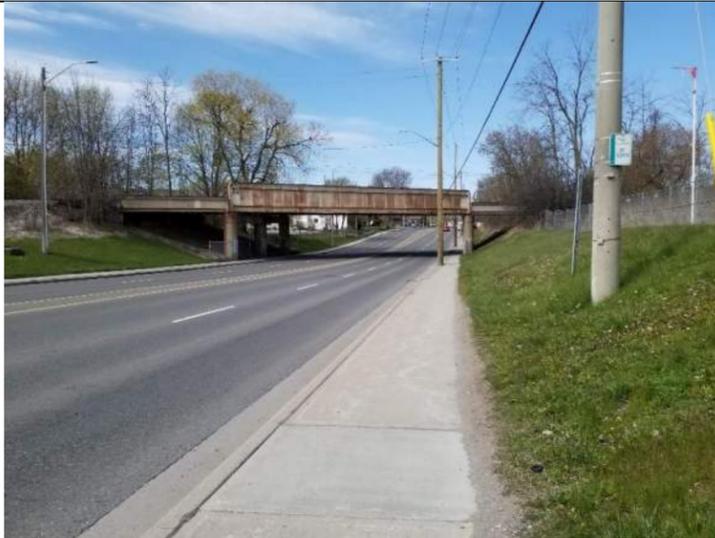
Ref #	Type of Cultural Heritage Resource	Type of Property	Location	Heritage Recognition	Description of Property and Known or Potential CHVI	Photographs/ Digital Image
WI-055	BHR	Bridge	Structure 15, CP Railway, Whitby	Potential BHR - Identified During Desktop/Field Review	<p>Property Description</p> <ul style="list-style-type: none"> - The property features a three-span through plate girder bridge with concrete abutments. - Located on the CP rail line over Dundas Street East, an early transportation route. - Date of construction is unknown. - Reflects twentieth-century transportation practices along Dundas Street East in Whitby Township. <p>Potential Cultural Heritage Value or Interest and associated heritage attributes</p> <p>This property has the potential to retain architectural and contextual value.</p>

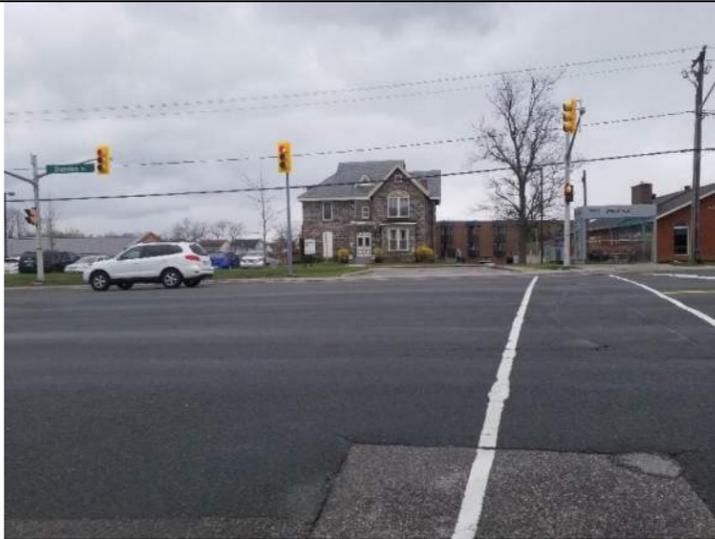
WI-056	BHR	Commercial	1635 Dundas St E, Whitby	Potential BHR - Identified During Desktop/Field Review	<p>Property Description</p> <ul style="list-style-type: none"> - The property features a two-storey stone residence that was constructed in 1884. The residence was known as the Jeremiah Lick House (Town of Whitby n.d.). The building has been incorporated into a nursing home. - Located on the south side of Dundas Street East, an early transportation route, set close to the road. - Reflects nineteenth-century settlement along Dundas Street East in Whitby Township. <p>Potential Cultural Heritage Value or Interest and associated heritage attributes</p> <p>This property has the potential to retain historical, architectural, and contextual value.</p>

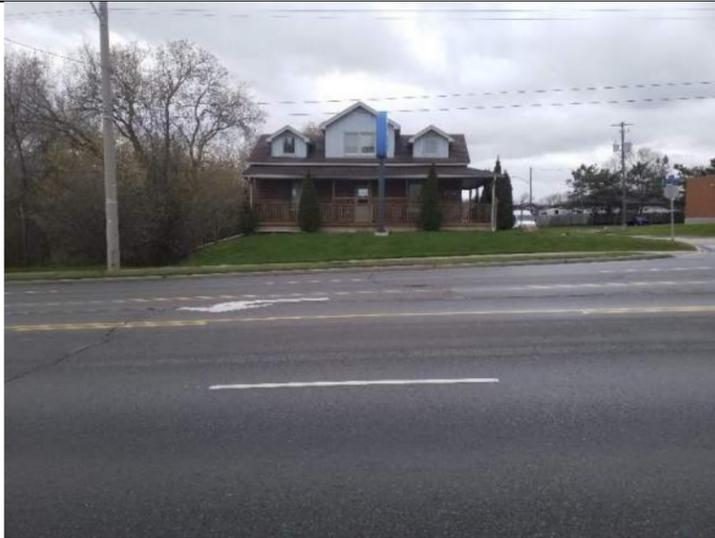
Ref #	Type of Cultural Heritage Resource	Type of Property	Location	Heritage Recognition	Description of Property and Known or Potential CHVI	Photographs/ Digital Image
WI-057	BHR	Commercial	1750 Dundas St E, Whitby	Potential BHR - Listed on Municipal Heritage Register	<p>Property Description</p> <ul style="list-style-type: none"> - The property features a one-and-a-half storey brick residence constructed in 1850. The house features a gable roof with three dormers along the southern roof slope. The house features a wrap-around porch, and has been heavily altered. - Located on the north side of Dundas Street East, an early transportation route, set close to the road. - Reflects nineteenth-century settlement along Dundas Street East in Whitby Township. <p>Potential Cultural Heritage Value or Interest and associated heritage attributes This property has the potential to retain architectural and contextual value.</p>

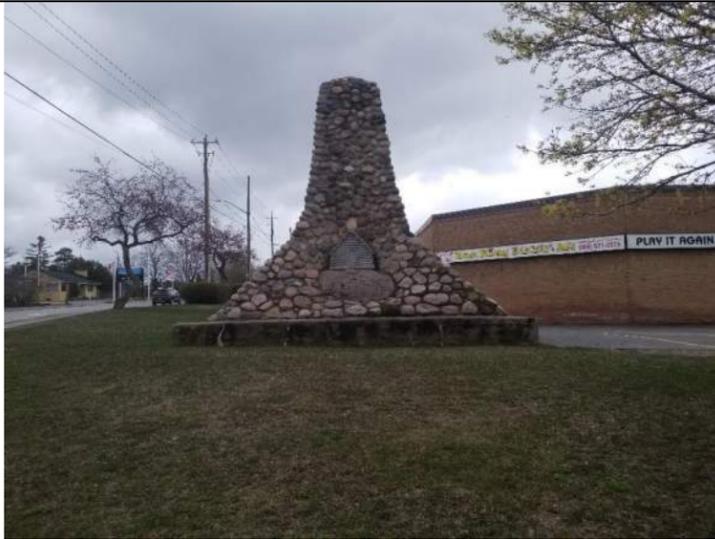
WI-058	BHR	Commemorative Feature	1801 Dundas St E, Whitby	Potential BHR - Identified During Desktop/Field Review	<p>Property Description</p> <ul style="list-style-type: none"> - The property features a memorial cairn for Robert H. Thornton that was constructed in 1933. It was moved to its present location in 1962 (N.A. 1933). - Located on the south side of Dundas Street East, an early transportation route, set close to the road. - Reflects twentieth-century memorial practices along Dundas Street East in Whitby Township. <p>Potential Cultural Heritage Value or Interest and associated heritage attributes This property has the potential to retain architectural, historical and contextual value.</p>

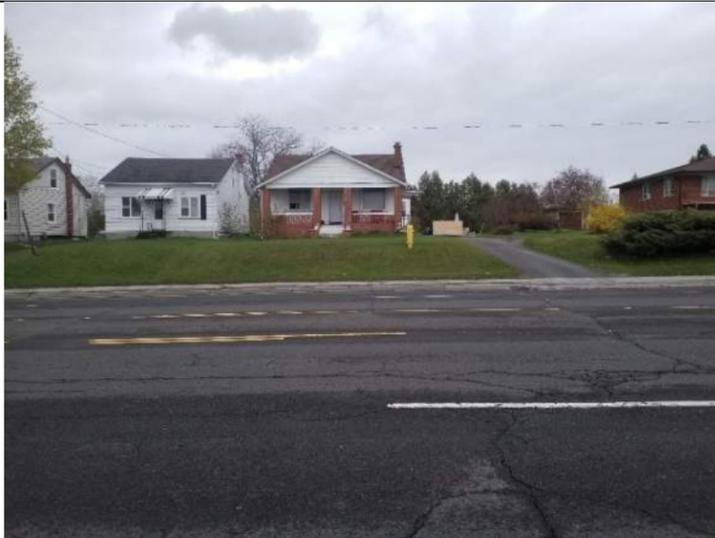
Ref #	Type of Cultural Heritage Resource	Type of Property	Location	Heritage Recognition	Description of Property and Known or Potential CHVI	Photographs/ Digital Image
WI-059	BHR	Residence	1917 Dundas St E, Whitby	Potential BHR - Identified During Desktop/Field Review	<p>Property Description</p> <ul style="list-style-type: none"> - The property features a one-and-a-half storey residence with cross-gable roof. The front porch is covered by the gable roof and features lattice brickwork. The windows on the front façade symmetrically flank the front entrance. The house has been clad in siding. The house features a rear addition. - The house is one in a row of three similarly constructed houses along Dundas Street East, this house is the largest of the three. - Located on the south side of Dundas Street East, an early transportation route, set close to the road. - Reflects twentieth-century settlement along Dundas Street East in Whitby Township. <p>Potential Cultural Heritage Value or Interest and associated heritage attributes This property has the potential to retain contextual value.</p>
