**DURHAM-SCARBOROUGH BUS RAPID TRANSIT PROJECT
CULTURAL HERITAGE REPORT – EXISTING CONDITIONS AND PRELIMINARY IMPACT ASSESSMENT
CITY OF TORONTO AND DURHAM REGION, ONTARIO**

ASI File: 18CH-142

October 2019 (Revised June and October 2020;
January, May, November and December 2021; January and February 2022)

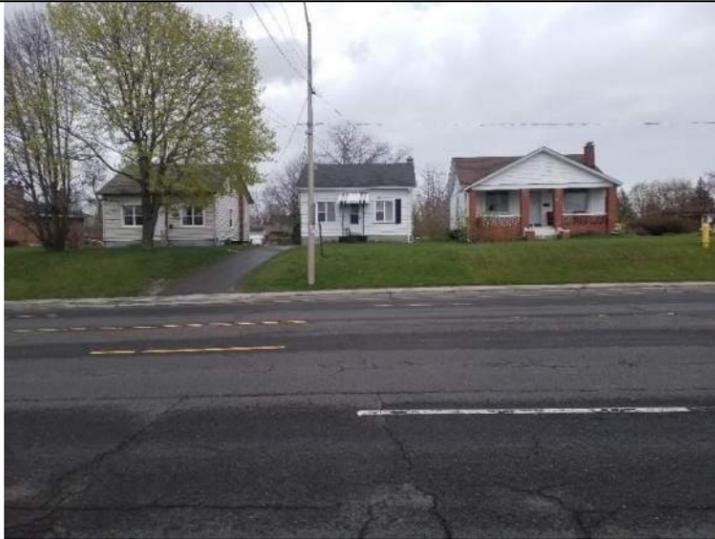
WI-060	BHR	Residence	1919 Dundas St E, Whitby	Potential BHR - Identified During Desktop/Field Review	<p>Property Description</p> <ul style="list-style-type: none"> - The property features a one-and-a-half storey residence with a gable roof. The windows on the front façade symmetrically flank the front entrance. The house has been clad in siding. The house features a small rear addition. - The house is one in a row of three similarly constructed houses along Dundas Street East. - Located on the south side of Dundas Street East, an early transportation route, set close to the road. - Reflects twentieth-century settlement along Dundas Street East in Whitby Township. <p>Potential Cultural Heritage Value or Interest and associated heritage attributes This property has the potential to retain contextual value.</p>

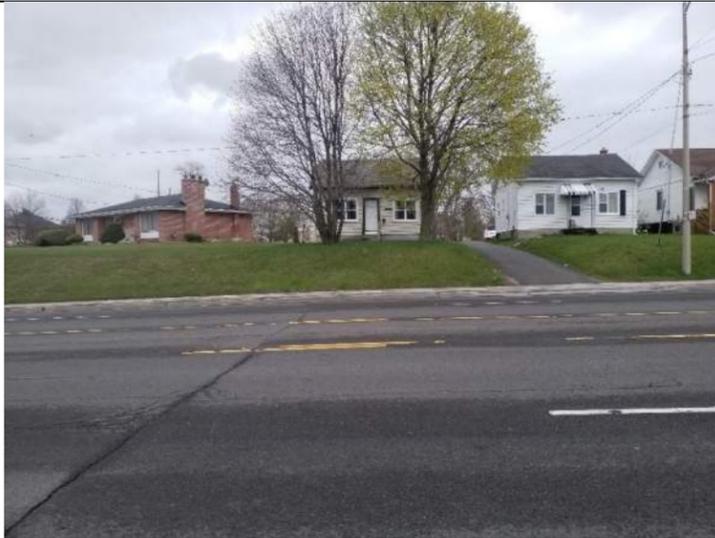
Ref #	Type of Cultural Heritage Resource	Type of Property	Location	Heritage Recognition	Description of Property and Known or Potential CHVI	Photographs/ Digital Image
WI-061	BHR	Residence	1921 Dundas St E, Whitby	Potential BHR - Identified During Desktop/Field Review	<p>Property Description</p> <ul style="list-style-type: none"> - The property features a one-and-a-half storey residence with a gable roof. The windows on the front façade symmetrically flank the front entrance. The house has been clad in siding. The house features a small rear addition. - The house is one in a row of three similarly constructed houses along Dundas Street East. - Located on the south side of Dundas Street East, an early transportation route, set close to the road. - Reflects twentieth-century settlement along Dundas Street East in Whitby Township. <p>Potential Cultural Heritage Value or Interest and associated heritage attributes This property has the potential to retain contextual value.</p>

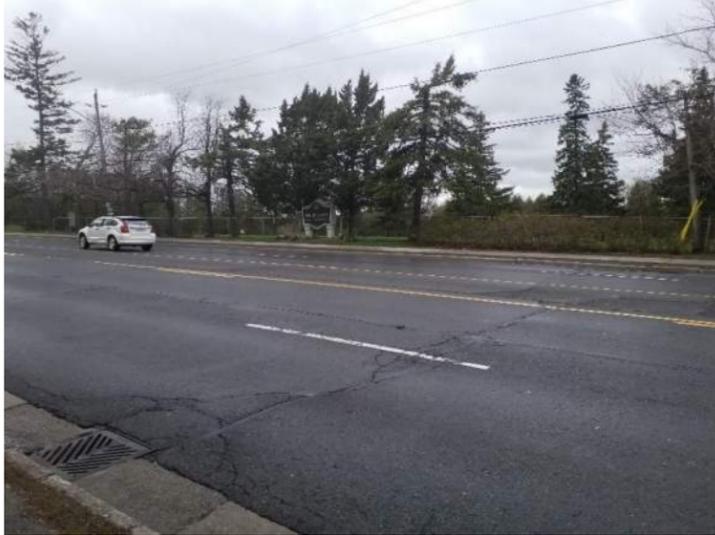
WI-062	CHL	Cemetery	2000 Dundas St E, Whitby	Potential CHL - Identified During Desktop/Field Review	<p>Property Description</p> <ul style="list-style-type: none"> - The cemetery is known as the Mount Lawn Cemetery. - The burials remain in situ in rows perpendicular to Dundas Street East. The property also features a funeral home, parking lot, and landscaped grounds. - Located on the north side of Dundas Street East, an early transportation route, set close to the road. - Reflects late-twentieth-century burial practices along Dundas Street East in Whitby Township. <p>Potential Cultural Heritage Value or Interest and associated heritage attributes This property has the potential to retain historical and contextual value.</p>

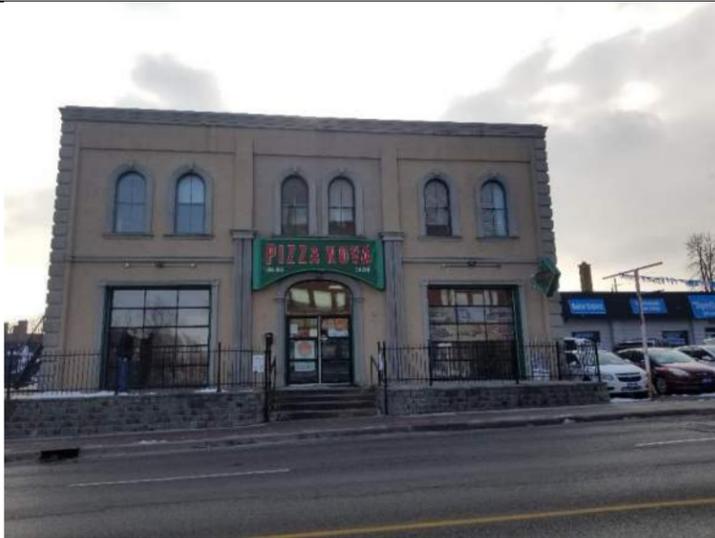
Ref #	Type of Cultural Heritage Resource	Type of Property	Location	Heritage Recognition	Description of Property and Known or Potential CHVI	Photographs/ Digital Image
WI-063	BHR	Commercial	207 Dundas St W, Whitby	Potential BHR - Identified During Desktop/Field Review	<p>Property Description</p> <ul style="list-style-type: none"> - The property features a two-storey mixed use building, designed in 1880, formerly known as the Whitby Hotel. The building has a rectangular footprint with later rear additions, a parapet along the front façade, and projecting quoins. The front façade features three bays with arched windows along the second storey and altered windows and entryway along the main floor. The building has been covered in stucco. - Located on the south side of Dundas Street West, an early transportation route, set close to the road. - Reflects late-nineteenth-century commercial practices along Dundas Street west in Whitby Township. <p>Potential Cultural Heritage Value or Interest and associated heritage attributes</p> <p>This property has the potential to retain historical, architectural, and contextual value. This property may be added in the future to the Town’s municipal heritage register (Pers. Comm., Town of Whitby, December 15 2020)</p>

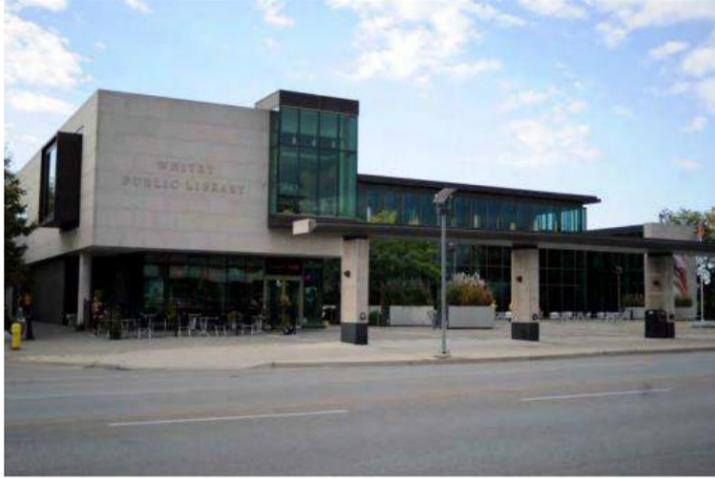
WI-064	CHL	Heritage Conservation District	Werden’s Plan Neighbourhood Heritage Conservation District	<p>Known CHL - Part V Designation (By-law #7297-17)</p> <p>The DSBRT Corridor Study Area includes 405 Dundas Street West, the Whitby Central Library, identified in the HCD Plan as a Complementary Property (exemplary) and is considered a contemporary landmark.</p>	<p>Property Description</p> <ul style="list-style-type: none"> - The Werden’s Plan Neighbourhood HCD encompasses roughly half of the plan of subdivision Asa Werden commissioned for his property south of Dundas Street in 1854, which was the second subdivision registered in the Town of Whitby. Also included within the boundaries are lands that were part of Radenhurtst’s and Wallace’s Plans which were registered prior to 1877-1878 (Goldsmith Borgal & Company Ltd. et al. 2017). - The District retains many features from the mid-nineteenth century to the mid-twentieth century during when Whitby remained a stable small town in which the built-up portion was confined to its nineteenth-century footprint (Goldsmith Borgal & Company Ltd. et al. 2017). - This neighbourhood is located south of Dundas Street West and west of Brock Street South, both important nineteenth century economic drivers. - Reflects the nineteenth-century settlement in Whitby Township. <p>Known Cultural Heritage Value or Interest under Ontario Regulation 9/06 and associated heritage attributes</p> <p>For additional information, please see: https://www.whitby.ca/en/play/resources/Heritage/Werden's-Plan-Neighbourhood-Heritage-Conservation-District-Plan.pdf and https://www.whitby.ca/en/play/resources/Heritage/Werden's-Plan_District-Description-of-the-Heritage-Attributes-of-Individual-Properties.pdf</p> <p>Physical heritage attributes that support the CHVI include:</p>

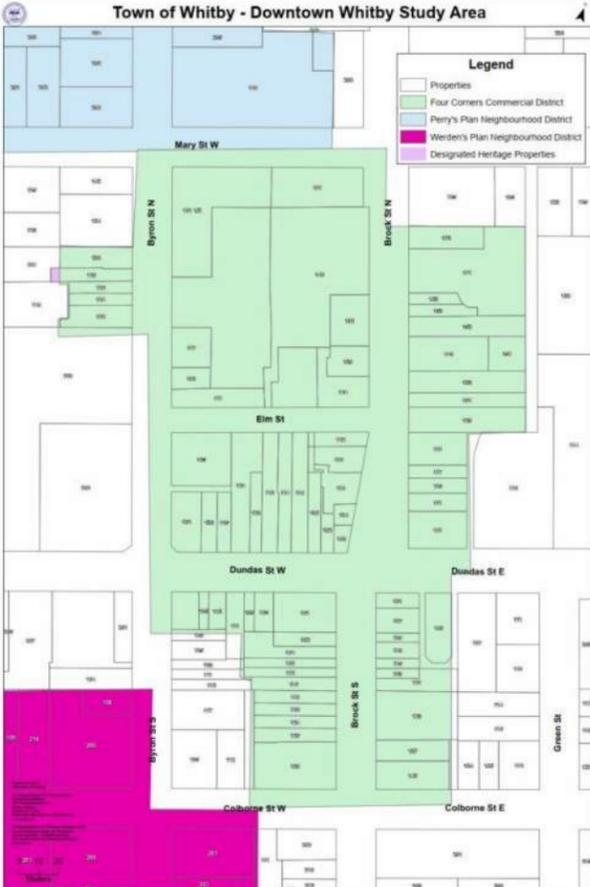
<p>Four Corners Proposed HCD is shaded green (Town of Whitby 2013b)</p>

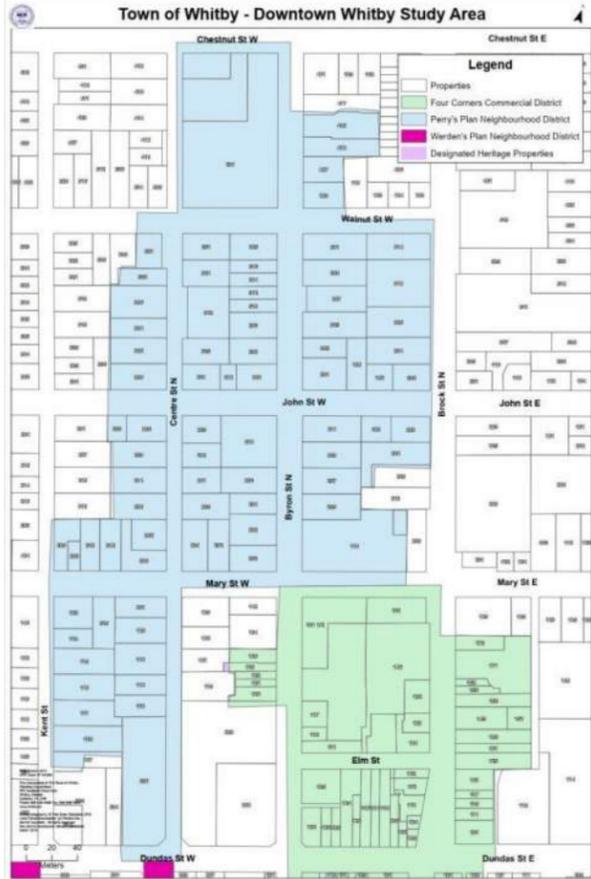
<p>Perry's Plan Neighbourhood is shaded blue (Town of Whitby 2013a)</p>

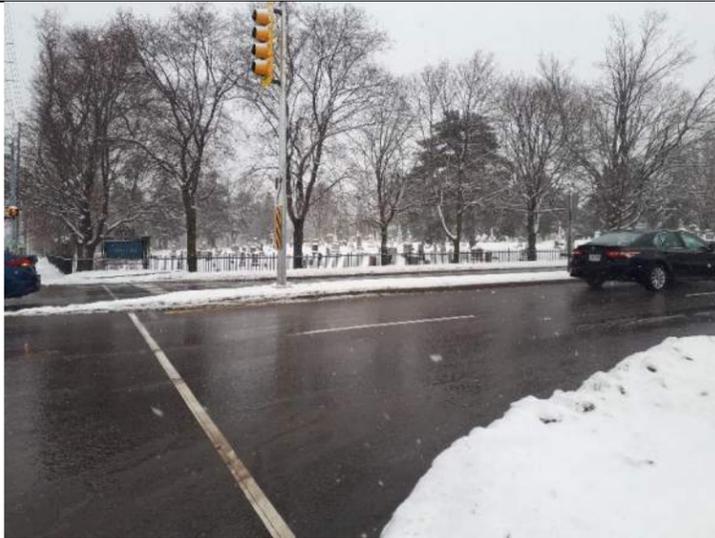
Ref #	Type of Cultural Heritage Resource	Type of Property	Location	Heritage Recognition	Description of Property and Known or Potential CHVI	Photographs/ Digital Image
OS-003	CHL	Cemetery	760 King St W, Oshawa	Potential CHL - Listed on Municipal Heritage Register	<p>Property Description</p> <ul style="list-style-type: none"> - The cemetery is known as Union Cemetery. - The site was originally purchased in 1835 by Dr. Robert Thornton, with the first interment occurring in 1837. The cemetery property was donated to the City of Oshawa in 1922 and a mausoleum was constructed on the site in 1924 (Heritage Oshawa 2015). - Located on the northeast corner of King Street West and Thornton Road North, both early transportation routes, with limited setback. - Reflects nineteenth-century burial practices in the City of Oshawa. <p>Potential Cultural Heritage Value or Interest and associated heritage attributes This property has the potential to retain historical, architectural, and contextual value.</p>

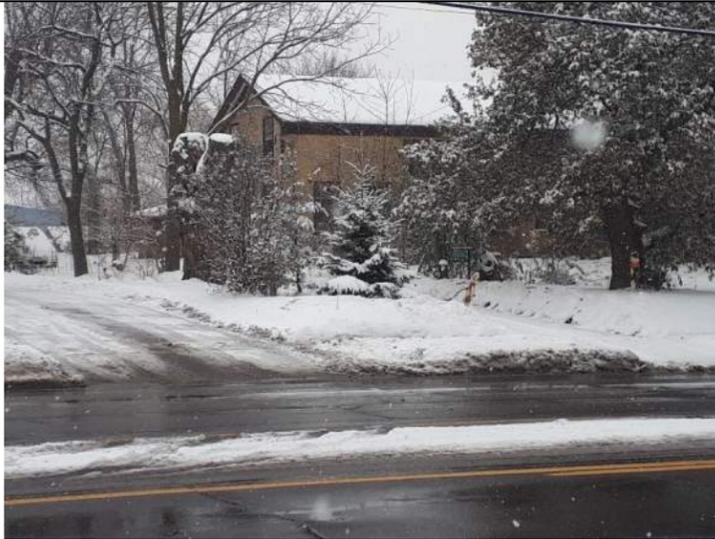
OS-004	BHR	Residence	773 King St W, Oshawa	Potential BHR - Listed on Municipal Heritage Register	<p>Property Description</p> <ul style="list-style-type: none"> - The property features a one-and-a-half storey Georgian style frame residence constructed in 1875 with a one storey addition to the rear (Heritage Oshawa 2015). The residence is clad with yellow brick, features a side gable roof, multi-light sash windows, dormer on the south elevation, and centre entrance with sidelights and transom marked by a small porch. The property is lined with mature trees. - Located on the south side of King Street West, an early transportation route, setback from the road. - Reflects nineteenth-century settlement along King Street West in the City of Oshawa. <p>Potential Cultural Heritage Value or Interest and associated heritage attributes This property has the potential to retain historical, architectural, and contextual value.</p>

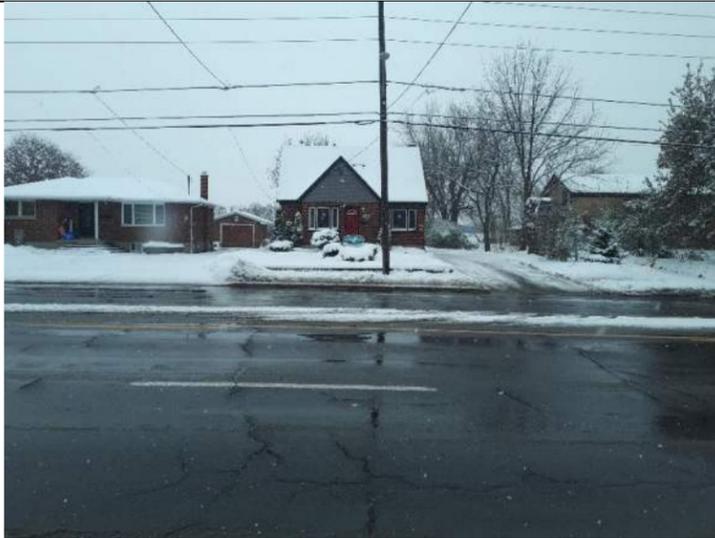
Ref #	Type of Cultural Heritage Resource	Type of Property	Location	Heritage Recognition	Description of Property and Known or Potential CHVI	Photographs/ Digital Image
OS-005	BHR	Residence	767 King St W, Oshawa	Potential BHR - Identified During Desktop/Field Review	<p>Property Description</p> <ul style="list-style-type: none"> - The property features a one-and-a-half storey frame residence with multi-space paved parking to the rear of the structure. The circa 1945 residence is clad with red brick and vinyl siding within the gables, and features a prominent projecting front gable with offset entrance, shallow eaves, and shed dormer on the south elevation. - Located on the south side of King Street West, an early transportation route, setback from the road. - Reflects post-war residential growth on King Street West in the City of Oshawa. <p>Potential Cultural Heritage Value or Interest and associated heritage attributes This property has the potential to retain historical and contextual value.</p>

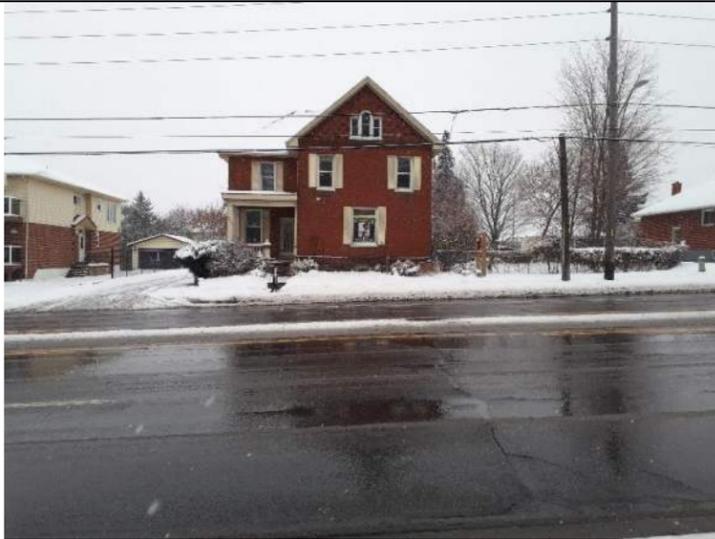
OS-006	BHR	Commercial	731 King St W, Oshawa	Potential BHR - Listed on Municipal Heritage Register	<p>Property Description</p> <ul style="list-style-type: none"> - The property features a two-and-a-half storey frame residence constructed in 1875 with multi-space paved parking to the rear of the structure (Heritage Oshawa 2015). The Edwardian Classical style residence has an L-shape footprint with a combination of hipped and front-facing gable roof. The structure clad with red brick, with wood singled cladding the front gable, and features an entry porch and Palladian window in the front gable. - Located on the south side of King Street West, an early transportation route, setback from the road. - Reflects turn-of-the-century settlement along King Street West in the City of Oshawa. <p>Potential Cultural Heritage Value or Interest and associated heritage attributes This property has the potential to retain historical, architectural, and contextual value.</p>

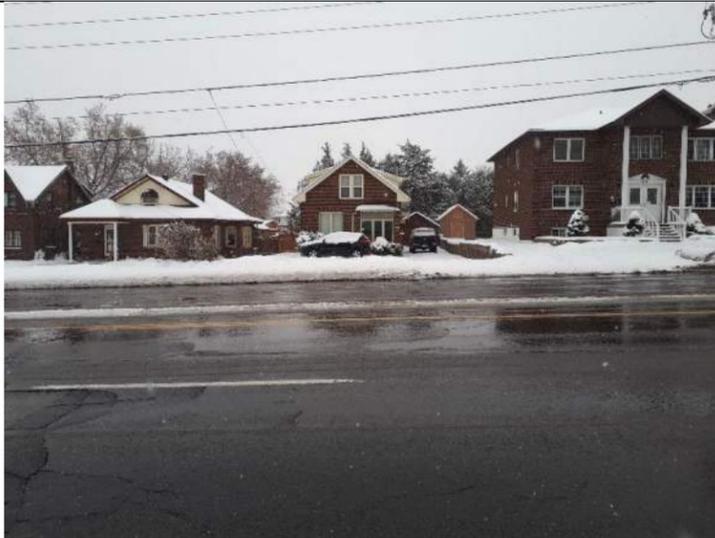
Ref #	Type of Cultural Heritage Resource	Type of Property	Location	Heritage Recognition	Description of Property and Known or Potential CHVI	Photographs/ Digital Image
OS-007	BHR	Residence	707 King St W, Oshawa	Potential BHR - Identified During Desktop/Field Review	<p>Property Description</p> <ul style="list-style-type: none"> - The property features a one-and-a-half storey frame residence with a small one storey addition to the rear. The circa 1940 residence is clad with brown brick and features a front gable roof with shed dormers on the east and west elevations. A projecting enclosed entryway is located on the north elevation. - Located on the south side of King Street West, an early transportation route, setback from the road. - Reflects post-war residential growth along King Street W. <p>Potential Cultural Heritage Value or Interest and associated heritage attributes This property has the potential to retain historical, architectural, and contextual value.</p>

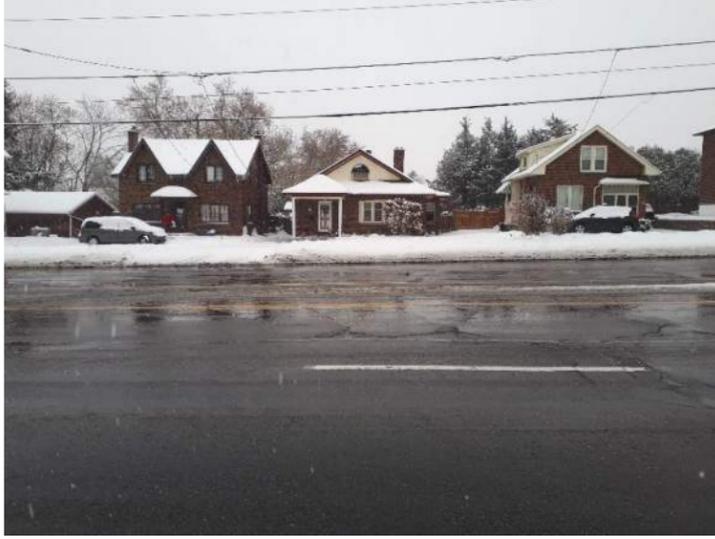
OS-008	BHR	Residence	705 King St W, Oshawa	Potential BHR - Identified During Desktop/Field Review	<p>Property Description</p> <ul style="list-style-type: none"> - The property features a one-and-a-half storey frame residence with a small single-storey addition to the rear and a detached garage. The circa 1940 residence is clad with brown brick and features a hipped roof with a front-gabled half storey above. The front gable is clad with vinyl siding and features a rounded-arch window. The entrance is offset to the east side of the north elevation and there is a windowed bay on the west elevation. - Located on the south side of King Street West, an early transportation route, setback from the road. - Reflects post-war residential growth along King Street West in the City of Oshawa. <p>Potential Cultural Heritage Value or Interest and associated heritage attributes This property has the potential to retain historical and contextual value.</p>

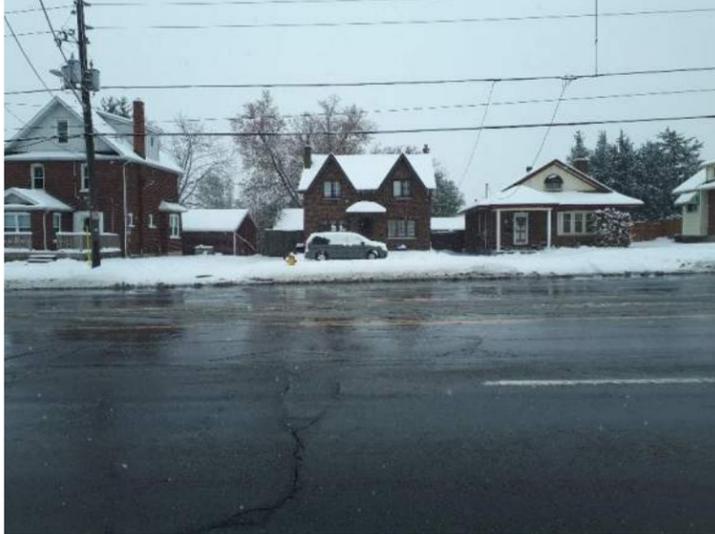
Ref #	Type of Cultural Heritage Resource	Type of Property	Location	Heritage Recognition	Description of Property and Known or Potential CHVI	Photographs/ Digital Image
OS-009	BHR	Residence	703 King St W, Oshawa	Potential BHR - Identified During Desktop/Field Review	<p>Property Description</p> <ul style="list-style-type: none"> - The property features a one-and-a-half storey frame residence with small single-storey rear enclosed porch and a large detached porch. The circa 1940 residence is clad with brown brick and has a side gable roof with two symmetrical gables on the north elevation and an enclosed projecting centred entrance. - Located on the south street King Street West, an early transportation route. - Reflects post-war residential growth along King Street West in the City of Oshawa. <p>Potential Cultural Heritage Value or Interest and associated heritage attributes</p> <p>This property has the potential to retain historical, architectural, and contextual value.</p>

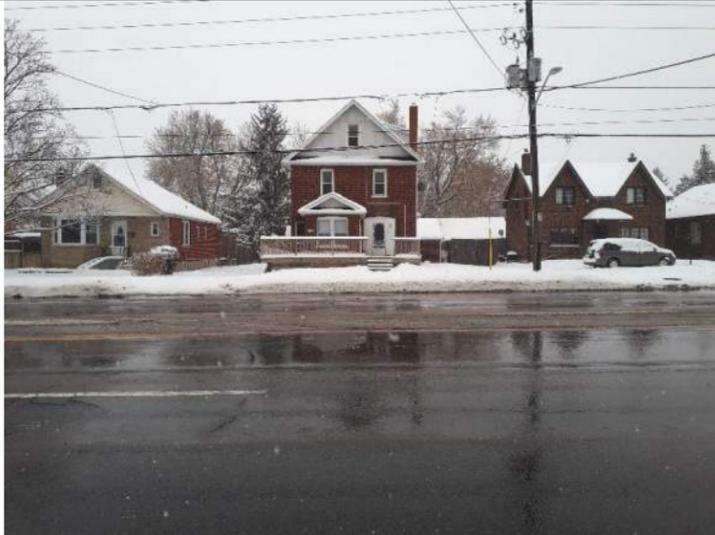
OS-010	BHR	Residence	697 King St W, Oshawa	Potential BHR - Identified During Desktop/Field Review	<p>Property Description</p> <ul style="list-style-type: none"> - The property features a two-and-a-half storey frame residence with a large rear detached shed. The Edwardian Classical style residence is clad with red brick with a front gable roof and features, vinyl siding in the front-facing gable, a one-storey projection and side entrance on the north elevation, and a bay and shed dormer on the west elevation. - Located on the south side of King Street West, an early transportation route, setback from the road. - Reflects turn-of-the-century settlement along King Street West in the City of Oshawa. <p>Potential Cultural Heritage Value or Interest and associated heritage attributes</p> <p>This property has the potential to retain historical, architectural, and contextual value.</p>

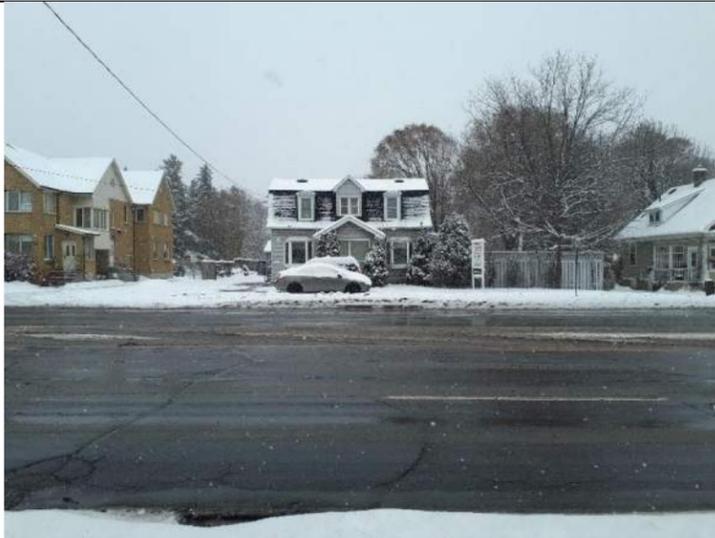
Ref #	Type of Cultural Heritage Resource	Type of Property	Location	Heritage Recognition	Description of Property and Known or Potential CHVI	Photographs/ Digital Image
OS-011	BHR	Residence	696 King St W, Oshawa	Potential BHR - Identified During Desktop/Field Review	<p>Property Description</p> <ul style="list-style-type: none"> - The property features a one-and-a-half storey frame residence with a small single-storey front addition, a one-and-a-half storey rear addition and detached two-vehicle garage. A majority of the property parcel is paved for parking with mature trees lining the east side of the property. The pre-1930 residence is clad with vinyl siding with a side gambrel roof and three dormers on the south elevation. - Located on the north side of King Street West, an early transportation route, setback from the road. - Reflects early twentieth century residential growth on King Street West in the City of Oshawa. <p>Potential Cultural Heritage Value or Interest and associated heritage attributes This property has the potential to retain contextual value.</p>

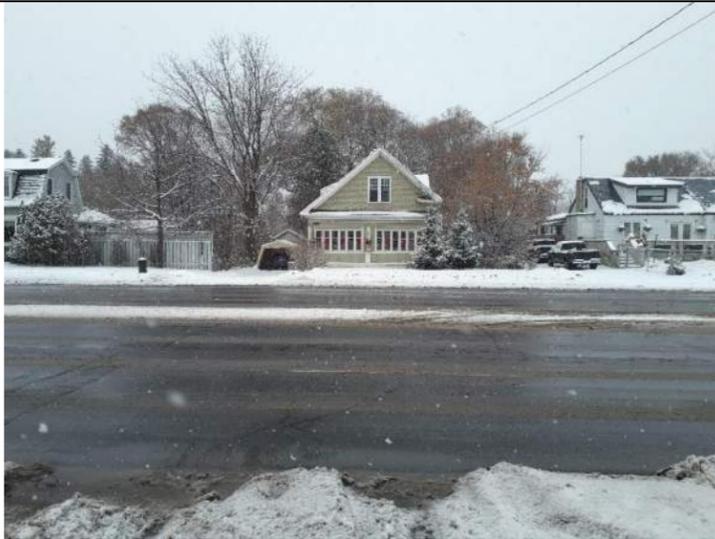
OS-012	BHR	Residence	688 King St W, Oshawa	Potential BHR - Identified During Desktop/Field Review	<p>Property Description</p> <ul style="list-style-type: none"> - The property features a one-and-a-half storey frame residence and mature trees. The residence is clad with wood siding, with intricate wood shingles cladding the centre gable. The asymmetric front gable roof has a return eave and extended eave on the west elevation, with a gabled dormer in east elevation and shed dormer on west elevation. The front porch that spans the south elevation has been enclosed with windows and vertical wood siding. - Located on the north side of King Street West, an early transportation route, setback from the road. - Reflects twentieth-century residential growth on King Street West in the City of Oshawa. <p>Potential Cultural Heritage Value or Interest and associated heritage attributes This property has the potential to retain architectural and contextual value.</p>

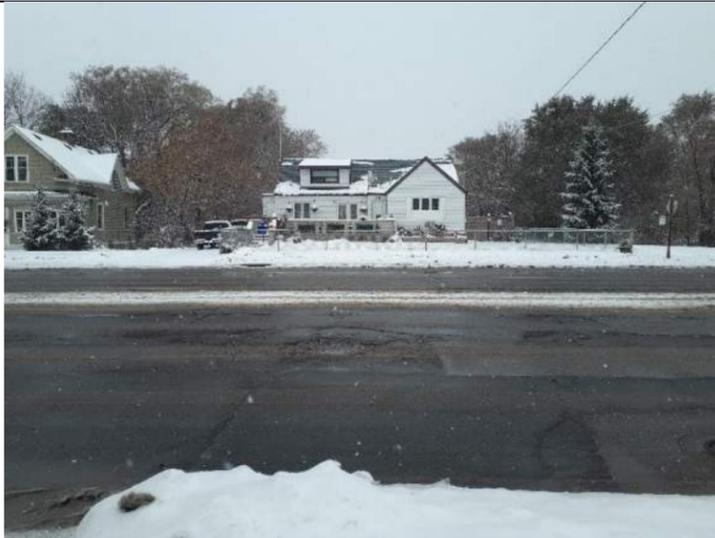
Ref #	Type of Cultural Heritage Resource	Type of Property	Location	Heritage Recognition	Description of Property and Known or Potential CHVI	Photographs/ Digital Image
OS-013	BHR	Residence	678 King St W, Oshawa	Potential BHR - Identified During Desktop/Field Review	<p>Property Description</p> <ul style="list-style-type: none"> - The property features a one-and-a-half storey frame residence with a single-storey, a detached garage, several sheds, and mature trees. A chain link fence runs along the south and east border of the property, north of the residence on the east border the chain link fence is replaced with wooden fencing. The residence is clad with vinyl siding with an L-shaped footprint and cross-gable roof and shed dormer on the south elevation. - Located on the north side of King Street West, an early transportation route, setback from the road. - Reflects twentieth-century residential growth on King Street West in the City of Oshawa. <p>Potential Cultural Heritage Value or Interest and associated heritage attributes This property has the potential to retain historical and contextual value.</p>

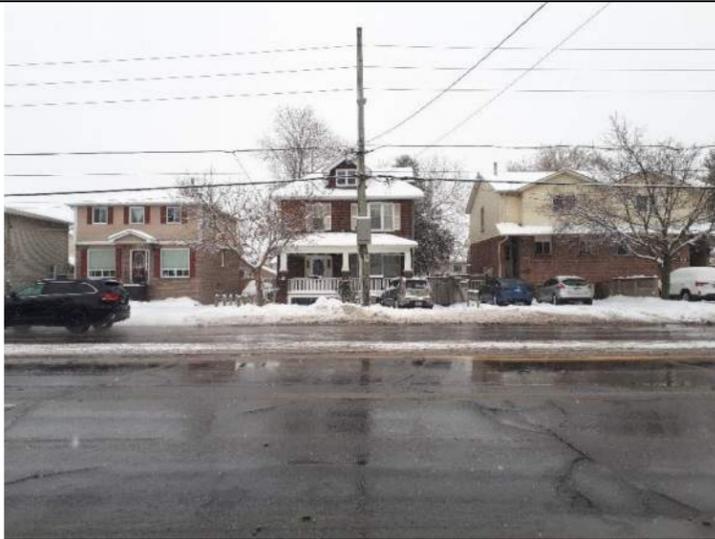
OS-014	BHR	Residence	685 King St W, Oshawa	Potential BHR - Identified During Desktop/Field Review	<p>Property Description</p> <ul style="list-style-type: none"> - The property features a two-and-a-half storey frame residence with mature trees in the rear of the property. The Edwardian Classical style residence is clad with red brick, features a hipped roof with dormers on the north and west elevations and a front porch that spans the primary elevation. The structure has an asymmetrical façade with a side entrance and expanded window openings on the west side. - Located on the north side of King Street West, an early transportation route, setback from the road. - Reflects turn-of-the-century settlement along King Street West in the City of Oshawa. <p>Potential Cultural Heritage Value or Interest and associated heritage attributes This property has the potential to retain historical, architectural, and contextual value.</p>

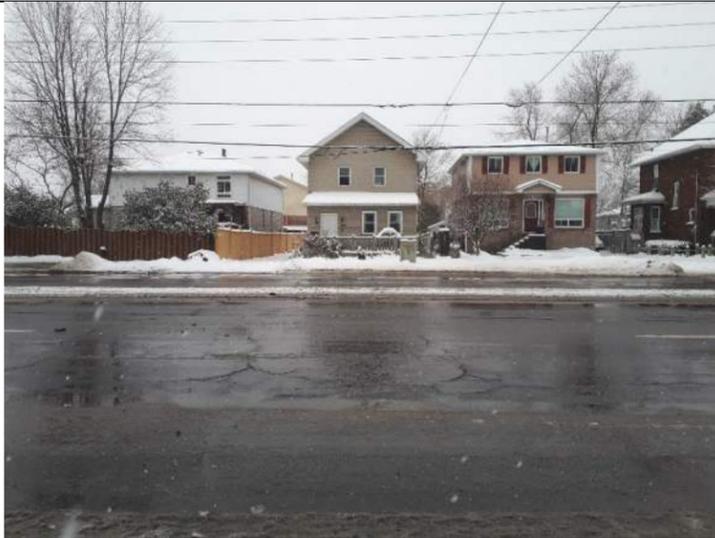
Ref #	Type of Cultural Heritage Resource	Type of Property	Location	Heritage Recognition	Description of Property and Known or Potential CHVI	Photographs/ Digital Image
OS-015	BHR	Residence	673 King St W, Oshawa	Potential BHR - Identified During Desktop/Field Review	<p>Property Description</p> <ul style="list-style-type: none"> - The property features a two-and-a-half storey residence with a single-storey rear addition and paved parking in the rear portion of the parcel. The residence is clad with vinyl siding and has a front gable roof. The front porch that spans the north elevation has been enclosed. - Located on the south side of King Street West, an early transportation route, setback from the road. - Reflects turn-of-the-century settlement along King Street West in the City of Oshawa. <p>Potential Cultural Heritage Value or Interest and associated heritage attributes This property has the potential to retain historical and contextual value.</p>

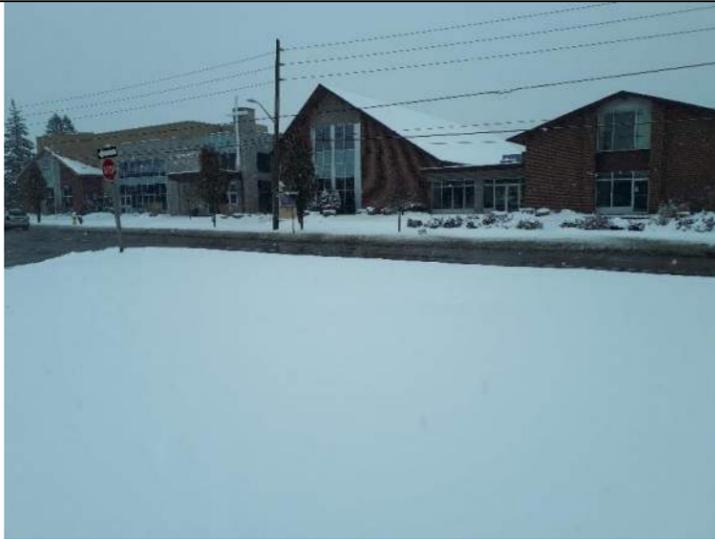
OS-016	BHR	Church	611 King St W, Oshawa	Potential BHR - Identified During Desktop/Field Review	<p>Property Description</p> <ul style="list-style-type: none"> - The property features a two-and-a-half storey church complex, King Street Community Church, that contains a structure from circa 1960s and a contemporary addition, a paved parking lot on the south and east portion of the parcel and a row of mature trees on the west side of the 1960s structure. The original Modernist church constructed in circa 1960 is clad with brown brick and features two gable-roof buildings connected by a single-storey structure with a flat roof. The pitch of the gables for each building differ, however both features a centered two-storey window opening, with metal spandrel featured on the west building. The contemporary addition is clad with brown brick and stone veneer, with aluminum siding cladding the second storey of the structure. The addition has a square footprint with an angled northeast corner and a flat roof. A projecting gabled feature is located on the north elevation. - Located on the south side of King Street West, an early transportation route, setback from the road. - Reflects twentieth-century religious practices along King Street West in the City of Oshawa. <p>Potential Cultural Heritage Value or Interest and associated heritage attributes This property has the potential to retain architectural and contextual value.</p>

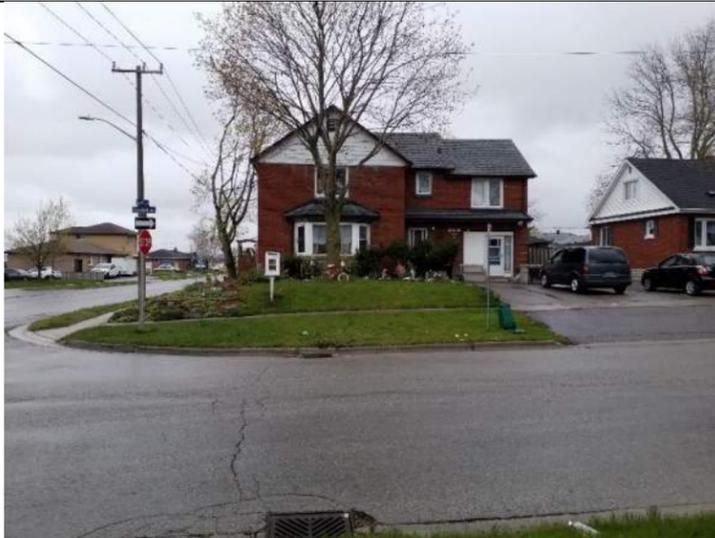
OS-018	BHR	Commercial	460 King St W, Oshawa	Potential BHR - Identified During Desktop/Field Review	<p>Property Description</p> <ul style="list-style-type: none"> - The property features a one-and-a-half storey commercial building with single-storey rear addition, paved parking on the west half of the property and grassed lawn south of the building. The circa 1940 former residence has a cross gable roof and is clad with red brick and aluminum siding in the gable ends and a parged concrete foundation. The original structure features stone veneer details on the south elevation. A set of stairs and a ramp have been added to the west and south elevations. - Located on the north side of King Street West, an early transportation route, setback from the road. - Reflects twentieth-century commercial development on King Street West in the City of Oshawa. <p>Potential Cultural Heritage Value or Interest and associated heritage attributes This property has the potential to retain architectural and contextual value.</p>

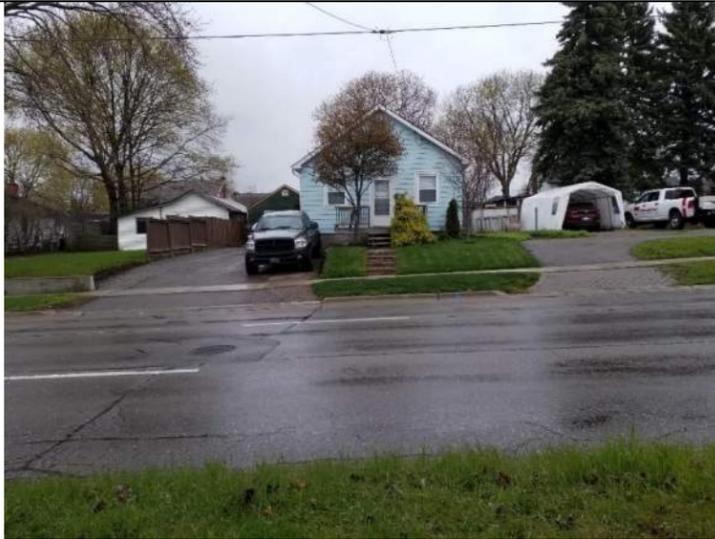
OS-020	BHR	Residence	454 Bond St W, Oshawa	Potential BHR - Identified During Desktop/Field Review	<p>Property Description</p> <ul style="list-style-type: none"> - The property features a one-and-a-half storey frame residence with a single-storey addition to the rear and a detached garage. The early twentieth-century residence is clad with vinyl siding with a front gable roof and a parged concrete foundation. The street-facing elevation is symmetrical with centre entrance. - Located on the north side of Bond Street West, an early transportation route, setback from the road. - Reflects early twentieth-century settlement north of Bond Street West in the City of Oshawa. <p>Potential Cultural Heritage Value or Interest and associated heritage attributes This property has the potential to retain contextual value.</p>

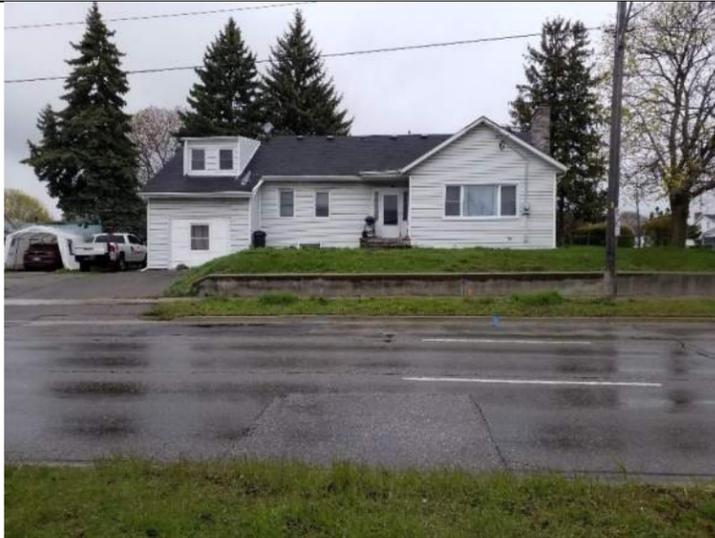
Ref #	Type of Cultural Heritage Resource	Type of Property	Location	Heritage Recognition	Description of Property and Known or Potential CHVI	Photographs/ Digital Image
OS-021	BHR	Residence	36 Rosehill Blvd, Oshawa	Potential BHR - Identified During Desktop/Field Review	<p>Property Description</p> <ul style="list-style-type: none"> - The property features a one-and-a-half storey frame residence with a driveway entrance off of both Bond Street West and Rosehill Boulevard, mature trees on the east portion of the lot and raised concrete retaining curb runs along the north side of the sidewalk that separates the property from Bond Street West. The early twentieth-century residence is clad with vinyl siding and features a cross-gable roof with two shed dormer additions. - Located on the northeast corner of Bond Street West and Rosehill Boulevard, both early transportation routes, setback from the road. - Reflects early twentieth-century settlement north of Bond Street West in the City of Oshawa. <p>Potential Cultural Heritage Value or Interest and associated heritage attributes This property has the potential to retain historical and contextual value.</p>

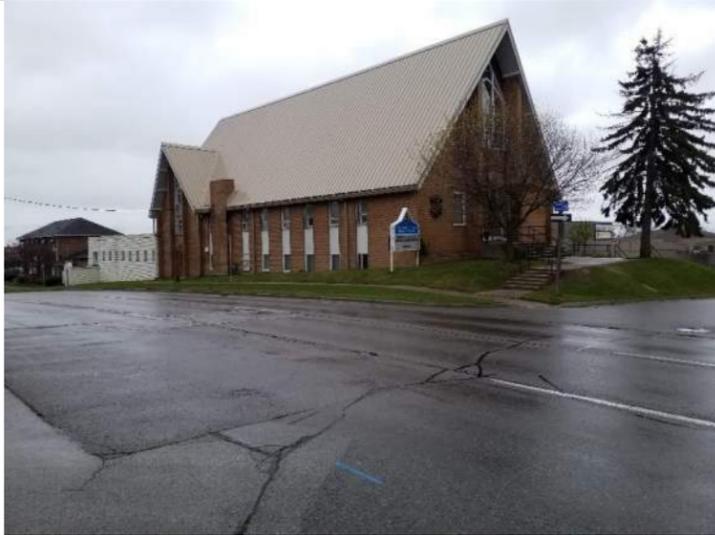
OS-022	BHR	Church	19 Rosehill Blvd, Oshawa	Potential BHR - Identified During Desktop/Field Review	<p>Property Description</p> <ul style="list-style-type: none"> - The property features a two-and-a-half storey church, Centennial Albert United Church, with a single-storey addition and a paved parking lot on the south portion of the parcel. The circa 1960 Modernist church is clad with brown brick and a steeply pitched gable roof with a cross gable feature on the northeast portion of the structure, fronting Bond Street West. Vertical window openings punctuate the bays of the structure on the north and south elevations, and the gable ends feature decorative geometric window tracery. The single-storey addition is located on the east side of the original church and features vinyl siding, a flat roof, and regularly spaced small rectangular window openings. - Located on the southeast corner of Bond Street West and Rosehill Boulevard, both early transportation routes, with a limited setback. - Reflects twentieth-century religious practices along Bond Street West in the City of Oshawa. <p>Potential Cultural Heritage Value or Interest and associated heritage attributes This property has the potential to retain historical, architectural, and contextual value.</p>

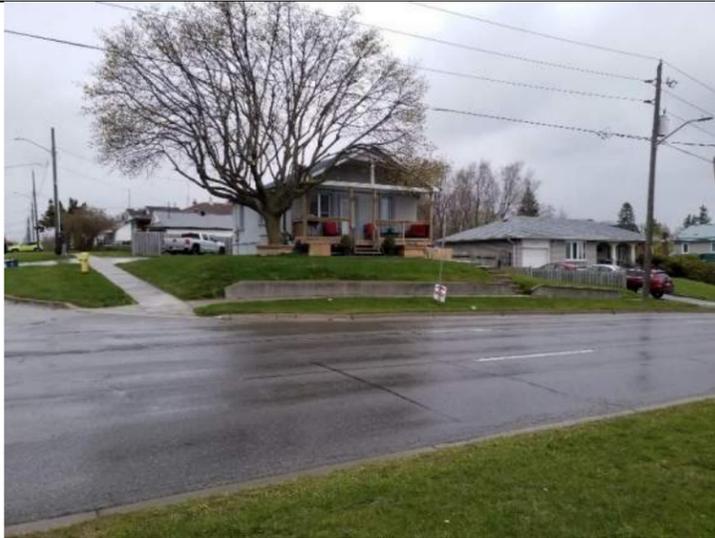
Ref #	Type of Cultural Heritage Resource	Type of Property	Location	Heritage Recognition	Description of Property and Known or Potential CHVI	Photographs/ Digital Image
OS-023	BHR	Residence	35 Rosehill Blvd, Oshawa	Potential BHR - Identified During Desktop/Field Review	<p>Property Description</p> <ul style="list-style-type: none"> - The property features a single-storey frame residence with raised concrete retaining curb runs along the north side of the sidewalk that separates the property from Bond Street West. The residence has been surfaced with contemporary stucco and features a front gable roof and centre entrance on the elevation fronting Bond Street West. - Located on the northeast corner of Bond Street West and Rosehill Boulevard, both early transportation routes, setback from the road. - Reflects turn-of-the-century settlement north of Bond Street West in the City of Oshawa. <p>Potential Cultural Heritage Value or Interest and associated heritage attributes This property has the potential to retain historical and contextual value.</p>

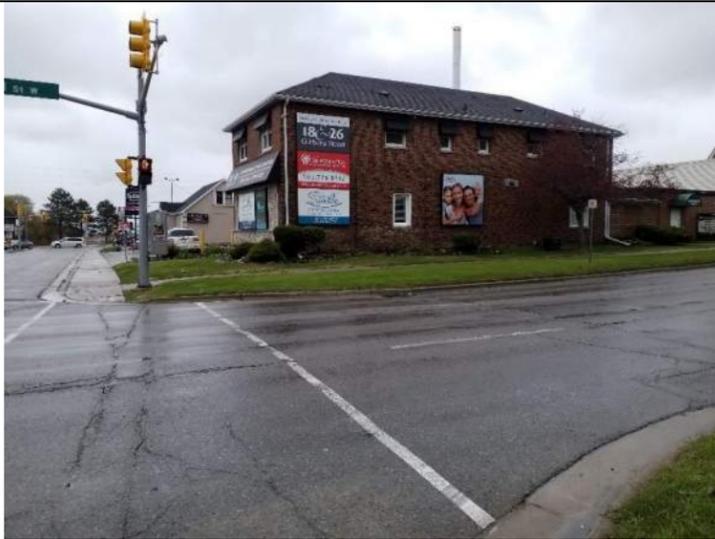
OS-024	BHR	Mixed Use	18-26 Gibbons St, Oshawa	Potential BHR - Identified During Desktop/Field Review	<p>Property Description</p> <ul style="list-style-type: none"> - The property features a two-storey frame mixed-use building with a single-storey commercial addition on the south original building and a parking lot occupying the space between the addition and Gibbons Street. The brown brick mixed-use building with a hipped roof is clad with stone veneer on the first storey of the east elevation. The additions to the south of the original structure are clad with red brick and stone veneer and with large plate glass windows. - Located on the southwest corner of Bond Street West and Gibbons Street, both early transportation routes, setback from the road. - Reflects commercial development south of Bond Street West in the City of Oshawa. <p>Potential Cultural Heritage Value or Interest and associated heritage attributes This property has the potential to retain architectural and contextual value.</p>

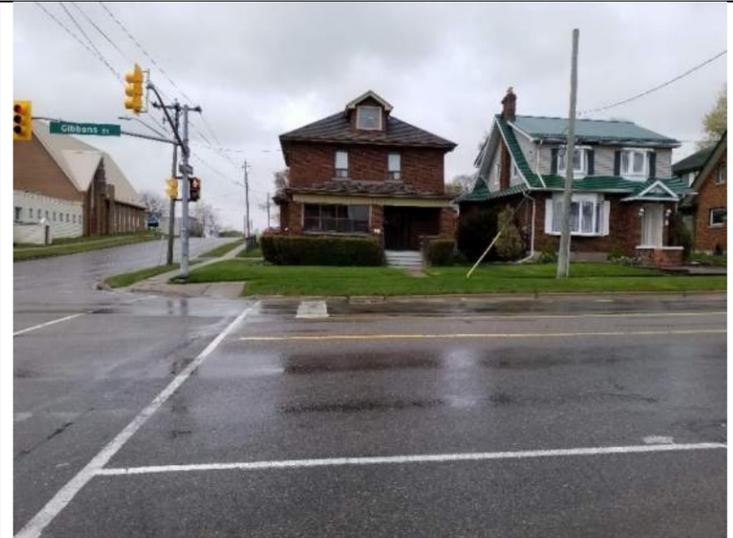
Ref #	Type of Cultural Heritage Resource	Type of Property	Location	Heritage Recognition	Description of Property and Known or Potential CHVI	Photographs/ Digital Image
OS-025	BHR	Residence	36 Gibbons St, Oshawa	Potential BHR - Identified During Desktop/Field Review	<p>Property Description</p> <ul style="list-style-type: none"> - The property features a two-and-a-half storey frame with a detached garage. The circa 1900 Edwardian Classical style residence is clad with brown brick and has a square footprint, with a hipped roof and dormer on the east elevation. A squared bay is on the south elevation and the front porch with brick piers on the east elevation has been partially enclosed. The detached garage contemporary with the residence. - Located on the northwest corner of Bond Street West and Gibbons Street, both early transportation routes, setback from the road. - Reflects twentieth-century residential development north of Bond Street West in the City of Oshawa. <p>Potential Cultural Heritage Value or Interest and associated heritage attributes</p> <p>This property has the potential to retain historical, architectural, and contextual value.</p>

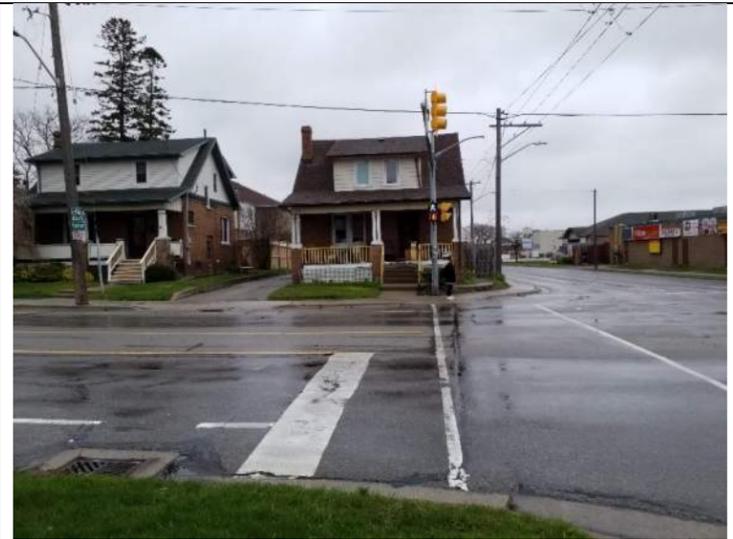
OS-026	BHR	Residence	35 Gibbons St, Oshawa	Potential BHR - Identified During Desktop/Field Review	<p>Property Description</p> <ul style="list-style-type: none"> - The property features a one-and-a-half storey frame residence with a wooden fence running along the south perimeter, bordering Bond Street West. The circa 1900 Craftsman Bungalow is clad with brown brick and features a side gable roof with extended eave over the front porch on the west elevation and shed dormers on the east and west sides. Vinyl siding clads the gables ends and dormers. - Located on the northeast corner of Bond Street West and Gibbons Street, both early transportation routes, with a limited setback. - Reflects twentieth-century residential development north of Bond Street West in the City of Oshawa. <p>Potential Cultural Heritage Value or Interest and associated heritage attributes</p> <p>This property has the potential to retain historical, architectural, and contextual value.</p>

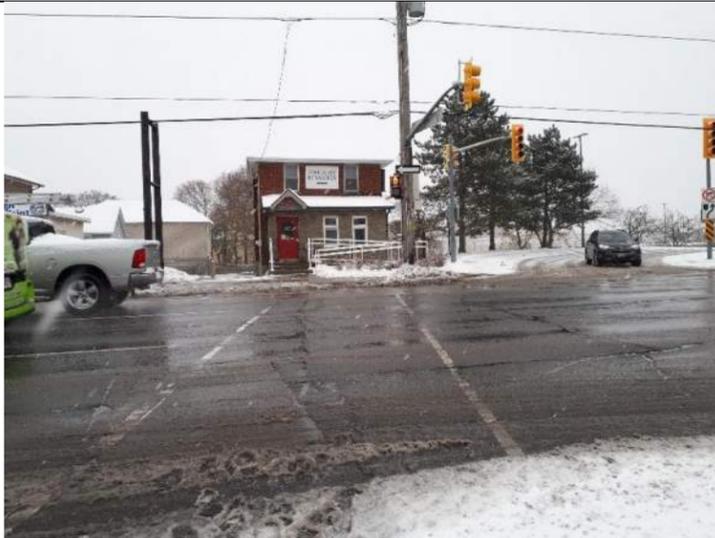
Ref #	Type of Cultural Heritage Resource	Type of Property	Location	Heritage Recognition	Description of Property and Known or Potential CHVI	Photographs/ Digital Image
OS-027	BHR	Commercial	403 King St W, Oshawa	Potential BHR - Identified During Desktop/Field Review	<p>Property Description</p> <ul style="list-style-type: none"> - The property features a two-storey frame commercial building with paved parking at the rear and a sloping topography that exposes a basement entrance on the rear of the building. The former-residential brown brick mixed-use building with a hipped roof has an enclosed front porch that is clad with stone veneer, parged concrete foundation and a bay on the west elevation. - Located on the southeast corner of King Street West and Gibbons Street, both early transportation routes, setback from the road. - Reflects twentieth-century commercial development on King Street West in the City of Oshawa. <p>Potential Cultural Heritage Value or Interest and associated heritage attributes This property has the potential to retain historical and contextual value.</p>

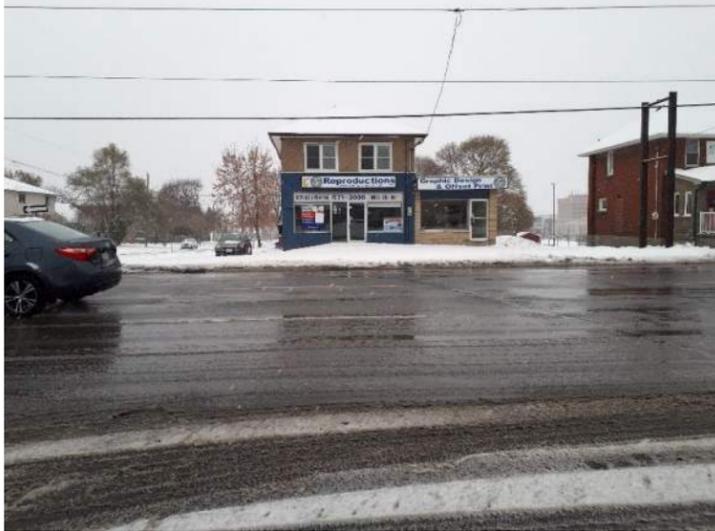
OS-028	BHR	Commercial	399 King St W, Oshawa	Potential BHR - Identified During Desktop/Field Review	<p>Property Description</p> <ul style="list-style-type: none"> - The property features a two-storey frame commercial building and a small single-storey addition on the west elevation, with paved parking covering a majority of the remaining lot. The commercial building is clad with wood siding and features a hipped roof and large plate glass storefront windows on the first storey of the north elevation. The single-storey addition also has a large plate glass storefront window and entrance, has a flat roof, and is clad with Angel stone. - Located on the southwest corner of King Street West and Westmount Street, both early transportation routes, with a limited setback. - Reflects twentieth-century commercial development on King Street West in the City of Oshawa. <p>Potential Cultural Heritage Value or Interest and associated heritage attributes This property has the potential to retain historical and contextual value.</p>

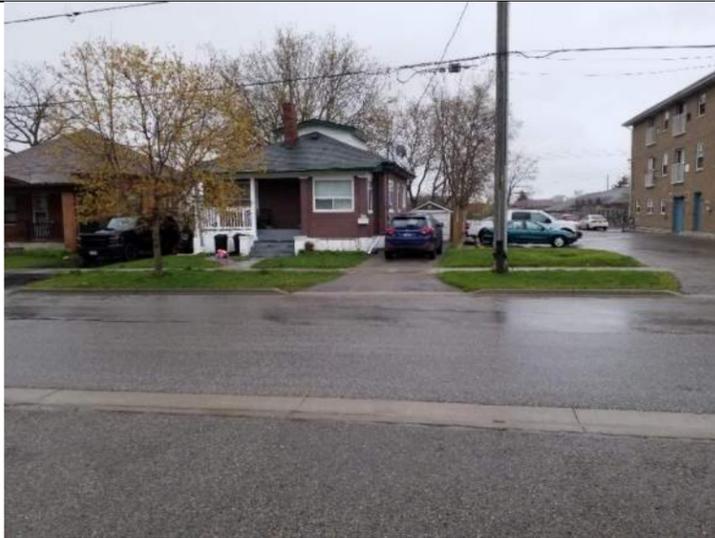
Ref #	Type of Cultural Heritage Resource	Type of Property	Location	Heritage Recognition	Description of Property and Known or Potential CHVI	Photographs/ Digital Image
OS-029	BHR	Residence	367 Buena Vista Ave, Oshawa	Potential BHR - Identified During Desktop/Field Review	<p>Property Description</p> <ul style="list-style-type: none"> - The property features a single-storey frame residence with a rear rooftop addition, a detached garage, and mature trees. The residence is clad with vinyl siding and features a rectangular footprint with hipped roof and projecting central brick chimney, and parged concrete foundation. A portion of the front porch on the north elevation has been enclosed. - Located on the south side of Buena Vista Avenue, an early transportation route, setback from the road. - Reflects twentieth-century residential development north of Bond Street West in the City of Oshawa. <p>Potential Cultural Heritage Value or Interest and associated heritage attributes This property has the potential to retain historical and contextual value.</p>

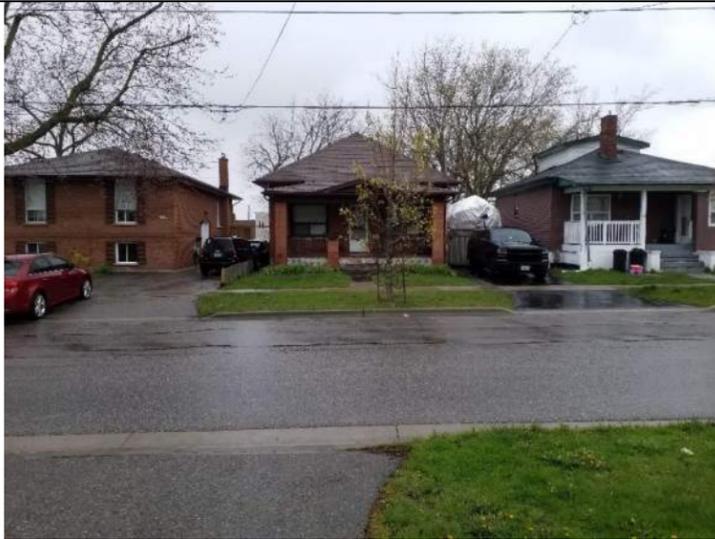
OS-030	BHR	Residence	363 Buena Vista Ave, Oshawa	Potential BHR - Identified During Desktop/Field Review	<p>Property Description</p> <ul style="list-style-type: none"> - The property features a single-storey frame residence and mature trees within the rear of the parcel. The red-bricked residence features a rectangular footprint with hipped roof with extended eave on the north elevation to form the roof of the front porch with is supported with brick piers. - Located on the south side of Buena Vista Avenue, an early transportation route, setback from the road. - Reflects twentieth-century residential development north of Bond Street West in the City of Oshawa. <p>Potential Cultural Heritage Value or Interest and associated heritage attributes This property has the potential to retain historical and contextual value.</p>
