**DURHAM-SCARBOROUGH BUS RAPID TRANSIT PROJECT
CULTURAL HERITAGE REPORT – EXISTING CONDITIONS AND PRELIMINARY IMPACT ASSESSMENT
CITY OF TORONTO AND DURHAM REGION, ONTARIO**

ASI File: 18CH-142

October 2019 (Revised June and October 2020;
January, May, November and December 2021; January and February 2022)

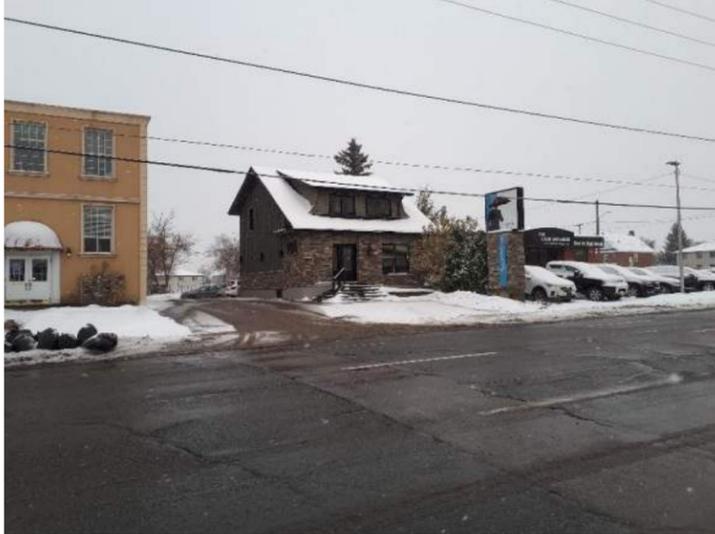
OS-032	BHR	Residence	329 Buena Vista Ave, Oshawa	Potential BHR - Identified During Desktop/Field Review	<p>Property Description</p> <ul style="list-style-type: none"> - The property features a two-storey frame residence with a front addition and a detached garage. The residence is clad with vinyl siding and features a roof that combines a hipped (rear) and gable (front) roofline and a parged concrete foundation. The bricked front addition has an asymmetrical front gable roofline that extends to the first storey on the east elevation and three arched openings within a front porch enclosure. - Located on the south side of Buena Vista Avenue, an early transportation route, setback from the road. - Reflects twentieth-century residential development north of Bond Street West in the City of Oshawa. <p>Potential Cultural Heritage Value or Interest and associated heritage attributes This property has the potential to retain historical and contextual value.</p>

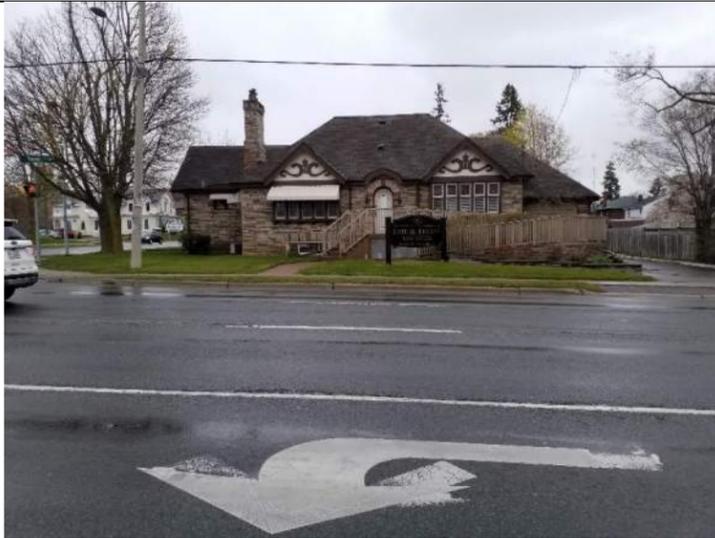
Ref #	Type of Cultural Heritage Resource	Type of Property	Location	Heritage Recognition	Description of Property and Known or Potential CHVI	Photographs/ Digital Image
OS-035	BHR	Commercial	270 Bond St W, Oshawa	Potential BHR - Identified During Desktop/Field Review	<p>Property Description</p> <ul style="list-style-type: none"> - The property features a one-and-a-half storey frame commercial building with a rear paved parking lot and mature trees. The building is a former early twentieth-century residence and is clad with stone veneer and features a hipped roof with two gables on the south elevation and shed dormer on the north elevation, and a rounded entrance on the south elevation. A concrete set of stairs and an accessibility ramp have been added to the south elevation. - Located on the northeast corner of Bond Street West and Park Road North, both early transportation routes, setback from the road. - Reflects twentieth-century residential development north of Bond Street West. <p>Potential Cultural Heritage Value or Interest and associated heritage attributes This property has the potential to retain historical, architectural, and contextual value.</p>

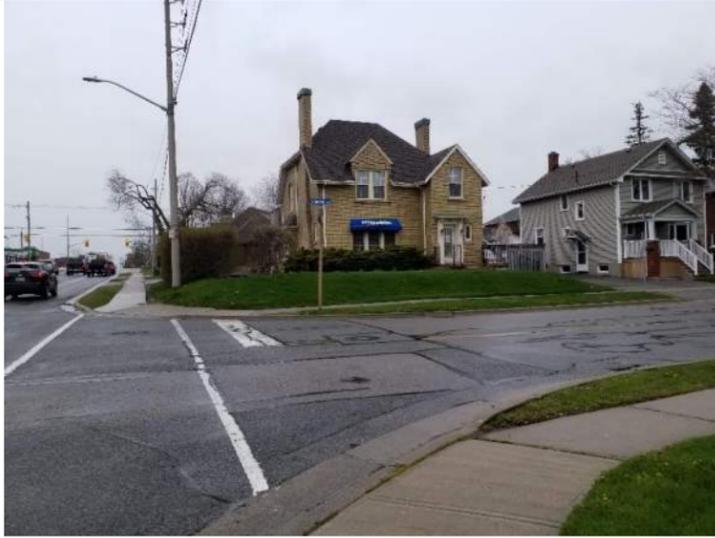
OS-036	BHR	Commercial	42 Warren Ave, Oshawa	Potential BHR - Listed on Municipal Heritage Register	<p>Property Description</p> <ul style="list-style-type: none"> - The property features a one-and-a-half storey frame commercial building with a rear paved parking lots accessed from Bond Street West. The building is a former early twentieth-century residence that is clad with yellow brick with a hipped roof and gable features on the east and west elevations, a single-storey sunroof extension with rooftop deck on the west elevation, a squared bay on the south elevation, and a decorative wood entry surround. - Located on the northwest corner of Bond Street West and Warren Avenue, both early transportation routes, setback from the road. - Reflects twentieth-century residential development north of Bond Street West in the City of Oshawa. <p>Potential Cultural Heritage Value or Interest and associated heritage attributes This property has the potential to retain historical, architectural, and contextual value.</p>

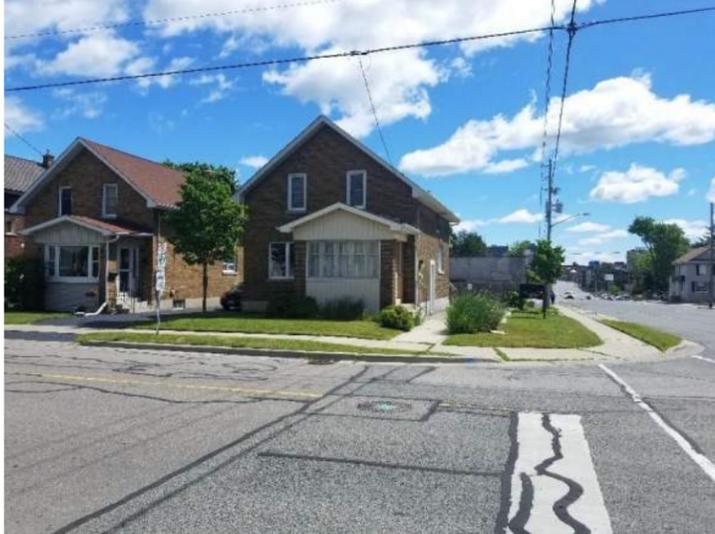
OS-038	BHR	Residence	27 Warren Ave, Oshawa	Potential BHR - Identified During Desktop/Field Review	<p>Property Description</p> <ul style="list-style-type: none"> - The property features a two-and-a-half storey frame residence with rear paved parking accessed from Bond Street W and a detached garage. The residence is clad with painting brick and features a hipped roof with dormer on the west elevation, an enclosed front porch and parged concrete foundation. - Located on the southeast side of Bond Street West and Warren Avenue, both early transportation routes. - Reflects twentieth-century residential development on Bond Street West in the City of Oshawa. <p>Potential Cultural Heritage Value or Interest and associated heritage attributes</p> <p>This property has the potential to retain historical, architectural, and contextual value.</p>

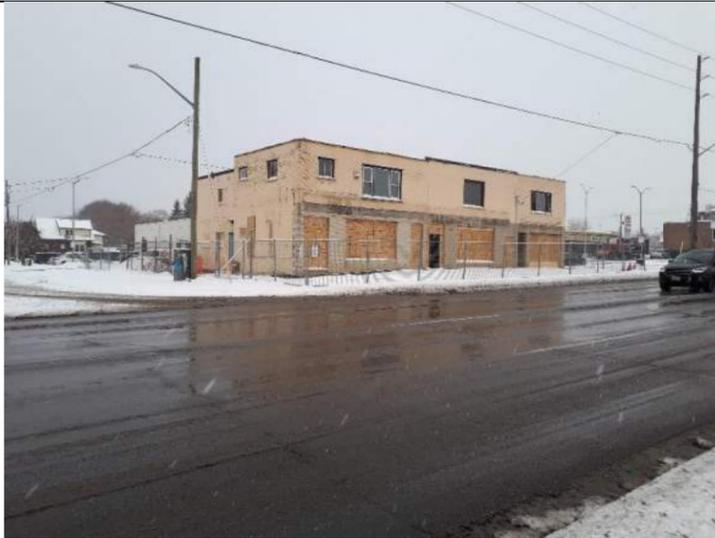
Ref #	Type of Cultural Heritage Resource	Type of Property	Location	Heritage Recognition	Description of Property and Known or Potential CHVI	Photographs/ Digital Image
OS-039	BHR	Commercial	223 – 229 King St W, Oshawa	Potential BHR - Identified During Desktop/Field Review	<p>Property Description</p> <ul style="list-style-type: none"> - The property features a two-storey commercial building, a two-storey rear addition, a detached garage and disturbed land in the rear, all surrounded by temporary construction fencing. The early twentieth century building is clad with painted brick and features a flat roof with large window openings on street level that have been boarded up with plywood, and there is evidence between the first and second storeys of former signage on the north elevation. The addition is constructed using concrete blocks (CMU). - Located on the southwest corner of King Street West and Burk Street, both early transportation routes, with a limited setback. - Reflects twentieth-century commercial development on King Street West in the City of Oshawa. <p>Potential Cultural Heritage Value or Interest and associated heritage attributes This property has the potential to retain historical and contextual value.</p>

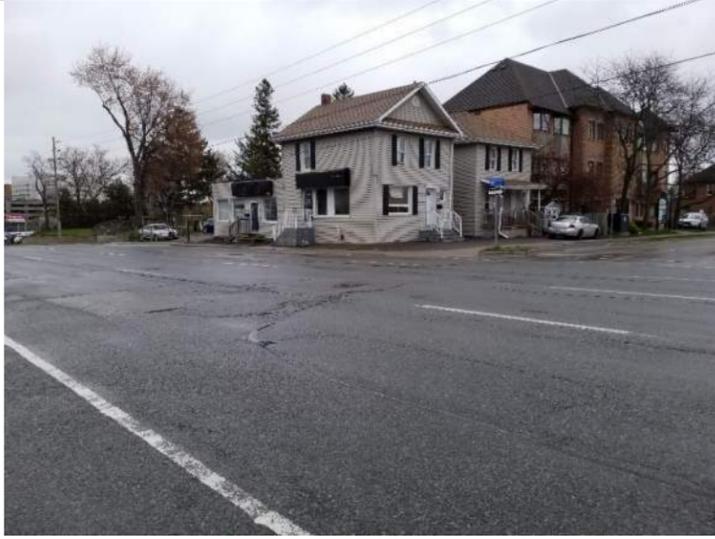
OS-040	BHR	Mixed Use	29 Gladstone Ave, Oshawa	Potential BHR - Identified During Desktop/Field Review	<p>Property Description</p> <ul style="list-style-type: none"> - The property features a two-and-a-half storey frame mixed-use building with a rear addition (associated with the address 205 Bond Street West). The former early twentieth century residential building is clad with vinyl siding and features a front gable roof with altered window openings on the first storey. - Located on the southeast corner of Bond Street West and Gladstone Avenue, both early transportation routes, with a limited setback. - Reflects twentieth-century residential development on Bond Street West in the City of Oshawa. <p>Potential Cultural Heritage Value or Interest and associated heritage attributes This property has the potential to retain historical and contextual value.</p>

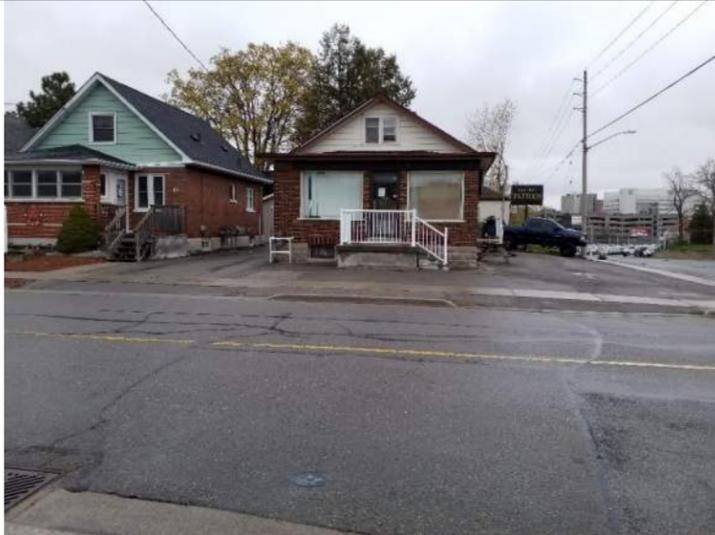
OS-042	BHR	Commercial	210 Bond St W, Oshawa	Potential BHR - Identified During Desktop/Field Review	<p>Property Description</p> <ul style="list-style-type: none"> - The property features a one-and-a-half storey frame commercial building with a single-storey rear addition and paved parking on the remaining lot. The former early twentieth century residence, now commercial building, is clad with brown brick and features a front gable roof clad with vinyl siding, an enclosed porch with brick piers, and cast concrete block foundation. The rear addition is clad with vertical aluminum siding. - Located on the northeast corner of Bond Street West and Gladstone Avenue, both early transportation routes, with a limited setback. - Reflects residential development north of Bond Street West in the City of Oshawa. <p>Potential Cultural Heritage Value or Interest and associated heritage attributes</p> <p>This property has the potential to retain historical, architectural, and contextual value.</p>

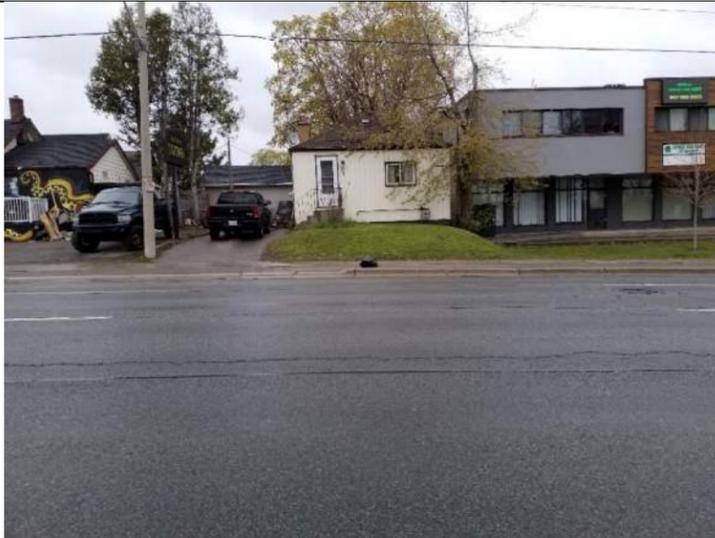
Ref #	Type of Cultural Heritage Resource	Type of Property	Location	Heritage Recognition	Description of Property and Known or Potential CHVI	Photographs/ Digital Image
OS-043	BHR	Residence	204 Bond St W, Oshawa	Potential BHR - Identified During Desktop/Field Review	<p>Property Description</p> <ul style="list-style-type: none"> - The property features a single-storey frame residence with a driveway and grassed front lawn. The residence has a rectangular footprint, is clad with vertical aluminum siding, and features a hipped roof and side-hall plan. - Located on the north side of Bond Street West, an early transportation route, with a limited setback. - Reflects twentieth-century residential development north of Bond Street West in the City of Oshawa. <p>Potential Cultural Heritage Value or Interest and associated heritage attributes</p> <p>This property has the potential to retain historical and contextual value.</p>

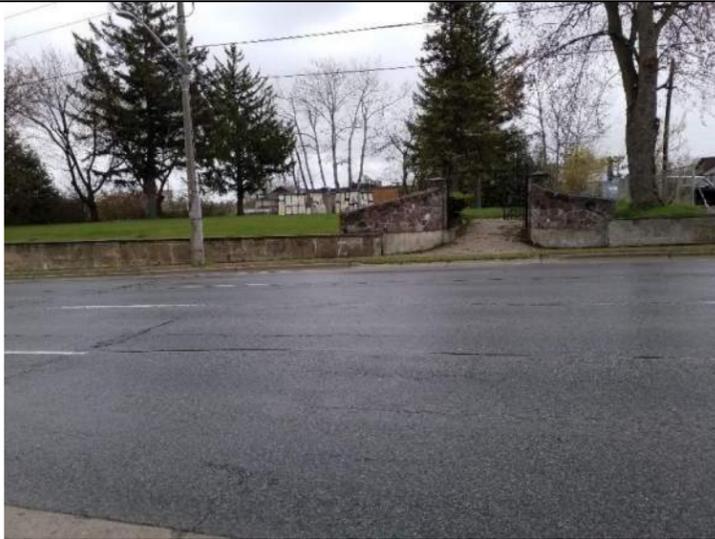
OS-044	CHL	Cemetery	185-201 Bond St W, Oshawa	Known CHL - Part IV Designation (By-law #68-2015)	<p>Property Description</p> <ul style="list-style-type: none"> - The site is known as Pioneer Memorial Garden Cemetery, and is a former Methodist cemetery and was restored as a partnership between Simcoe Street United Church, the City of Oshawa and the Oshawa Horticultural Society (Heritage Oshawa 2015). - The property features open grassed lawn with mature trees along the perimeter, a commemorative feature in the centre of the parcel, and concrete retaining wall along the south side of the sidewalk that separates the property from Bond Street West. <p>Known Cultural Heritage Value or Interest under Ontario Regulation 9/06 and associated heritage attributes</p> <p>For additional information, please see the By-Law available at: https://www.heritagetrust.on.ca/en/oha/details?id=5699&backlinkslug=search-results&fields%5Blocation%5D=7%2C301</p> <p>Physical heritage attributes that support the CHVI include:</p> <ul style="list-style-type: none"> - The original monuments and markers with their variety of size, motifs, materials, inscription and current placement within the cemetery; - The original location of some monuments and markers with their surviving inscriptions; - The placement of the monuments and markers within the cairns arranged in the shape of a six-pointed star radiating from a central column; - The wrought iron gates and fieldstone wall at the entrance into the cemetery; - The plaque commemorating the Memorial Garden unveiling; the plaque commemorating the erection of the fieldstone wall;

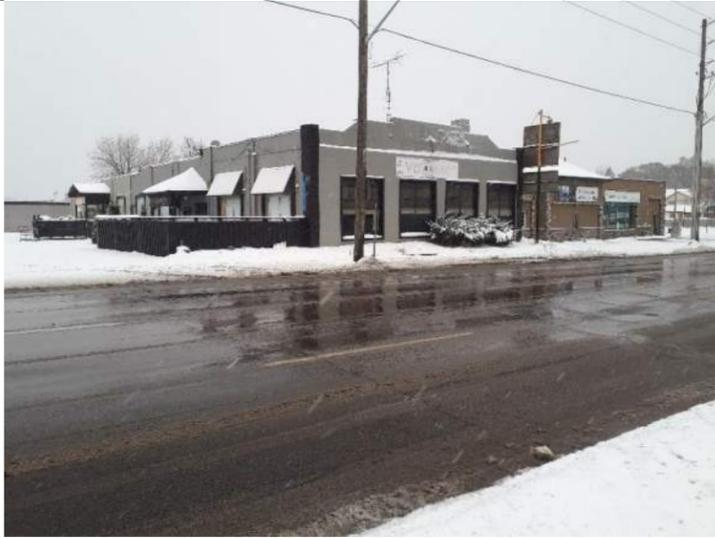
Ref #	Type of Cultural Heritage Resource	Type of Property	Location	Heritage Recognition	Description of Property and Known or Potential CHVI	Photographs/ Digital Image
					<ul style="list-style-type: none"> - The location, dimensions and orientation of the cemetery in relation to the encompassing community; and - The park-like setting and natural features of the site. 	
OS-045	BHR	Commercial	145 King St W, Oshawa	Potential BHR - Identified During Desktop/Field Review	<p>Property Description</p> <ul style="list-style-type: none"> - The property features a single-storey frame commercial building with paved parking lot on the east half of the parcel. The early twentieth century building has a rectangular footprint with a flat roof and parapet wall on the north and east elevations. The building has been surfaced with contemporary stucco and some areas have wood siding. Large window openings are located on the north and east elevations, and two entrances are located on the east elevation with access to the adjacent paved parking. - Located on the south side of King Street West, an early transportation route, with a limited setback. - Reflects early twentieth-century commercial development on King Street West in the City of Oshawa. <p>Potential Cultural Heritage Value or Interest and associated heritage attributes This property has the potential to retain historical and contextual value.</p>

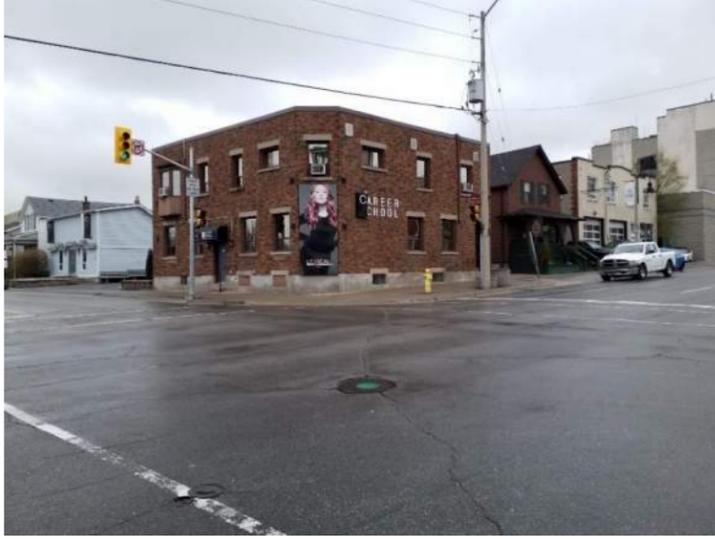
OS-046	BHR	Mixed-Use	92 Bond St W, Oshawa	Potential BHR - Identified During Desktop/Field Review	<p>Property Description</p> <ul style="list-style-type: none"> - The property features a two-storey frame mixed-use building with a two-storey rear addition and rear paved parking. The circa 1920 building has a rectangular footprint with angled southwest corner, is clad with brown brick and features a flat roof with parapet walls, stone lintels and sill, and parged concrete foundation. The addition is also clad with brown brick, has a flat roof, with minimal windows. - Located on the northeast corner of Bond Street West and McMillan Drive, both early transportation routes, with a limited setback. - Reflects early twentieth-century commercial development on Bond Street West in the City of Oshawa. <p>Potential Cultural Heritage Value or Interest and associated heritage attributes This property has the potential to retain historical, architectural, and contextual value.</p>

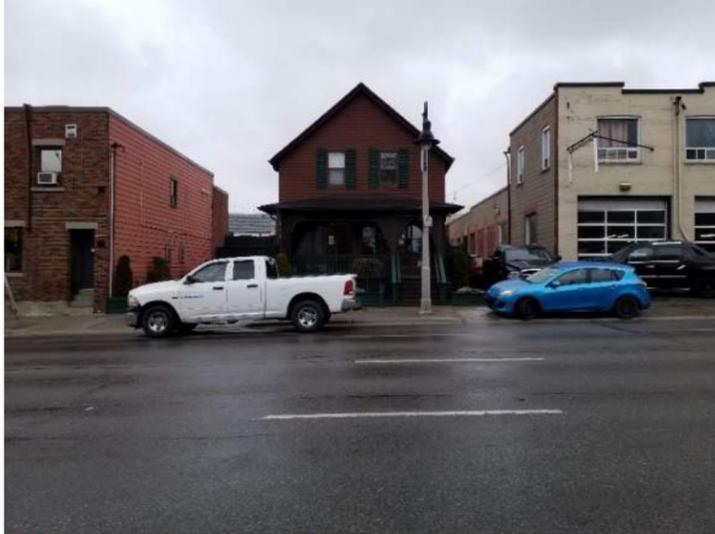
Ref #	Type of Cultural Heritage Resource	Type of Property	Location	Heritage Recognition	Description of Property and Known or Potential CHVI	Photographs/ Digital Image
OS-047	BHR	Commercial	90 Bond St W, Oshawa	Potential BHR - Identified During Desktop/Field Review	<p>Property Description</p> <ul style="list-style-type: none"> - The property features a one-and-a-half storey frame commercial building with a rear addition. The former residence was constructed in the early twentieth century and is clad with wood siding and features a front gable roof and covered front porch. - Located on the north side of Bond Street West, an early transportation route, with a limited setback. - Reflects twentieth-century commercial development on Bond Street West in the City of Oshawa. <p>Potential Cultural Heritage Value or Interest and associated heritage attributes</p> <p>This property has the potential to retain historical, architectural, and contextual value.</p>

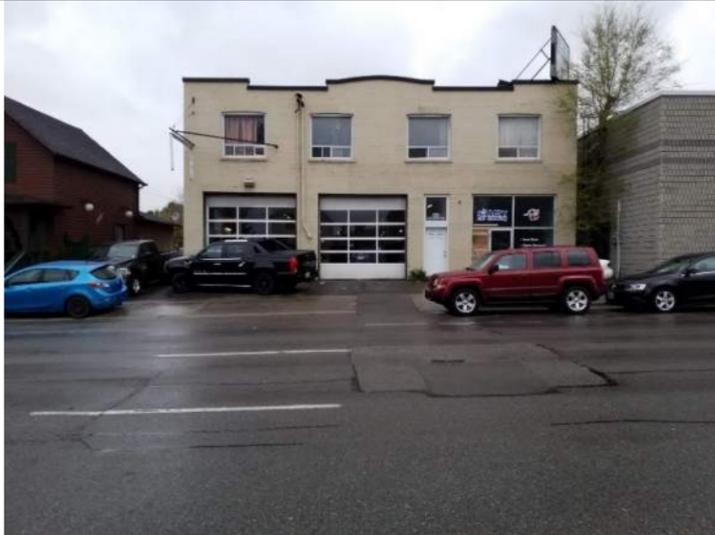
OS-048	BHR	Commercial	88 Bond St W, Oshawa	Potential BHR - Identified During Desktop/Field Review	<p>Property Description</p> <ul style="list-style-type: none"> - The property features a two-storey frame commercial building with a one storey rear addition with paved parking between the building and Bond Street West. The early twentieth century building has a rectangular footprint with a flat roof and parapet walls. The south elevation is clad with painted brick, with the remaining elevations (including the rear addition) are clad with concrete black and red brick. The south elevation features large window openings and two garage doors. - Located on the north side of King Street West, an early transportation route, setback from the road. - Reflects early twentieth-century commercial development on King Street West in the City of Oshawa. <p>Potential Cultural Heritage Value or Interest and associated heritage attributes</p> <p>This property has the potential to retain historical, architectural, and contextual value.</p>

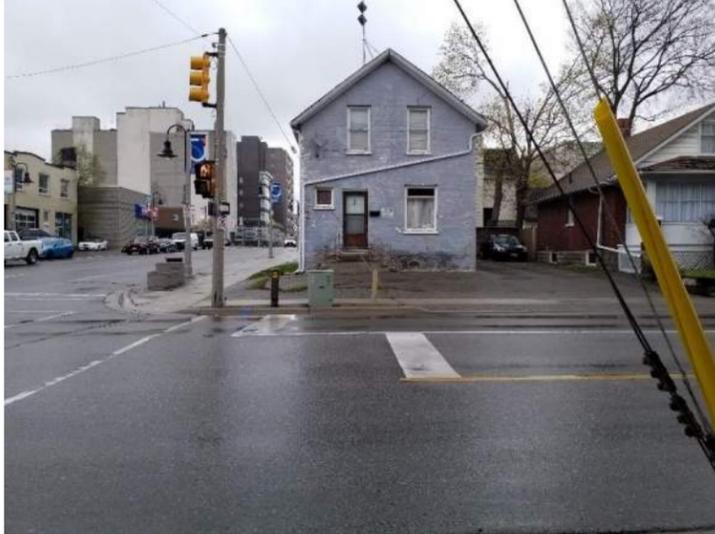
Ref #	Type of Cultural Heritage Resource	Type of Property	Location	Heritage Recognition	Description of Property and Known or Potential CHVI	Photographs/ Digital Image
OS-049	BHR	Commercial	25 McMillian Dr, Oshawa	Potential BHR - Identified During Desktop/Field Review	<p>Property Description</p> <ul style="list-style-type: none"> - The property features a one-and-a-half storey frame commercial building with paving on a majority of the remaining parcel. The former residence was constructed in the early twentieth century and is clad with painted brick and features a front gable roof and stone foundation. - Located on the southeast corner of Bond Street West and McMillan Avenue, both early transportation routes, with a limited setback. - Reflects twentieth-century commercial development on Bond Street West in the City of Oshawa. <p>Potential Cultural Heritage Value or Interest and associated heritage attributes</p> <p>This property has the potential to retain historical, architectural, and contextual value.</p>

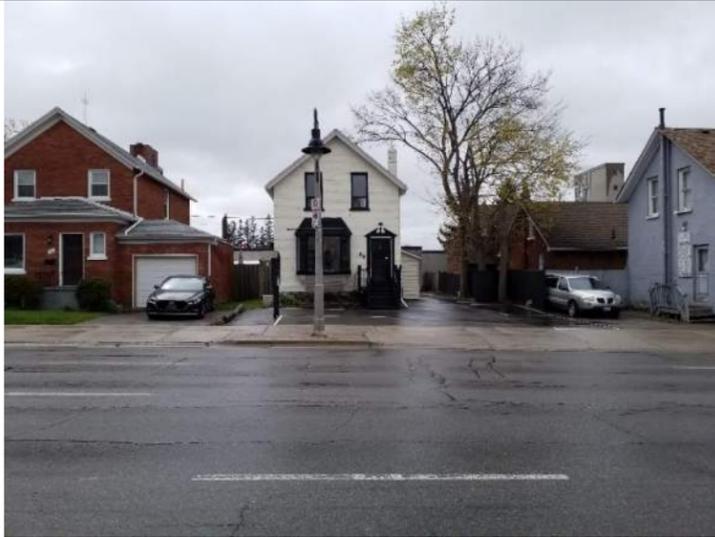
OS-050	BHR	Residence	89 Bond St W, Oshawa	Potential BHR - Identified During Desktop/Field Review	<p>Property Description</p> <ul style="list-style-type: none"> - The property features a one-and-a-half storey frame residence with a one storey rear addition and rear paved parking and mature trees. The early twentieth century residence is clad with painted brick and features a front gable roof, bay window and ornamental entry surround on the north elevation. - Located on the south side of Bond Street West, an early transportation route, setback from the road. - Reflects early twentieth-century residential development on Bond Street West in the City of Oshawa. <p>Potential Cultural Heritage Value or Interest and associated heritage attributes</p> <p>This property has the potential to retain historical, architectural, and contextual value.</p>

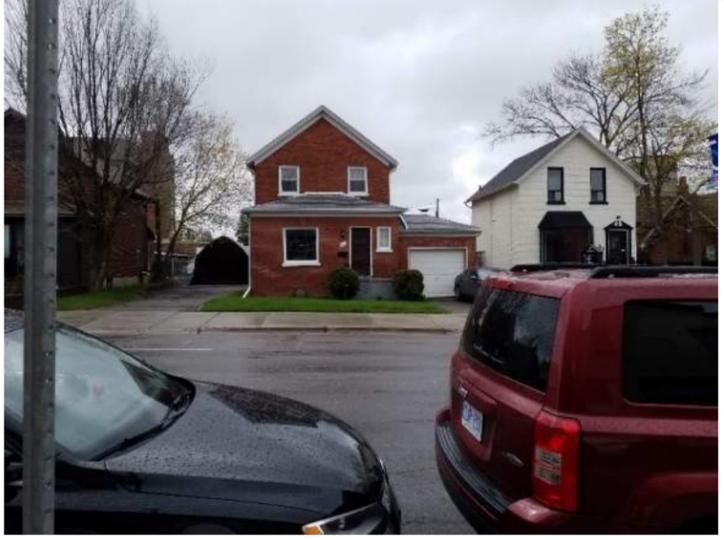
Ref #	Type of Cultural Heritage Resource	Type of Property	Location	Heritage Recognition	Description of Property and Known or Potential CHVI	Photographs/ Digital Image
OS-051	BHR	Residence	85 Bond St W, Oshawa	Potential BHR - Identified During Desktop/Field Review	<p>Property Description</p> <ul style="list-style-type: none"> - The property features a one-and-a-half storey frame residence with a single-storey garage addition, enclosed front porch addition and rear paved parking with two sheds. The early twentieth century residence is clad with red brick and features a front gable roof and stone foundation. - Located on the south side of Bond Street West, an early transportation route, with a limited setback. - Reflects early twentieth-century residential development on Bond Street West in the City of Oshawa. <p>Potential Cultural Heritage Value or Interest and associated heritage attributes This property has the potential to retain historical, architectural, and contextual value.</p>

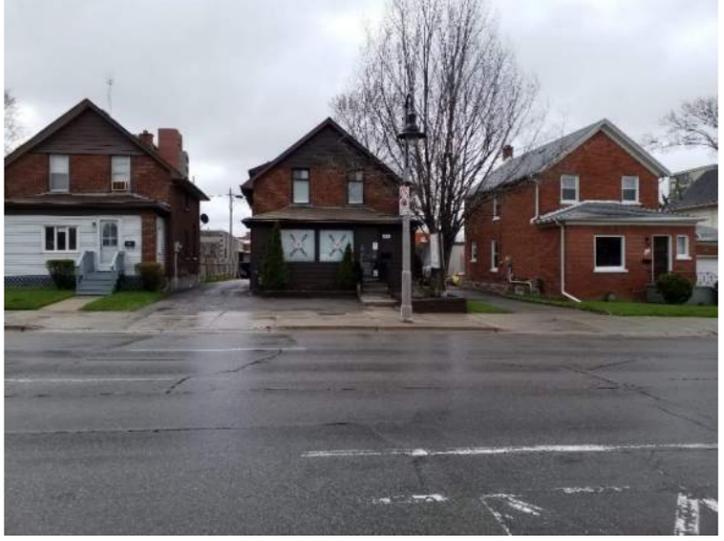
OS-052	BHR	Residence	81 Bond St W, Oshawa	Potential BHR - Identified During Desktop/Field Review	<p>Property Description</p> <ul style="list-style-type: none"> - The property features a one-and-a-half storey frame residence with rear paved parking. The early twentieth century residence is clad with brown brick and features a front gable roof with wood siding within the gable and a shed dormer on the east side, enclosed front porch, and concrete foundation. - Located on the south side of Bond Street West, an early transportation route, with a limited setback. - Reflects early twentieth-century residential development on Bond Street West in the City of Oshawa. <p>Potential Cultural Heritage Value or Interest and associated heritage attributes This property has the potential to retain historical, architectural, and contextual value.</p>

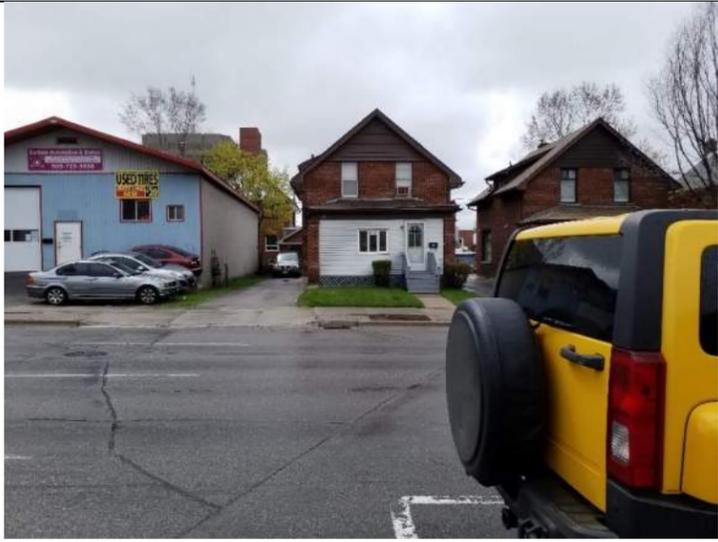
Ref #	Type of Cultural Heritage Resource	Type of Property	Location	Heritage Recognition	Description of Property and Known or Potential CHVI	Photographs/ Digital Image
OS-053	BHR	Residence	77 Bond St W, Oshawa	Potential BHR - Identified During Desktop/Field Review	<p>Property Description</p> <ul style="list-style-type: none"> - The property features a one-and-a-half storey frame residence and a detached garage. The early twentieth century residence is clad with brown brick and features a front gable roof with vinyl siding within the gable and a shed dormer on the east side, enclosed front porch with brick piers, and concrete foundation. - Located on the south side of Bond Street West, an early transportation route, with a limited setback. - Reflects early twentieth-century residential development on Bond Street West in the City of Oshawa. <p>Potential Cultural Heritage Value or Interest and associated heritage attributes</p> <p>This property has the potential to retain historical, architectural, and contextual value.</p>

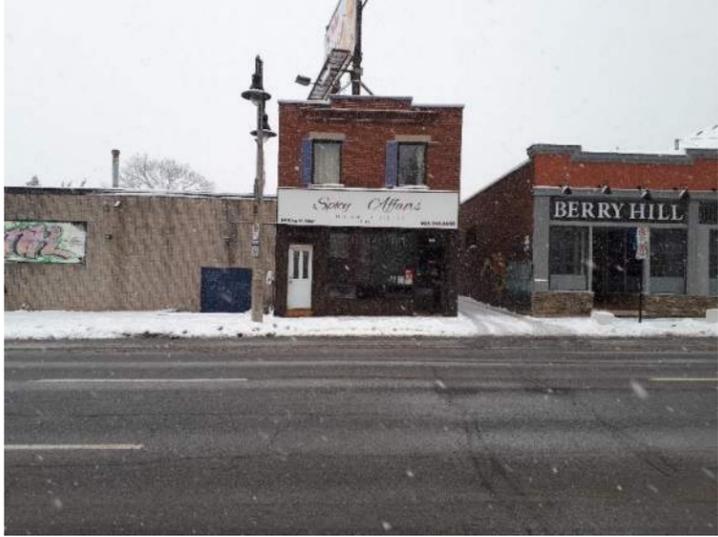
OS-054	BHR	Mixed Use	84 King St W, Oshawa	Potential BHR - Identified During Desktop/Field Review	<p>Property Description</p> <ul style="list-style-type: none"> - The property features a two-storey framed mixed use building with rear addition and rear paved parking. The early twentieth-century building has a rectangular footprint and is clad with red brick and features a flat roof with parapet wall. The street-facing south elevation features decorative brick on the parapet wall, concrete sills and lintels on the second storey windows and aluminum siding on the first storey storefront façade. - Located on the north side of King Street West, an early transportation route, with a limited setback. - Reflects early twentieth-century commercial development on King Street West in the City of Oshawa. <p>Potential Cultural Heritage Value or Interest and associated heritage attributes</p> <p>This property has the potential to retain historical, architectural, and contextual value.</p>

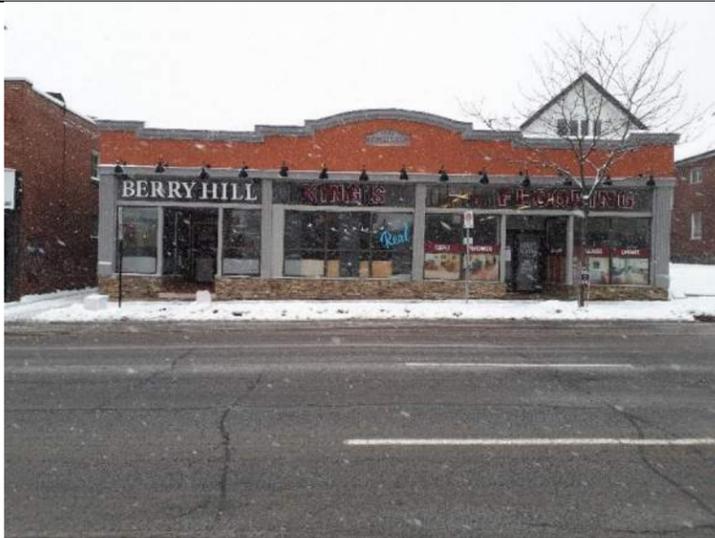
Ref #	Type of Cultural Heritage Resource	Type of Property	Location	Heritage Recognition	Description of Property and Known or Potential CHVI	Photographs/ Digital Image
OS-055	BHR	Commercial	78-82 King St W, Oshawa	Potential BHR - Listed on Municipal Heritage Register	<p>Property Description</p> <ul style="list-style-type: none"> - The M. Collis Building was constructed in 1928 following designs by architect C.C. Stenhouse (Heritage Oshawa 2015). - The property features a single-storey frame L-shaped commercial building with rear addition and paved rear parking. The early twentieth-century building features a flat roof with parapet wall. The south elevation has been altered with contemporary stucco, stone veneer and storefront surrounds, but retains the date stone and leaded glass transom. - Located on the north side of King Street West, an early transportation route. - Reflects early twentieth-century commercial development on King Street West in the City of Oshawa. <p>Potential Cultural Heritage Value or Interest and associated heritage attributes This property has the potential to retain historical, architectural, and contextual value.</p>

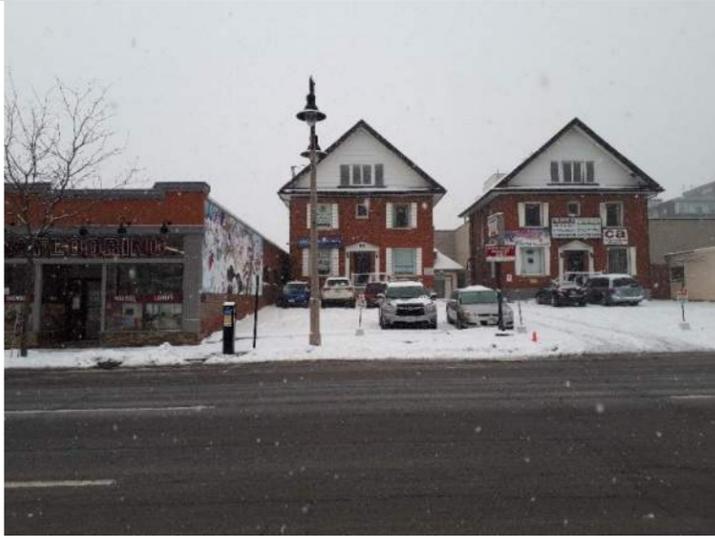
OS-056	BHR	Commercial	74-76 King St W, Oshawa	Potential BHR - Identified During Desktop/Field Review	<p>Property Description</p> <ul style="list-style-type: none"> - The property features two detached frame mixed-use buildings, a detached garage and paved parking in the front and rear of the parcel. The buildings are Edwardian Classical style former residential buildings that were constructed in the early twentieth century that mirror each other. Both have symmetrical facades, are clad with red brick, have front gable roofs with vinyl siding within the gables and feature decorative entry surrounds. - Located on the west side of King Street West, an early transportation route, setback from the road. - Reflects twentieth-century commercial development on King Street West in the City of Oshawa. <p>Potential Cultural Heritage Value or Interest and associated heritage attributes This property has the potential to retain historical, architectural, and contextual value.</p>

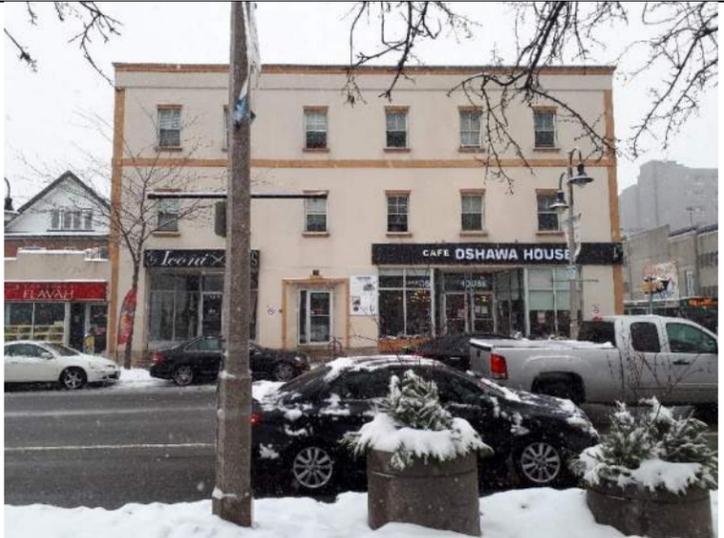
Ref #	Type of Cultural Heritage Resource	Type of Property	Location	Heritage Recognition	Description of Property and Known or Potential CHVI	Photographs/ Digital Image
OS-057	BHR	Mixed Use	62-70 King St W, Oshawa	Potential BHR - Listed on Municipal Heritage Register	<p>Property Description</p> <ul style="list-style-type: none"> - The property features a three-storey frame mixed-use building with paved parking on the remaining parcel in the northwest corner. The L-shaped building constructed in 1838 is surfaced with contemporary stucco and features a flat roof with parapets, large plate-glass storefront windows on the first storey, regularly spaced double-hung windows on the second and third floor, and minimally ornamented cornice. The building is the recipient of a Historic Building plaque from the City of Oshawa (Heritage Oshawa 2015). - Located on the northwest corner of King Street West and Centre Street North, both early transportation routes, with a limited setback. - Reflects nineteenth-century commercial development on King Street West in the City of Oshawa. <p>Potential Cultural Heritage Value or Interest and associated heritage attributes This property has the potential to retain historical, architectural, and contextual value.</p>

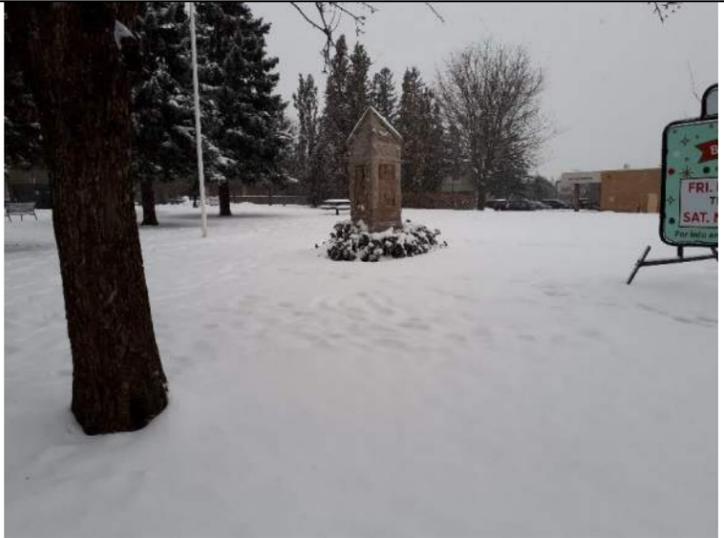
OS-058	CHL	Park	61-67 King St W, Oshawa	Potential CHL - Commemorative Feature	<p>Property Description</p> <ul style="list-style-type: none"> - The park features pedestrian pathways leading from the northeast corner and from the east and south sides of the property to the centre of the park, a paved parking lot in the southeast corner, mature trees, and landscaped gardens. A stone commemorative feature is located on the north portion of the property. - Located on the southwest corner of King Street West and Centre Street South, both early transportation routes. <p>Potential Cultural Heritage Value or Interest and associated heritage attributes This property and commemorative feature do not have potential for CHVI.</p>

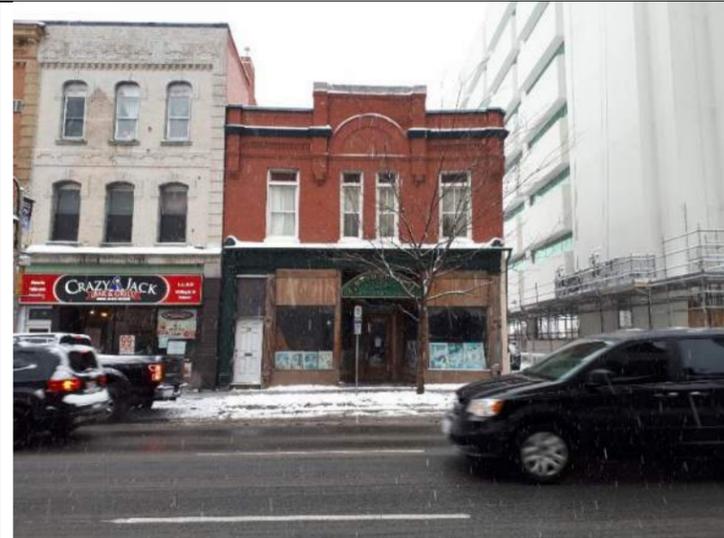
Ref #	Type of Cultural Heritage Resource	Type of Property	Location	Heritage Recognition	Description of Property and Known or Potential CHVI	Photographs/ Digital Image
OS-059	BHR	Mixed Use	21-23 King St W, Oshawa	Potential BHR - Listed on Municipal Heritage Register	<p>Property Description</p> <ul style="list-style-type: none"> - The property features a two-storey frame mixed-use building rear paved parking. The 1860 building has a rectangular footprint, flat roof with ornamental parapet and shared party wall with the property located to the west (Heritage Oshawa 2015). The red brick building has pressed metal remnants of its nineteenth-century storefront, as well as replacement doors and wood siding on the first storey. The second storey features symmetrical window openings and ornamental brickwork. - Located on the south side of King Street West, an early transportation route, with a limited setback. An alleyway runs along the west side of the property. - Reflects late nineteenth-century commercial development on King Street West in the City of Oshawa. <p>Potential Cultural Heritage Value or Interest and associated heritage attributes This property has the potential to retain historical, architectural, and contextual value.</p>

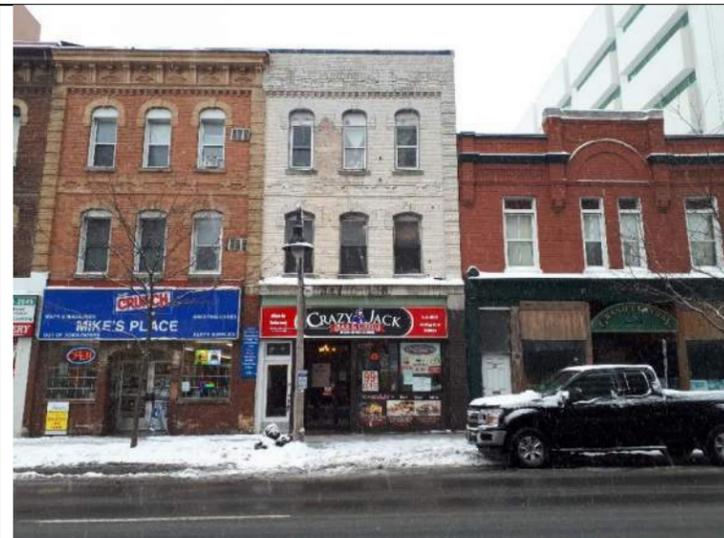
OS-060	BHR	Mixed Use	19 King St W, Oshawa	Potential BHR - Listed on Municipal Heritage Register	<p>Property Description</p> <ul style="list-style-type: none"> - The property features a three-storey frame mixed use building with a one storey rear addition and rear paved parking. The 1860 building has a rectangular footprint, flat roof with parapet and shares a party wall with its neighbouring properties (Heritage Oshawa 2015). The painted brick building has a pressed metal entablature remaining of its nineteenth-century storefront, as well as replacement features on the first storey. The second and third storeys features symmetrical window openings and ornamental brickwork such as quoining and dentils. There is evidence that the building originally featured an ornamental cornice, however, it is no longer extant. - Located on the south side of King Street West, an early transportation route, with a limited setback. - Reflects late nineteenth-century commercial development on King Street West in the City of Oshawa. <p>Potential Cultural Heritage Value or Interest and associated heritage attributes This property has the potential to retain historical, architectural, and contextual value.</p>

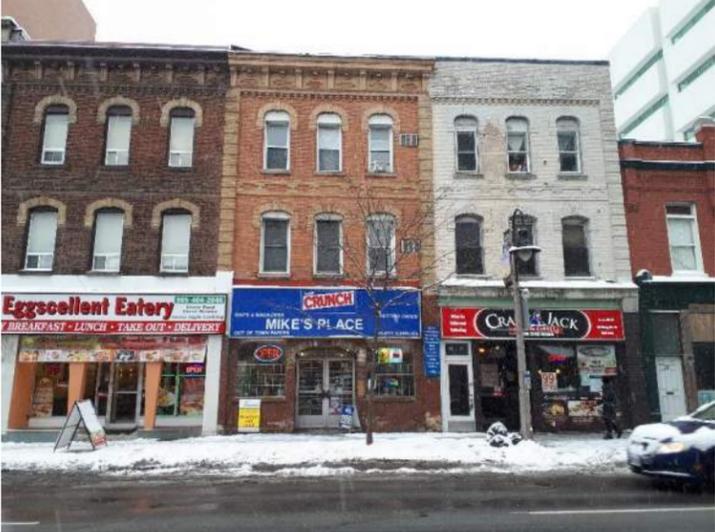
Ref #	Type of Cultural Heritage Resource	Type of Property	Location	Heritage Recognition	Description of Property and Known or Potential CHVI	Photographs/ Digital Image
OS-061	BHR	Mixed Use	17 King St W, Oshawa	Potential BHR - Listed on Municipal Heritage Register	<p>Property Description</p> <ul style="list-style-type: none"> - The property features a three-storey frame mixed use building with a one storey rear addition and rear paved parking. The 1860 building has a rectangular footprint, flat roof with parapet and shares a party wall with its neighbouring properties (Heritage Oshawa 2015). The dichromatic brick building has brick segmental arch entryway and storefront window openings with contemporary window replacements and signage on the first storey. The second and third storeys features symmetrical window openings and ornamental brickwork such as quoining, window hoods and dentils. The street-facing parapet has an ornamental cornice. - Located on the south side of King Street West, an early transportation route, with a limited setback. - Reflects late nineteenth-century commercial development on King Street West in the City of Oshawa. <p>Potential Cultural Heritage Value or Interest and associated heritage attributes</p> <p>This property has the potential to retain historical, architectural, and contextual value.</p>

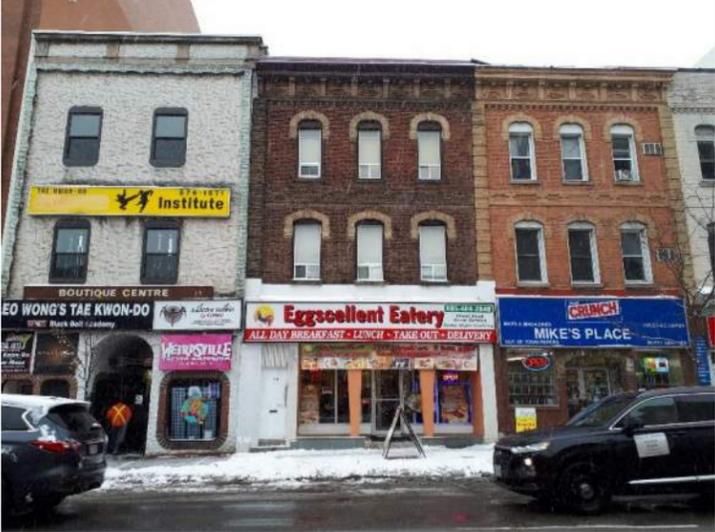
OS-062	BHR	Mixed Use	15 King St W, Oshawa	Potential BHR - Listed on Municipal Heritage Register	<p>Property Description</p> <ul style="list-style-type: none"> - The property features a three-storey frame mixed use building with a one storey rear addition and rear paved parking. The 1860 building has a rectangular footprint, flat roof with parapet and shares a party wall with its neighbouring properties (Heritage Oshawa 2015). The dichromatic brick building has brick segmental arch entryway and storefront window openings with contemporary window replacements and signage on the first storey. The second and third storeys features symmetrical window openings and ornamental brickwork such as quoining, window hoods and dentils. There is evidence that the building originally featured an ornamental cornice, however, it is no longer extant. - Located on the south side of King Street West, an early transportation route, with a limited setback. - Reflects late nineteenth-century commercial development on King Street West in the City of Oshawa. <p>Potential Cultural Heritage Value or Interest and associated heritage attributes</p> <p>This property has the potential to retain historical, architectural, and contextual value.</p>

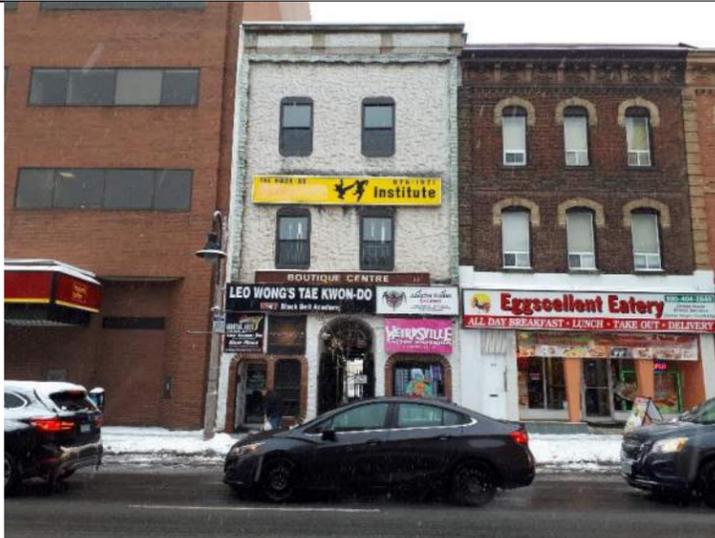
Ref #	Type of Cultural Heritage Resource	Type of Property	Location	Heritage Recognition	Description of Property and Known or Potential CHVI	Photographs/ Digital Image
OS-063	BHR	Mixed Use	13 King St W, Oshawa	Potential BHR - Listed on Municipal Heritage Register	<p>Property Description</p> <ul style="list-style-type: none"> - The property features a three-storey frame mixed-use building with a three storey rear addition and rear paved parking. The 1861 building has a rectangular footprint, flat roof with parapet and shares a party wall with its neighbouring properties (Heritage Oshawa 2015). The street-facing elevation has been surfaced with a textured concrete parge coat and has a rounded-arch interior pedestrian arcade that leads from the south elevation to the north elevation, providing access to the rear of the parcel. The window openings on all levels have rounded corners and have a brick surround on the storefront level. The street-facing parapet has an ornamental cornice. - Located on the south side of King Street West, an early transportation route, with a limited setback. - Reflects late nineteenth-century commercial development on King Street West in the City of Oshawa. <p>Potential Cultural Heritage Value or Interest and associated heritage attributes This property has the potential to retain historical and contextual value.</p>

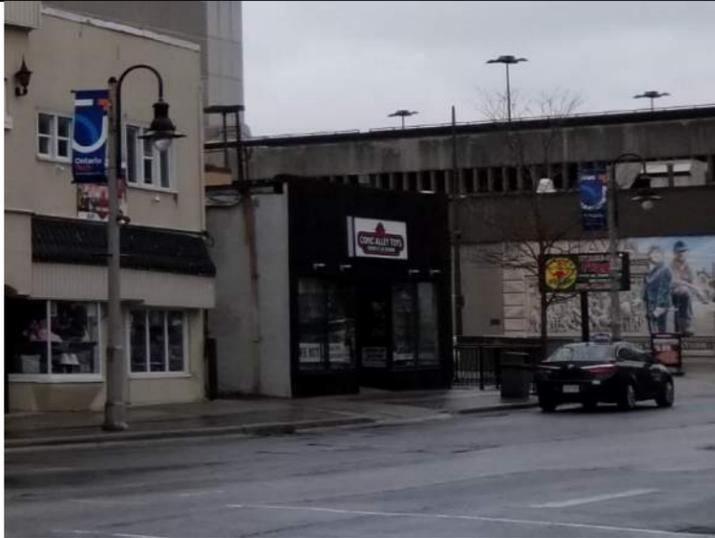
OS-064	BHR	Commercial	9 Bond St W, Oshawa	Potential BHR - Identified During Desktop/Field Review	<p>Property Description</p> <ul style="list-style-type: none"> - The property features a single-storey concrete commercial building. The early twentieth-century building has a flat roof a storefront arrangement on the north elevation surrounded by vertical aluminum cladding. The west elevation shares a party wall with its neighbouring commercial building, and the east elevation shows brick construction with concrete parge and concrete block infill in the window openings. - Located on the south side of Bond Street West, an early transportation route, with a limited setback. - Reflects twentieth-century commercial development on Bond Street West in the City of Oshawa. <p>Potential Cultural Heritage Value or Interest and associated heritage attributes This property has the potential to retain historical and contextual value.</p>

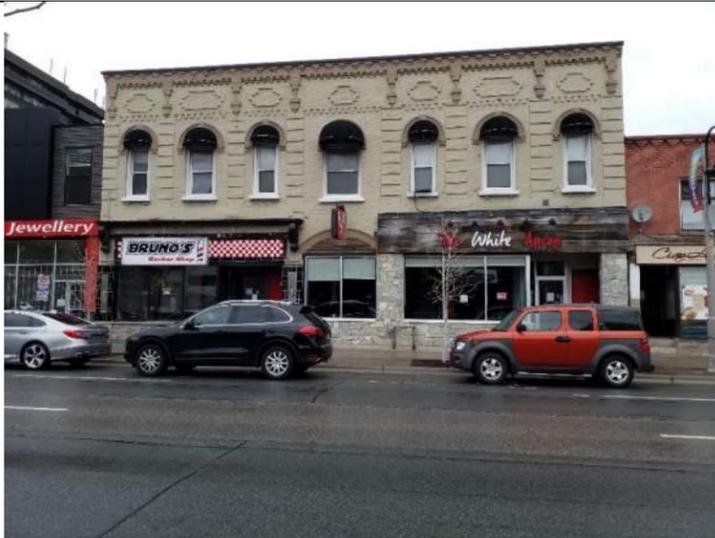
Ref #	Type of Cultural Heritage Resource	Type of Property	Location	Heritage Recognition	Description of Property and Known or Potential CHVI	Photographs/ Digital Image
OS-065	BHR	Mixed Use	10-16 Bond St W, Oshawa	Potential BHR - Listed on Municipal Heritage Register	<p>Property Description</p> <ul style="list-style-type: none"> - The property features a two-storey mixed-use building with a two storey rear addition and rear paved parking. The 1880 building has a rectangular footprint, flat roof with parapet and shares a party wall with its neighbouring properties (Heritage Oshawa 2015). The painted brick building has large storefront window openings with contemporary window replacements, stone veneer and signage on the first storey. The second and storey features symmetrical rounded arch window openings with decorative hoods and ornamental brickwork that creates quoining and a decorative cornice. - Located on the north side of Bond Street West, an early transportation route, with a limited setback. - Reflects late nineteenth-century commercial development on Bond Street West in the City of Oshawa. <p>Potential Cultural Heritage Value or Interest and associated heritage attributes This property has the potential to retain historical, architectural, and contextual value.</p>

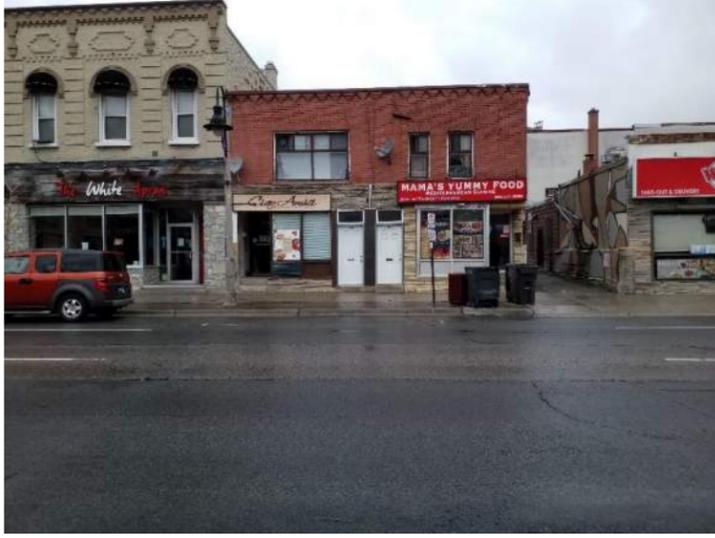
OS-066	BHR	Mixed Use	4-8 Bond St W, Oshawa	Potential BHR - Identified During Desktop/Field Review	<p>Property Description</p> <ul style="list-style-type: none"> - The property features a two-storey frame mixed-use building rear paved parking. The late nineteenth-century building has a rectangular footprint, flat roof with ornamental parapet and shared party wall with the property located to the west. The red brick building has large storefront windows, stone veneer commercial entrances and coupled residential entrances on the first storey. The second storey features symmetrical window openings on the east half, and an altered window opening on the west half, with an ornamental brickwork cornice across the entire south elevation. - Located on the north side of Bond Street West, an early transportation route, with a limited setback. - Reflects late nineteenth-century commercial development on Bond Street West in the City of Oshawa. <p>Potential Cultural Heritage Value or Interest and associated heritage attributes This property has the potential to retain architectural and contextual value.</p>

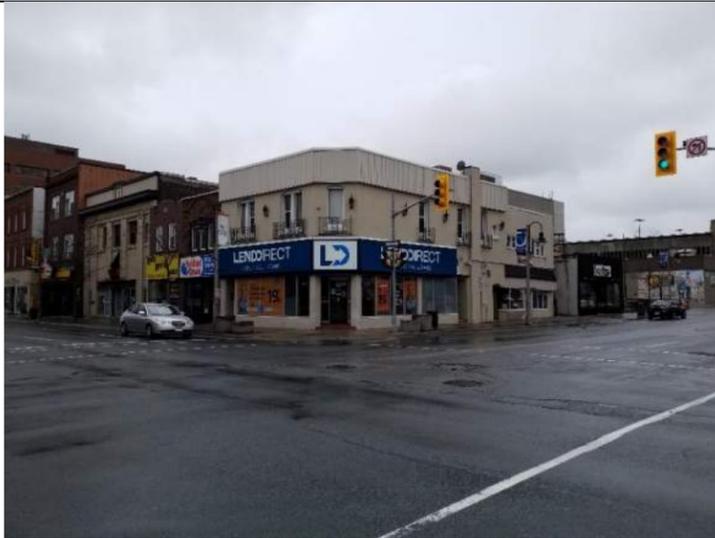
Ref #	Type of Cultural Heritage Resource	Type of Property	Location	Heritage Recognition	Description of Property and Known or Potential CHVI	Photographs/ Digital Image
OS-067	BHR	Commercial	26-28 Simcoe St N, Oshawa	Potential BHR - Listed on Municipal Heritage Register	<p>Property Description</p> <ul style="list-style-type: none"> - The property features a two-storey commercial building that fills the parcel boundary. The 1870 corner property has been significantly altered with the addition of contemporary stucco, aluminum siding, replacement windows and contemporary signage (Heritage Oshawa 2015). The flat roof, entrance locations on the first story and the window openings on the second storey have been maintained. The property features a two-storey frame commercial building that fills the parcel boundary. - Located on the southwest corner of Bond Street West and Simcoe Street North, both early transportation routes, with a limited setback. - Reflects late nineteenth-century commercial development on Bond Street West and Simcoe Street North in the City of Oshawa. <p>Potential Cultural Heritage Value or Interest and associated heritage attributes This property has the potential to retain historical and contextual value.</p>
