**DURHAM-SCARBOROUGH BUS RAPID TRANSIT PROJECT
CULTURAL HERITAGE REPORT – EXISTING CONDITIONS AND PRELIMINARY IMPACT ASSESSMENT
CITY OF TORONTO AND DURHAM REGION, ONTARIO**

ASI File: 18CH-142

October 2019 (Revised June and October 2020;
January, May, November and December 2021; January and February 2022)

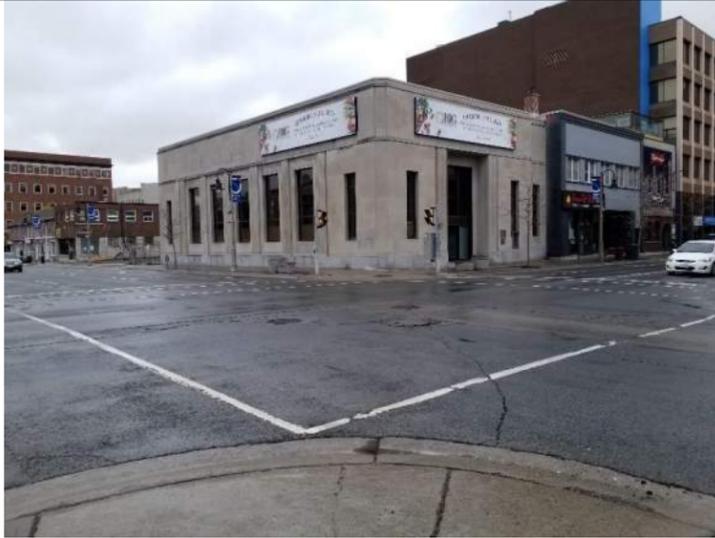
OS-068	BHR	Commercial	27 Simcoe St N, Oshawa	Potential BHR - Identified During Desktop/Field Review	<p>Property Description</p> <ul style="list-style-type: none"> - The property features a one-and-a-half storey commercial building that fills the parcel boundary. The circa 1930 corner property is clad with limestone and features a flat roof with fluted pilasters marking the bays and vertical windows puncturing the bays. The primary entrance is located on the west elevation and is set back from the sidewalk and flanked by giant-order pilasters. - Located on the southeast corner of Bond Street West and Simcoe Street North, both early transportation routes, with a limited setback. - Reflects early twentieth-century commercial development on Bond Street West and Simcoe Street North in the City of Oshawa. <p>Potential Cultural Heritage Value or Interest and associated heritage attributes This property has the potential to retain historical, architectural, and contextual value.</p>

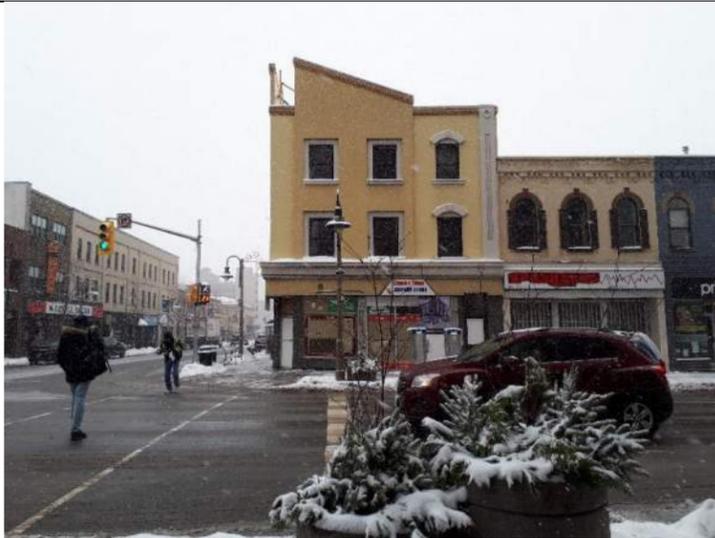
Ref #	Type of Cultural Heritage Resource	Type of Property	Location	Heritage Recognition	Description of Property and Known or Potential CHVI	Photographs/ Digital Image
OS-069	BHR	Mixed Use	1-5 Simcoe St S, Oshawa	Potential BHR - Listed on Municipal Heritage Register	<p>Property Description</p> <ul style="list-style-type: none"> - The property features a three-storey mixed building that fills the parcel boundary. The 1860 corner property has been altered with the addition of contemporary stucco, granite veneer within storefront openings, angled projecting parapet walls at the intersection corner and contemporary signage (Heritage Oshawa 2015). The flat roof, entrance locations and some remaining cast-stone details, such as window hoods and pilasters, have been maintained. - Located on the northeast corner of King Street East and Simcoe Street South, both early transportation routes, with a limited setback. - Reflects late nineteenth-century commercial development on Simcoe Street South in the City of Oshawa. <p>Potential Cultural Heritage Value or Interest and associated heritage attributes</p> <p>This property has the potential to retain contextual value.</p>

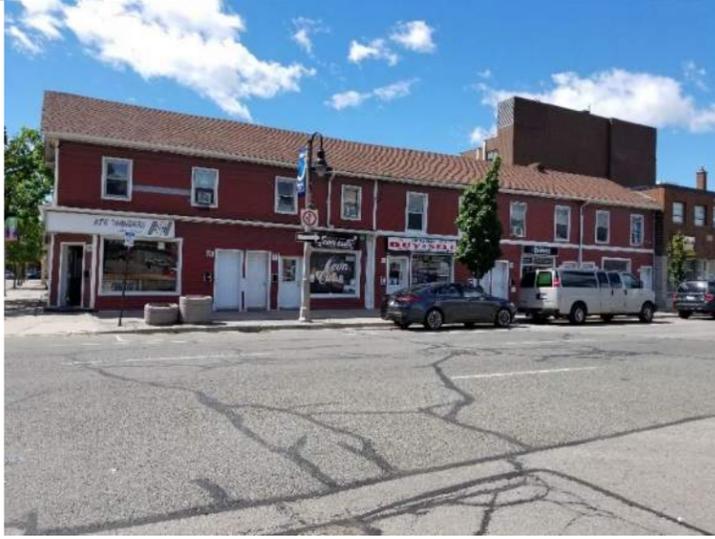
OS-070	BHR	Mixed Use	27 Bond St E, Oshawa	Potential BHR - Listed on a Municipal Heritage Register	<p>Property Description</p> <ul style="list-style-type: none"> - The property features a one-and-a-half storey frame mixed use building with one- and one-and-a-half storey rear addition and rear paved parking. The row of housing above commercial storefronts features a side gable roof, vinyl siding and regularly spaced windows on the second storey. The first storey features large storefront windows, contemporary signage, entryway to the commercial spaces as well as access to the apartments above, and an angled corner entrance on the northeast corner. - Located on the southwest corner of Bond Street East and Ontario Street, both early transportation routes, with a limited setback. - Reflects early twentieth-century commercial development on Bond Street East in the City of Oshawa. <p>Potential Cultural Heritage Value or Interest and associated heritage attributes</p> <p>This property has the potential to retain architectural and contextual value.</p>

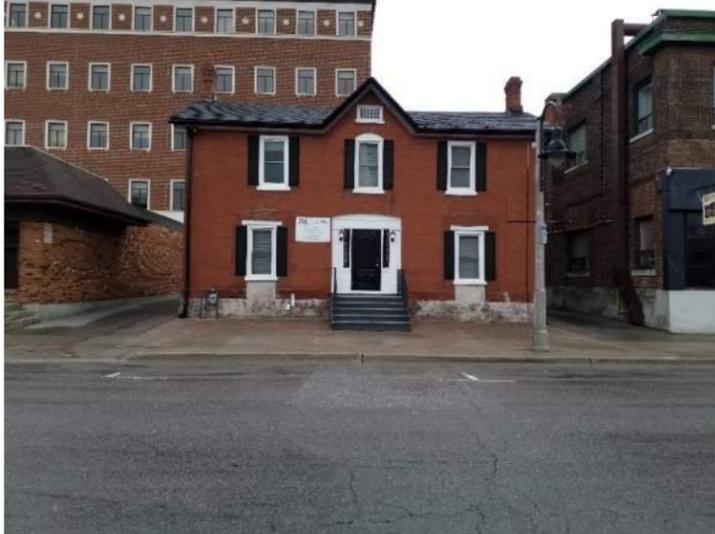
Ref #	Type of Cultural Heritage Resource	Type of Property	Location	Heritage Recognition	Description of Property and Known or Potential CHVI	Photographs/ Digital Image
OS-071	BHR	Commercial	17 Ontario St, Oshawa	Potential BHR - Listed on Municipal Heritage Register	<p>Property Description</p> <ul style="list-style-type: none"> - The property features a two-and-a-half storey frame commercial building with rear paved parking. The former residential building was constructed in 1860 and has a T-shape footprint with red brick cladding, side gable roof with centre gable in the west elevation, brick chimneys on the north and south elevations, and a parged foundation (Heritage Oshawa 2015). The window openings and entry surround on the west elevation have been altered. - Located on the east side of Ontario Street, an early transportation route, with a limited setback. - Reflects nineteenth-century residential development On Ontario Street in the City of Oshawa. <p>Potential Cultural Heritage Value or Interest and associated heritage attributes This property has the potential to retain historical, architectural, and contextual value.</p>

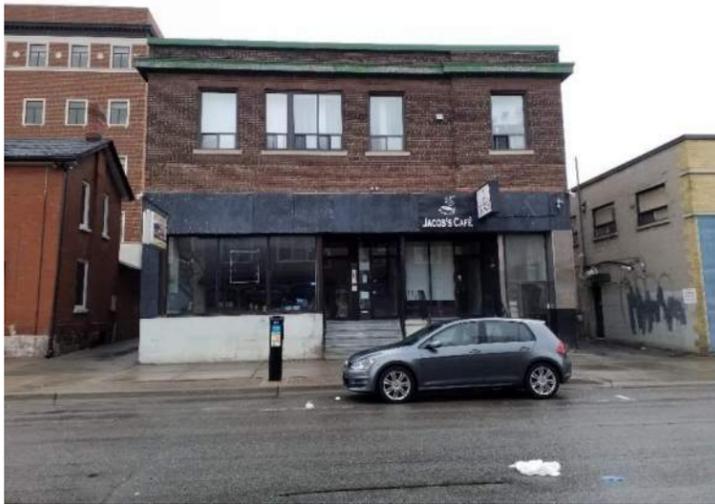
OS-072	BHR	Mixed Use	11 Ontario St, Oshawa	Potential BHR - Identified During Desktop/Field Review	<p>Property Description</p> <ul style="list-style-type: none"> - The property features a two-storey frame mixed use building that fills the parcel boundary. The early twentieth-century building is clad with brown brick and features a flat roof with parapets and a concrete foundation. The first storey storefront has been heavily altered and includes large window openings, raised entryway and contemporary signage. The second storey has an asymmetrical window configuration that responds to a slight projection on the plane of the west elevation. The modest pressed metal cornice also follows the line of this projection. - Located on the east side of Ontario Street, an early transportation route, with a limited setback. - Reflects twentieth-century commercial development on Ontario Street in the City of Oshawa. <p>Potential Cultural Heritage Value or Interest and associated heritage attributes This property has the potential to retain architectural and contextual value.</p>

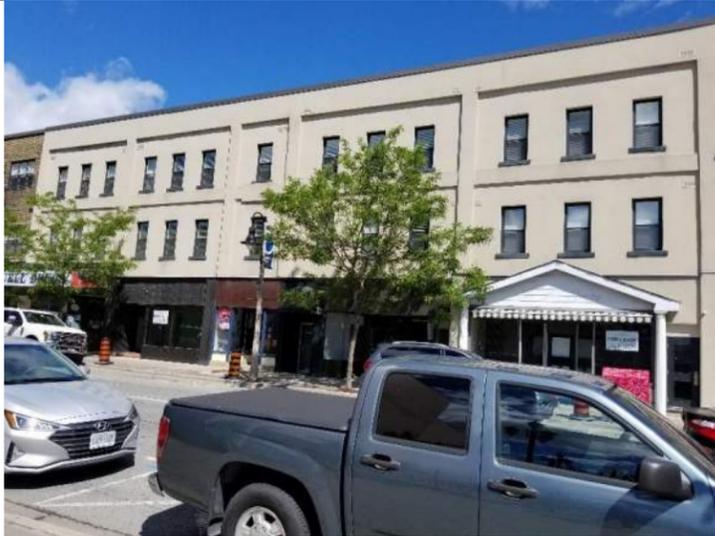
Ref #	Type of Cultural Heritage Resource	Type of Property	Location	Heritage Recognition	Description of Property and Known or Potential CHVI	Photographs/ Digital Image
OS-073	BHR	Commercial	6-18 King St E, Oshawa	Potential BHR - Listed on Municipal Heritage Register	<p>Property Description</p> <ul style="list-style-type: none"> - The property features a three-storey frame commercial building with a rear enclosed stair addition and two single-storey rear additions. The row of commercial units was constructed in 1860 and features a rectangular footprint, flat roof with parapet. 8-18 King Street East is surfaced with contemporary stucco on the upper storeys, and 6 King Street East is clad with buff brick. The first storey features large storefront windows openings and aluminum siding. The building is the recipient of a Historic Building plaque from the City of Oshawa (Heritage Oshawa 2015). - Located on the north side of King Street East, an early transportation route, with a limited setback. - Reflects late nineteenth-century commercial development on King Street East in the City of Oshawa. <p>Potential Cultural Heritage Value or Interest and associated heritage attributes</p> <p>This property has the potential to retain contextual value.</p>

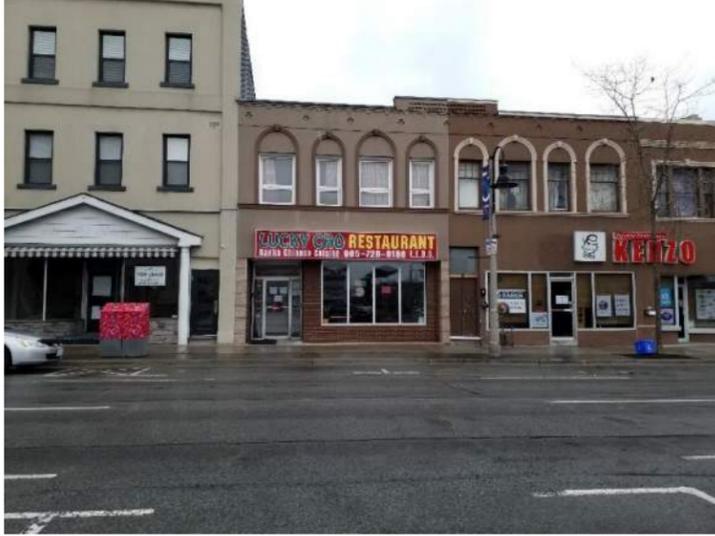
OS-074	BHR	Commercial	20-22 King St E, Oshawa	Potential BHR - Listed on Municipal Heritage Register	<p>Property Description</p> <ul style="list-style-type: none"> - The property features a two-storey frame commercial building with rear two-storey addition. The 1872 building has a side gable roof with a flat roof extension on the south elevation (Heritage Oshawa 2015). The street-facing elevation has been surfaced with contemporary stucco, however, ornamental brick detailing is still evident along the parapet wall. The first storey features altered commercial storefront configurations, and the second storey features symmetrical rounded arch window openings with replacement windows. - Located on the north side of King Street East, an early transportation route, with a limited setback. - Reflects late nineteenth-century commercial development on King Street East in the City of Oshawa. <p>Potential Cultural Heritage Value or Interest and associated heritage attributes</p> <p>This property has the potential to retain historical, architectural, and contextual value.</p>

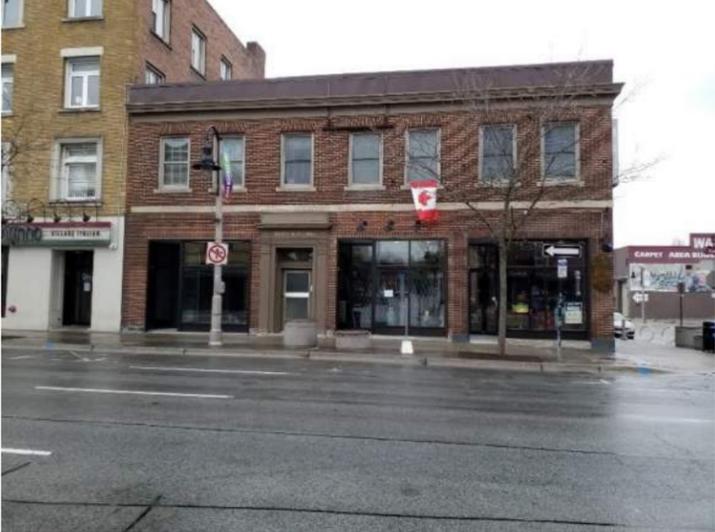
Ref #	Type of Cultural Heritage Resource	Type of Property	Location	Heritage Recognition	Description of Property and Known or Potential CHVI	Photographs/ Digital Image
OS-075	BHR	Mixed Use	27-33 King St E, Oshawa	Potential BHR - Listed on Municipal Heritage Register	<p>Property Description</p> <ul style="list-style-type: none"> - Known as the Disney Block (Heritage Oshawa 2015). - The property features a two-storey frame mixed use building that fills the parcel boundary. The 1920 building is clad with brown brick and features a flat roof with a cross-hipped roof in the east side of the building (not visible from the right-of-way) and a concrete foundation (Heritage Oshawa 2015). The first storey features large storefront window openings and an ornamental pressed metal surround for one of the entryways on the north elevation. The second storey features regularly spaces six-over-six double hung windows and a modest pressed metal cornice with contemporary sheet metal capping the parapet. - Located on the southeast corner of King Street East and Celina Street, with a limited setback. - Reflects twentieth-century commercial development along King Street East in the City of Oshawa. <p>Potential Cultural Heritage Value or Interest and associated heritage attributes This property has the potential to retain architectural and contextual value.</p>

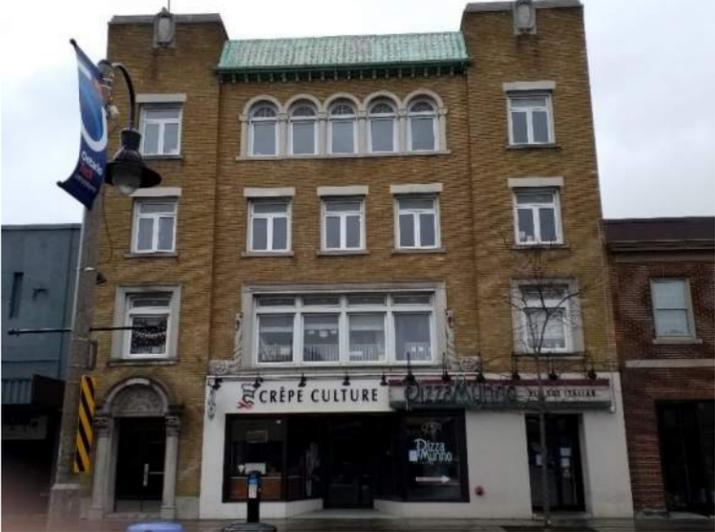
OS-076	BHR	Commercial	35-37 King St E, Oshawa	Potential BHR - Listed on Municipal Heritage Register	<p>Property Description</p> <ul style="list-style-type: none"> - The property features a four-storey commercial building with a two-storey rear addition, with the footprint of the building filling the parcel boundary. The 1928 Spanish Revival style commercial building is clad with buff brick and features a flat roof with tiled awning feature in the centre of the north elevation (Heritage Oshawa 2015). The north elevation is divided into three bays, with symmetrical placement of entrances and window openings. The east entrance on the north elevation features an ornamental stone surround, the remaining first storey has been altered. An arched window arcade is located on the fourth storey beneath the tiled roof awning. Decorative stone elements remain in various locations on the north elevation. The building is the recipient of a Historic Building plaque from the City of Oshawa (Heritage Oshawa 2015). - Located on the south side of King Street East, an early transportation route, with a limited setback. - Reflects twentieth-century commercial practices along King Street East in the City of Oshawa. <p>Potential Cultural Heritage Value or Interest and associated heritage attributes This property has the potential to retain architectural and contextual value.</p>

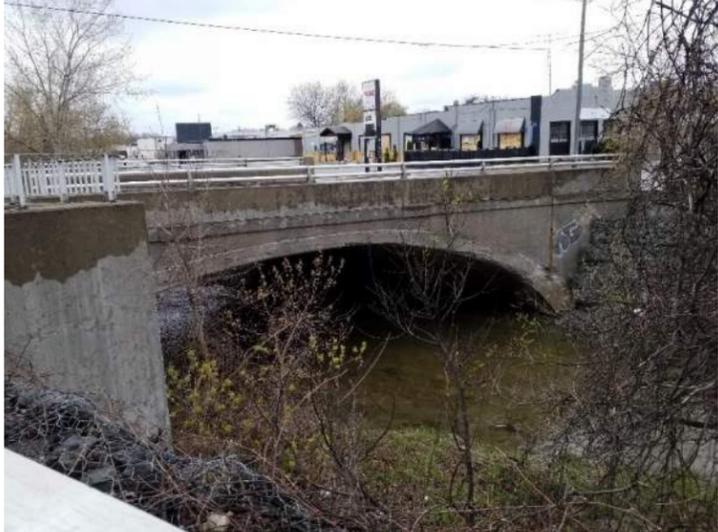
Ref #	Type of Cultural Heritage Resource	Type of Property	Location	Heritage Recognition	Description of Property and Known or Potential CHVI	Photographs/ Digital Image
OS-077	BHR	Bridge	Structure 16, Oshawa Creek	Potential BHR - Identified During Desktop/Field Review	<p>Property Description</p> <ul style="list-style-type: none"> - The property features an arched concrete bridge with modern railings. - Date of construction is unknown. - Located on King Street West, carrying the roadway over Oshawa Creek. - Reflects twentieth-century transportation practices along King Street West in the City of Oshawa. <p>Potential Cultural Heritage Value or Interest and associated heritage attributes</p> <p>This property has the potential to retain historical, design, and contextual value.</p>

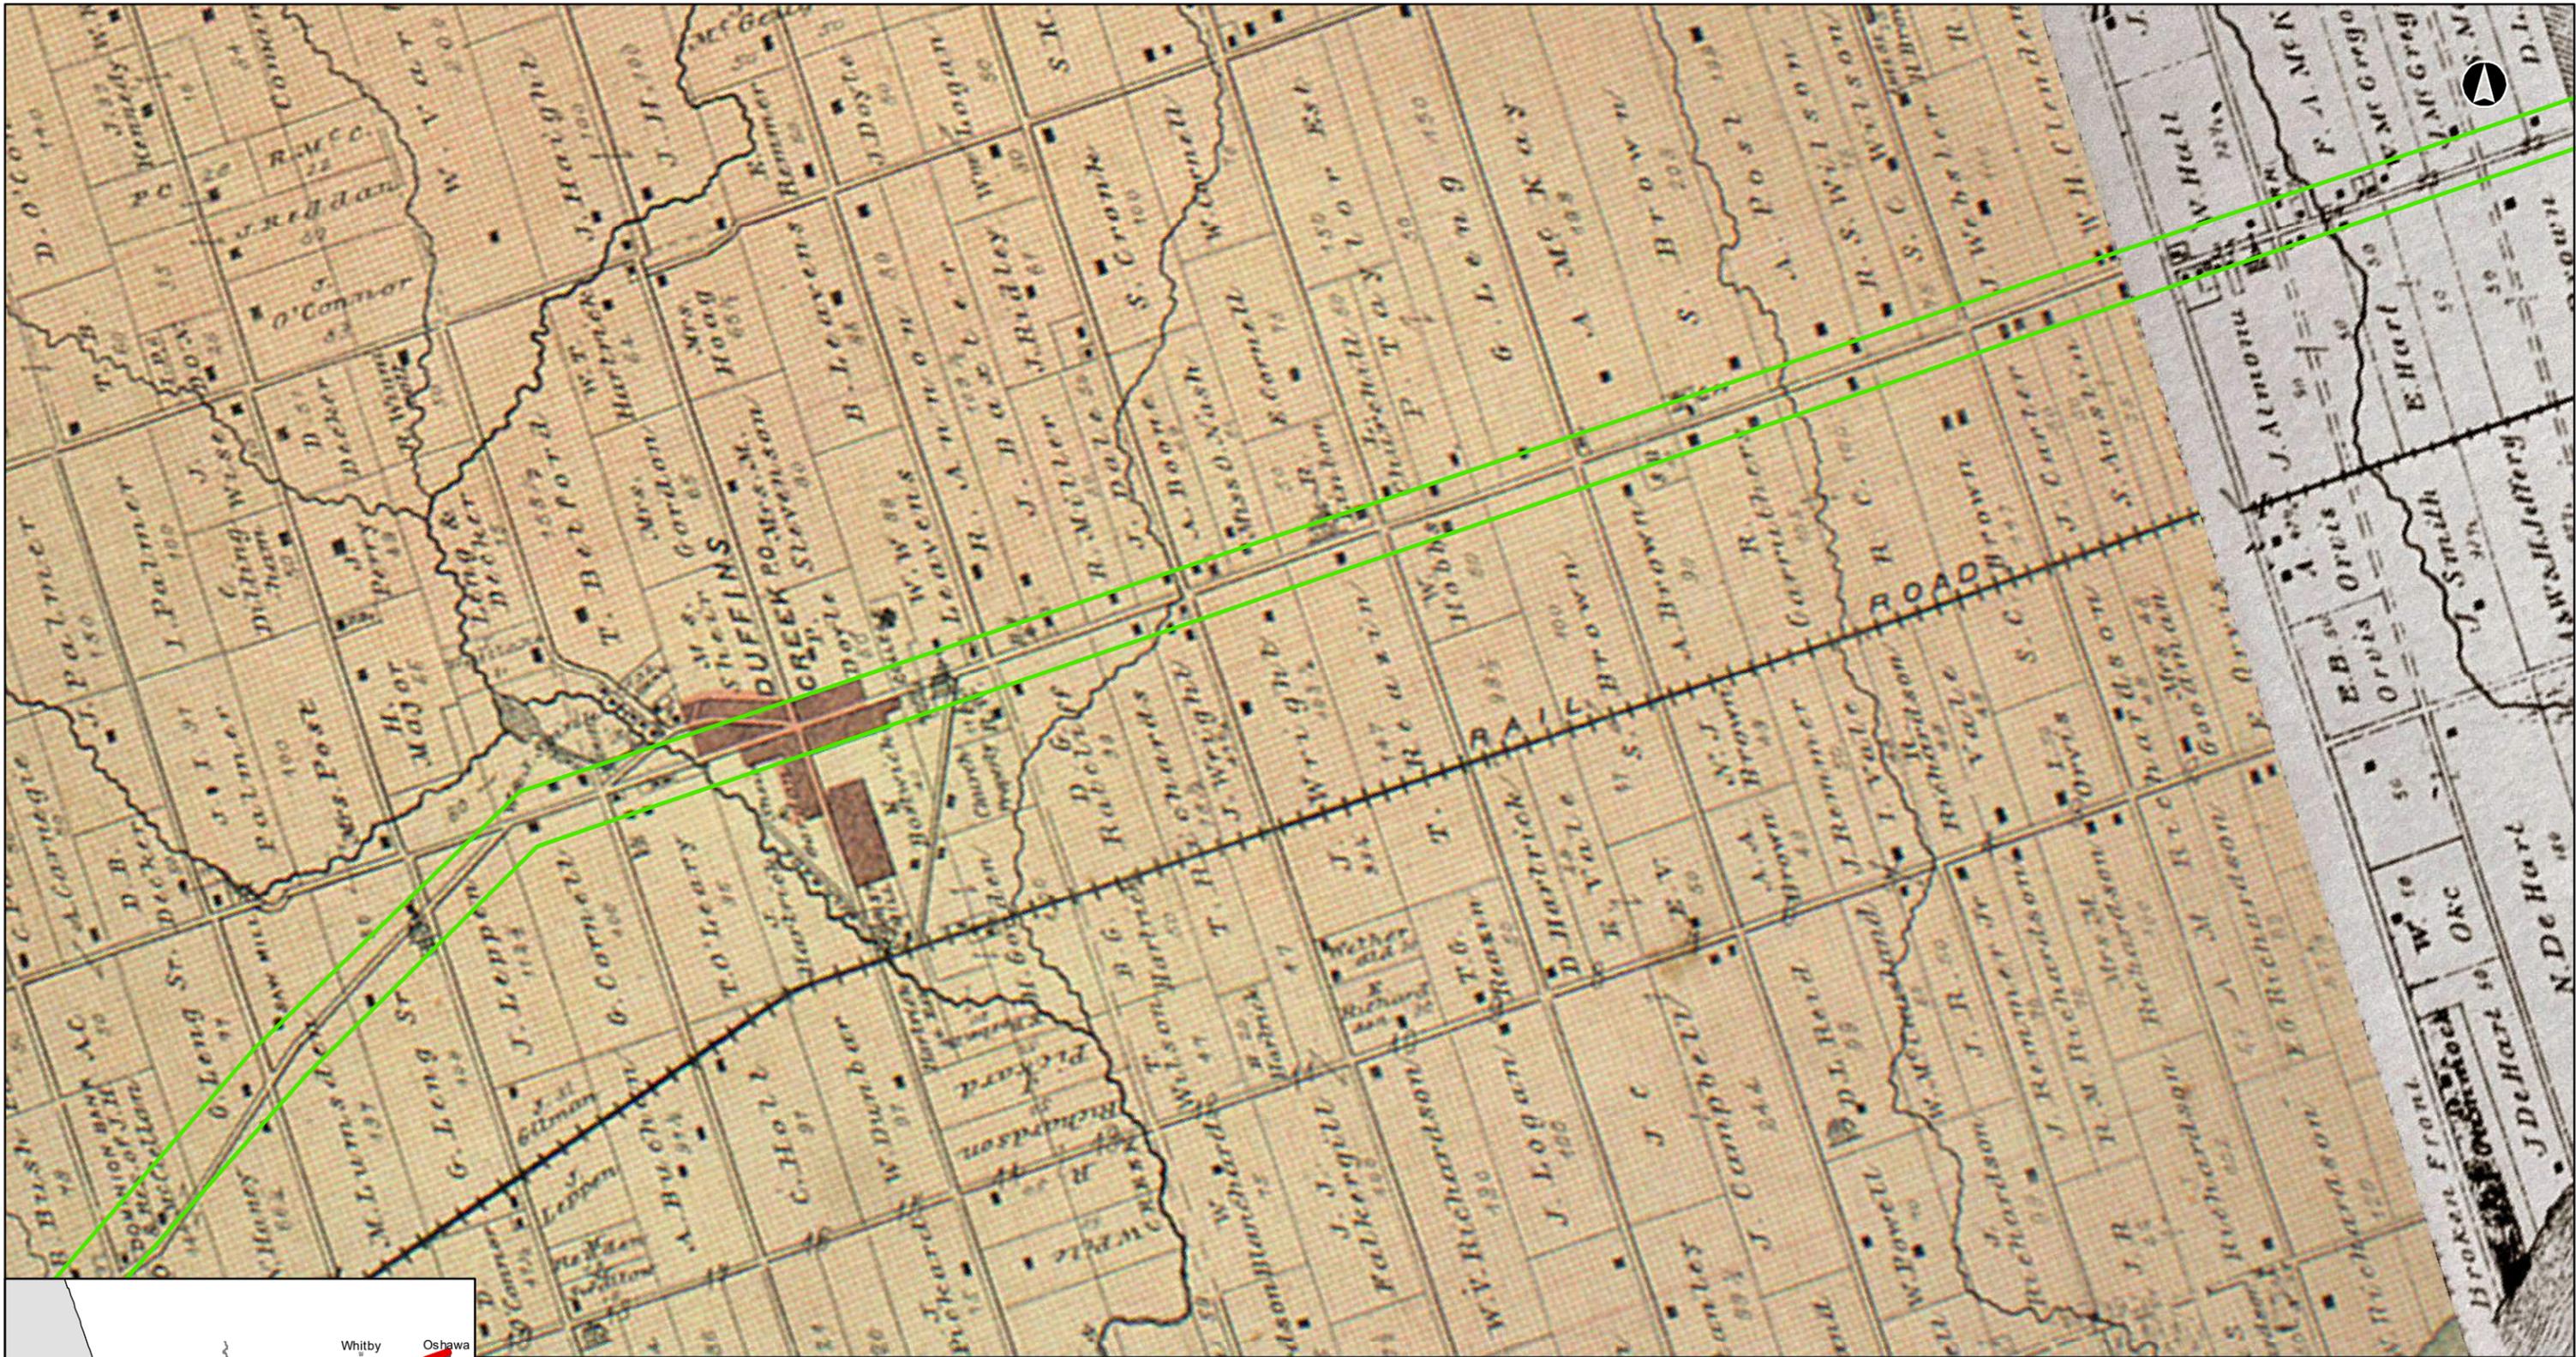
Figure A - 2

DSBRT Corridor - 1877 Illustrated Historical Atlas

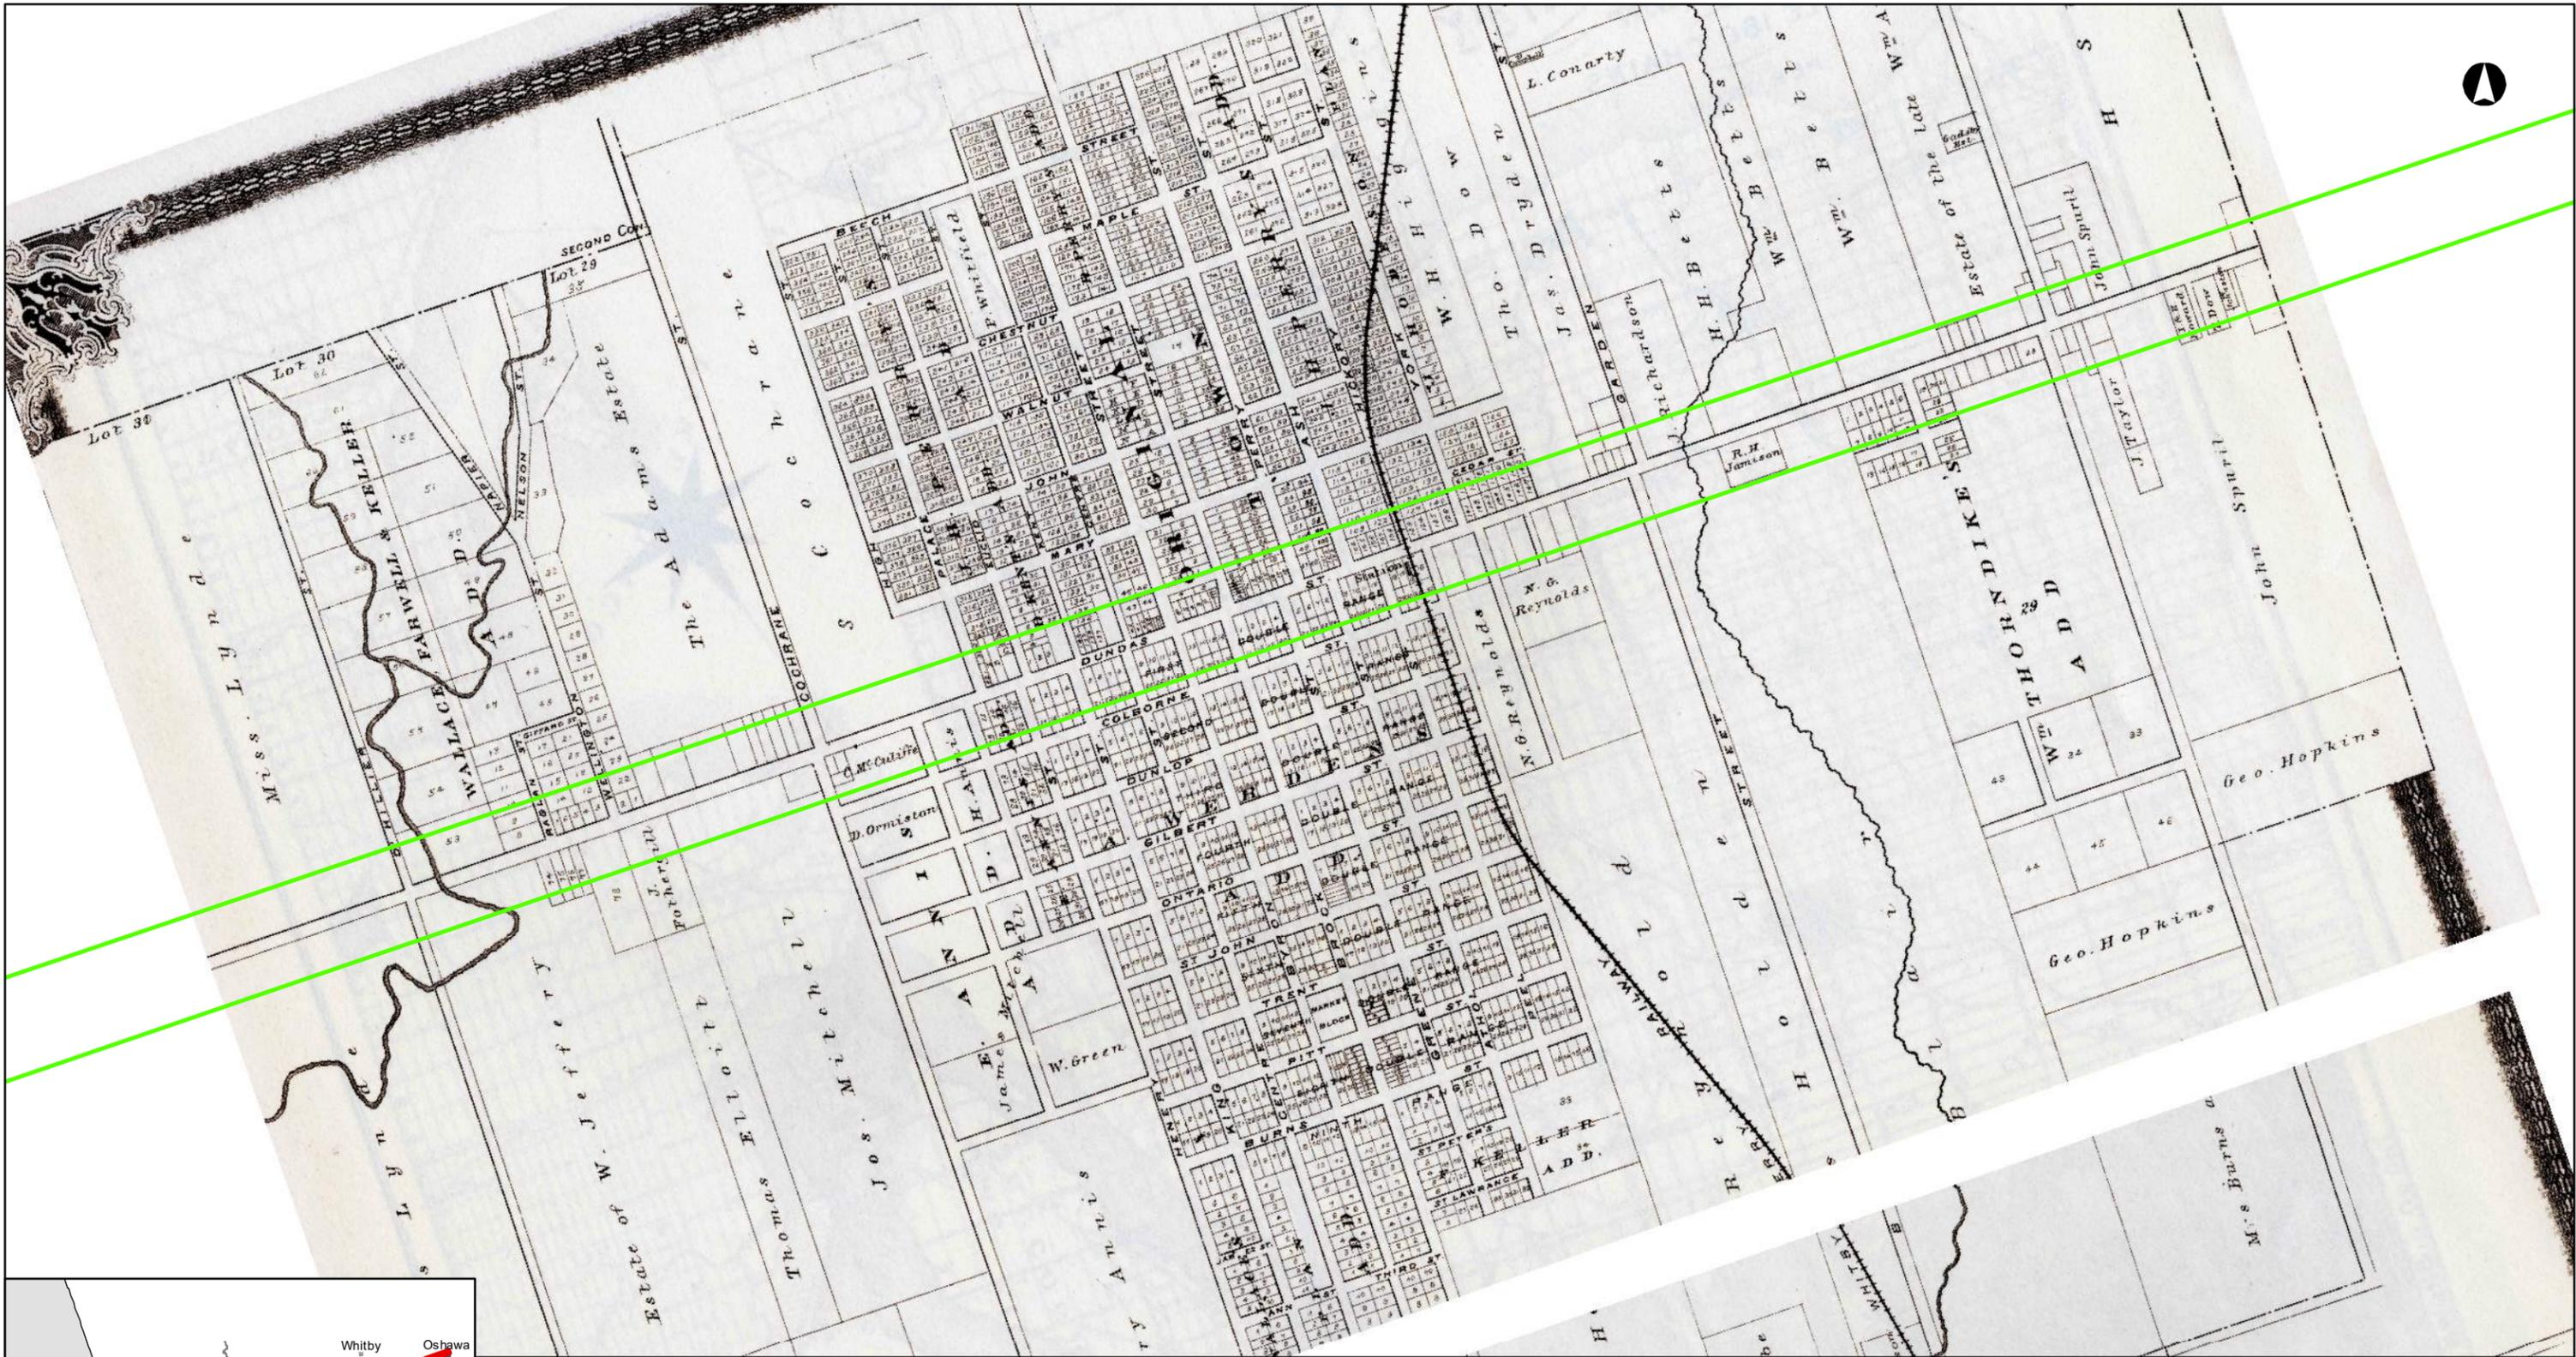
Figure A - 4

DSBRT Corridor - 1877 Illustrated Historical Atlas (Whitby Inset)

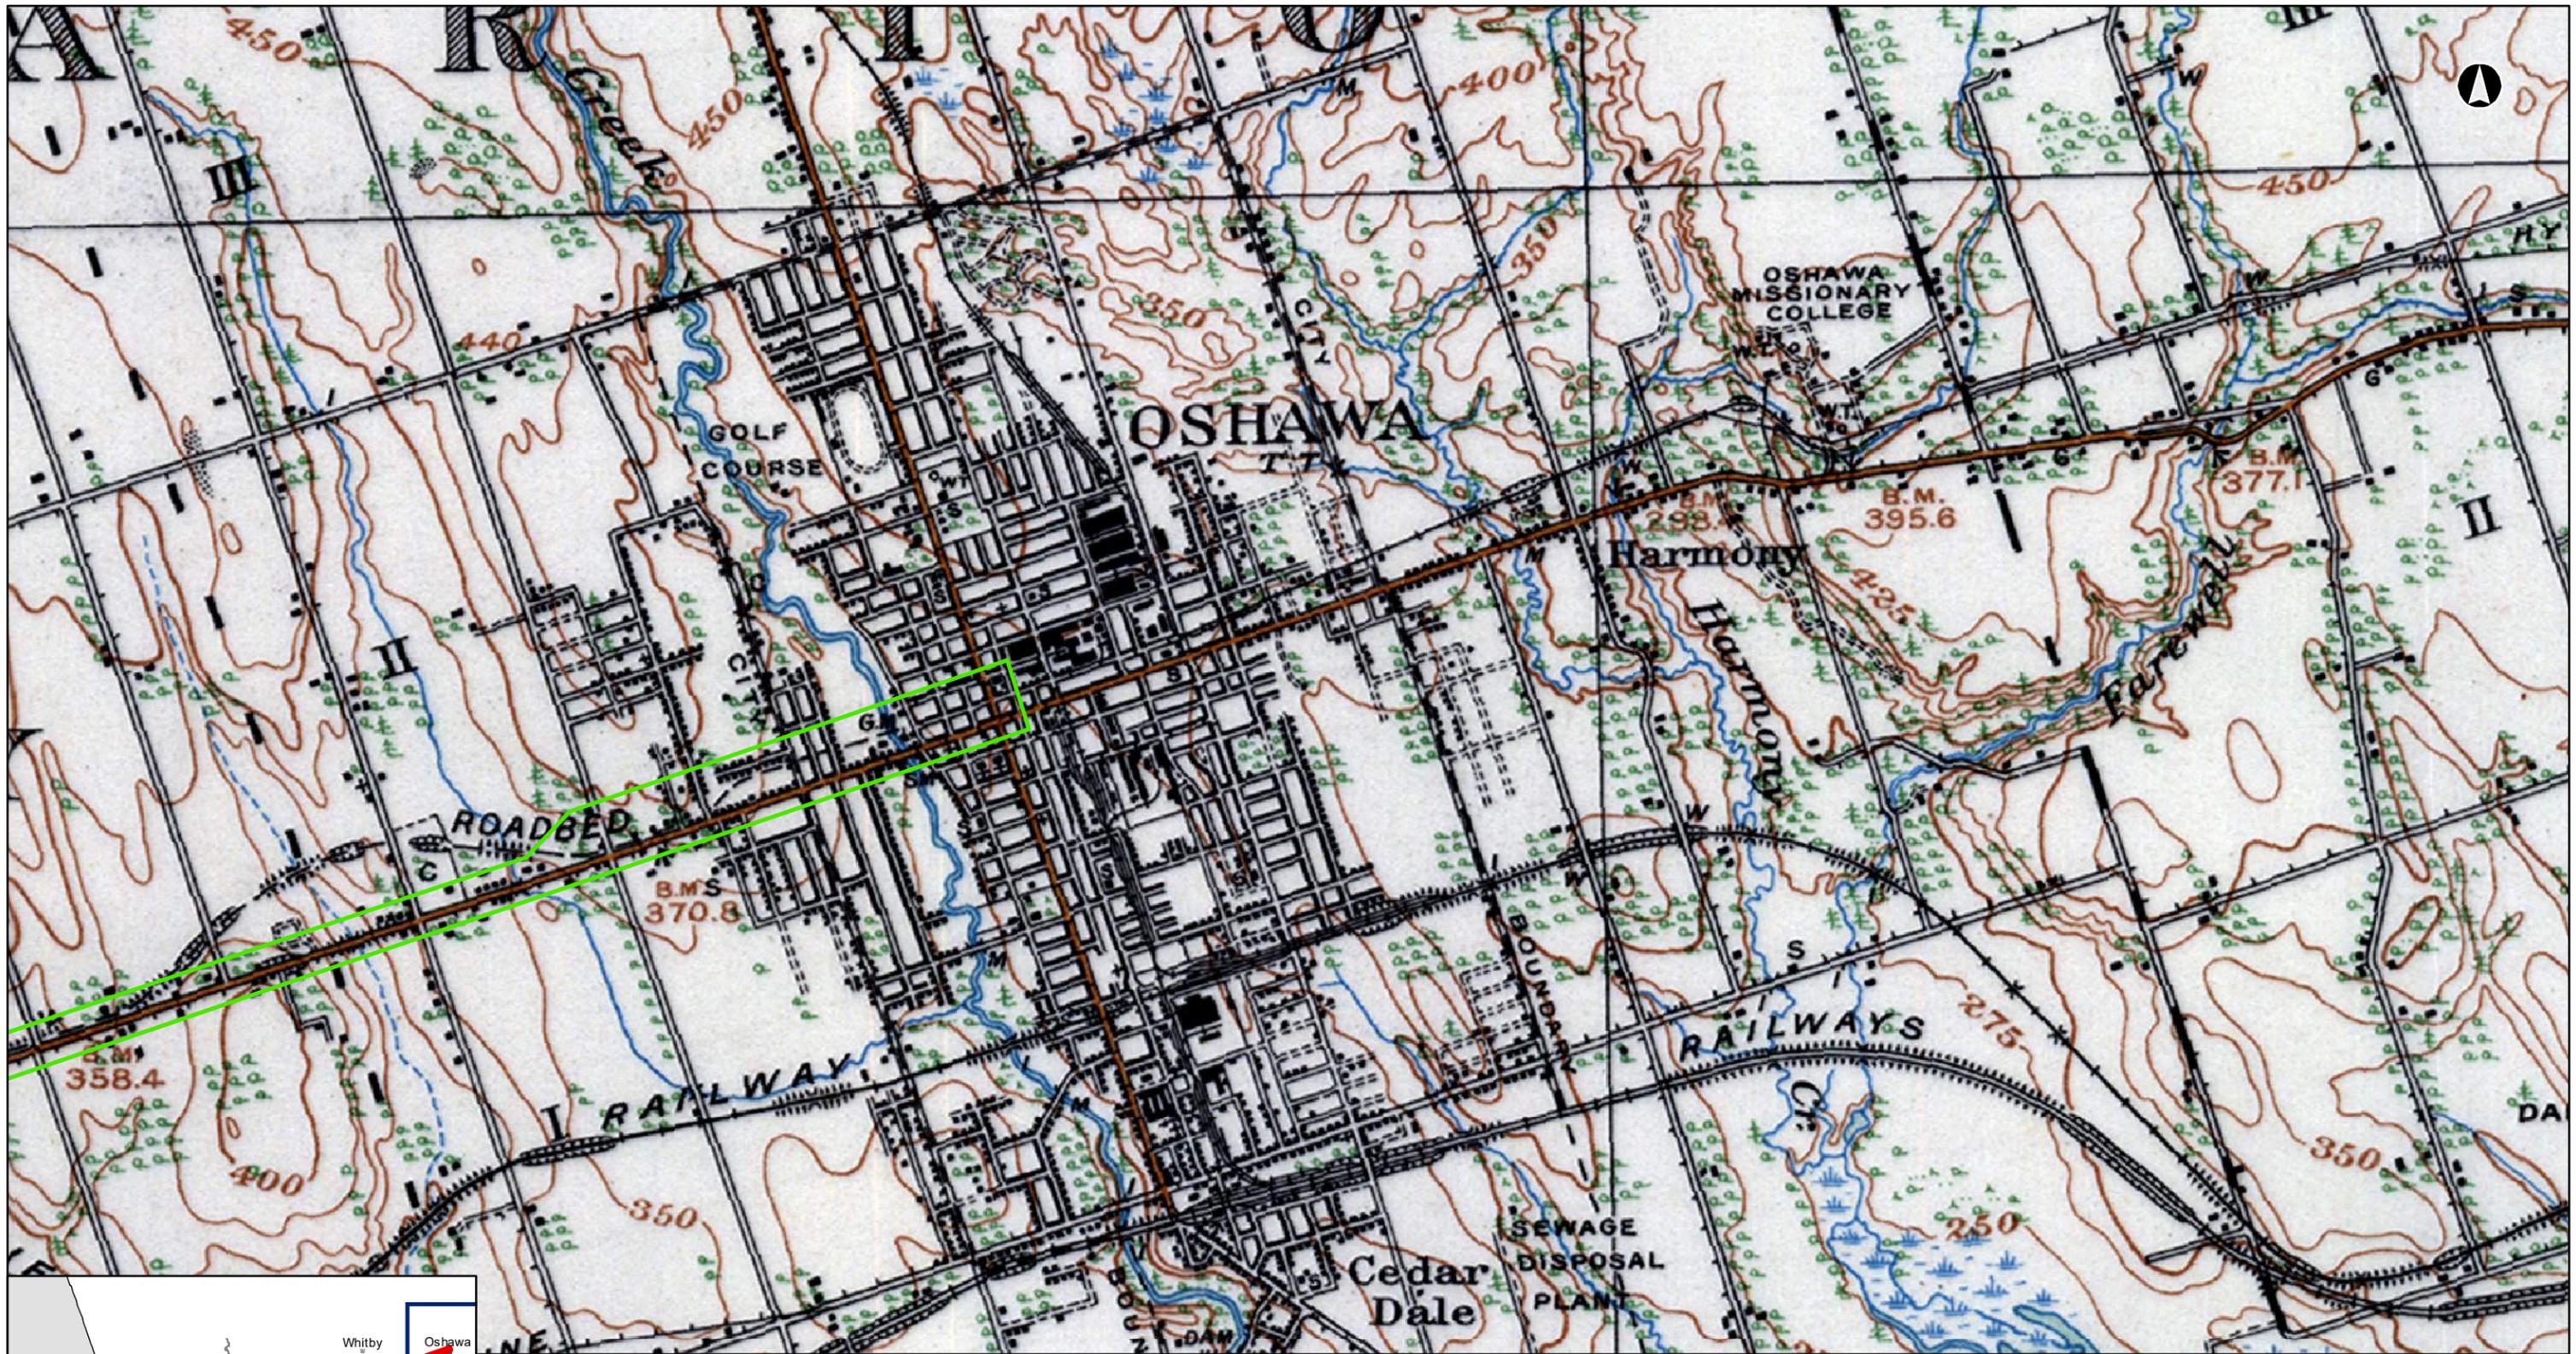
Figure A - 9

DSBRT Corridor - 1930 NTS Maps (Markham & Oshawa Sheets)
