Ontario Line Project

Lakeshore East Joint Corridor Early Works – Heritage Detailed Design Report

Heritage Detailed Design Report

Date: November 2021

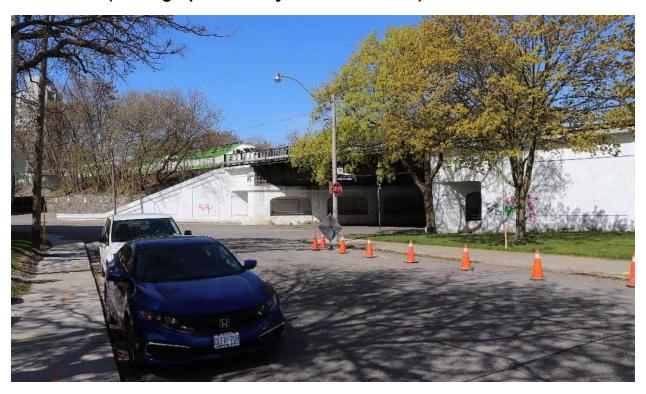
Image 4: Looking west on Gerrard Street East to Carlaw Avenue showing Carlaw Avenue Subway and railway embankment at left (Photograph taken by AECOM in 2021)
