Ontario Line Project

**Exhibition Station Early Works –
Final Heritage Detailed Design Report**

Ontario Line Exhibition Station Early Works

Date: February 2021

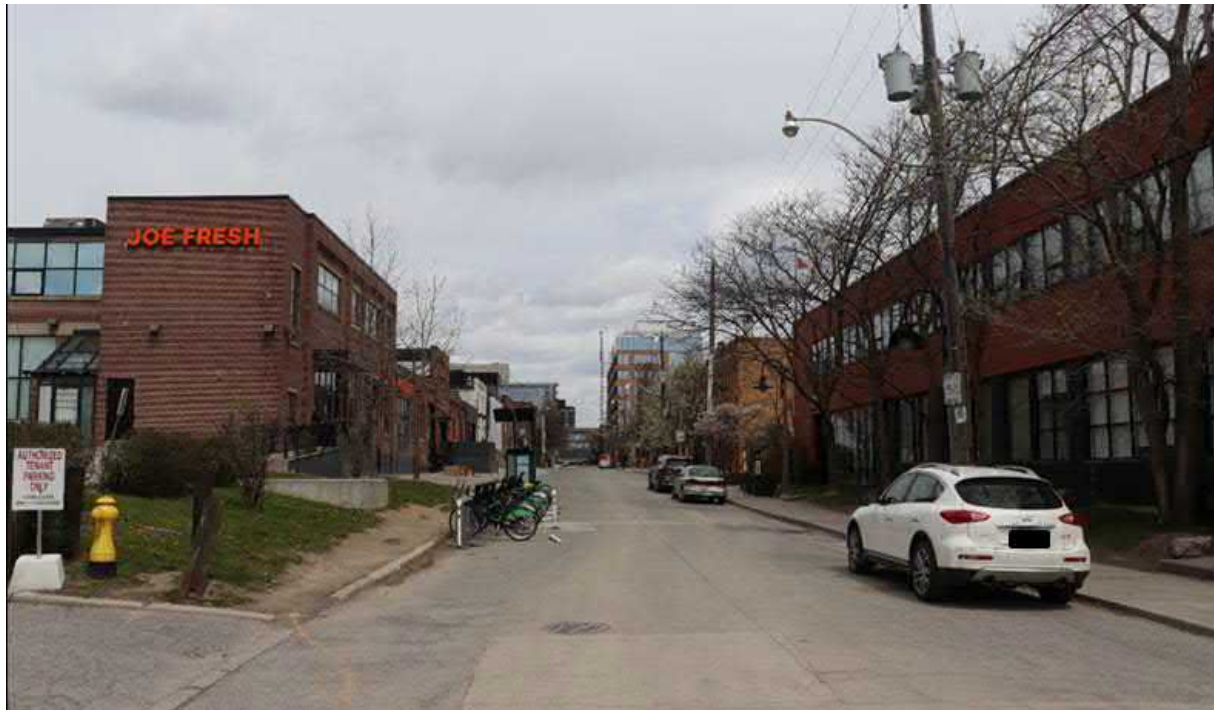
Image 1: Looking North from South End of Atlantic Avenue, 1 Atlantic Avenue on Right (Photograph taken by AECOM in 2020)

The Exhibition Station Study Area consists of a portion of the Lakeshore West Rail Corridor, a portion of Liberty Village on the north side of the rail corridor, Exhibition Place in the south, and Fort York in the east. Liberty Village is considered a transitional area of repurposed 19th century and early-20th century industrial buildings, with considerable recent high-density infill development (**Image 1**). The Exhibition Station Early Works Project Footprint is adjacent to the northern edge of Exhibition Place and is just west of Fort York, both significant cultural heritage landscapes in Downtown Toronto.

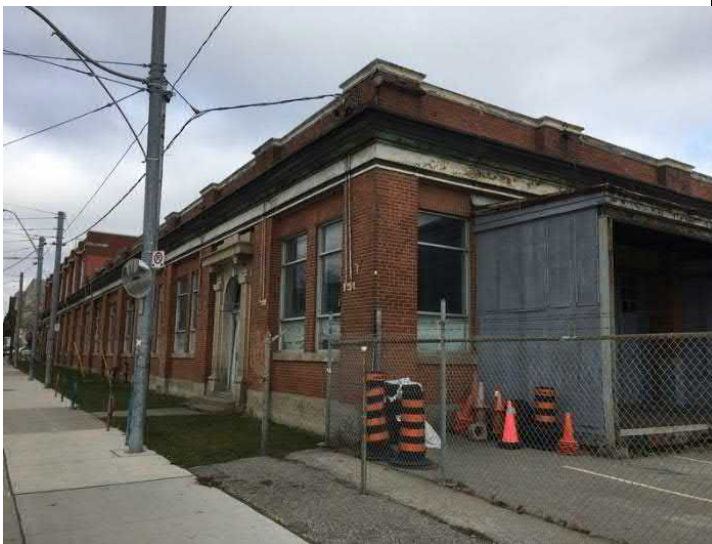
<p>Photograph taken by AECOM in 2020.</p>

Cultural Heritage Report Reference # ⁸	Type of Property	Location /Address	Heritage Recognition	Description of Known or Potential Cultural Heritage Value or Interest and Heritage Attributes	Photographs/Digital Image
OLW-007	Commercial	153 Dufferin Street	Potential built heritage resource/cultural heritage landscape – identified during Ontario Line Cultural Heritage Report field review (AECOM, 2020a)	<p>153 Dufferin Street</p> <p>Design or Physical Value:</p> <ul style="list-style-type: none">Two-storey commercial/industrial building with single-storey south wing. Classical-inspired design including arched entranceways with crossheads and Roman Doric pilasters and cornice moulding above first storey. <p>Historical or Associative Value:</p> <ul style="list-style-type: none">Rear part of building constructed between 1903 and 1913.Formerly the Universal Tool and Steel Company. <p>Contextual Value:</p> <ul style="list-style-type: none">One of several repurposed commercial and industrial buildings in the Liberty Village area. <p>Potential to Meet Ontario Regulation 10/06: No</p> <p>Potential Heritage Attributes:</p> <ul style="list-style-type: none">Flat roof with parapet, arched entranceways with stone surrounds with crossheads and flattened Roman Doric pilasters, cornice moulding above first storey, paired windows with brick voussoirs and concrete sills.

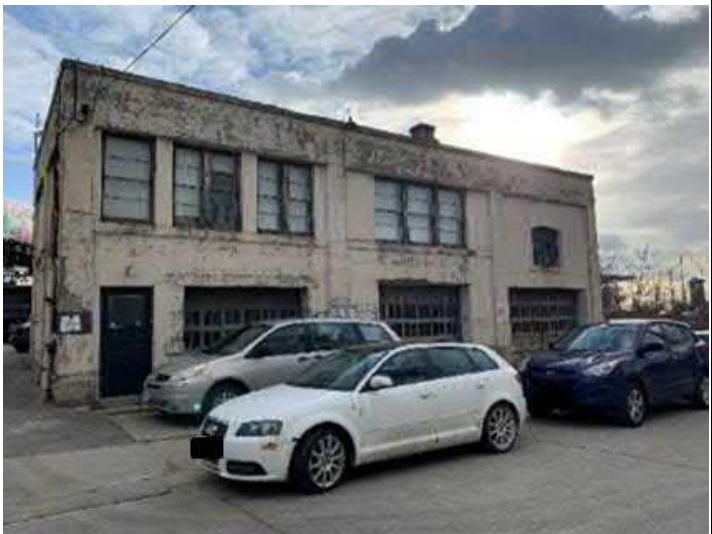
OLW-008	Industrial	7-19 Fraser Avenue	Listed on Municipal Heritage Register (July 19, 2005)	<p>Expanded Metal and Fireproofing Company Factory- 7-19 Fraser Avenue</p> <p>Design or Physical Value:</p> <ul style="list-style-type: none">An example of two-storey industrial building that marked an early use of reinforced concrete construction in Toronto.Includes a flat roof with parapets and a penthouse extension on the west end Buttresses extend above the cornice dividing the floors. The first storey contains a mixture of entrances with oversized industrial windows, while the upper floor displays flat-headed window openings. <p>Historical or Associative Value:</p> <ul style="list-style-type: none">The single-storey factory building built in 1908 and 1909, designed by architect Frederick H. Herbert. Two-storey workers' residence and garage built to the south.Main factory/adjoining powerhouse were completed in 1908 for the Sunbeam Incandescent Lamp Company of Canada according to the designs of Toronto architect F. H. Herbert.A second storey designed by architect F.S. Mallory (who took over Herbert's practice), was added in 1930Became home of Warren K. Cook Ltd., one of Canada's successful garment companies.In 2014, property purchased by companies under aegis of York Heritage Properties and Adgar Investments and Development Ltd. <p>Contextual Value:</p> <ul style="list-style-type: none">Located on the east side of Fraser Avenue near the south end of the street, the Expanded Metal and Fireproofing Company Factory contributes contextually to the Liberty Street neighbourhood in Garrison Common North.South Liberty Trail is to the south of the property which contains a cultural interpretative sign for 7-15 Fraser Avenue (see ES-001). <p>Potential to Meet Ontario Regulation 10/06: No</p> <p>Potential Heritage Attributes:</p> <ul style="list-style-type: none">Early use of reinforced concrete, two-storey building with flat roof with parapets and a penthouse extension on the west end, use of buttresses above the cornice dividing the floors and organizing the long, principal façade, first storey has a mixture of oversized industrial windows, while the upper story has flat-headed windows.

<p>Photograph taken by AECOM in 2020.</p>

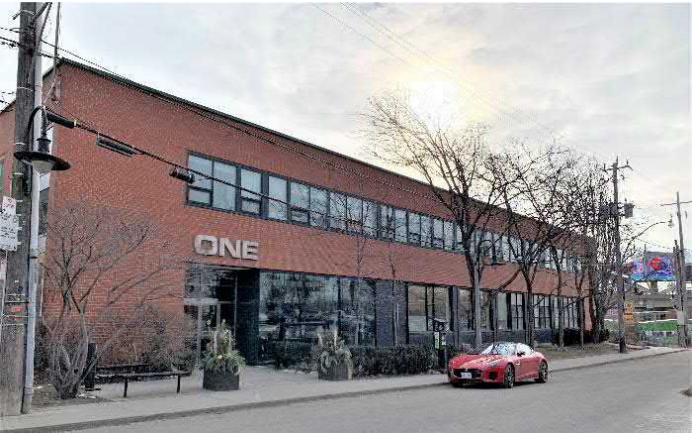
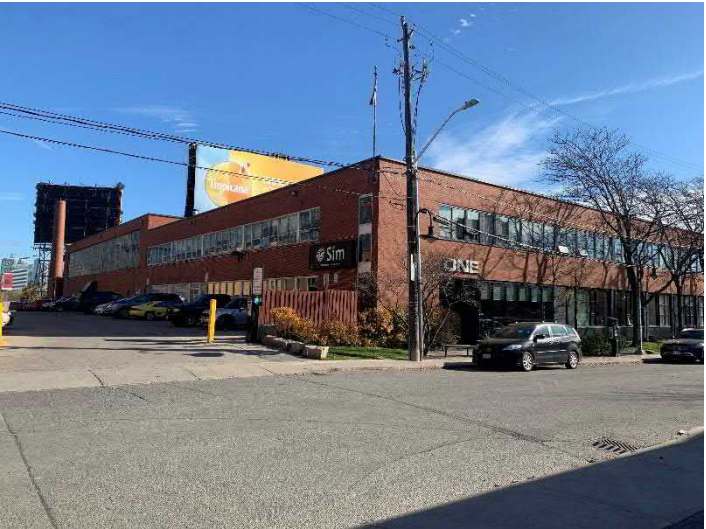
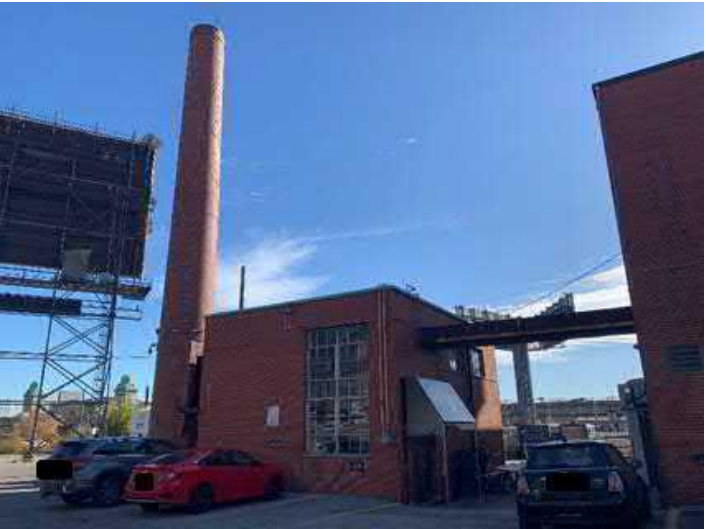
<p>Photograph taken by AECOM in 2020.</p>

Cultural Heritage Report Reference # ⁸	Type of Property	Location /Address	Heritage Recognition	Description of Known or Potential Cultural Heritage Value or Interest and Heritage Attributes	Photographs/Digital Image
OLW-011	Commercial	1 Atlantic Avenue	Potential built heritage resource/cultural heritage landscape – identified during Ontario Line Cultural Heritage Report field review (AECOM, 2020a)	<p>1 Atlantic Avenue</p> <p>Design or Physical Value:</p> <ul style="list-style-type: none">Two-storey commercial building, clad in red brick, with a flat roof, and horizontal massing with continuous bands of windows suggest influences of Mid-Century Modern style.Rear of property, east side of two-storey commercial building, includes a tall brick chimney and small one-storey brick accessory building with a large multi-paned window.Includes urban landscaping, including trees, at the front (west) of the building contributing to the character of Atlantic Avenue, acting as a screen between the building and street. <p>Historical or Associative Value:</p> <ul style="list-style-type: none">Constructed between 1950-1953.Originally Westeel Company Ltd., metal fabricators.Later example of a Liberty Village manufacturing plant. <p>Contextual Value:</p> <ul style="list-style-type: none">Located on the east side of Atlantic Street, south of Liberty Street, directly north of Lakeshore West Rail Corridor.One of several commercial/industrial buildings in Liberty Village area. <p>Potential to meet Ontario Regulation 10/06: No</p> <p>Potential Heritage Attributes:</p> <ul style="list-style-type: none">Low, horizontal massing, two-storey commercial building, clad in red brick, with a flat roof and horizontal bands of windows with aluminum frames, tall brick chimney and brick accessory building at rear of property, urban landscaping including trees.

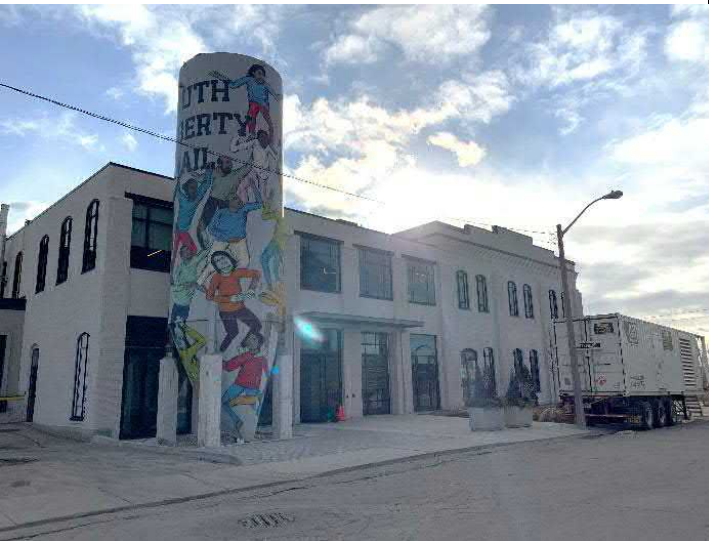
<p>Photograph taken by AECOM in 2020.</p>

Cultural Heritage Report Reference # ⁸	Type of Property	Location /Address	Heritage Recognition	Description of Known or Potential Cultural Heritage Value or Interest and Heritage Attributes	Photographs/Digital Image
OLW-012	Commercial	3 Mowat Avenue/2 Fraser Avenue	Potential built heritage resource/cultural heritage landscape – identified during Ontario Line Cultural Heritage Report field review (AECOM, 2020a)	<p>Former Canada Bread factory- 3 Mowat Avenue/2 Fraser Avenue</p> <p>Design or Physical Value:</p> <ul style="list-style-type: none">▪ Repurposed one/two-storey commercial/industrial brick building that forms an entire block with entrances on Fraser and Mowat Avenues.▪ South section of building has stepped cornice, paired windows, brick pilasters.▪ Northern extension has flat roof, continues brick pilasters of south section.▪ Concrete silo with art mural at the western end of the building.▪ Five other silos and hoppers with art murals related to the property have been relocated as way finders along the South Liberty Trail (see ES-001).▪ South Liberty Trail passes through the interior and connects GO train passengers to Dufferin Street. <p>Historic or Associative Value:</p> <ul style="list-style-type: none">▪ South section completed between 1903-1913.▪ Extended north between 1913-1924.▪ Originally part of the Grand Trunk Railway lands, the site was home to Henry Disston & Sons, an American supplier of hand and industrial saw blades, 1910-1955. Bought by Canada Bread Company in 1960.▪ In 2012, the building was decommissioned and retrofitted by York Heritage Properties. <p>Contextual Value:</p> <ul style="list-style-type: none">▪ Located between Mowat Avenue and Fraser Avenue, directly north of the Lakeshore West railway corridor.▪ Silos are considered local landmarks within Liberty Village.▪ One of several repurposed commercial and industrial buildings in the Liberty Village area. <p>Potential to Meet Ontario Regulation 10/06: No</p> <p>Potential Heritage Attributes:</p> <ul style="list-style-type: none">▪ Stepped cornice, paired windows with voussoir arched lintels, parapet, brick façade, silo with art mural within the property a part of the “Liberty Village Trail”.

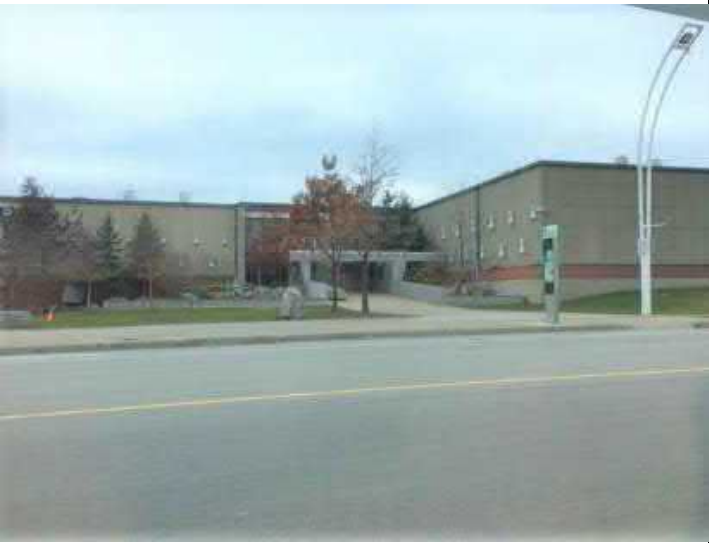
<p>Photograph taken by AECOM in 2020.</p>

Cultural Heritage Report Reference # ⁸	Type of Property	Location /Address	Heritage Recognition	Description of Known or Potential Cultural Heritage Value or Interest and Heritage Attributes	Photographs/Digital Image
OLW-014	Public	10 Nova Scotia Avenue	Listed on Municipal Heritage Register (May 3, 4, 1993)	<p>Exhibition Place, Food Products Building- 10 Nova Scotia Avenue</p> <p>NOTE, OLW-013 and OLW-014 are within OLW-013A (the Exhibition Place complex)</p> <p>Design or Physical Value:</p> <ul style="list-style-type: none"> Modernist style building constructed of red brick and concrete. Building has an irregular plan and a flat roof. <p>Historical or Associative Value:</p> <ul style="list-style-type: none"> Built in 1954. Designed by architect Richard A. Fisher. Built as part of a new phase of building construction to replace buildings destroyed by fire, demolished for the construction of the Gardiner Expressway, or needed expansions. <p>Contextual Value:</p> <ul style="list-style-type: none"> Part of the Exhibition Place cultural heritage landscape which extends from Strachan Avenue to the east, Lake Shore Boulevard. West to the south and west, and the Gardiner Expressway to the north. <p>Meets Ontario Regulation 10/06: Yes (see OLW-013A)</p> <p>Potential Heritage Attributes:</p> <ul style="list-style-type: none"> Use of Modernist building style. West to the south and west, and the Gardiner Expressway to the north. Mid-century lighting design and signage.

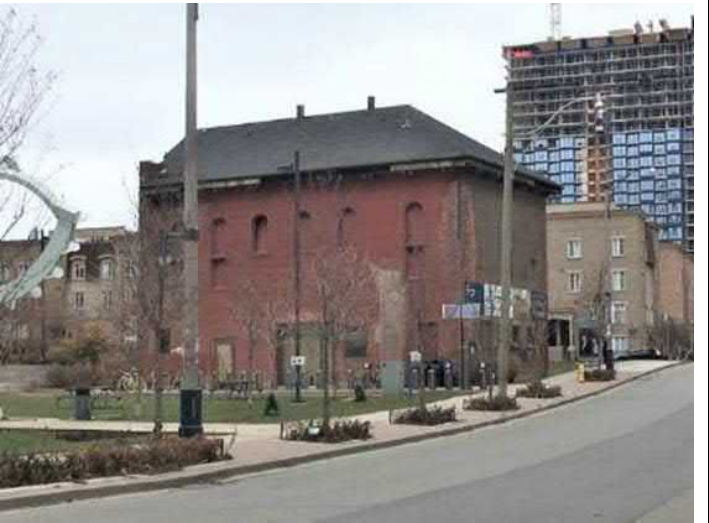
OLW-017	Institutional	70, 75, 0 East Liberty Street (formerly 20 Strachan Avenue)	Designated Part IV of the <i>Ontario Heritage Act</i> (By-Law #378-96) City of Toronto Heritage Easement Agreement: CCA681470	<p>Remnants of Central Prison Chapel- 70, 75, 0 East Liberty Street</p> <p>Design or Physical Value:</p> <ul style="list-style-type: none"> Two-storey brick Central Prison Chapel is designed with Classical features associated with the Renaissance Revival including stone detailing, and rectangular plan with a hipped roof. <p>Historical or Associative Value:</p> <ul style="list-style-type: none"> Built in 1877. Designed or built by Jacob P. Wagner. Design attributed to architect Kivas Tully and is one of only two known extant buildings in Toronto which he designed. The Chapel is significant as the only surviving member of the group of buildings forming the Central Prison complex. <p>Contextual Value:</p> <ul style="list-style-type: none"> The City of Toronto Heritage Register includes addresses associated with the designation by-law on the south and north side of East Liberty Street. Central Prison Chapel is located on the north side of East Liberty Street, west of Pirandello Street. Located in Garrison Common, the former military reserve, the Chapel is significant as the only surviving member of the group of buildings forming the Central Prison complex. The south side of East Liberty Street includes a recent condo development. <p>Potential to Meet Ontario Regulation 10/06: No</p> <p>Heritage Attributes:</p> <ul style="list-style-type: none"> Central Prison Chapel: Rectangular plan, hip roof with brackets, brick surfaces, round-headed window openings, and stone and brick details complemented the Classical features of the centre block and wings of the Central Prison (now demolished).

<p>Photograph taken by AECOM in 2020.</p>

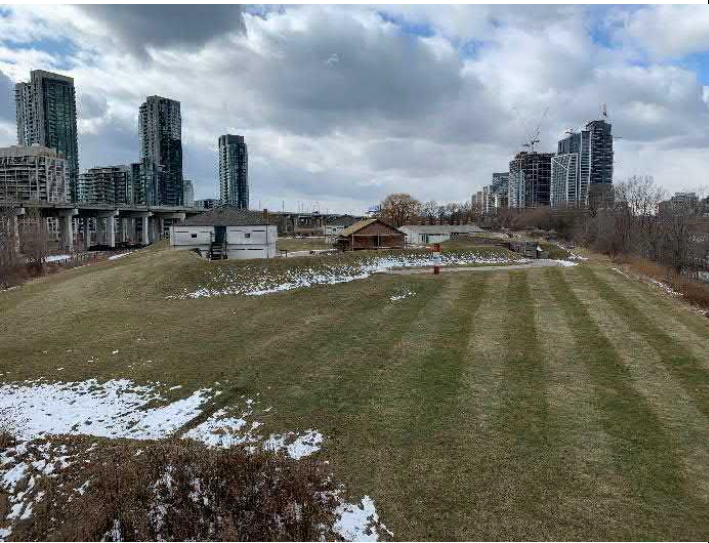
<p>Photograph taken by AECOM in 2020.</p>

Cultural Heritage Report Reference # ⁸	Type of Property	Location /Address	Heritage Recognition	Description of Known or Potential Cultural Heritage Value or Interest and Heritage Attributes	Photographs/Digital Image
OLW-018	Fort York-Cultural Heritage Landscape (HCD) And Fort York National Historic Site	250 Fort York Boulevard	National Historic Site Designated Part V, Heritage Conservation District (By-Laws #420-85 and 541-2004) Listed on Canadian Register	<p>Fort York/Garrison Common Heritage Conservation District and Fort York National Historic Site – 250 Fort York Blvd. (100 Garrison Road)</p> <p>Design or Physical Value:</p> <ul style="list-style-type: none">▪ A late 18th and early 19th century military complex- 16.6 parcel of land.▪ Includes seven buildings erected between 1813 and 1815 which are important surviving examples of British military architecture.▪ The fort an irregular polygon shape enclosing all structures and archaeological resources.▪ Military Burying Ground. <p>Historical or Associative Value:</p> <ul style="list-style-type: none">▪ Architect: Royal Engineers.▪ Its association with the establishment of the Town of York (City of Toronto) – constituted the primary defensive position of early York.▪ Military action during the war of 1812.▪ The sacking of York and the retaliatory raid on Washington.▪ Associations with significant historical organisations and persons including The Queen’s Rangers, Lt. Governor John Graves Simcoe, Major General Isaac Brock, American Brigadier General Zebulon Pike.▪ Role in the 1838 Fenian Raids and Anglo-American tensions of the 1860s.▪ Restoration by City of Toronto in 1930s as a Great Depression “make work” project.▪ Efforts to save the Fort from destruction during construction of the Gardiner Expressway were a catalyst for the historic preservation movement in Toronto and Ontario. <p>Contextual Value:</p> <ul style="list-style-type: none">▪ Location at the western entrance to Toronto Harbour adjacent to Garrison Creek on the former shoreline of Lake Ontario. On the north limit is the rail corridor.▪ Strategic location to protect the harbour and the town of York. <p>Potential to meet Ontario Regulation 10/06: Yes (Criteria 1, 2, 3, 4)</p> <ul style="list-style-type: none">▪ Fort York represents or demonstrates a theme or pattern in Ontario’s history - it represents themes of military defence and territorial expansion in the early- to mid-19th century in the Province of Ontario. The property yields, or has the potential to yield, information that contributes to an understanding of Ontario’s history. There are remains of 1813 battlefield, military cemeteries, and archaeological resources. Fort York is of aesthetic, visual or contextual importance to the province of Ontario – it constituted the primary defensive position of early York (Toronto); and the seven buildings erected between 1813 and 1815 are important surviving examples of British military architecture. The property demonstrates an uncommon, rare or unique aspect of Ontario’s cultural heritage as it serves as a museum of the largest collection of War of 1812 buildings in Canada. The property has a strong association with the Canadian National Exhibition and the Royal, the British and Canadian military. <p>Heritage Attribute Categories: From Section 3: Commemorative Integrity Statement, 2004 https://www.fortyork.ca/images/management-docs/fort-york-commemorative-integ-stmt-2004.pdf</p> <ul style="list-style-type: none">▪ The Designated Place▪ Landscape and Landscape Features▪ Built Heritage▪ Moveable Objects <p>Heritage Attribute Categories (UP Express Electrification EA):</p> <ul style="list-style-type: none">▪ Garrison Creek and Garrison Creek Ravine▪ Darkness/No light▪ Viewpoints

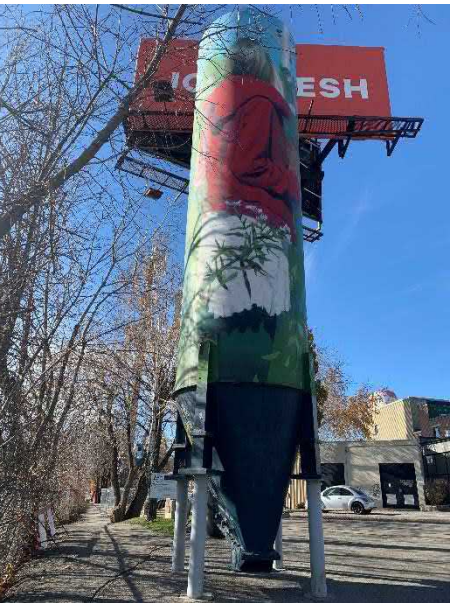
<p>Photograph taken by AECOM in 2020.</p>

Cultural Heritage Report Reference # ⁸	Type of Property	Location /Address	Heritage Recognition	Description of Known or Potential Cultural Heritage Value or Interest and Heritage Attributes	Photographs/Digital Image
				Fort York National Historic Site Heritage Attributes (historicplaces.ca): <ul style="list-style-type: none">▪ The strategic location of the fort near the original shore of Lake Ontario.▪ The cultural landscape comprising the bastioned fort, Garrison Common, and the cemetery, Victoria Memorial Square, with its natural setting including those portions of the ravine bank on the north and east sides which have not been modified and the western earth work, moat and those portions of other earthworks which align with the original trace and that contain significant amounts of original fabric.	
ES-001	Cultural Interpretative Signs and Silos/Hoppers along the South Liberty Trail	South Liberty Trail from Dufferin Street to the Exhibition GO station at the south end of Atlantic Avenue	Potential built heritage resource/cultural heritage landscape-identified during HDDR field review	Design or Physical Value: <ul style="list-style-type: none">▪ Segments of the South Liberty Trail, a pedestrian pathway, from Dufferin Street to the Exhibition GO station at the south end of Atlantic Avenue demarcated by silos and cultural interpretative signs.▪ Four industrial silos and two grain hoppers, industrial artifacts, associated with the Canada Bread Company and the South Liberty Trail Silos Mural Project, have been repurposed and painted by artists to function as way finders along the trail (see OLW-012).▪ Six cultural interpretative signs with photographs along the trail providing history of buildings that reflect the industrial history of the Liberty Village area. Historic or Associative Value: <ul style="list-style-type: none">▪ The cultural interpretative signs provide historical context-specific information along the South Liberty Trail which commemorates the industrial history of the area.▪ Silos and hoppers were salvaged and relocated from the Canada Bread factory (OLW-012). Contextual Value: <ul style="list-style-type: none">▪ South Liberty Trail from Dufferin Street to the Exhibition GO station at the south end of Atlantic Avenue located on the southern most edge of Liberty Village neighbourhood. Potential to Meet Ontario Regulation 10/06: No Potential Heritage Attributes: <ul style="list-style-type: none">▪ Context-specific cultural interpretative signs and silos and hoppers along the route of the South Liberty Trail.▪ Views of the silos along the public trail.

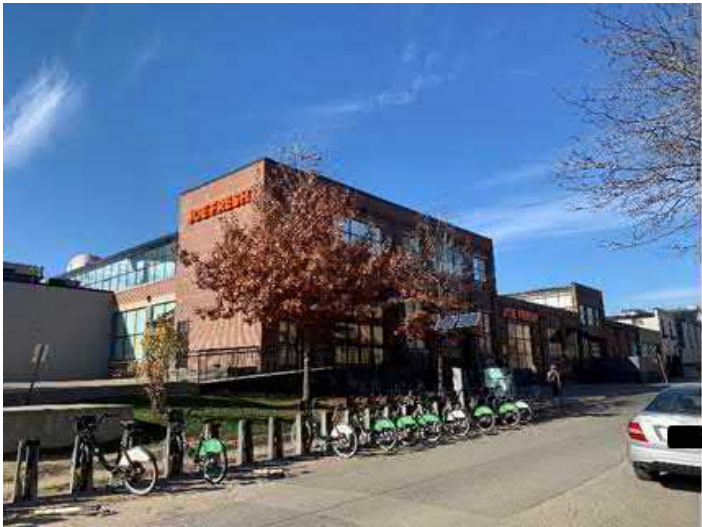
Photograph taken by AECOM in 2020.</div>

Jefferson Avenue Cultural Interpretive Sign</div>
ES-002	Industrial/ Commercial	2-20 Atlantic Avenue	Potential built heritage resource/cultural heritage landscape-identified during HDDR field review	<p>Former Winnipeg Ceiling and Roofing Company- 2-20 Atlantic Avenue</p> <p>Design or Physical Value:</p> <ul style="list-style-type: none">▪ Repurposed one/two-storey commercial/industrial brick buildings that forms roughly half of the commercial streetscape on the west side of Atlantic Avenue.▪ Front façade, on Atlantic Avenue, is clad in brick, with brick parapets, brick pilasters dividing large multi-paned windows and brick corbelling beneath the roofline. <p>Historic or Associative Value:</p> <ul style="list-style-type: none">▪ Built between 1913 and 1924.▪ Factory supported Canada’s agricultural sector.▪ Former Winnipeg Ceiling and Roofing Company, which manufactured steel ceilings and roofing panels. In 1928, the company designed and produced the first corrugated steel grain silos.▪ In 1985, Upper Canada Brewing bought the buildings and adapted them for brewing. In 1988 bought by Sleeman Breweries, then eventually bought by Iron Mountain Canada Corporation then sold in 2005 to a company under aegis of York Heritage Properties which adapted the building for Joe Fresh, the retail chain. In 2014, 20 Atlantic Avenue was acquired by York Heritage. <p>Contextual Value:</p> <ul style="list-style-type: none">▪ Located between Atlantic Avenue and Jefferson Avenue, directly north of the Lakeshore West railway corridor▪ South Liberty Trail is to the south of the property and contains a cultural interpretative sign for 2 Atlantic Avenue (see ES-001).▪ One of several repurposed commercial and industrial buildings in the Liberty Village area. <p>Potential to Meet Ontario Regulation 10/06: No</p> <p>Potential Heritage Attributes:</p> <ul style="list-style-type: none">▪ Front façade on Atlantic Avenue clad in brick with large multi-paned windows with decorative brickwork including; brick parapets, brick pilasters, and brick corbelling beneath the roofline.	<div>
