Appendix A7-19
Cultural Heritage Evaluation Report:
1558, 1580, 1598, and 1604 Baseline
Road, Clarington

Final Report

August 24, 2023

Client/Project
METROLINX, OSHAWA TO BOWMANVILLE RAIL SERVICE EXTENSION PROJECT CULTURAL HERITAGE EVALUATION REPORT— 1558, 1580, 1598, AND 1604 BASELINE ROAD, CLARINGTON

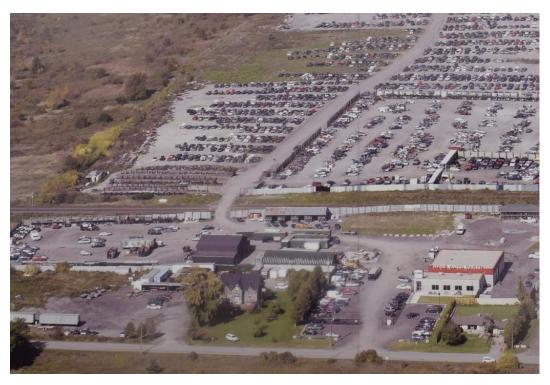
Photo 1: Undated aerial view of Study Area, found on promotional material within Study Area

The Study Area contains the municipal addresses 1558, 1580, 1598, and 1604 Baseline Road. These properties are presently owned and operated as part of Dom's Automotive Parts. The property at 1558/1580 Baseline Road contains an early 20th century residence and outbuilding. The property at 1598 Baseline Road contains a late 19th century stone house and modern outbuildings. The property at 1604 Baseline Road contains the mid-to late 20th century main office for Dom's Automotive and modern, although heavily modified, outbuildings. Much of the land surrounding the existing houses consist of vehicle yards with vehicles in various states of salvage (Photo 1).

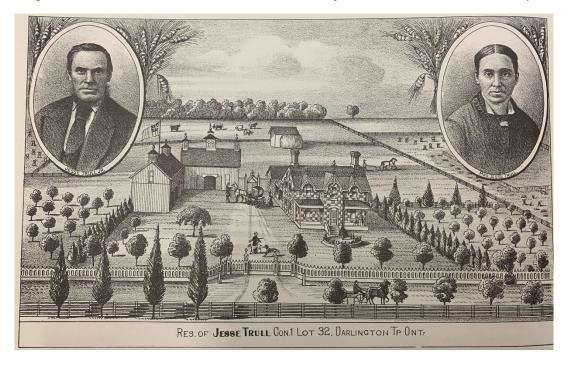
Plate 1: Jesse Trull Farm, 1878 (Belden 1878)

Jesse Trull was responsible for creating the Trull Cemetery, located in a separate property parcel surrounded by the Study Area. According to an article in *The Canadian Statesman* from 1951, the cemetery was originally six acres size and had a northern boundary of the CPR tracks and southern boundary near Highway 401. Some of the markers in the cemetery were brought over from the original farmstead of Captain John C. Trull. The article also noted about 20 tombstones in the cemetery and area surrounded by a metal fence was just one part of the cemetery (Canadian Statesman 1951). However, topographic mapping from 1930 shows the cemetery boundary closer to its present-day size (Figure 5). In addition, land registry records from 1948 indicate the cemetery boundary was surrounded by a fence (OnLand 2023). Therefore, the article in the *Canadian Statesman* may be an error as both topographic mapping and land registry records do not indicate the cemetery extended north to the CPR tracks. A photograph from about 1964 shows the part of the cemetery within the fence (Plate 2). Beginning in 1898, Jesse Trull held an annual family reunion at the farmstead (Plate 3).

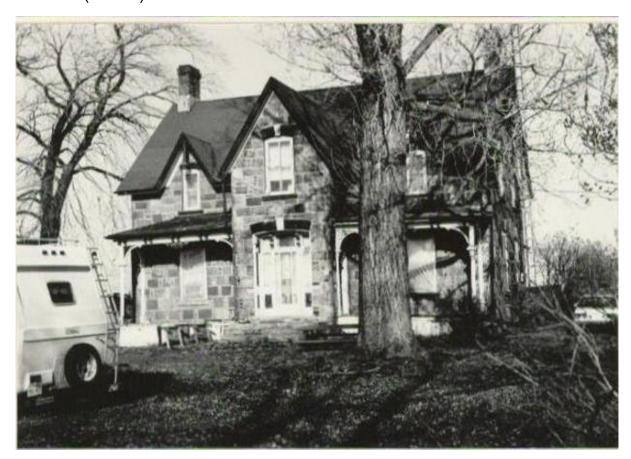
Plate 4: 1598 Baseline Road, *circa* 1985 (Town of Newcastle 1985)

Study Area remained rural and agricultural (Figure 6). Between 1955 and 1967, 65 acres of the Study Area was purchased by Motor City Auto Parts. In 1968, this property was purchased by Dominic Vetere and his son Mickey Vetere of Dom's Auto Parts (Dom's Auto Parts 2022). Topographic mapping from 1976 shows the extent of Dom's Auto Parts dilenated by a fence. The mapping also shows the structure at 1558/1580 Baseline Road and the Trull Cemetery (Figure 7). By 1980, the entirity of the Study Area was acquired by Dom's Auto Parts (OnLand 2023). Photography of 1598 Baseline Road from 1985 indicates the original front porch of the structure remained until at least the mid-1980s (Plate 4).
