**Addendum to Oshawa  
to Bowmanville Rail  
Service Extension:  
Cultural Heritage Report  
- Existing Conditions  
and Preliminary Impact  
Assessment**

**Final**

September 26, 2023

Project Number: 165011019

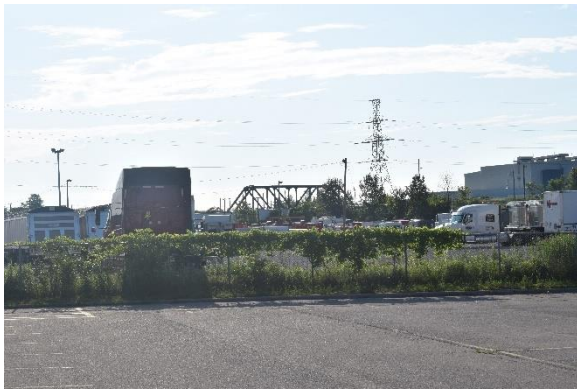
**Plate 1: Industrial character of area looking east on Thornton Road South**

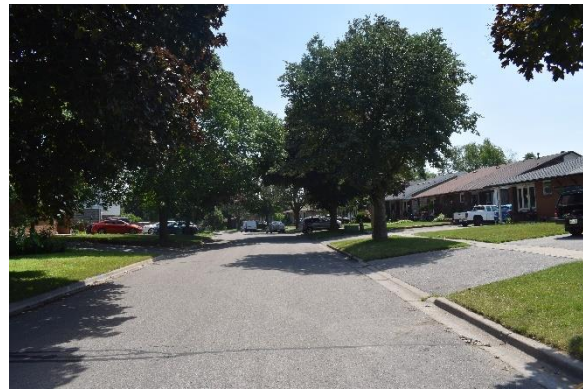
**Plate 2: Semi-attached suburban residences on Grenfell Street, looking east**

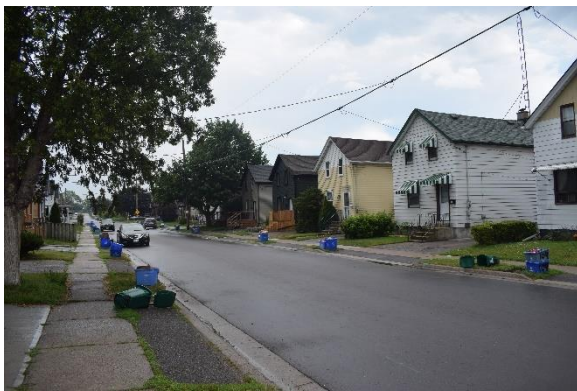
**Plate 3: Looking east down Banting Street showing late 19th to early 20th century detached residences**

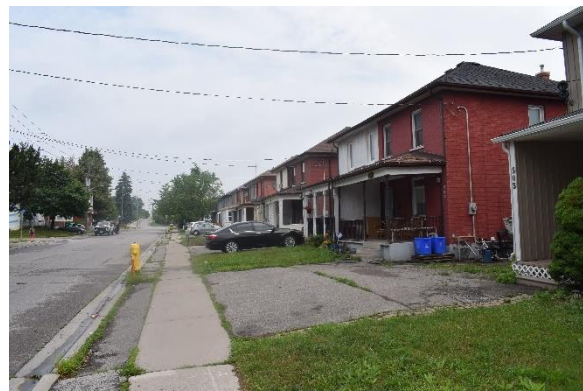
**Plate 4: Looking north on Albert Street showing semi-attached late 19th to early 20th century residences**

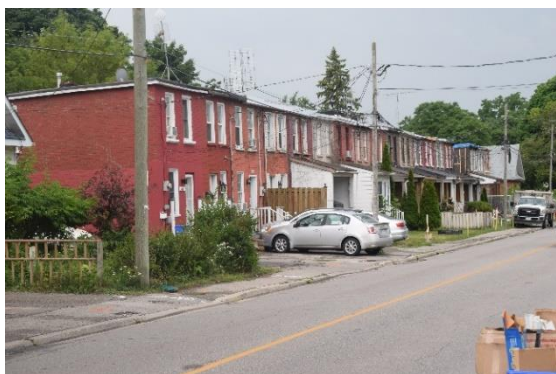
**Plate 5: Looking west on Olive Avenue showing rowhouses**

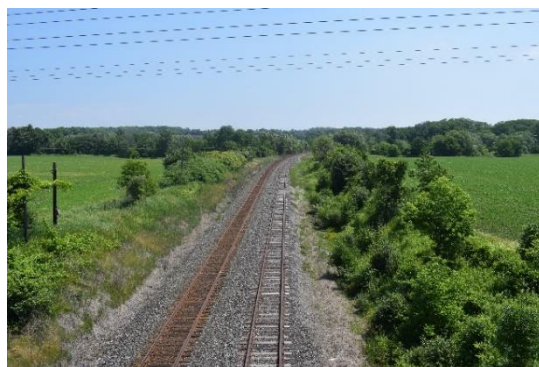
**Plate 6: Rural landscape, looking east from Courtice Road**

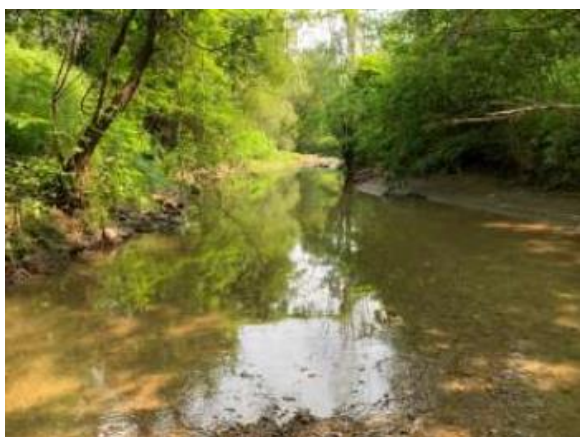
**Plate 7: Looking north at Harmony Creek**

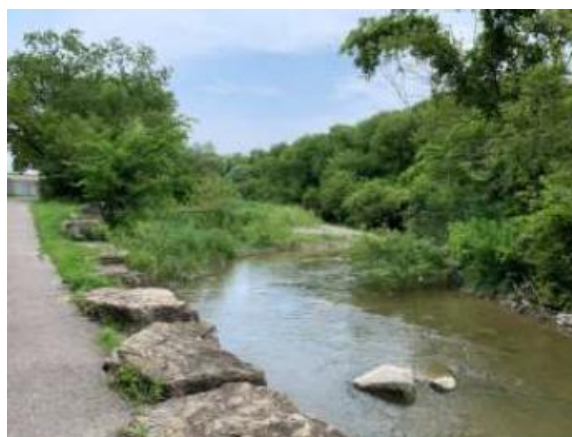
**Plate 8: Looking northeast at Oshawa Creek**

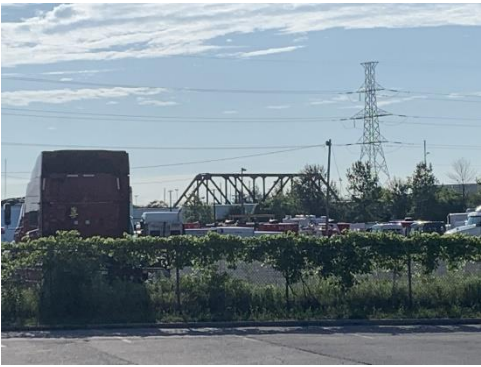
CHR Reference Number	Type of Property	Location	Previous Heritage Recognition	Description of Known or Potential CHVI	Photograph
BHR-1	Bridge	N/A—CPR Bridge over CN Tracks, Oshawa	Identified during field review	The bridge is a steel truss structure that carries the CPR tracks over the CN tracks and is located south of Bloor Street West. Additional details about the bridge are obscured by distance from roadway. The bridge was likely built between 1939 and 1953 based on aerial photography and topographic mapping. The bridge has potential design value as a representative mid-20 <sup>th</sup> century truss bridge and late example of the style.

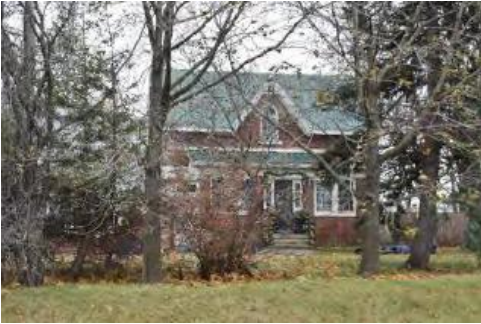
BHR-2	Residence	555 Thornton Road South, Oshawa	Previously identified by Stantec in 2018 in the Bowmanville Corridor Expansion CHSR	The property contains a one and one-half storey residence with a centre gabled dormer and an inverted finial. The residence has a red brick exterior with buff brick quoins and voussoirs with drip moulds. The residence has a pointed arch window in the centre gable and a covered front porch with side lights on both sides of the door. The foundation is obscured. The residence was built between 1861 and 1877 based on historical mapping. The residence has potential design value as a rare example of a 19 <sup>th</sup> century Ontario vernacular residence with Gothic Revival and Italianate design influences that also displays a high degree of craftsmanship. The residence is one of only a few remaining 19 <sup>th</sup> century structures in the area.

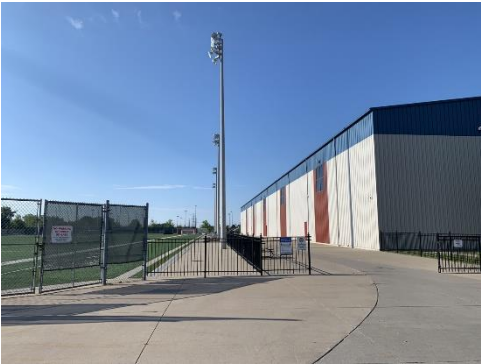
BHR-3	Civic	99 Thornton Road South, Oshawa	Previously identified by Stantec in 2018 in the Bowmanville Corridor Expansion CHSR	The property contains the Oshawa Civic Centre and includes five outdoor fields, a full-size indoor fieldhouse, indoor and outdoor tracks, a swimming pool, fitness centre, indoor tennis courts, indoor squash courts, and an outdoor playground. The property has potential historical or associative value because of its significant connection to the community. The original arena was constructed in 1964 and was home to the local ice hockey team, the Oshawa Generals, from December 1964 to October 2006. The arena hosted the 1987 Memorial Cup and has also hosted large capacity music concerts including the Rolling Stones and Alice Cooper. Topographic mapping shows that the sports track and stadium seating date to circa 1976. The property also has significant contextual value as a landmark in the community.

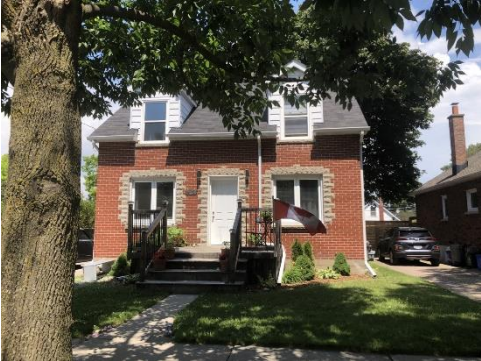
CHR Reference Number	Type of Property	Location	Previous Heritage Recognition	Description of Known or Potential CHVI	Photograph
BHR-4	Residence	254 Hibbert Avenue, Oshawa	Identified during field review	The property contains a one and one-half storey residence with a steeply pitched side gable roof and two gable dormers on the front (south) elevation. The dormers are clad in modern siding and the windows have a rusticated concrete sill. The residence has a red brick exterior with rusticated concrete window and door surrounds. The residence has modern windows and doors. The foundation is concrete block. The residence was likely built between 1939 and 1954 based on topographic mapping and aerial photography. The residence has potential design value as a representative early 20 <sup>th</sup> century Ontario vernacular structure with Colonial Revival design influence.

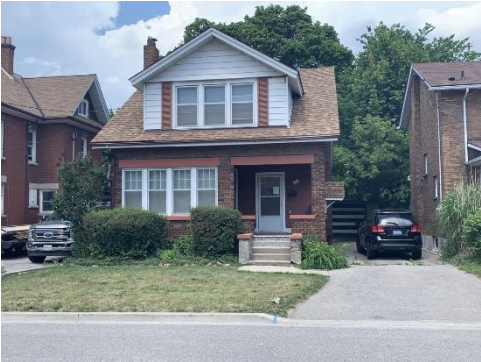
BHR-5	Residence	22 Royal Street, Oshawa	Identified during field review	The property contains a one and one-half storey residence with a side gable roof and a front facing gable dormer on the south façade. The dormer is clad in modern siding and the exterior of the house is clad in red brick. The dormer has modern windows, while the first storey has wood frame 6/1 windows. There is a wooden door behind a modern screen door. The front entrance is within a recessed, covered front porch that spans approximately half of the front façade. The first storey front window and entrance to the front porch have plain rectangular lintels. The foundation is concrete block. The residence was likely built between 1911 and 1938 based on the fire insurance plan and topographic mapping. The residence has potential design value as a representative early 20 <sup>th</sup> century Ontario vernacular structure.

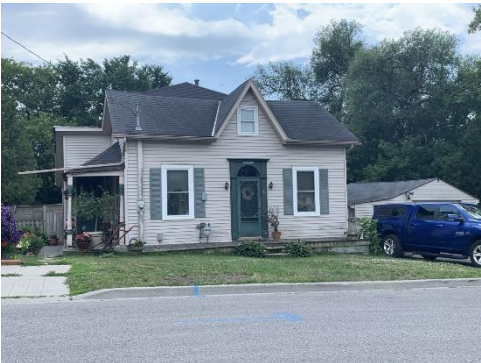
BHR-6	Residence	83 Avenue Street, Oshawa	Class A Listed Property on the Municipal Heritage Register <sup>3</sup>	<p>The property contains a residence. The residence is a one and one-half storey structure with a side gable roof and steeply pitched centre gable on the front (north) façade. There is a covered porch with a shed roof on the east façade with decorative wooden support beams. There also appears to be at least one addition at the rear of the structure. The residence is clad in modern siding with modern windows and doors. The front entrance has a decorative surround with pilaster and a rectangular pediment with a fan light. The foundation is obscured. The construction date associated with this residence in the Heritage Oshawa Inventory is 1880. This residence retains design value as a representative Gothic Revival structure.</p> <p>A CHER was completed for this property and determined the residence was built between 1912 and 1920 and is an Ontario vernacular structure with a centre gable commonly found in “Gothic Cottage” architecture in Ontario.</p>

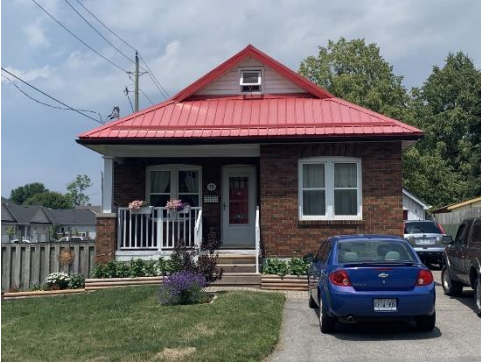
CHR Reference Number	Type of Property	Location	Previous Heritage Recognition	Description of Known or Potential CHVI	Photograph
BHR-7	Residence	50 Avenue Street, Oshawa	Identified during field review	The property contains a one storey residence with a front facing Dutch gable roof with the gable clad in modern siding. The exterior of the residence is red brick. The windows and door have segmental arch openings with brick voussoirs and sills. Half of the front (south) façade is a covered porch. The foundation is poured concrete. The residence was likely built between 1911 and 1938 based on the fire insurance plan and topographic mapping. The residence has potential design value as a representative early 20 <sup>th</sup> century Ontario vernacular structure.

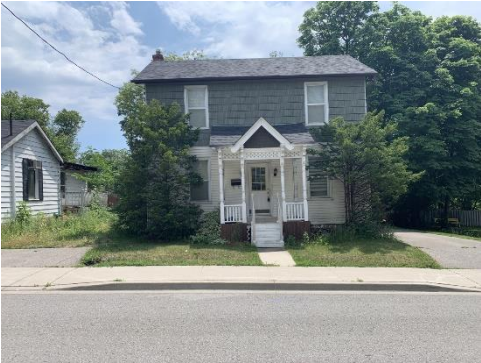
BHR-8	Residence	33 Avenue Street, Oshawa	Class B Listed Property on the Municipal Heritage Register <sup>4</sup>	This property contains a two storey residence with a side gable roof with a brick chimney. The residence is clad in modern siding and contains modern windows and doors. The residence has a partial-width front porch and a stone foundation that has been whitewashed. This residence was likely built between 1880 and 1911 based on architectural style and fire insurance plans. The residence has potential design value as a representative Ontario vernacular structure.

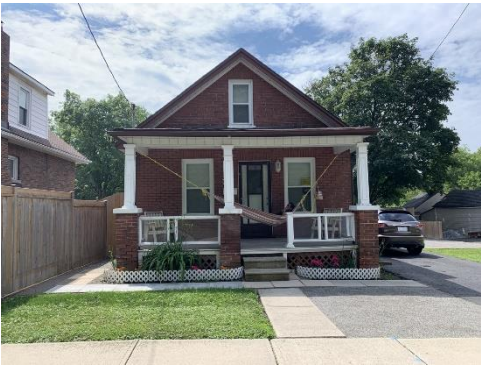
BHR-9	Residence	75 Hall Street, Oshawa	Identified during field review	The property contains a one and one-half storey residence with front gable roof. The exterior of the residence is red brick with matching brick lintels above the door and windows. The residence has a full-width front porch supported by red brick columns. The residence has a modern door and windows. The foundation is poured concrete. The residence was likely built between 1911 and 1938 based on the fire insurance plan and topographic mapping. The residence has potential design value as a representative early 20 <sup>th</sup> century Ontario vernacular structure.

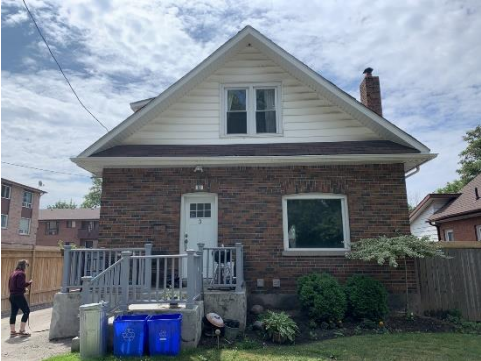
CHR Reference Number	Type of Property	Location	Previous Heritage Recognition	Description of Known or Potential CHVI	Photograph
BHR-10	Residence	71 Hall Street, Oshawa	Identified during field review	The property contains a one and one-half storey residence with a front gable roof. There is modern siding on the front gable and shed roof dormers on the side elevations. The residence has segmental arch door and window openings on the first storey with brick voussoirs. The residence has modern windows and doors. The foundation is poured concrete. The residence was likely built between 1911 and 1930 based on fire insurance plans and topographic mapping. The residence has potential design value as a representative early 20 <sup>th</sup> century Ontario vernacular structure.

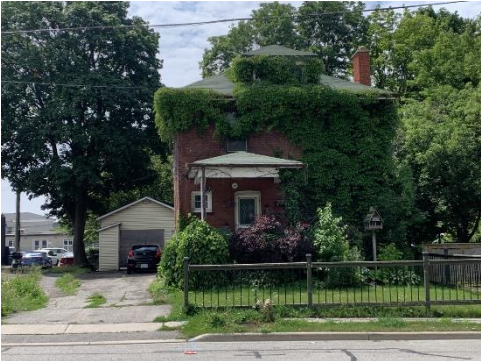
BHR-11	Residence	15 Hall Street, Oshawa	Identified during field review	The property contains a two and one-half storey residence with a hip roof and a hip dormer in the front (north) elevation. The exterior is red brick. The residence has a segmental arch door opening with a modern door and hip roof porch above the door with unelaborated square support columns. The residence has a four-pane square window on the front elevation with the other windows obscured by vegetation. The visible window and door have red brick voussoirs. The foundation is poured concrete. The residence was likely built between 1911 and 1930 based on fire insurance plans and topographic mapping. The residence has potential design value as a representative early 20 <sup>th</sup> century Ontario vernacular structure.

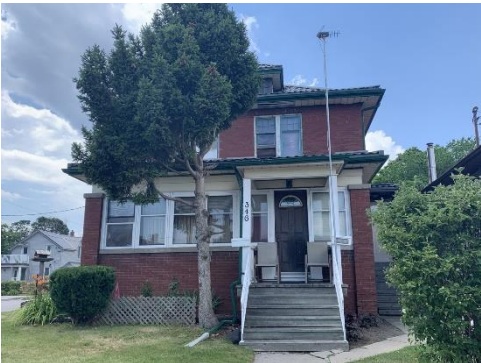
BHR-12	Residence	346 Simcoe Street South, Oshawa	Identified during field review	This property contains a two and one-half storey residence with a hip roof and hip dormer on the front (east) elevation. The exterior is red brick. The residence has modern windows, a modern door, and an enclosed front porch. The south elevation contains a projecting bay clad in pebbledash. The foundation is concrete block and the west elevation contains an attached garage. The residence was likely built between 1912 and 1940 based on fire insurance mapping and architectural style. The residence has potential design value as a representative early to mid-20 <sup>th</sup> century Ontario vernacular structure.

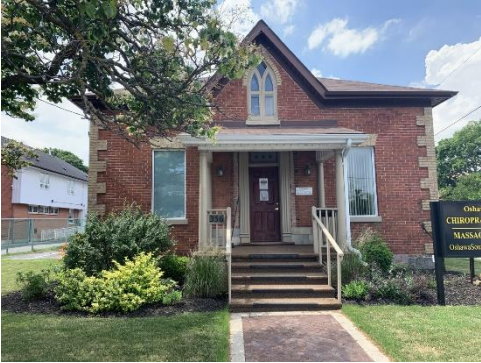
CHR Reference Number	Type of Property	Location	Previous Heritage Recognition	Description of Known or Potential CHVI	Photograph
BHR-13	Residence	356 Simcoe Street South, Oshawa	Class B Listed Property on the Municipal Heritage Register	The property contains a one and one-half storey residence with a centre gable roof. The exterior of the residence is red brick with contrasting buff brick quoins, voussoirs, and edging around the door. The first storey windows are modern, with a pointed arch window on the upper storey. The door on the front (east) façade is modern with a rectangular stained-glass transom window above it and a decorative wood surround. There is a small, covered porch around the door with the roof supported by round columns. The foundation is cut stone. According to the Heritage Oshawa Inventory, the residence was constructed in 1880. The residence has value as a representative Gothic Revival structure.

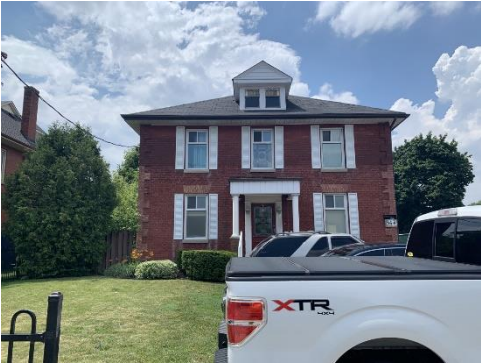
BHR-14	Residence	364 Simcoe Street South, Oshawa	Identified during field review	This property contains a residence. The residence is a two and one-half storey structure with a hip roof. The exterior is red brick and contains red brick quoins on the front (east) elevation. The residence has modern windows, a modern door, and partial width porch. The rear (west) elevation contains a modern addition. The foundation is poured concrete or stone with parging. The residence was likely built between 1880 and 1911 based on architectural style and fire insurance mapping from 1911. The residence has potential design value as a representative mid to late 19 <sup>th</sup> century Ontario vernacular structure.

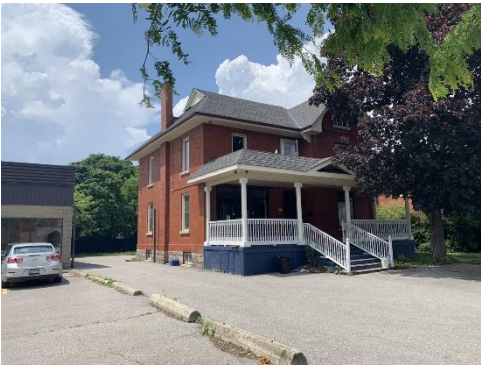
BHR-15	Residence	370 Simcoe Street South, Oshawa	Class B Listed Property on the Municipal Heritage Register	This property contains a residence. The residence is a two and one-half storey structure with a hip and gable roof and projecting gable bay with bargeboard and decorative brick banding. The exterior is red brick. The residence contains a full-width front porch, modern windows, and a modern door. The front (east) elevation has been modified with a large picture window. The foundation is stone. The residence was likely built between 1880 and 1911 based on architectural style and fire insurance mapping. The residence has potential design value as a representative late 19 <sup>th</sup> to early 20 <sup>th</sup> century Ontario vernacular structure with Queen Anne design elements.

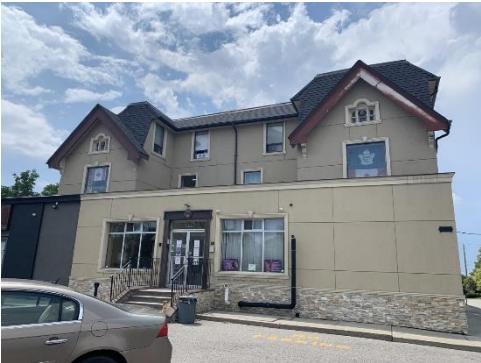
CHR Reference Number	Type of Property	Location	Previous Heritage Recognition	Description of Known or Potential CHVI	Photograph
BHR-16	Residence (converted to commercial)	394 Simcoe Street, Oshawa	Class B Listed Property on the Municipal Heritage Register	<p>This property contains a heavily modified residence converted to commercial use. The structure is three storeys tall and has a hip and gable roof. The structure is clad in modern stucco and contains modern windows and doors. The front (east) elevation has a modern storefront addition while the rear (west) elevation has a modern apartment complex attached. The residence was built between 1880 and 1911 based on architectural style and fire insurance mapping. The residence retains potential design value for remaining representative Queen Anne design elements.</p> <p>A CHER was completed for this property and determined this property contains a former residence later converted into a hotel that was built between approximately 1882 and 1891. The remaining original architectural details of the residence indicate the structure was an example of the Queen Anne style of architecture.</p>

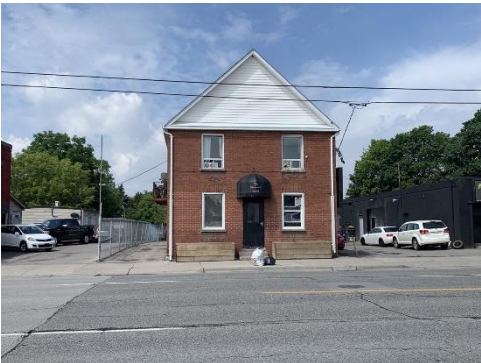
BHR-17	Residence (converted to commercial)	442 Simcoe Street South, Oshawa	Identified during field review	<p>The property contains a two storey residence with a front gable roof and modern siding in the gable. The exterior of the residence is red brick exterior with matching brick voussoirs above the windows. The residence has a modern door and windows. The foundation is below the street grade. The residence was likely built between 1911 and 1930 based on the fire insurance plan and topographic mapping. The residence has design value and a representative early 20<sup>th</sup> century Ontario vernacular structure.</p>

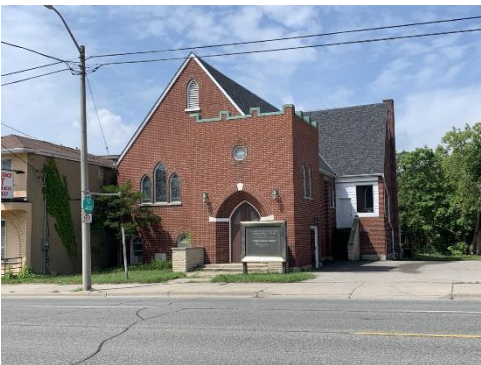
BHR-18	Church	486 Simcoe Street South, Oshawa	Identified during field review	<p>The property contains a one and one-half storey cross gabled church. The church has a red brick exterior. The window openings are a combination of pointed and round arches. The entry way is situated in a square tower with battlements along the roof line, an octagonal window, and a double door in a pointed arch opening with keystones. The date stone says the structure was built in 1930. This structure has potential design value as an early 20<sup>th</sup> century church with Gothic Revival design influences.</p>

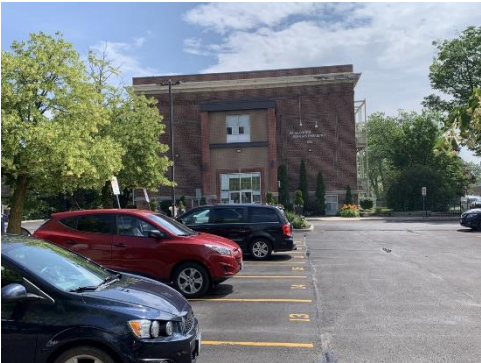
CHR Reference Number	Type of Property	Location	Previous Heritage Recognition	Description of Known or Potential CHVI	Photograph
BHR-19	Civic	505 Simcoe Street South, Oshawa	Class B Listed Property on the Municipal Heritage Register	The property contains the former South Simcoe School building, which has been converted into the St. George's Ukrainian Seniors Residence. The structure has three stories with a flat roof. The exterior of the structure is red brick. There is a large cornice below the roof line and stone banding above the first storey with decorative brick work on the west façade. The doors and windows are modern. The front entrance, on the west façade, is housed in a rectangular projection with red brick pillars at the corners, buff brick walls, and modern glass doors surrounded by large windows in an opening with a red brick border and keystone. The north, south, and east facades have multiple balconies. The foundation is poured concrete. According to the Heritage Oshawa Inventory, this structure was built in 1925. This structure has design value as a representative early 20 <sup>th</sup> century Ontario vernacular school building and historical or associative value from its connection with the South Simcoe School.

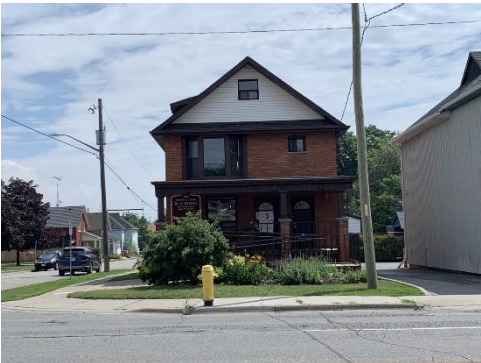
BHR-20	Residence	491 Simcoe Street South, Oshawa	Identified during field review	The property contains a two and one-half storey residence with a front gable roof. There is modern siding in the gable and a shed roof dormer on the north façade. The exterior of the structure is red brick. The residence has modern doors and windows with a bay window on the second storey. There is a full width covered front porch with red brick piers and half storey square columns. The foundation is poured concrete foundation. The residence was likely built between 1900 and 1930 based on the structure's style and topographic mapping. The structure has potential design value as a representative early 20 <sup>th</sup> century Ontario vernacular structure.

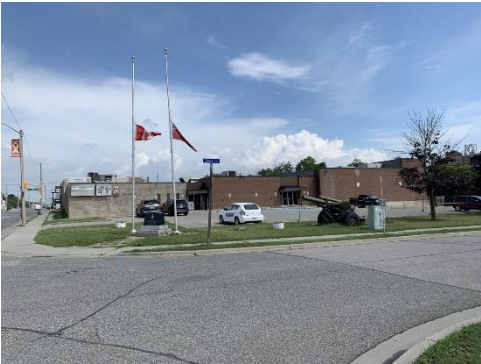
BHR-21	Civic	471 Simcoe Street, Oshawa	Identified during field review	This property contains a one storey structure. The structure is a one storey civic building with a flat roof. The exterior is clad in patterned concrete and red brick. The structure has modern windows and a modern door. The foundation is obscured. The building contains Branch 43 of the Royal Canadian Legion. The structure was built between 1950 and 1968 based on architectural style and topographic mapping. The structure has potential associative value for its role in the veterans' community of Oshawa.

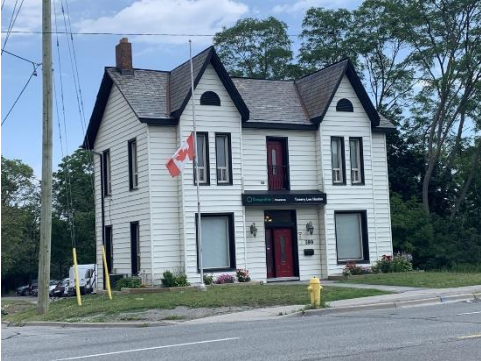
CHR Reference Number	Type of Property	Location	Previous Heritage Recognition	Description of Known or Potential CHVI	Photograph
BHR-22	Residence	399 Simcoe Street South, Oshawa	Class B Listed Property on the Municipal Heritage Register	<p>The property contains a two storey residence with attic. The structure has a side gable roof with a red brick chimney and two steeply pitched, projecting gables on the front (west) façade. The projections span both stories and each have a fan shaped louvre in the gable. The exterior of the residence is clad in modern siding. The windows and doors are modern. The front entrance has a rectangular transom window above the door and a rectangular side light to the left. Above the main entrance is a modern door and balcony. According to the Heritage Oshawa Inventory, this residence was constructed in 1890. This residence has design value as a late 19<sup>th</sup> century Gothic Revival structure.</p> <p>A CHER was completed for this property and determined the structure at 399 Simcoe Street South is a <i>circa</i> 1900 Ontario vernacular structure with Bay and Gable and Gothic Revival influence.</p>

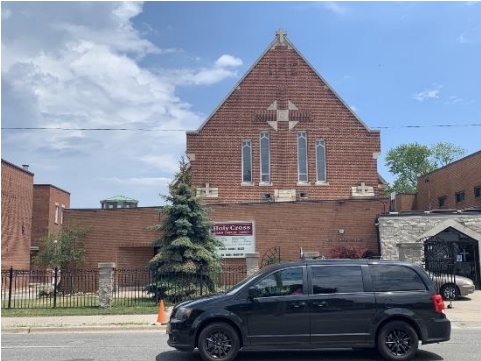
BHR-23	Church	373 Simcoe Street South, Oshawa	Class B Listed Property on the Municipal Heritage Register	<p>The property contains a two storey church with a front gable roof. The exterior of the church is red brick with a large brickwork and stone cross in the centre of the second storey of the front (west) façade. The west façade has additional decorative elements made from brick and stone as well as narrow, rectangular stained-glass windows with stone sills. The foundation of the building is obscured. According to the Heritage Oshawa Inventory, the church was constructed in 1950. The church has historic or associative value from its relationship to the Holy Cross Roman Catholic Church and community.</p>

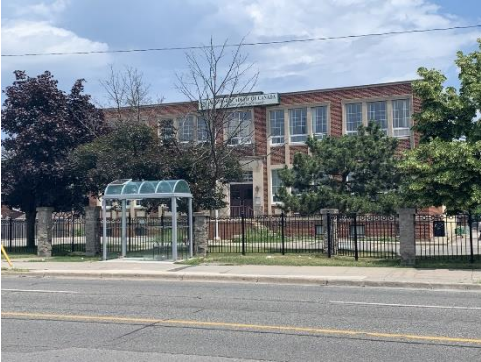
BHR-24	Civic	357 Simcoe Street South, Oshawa	Class A Listed Property on the Municipal Heritage Register	<p>The property contains a two storey building with a flat roof. The exterior of the building is red brick. The front (west) façade has stone window surrounds, vertical stone banding and stone decoration. The front façade also features twelve pane windows in groups of three. The front entrance is a double metal door with a large, rectangular transom window above it in a stone surround. There is no visible foundation. According to the Heritage Oshawa Inventory, the construction date for this building was 1942. The building has design value as a representative early 20<sup>th</sup> century Ontario vernacular civic structure and historical or associative value from its connection of the Holy Cross School and community.</p>

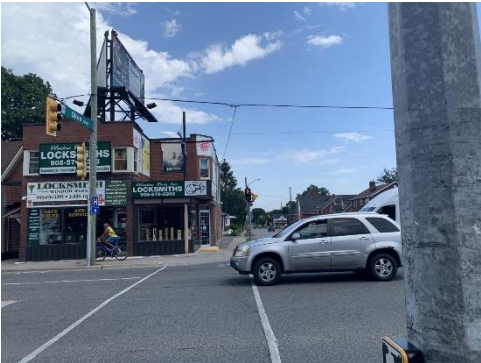
CHR Reference Number	Type of Property	Location	Previous Heritage Recognition	Description of Known or Potential CHVI	Photograph
BHR-25	Commercial	335-339 Simcoe Street South, Oshawa	Identified during field review	This property contains a two storey commercial structure. The building has an irregular shape and a flat roof with a parapet cornice. The exterior of the building is red brick with matching red brick voussoirs above the windows and contrasting buff brick sills. The windows and doors are modern and the first storey contains large shop windows on the west and south facades. The foundation is poured concrete. The building was likely built between 1954 and 1968 based on aerial photography and topographic mapping. The building has potential design value as a representative mid-20 <sup>th</sup> century Ontario vernacular commercial structure.

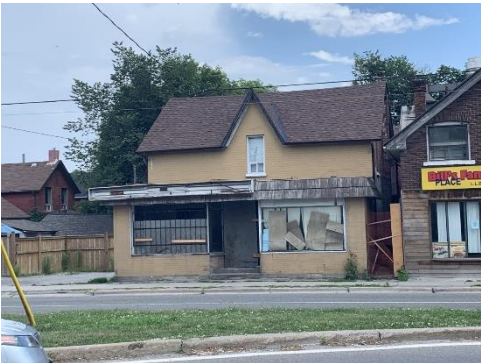
BHR-26	Residence (converted to commercial)	325 Simcoe Street South, Oshawa	Class B Listed Property on the Municipal Heritage Register	The property contains a one and one-half storey residence with a centre gabled roof and a one storey shop addition on the front (west) façade with a flat roof. The exterior of the original residence is brick in a stretcher bond pattern with brick voussoirs above the window openings, which contain modern windows. The one storey addition has a brick exterior in a stack bond arrangement with two large shop windows and a concrete block foundation. The foundation of the original residence is poured concrete. According to the Heritage Oshawa Inventory, the residence was constructed in 1900. The residence has potential design value as a representative early 20 <sup>th</sup> century Gothic Revival structure.

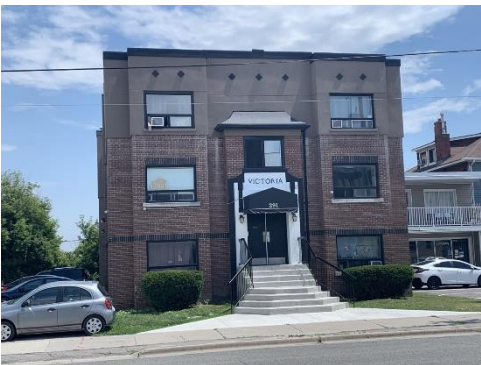
BHR-27	Residence	291 Simcoe Street South, Oshawa	Class B Listed Property on the Municipal Heritage Register	The property contains a three storey apartment building with a flat roof. The exterior of the building is red brick with darker brick banding on the first storey and darker brick voussoirs on the second storey. The third storey is covered in stucco. The windows are modern. The building has double wooden doors with a stained-glass transom window inside a stone surround on the front (west) façade. There is no visible foundation. According to the Heritage Oshawa Inventory, the building was constructed in 1930. The building has potential design value as a representative early 20 <sup>th</sup> century Ontario vernacular structure.

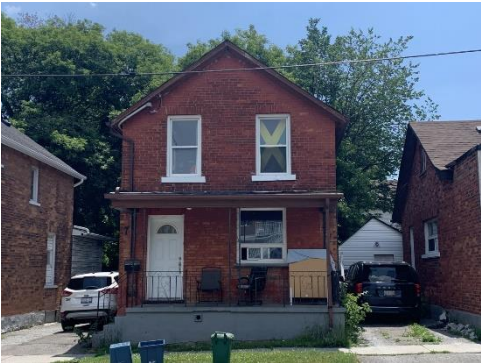
CHR Reference Number	Type of Property	Location	Previous Heritage Recognition	Description of Known or Potential CHVI	Photograph
BHR-28	Residence	7 Maple Street, Oshawa	Identified during field review	The property contains a one and one-half storey residence. The residence has a front gable roof. The exterior of the residence is red brick with matching brick voussoirs above the window and door openings. The windows and doors are modern. The front (north) façade has a full width covered porch with metal work support beams and railings. The foundation is poured concrete. Residence was likely built between 1900 and 1911 based on the style and fire insurance plan. The residence has potential design value as a representative early 20 <sup>th</sup> century Ontario vernacular structure.

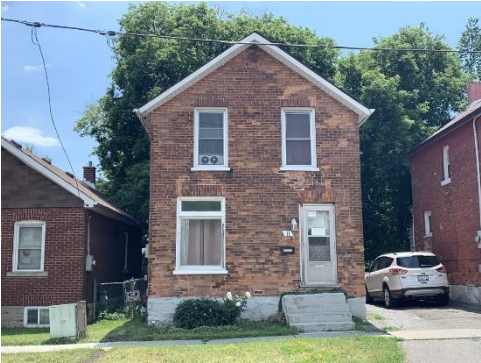
BHR-29	Residence	11 Maple Street, Oshawa	Identified during field review	The property contains a one and one-half storey residence with a front gabled roof. The exterior of the residence is red brick with matching brick voussoirs above the window and door openings. The residence has a modern door and windows. The first storey window on the front (north) façade has a transom window above it. The residence has a stone foundation. The residence was likely built between 1900 and 1911 based on the style and fire insurance plan. The residence has potential design value as a representative early 20 <sup>th</sup> century Ontario vernacular structure.

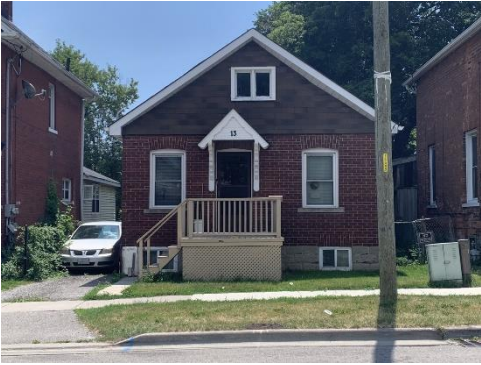
BHR-30	Residence	13 Maple Street, Oshawa	Identified during field review	The property contains a one and one-half storey residence with a front gable roof. The gable is covered with shingles and the exterior of the residence is red brick. The residence has matching brick voussoirs and stone sills with segmental arch window and door openings. The windows and doors are modern. The front entrance (on the north façade) has a triangular pediment with decorative brackets and bargeboard in the gable. The foundation is rusticated concrete block. The residence was likely built between 1911 and 1931 based on fire insurance mapping and city directories. The residence has potential design value as a representative early to mid-20 <sup>th</sup> century Ontario vernacular structure.

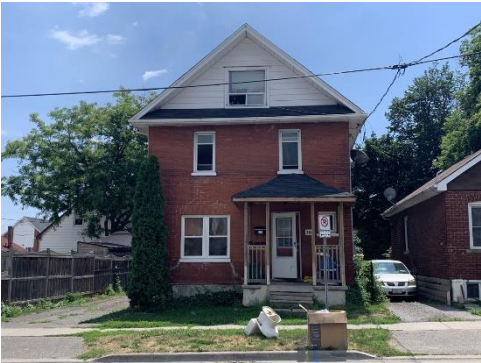
CHR Reference Number	Type of Property	Location	Previous Heritage Recognition	Description of Known or Potential CHVI	Photograph
BHR-31	Residence	15 Maple Street, Oshawa	Identified during field review	The property contains a two and one-half storey residence with a front gable roof. The gable is filled with modern siding. The exterior of the residence is red brick with matching brick voussoirs above the window openings. The residence has modern doors and windows with a bay window on the side (east) façade. There is a half width covered porch on the front façade. The foundation is poured concrete. The residence was likely built between 1911 and 1930 based on the fire insurance plan and topographic mapping. The residence has potential design influence as a representative early 20 <sup>th</sup> century Ontario vernacular structure.

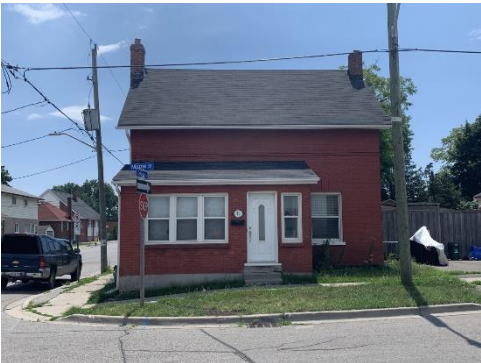
BHR-32	Residence	21 Maple Street, Oshawa	Class B Listed Property on the Municipal Heritage Register	The property contains a one and one-half storey residence with a side gable roof. The exterior of the residence is brick with decorative banding on the upper storey and brick voussoirs above the window openings. The windows and doors are modern. The front (north) façade of the residence has a small shed roof entrance room that spans approximately 2/3 of the house. The foundation is poured concrete. According to the Oshawa Heritage Inventory, the residence was constructed in 1900. The residence has design value as a representative early 20 <sup>th</sup> century Ontario vernacular structure.

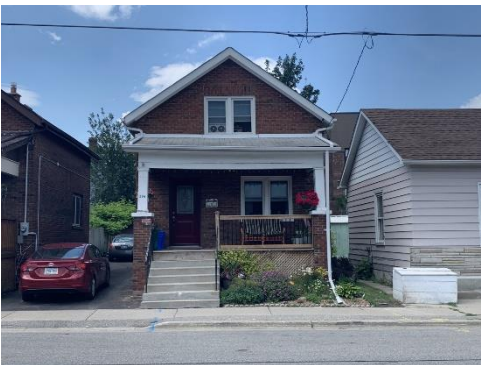
BHR-33	Residence	296 Celina Street, Oshawa	Identified during field review	The property contains a one and one-half storey residence with a front gable roof. The exterior of the residence is red brick with matching brick voussoirs above the door and window openings. The windows and door are modern. There is a full width covered porch on the front (east) façade supported by brick pillars with square half columns. The foundation is rusticated concrete block. The residence was likely built between 1911 and 1930 based on the fire insurance plan and topographic mapping. The residence has potential design value as a representative early 20 <sup>th</sup> century Ontario vernacular structure.

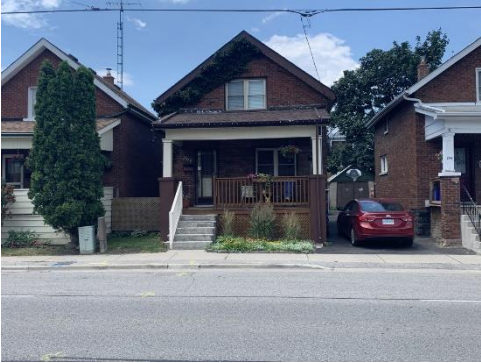
CHR Reference Number	Type of Property	Location	Previous Heritage Recognition	Description of Known or Potential CHVI	Photograph
BHR-34	Residence	298 Celina Street, Oshawa	Identified during field review	The property contains a one and one-half storey residence with a front gable roof. The exterior of the residence is red brick with matching brick voussoirs above the door and window openings. The windows are modern. There is a full width covered porch on the front (east) façade supported by pillars with square half columns. The foundation is rusticated concrete block. The residence was likely built between 1911 and 1930 based on the fire insurance plan and topographic mapping. The residence has potential design value as a representative early 20 <sup>th</sup> century Ontario vernacular structure.

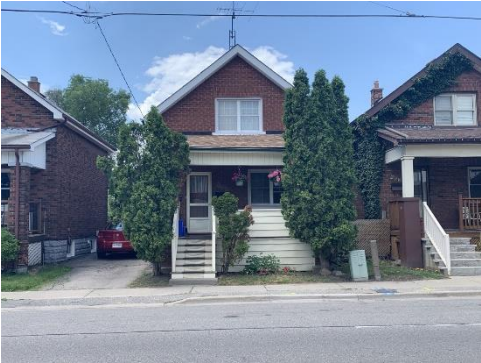
BHR-35	Residence	302 Celina Street, Oshawa	Identified during field review	The property contains a one and one-half storey residence with a front gable roof. The exterior of the residence is red brick with matching brick voussoirs above the door and window openings. The windows are modern. There is a full width covered porch on the front (east) façade supported by brick pillars. The foundation has faux stone panels covering rusticated concrete blocks. The residence was likely built between 1911 and 1930 based on the fire insurance plan and topographic mapping. The residence has potential design value as a representative early 20 <sup>th</sup> century Ontario vernacular structure.

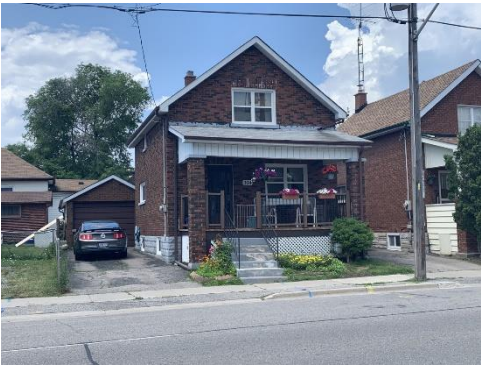
BHR-36	Residence	304 Celina Street, Oshawa	Identified during field review	The property contains a one and one-half storey residence with a front gable roof. The exterior of the residence is red brick with matching brick voussoirs above the door and window openings. The windows and door are modern. There is a full width covered porch on the front (east) façade supported by brick pillars. The foundation is rusticated concrete block. The residence was likely built between 1911 and 1930 based on the fire insurance plan and topographic mapping. The residence has potential design value as a representative early 20 <sup>th</sup> century Ontario vernacular structure.

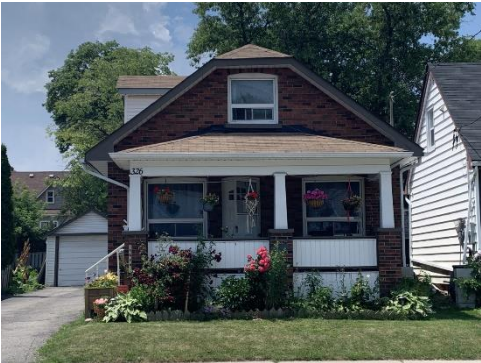
CHR Reference Number	Type of Property	Location	Previous Heritage Recognition	Description of Known or Potential CHVI	Photograph
BHR-37	Residence	326 Celina Street, Oshawa	Identified during field review	The property has a one and one-half storey residence with a clipped gable roof. The exterior of the residence is red brick with matching brick voussoirs above segmental arch window and door openings. There is a gable dormer on the side (south) façade. The windows are modern. The foundation is poured concrete. The residence was likely built between 1932 and 1951 based on city directories. The residence has potential design value as a representative mid-20 <sup>th</sup> century Ontario vernacular structure.

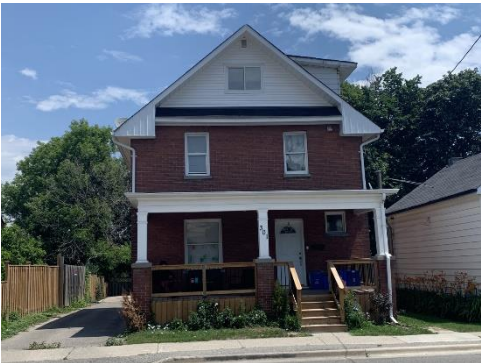
BHR-38	Residence	301 Celina Street, Oshawa	Identified during field review	This property contains a residence. The residence is a two and one-half storey structure with a front facing gable roof, return eaves, and a shed roof dormer on the south façade. The exterior is clad in modern siding and red brick. The residence contains modern windows, a modern door, and a full-width front porch. The foundation is poured concrete. The residence was likely built between 1912 and 1930 based on fire insurance mapping and architectural style. The residence has potential design value as an early 20 <sup>th</sup> century Ontario vernacular structure with Edwardian design elements.

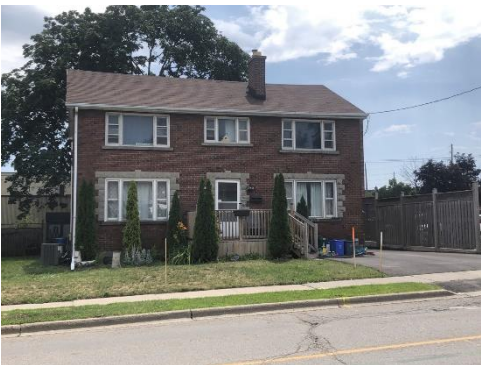
BHR-39	Residence	19 Olive Avenue, Oshawa	Identified during field review	This property contains a residence. The residence is a two storey structure with a side gable roof and brick chimney. The exterior is red brick. The residence contains modern windows and the first storey has stone window and door surrounds. The foundation is rusticated concrete block. The residence was likely built between 1946 and 1968 based on topographic mapping. The residence has potential design value as a mid-20 <sup>th</sup> century Ontario vernacular structure with Colonial Revival design elements.

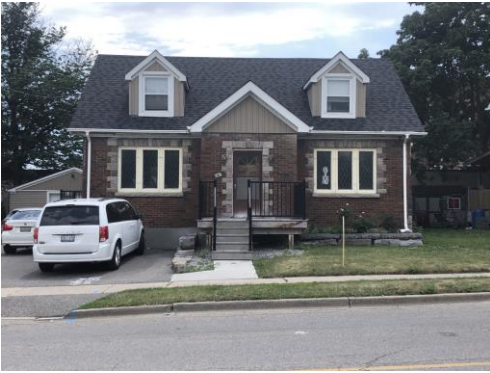
CHR Reference Number	Type of Property	Location	Previous Heritage Recognition	Description of Known or Potential CHVI	Photograph
BHR-40	Residence	25 Olive Avenue, Oshawa	Identified during field review	This property contains a residence. The residence is a one and one-half storey structure with a side gable roof and two gable dormers on the front (north) façade. The residence contains a modern shed roof rear addition. The residence is clad in red brick and modern siding. The residence has stone window and door surrounds, modern windows, a modern bay window on the west elevation, and a modern door. The foundation is poured concrete. The residence was likely built between 1946 and 1968 based on topographic mapping. The residence has potential design value as a mid-20 <sup>th</sup> century Ontario vernacular structure with Colonial Revival design elements.

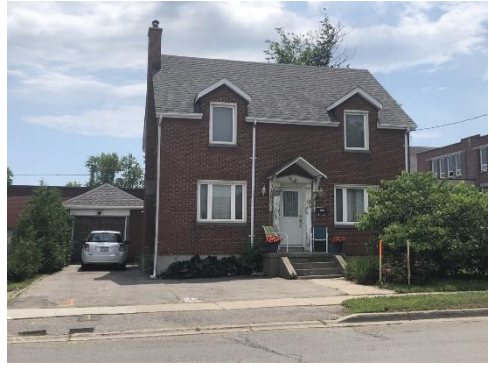
BHR-41	Residence	29 Olive Avenue Oshawa	Identified during field review	This property contains a residence. The residence is a one and one-half storey structure with a side gable roof, brick chimney, and two gable dormers on the front (north) façade. The exterior is red brick. The residence contains modern windows and a modern door. The foundation is poured concrete. The residence was likely built between 1946 and 1968 based on topographic mapping. The residence has potential design value as a mid-20 <sup>th</sup> century Ontario vernacular structure with Colonial Revival design elements.

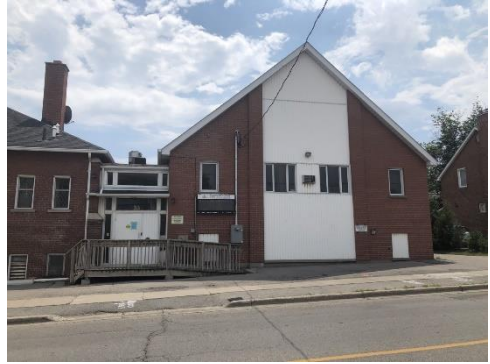
BHR-42	Civic	33 Olive Avenue, Oshawa	Identified during field review	The property contains a one storey building with a side gable roof and brick chimney. The building is attached to the church at 348 Albert Street. The exterior of the building is red brick with brick columns on either side of a vertical band of modern siding at the centre of the north façade and west façade. The windows and doors are modern. The foundation is poured concrete. The date stone at the northeast corner of the building says it was constructed in 1960. The building has potential design value as a vernacular structure with mid-century modern design influences and potential historical and associative value due to its connection to the New Life Seventh Day Adventist Church and the New Life Neighbourhood Centre, and the wider community.

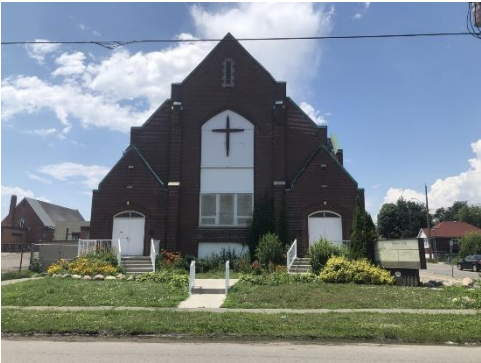
CHR Reference Number	Type of Property	Location	Previous Heritage Recognition	Description of Known or Potential CHVI	Photograph
BHR-43	Church	348 Albert Street, Oshawa	Identified during field review	This property contains a church. The church is a two storey structure with a steeply pitched front facing gable roof. The exterior of the church is red brick. The front (north) façade contains two projecting gable bays with modern double entrance doors and transoms. Between the bays is a multi-storey former window opening with modern windows and a stylized cross. The west and east elevations contain projecting gable bays and modern pointed arch windows. The church was built in 1928 according to its cornerstone. It has potential design value as a representative Neo-Gothic church. The building has potential historical and associative value due to its connection to the New Life Seventh Day Adventist Church and community.

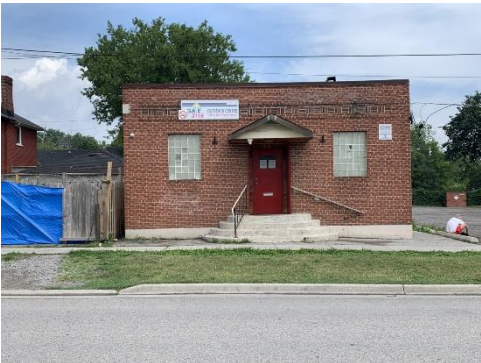
BHR-44	Commercial	64 Albany Street, Oshawa	Identified during field review	The property contains a one storey commercial building. The building has a flat roof with a red brick exterior. There is a decorative brick band below the roof. The building has glass block windows and a modern door with a triangular pediment above it. The foundation is concrete block. The building was likely built between 1934 and 1954 based on topographic mapping and aerial photography. The building has potential design value as a representative mid-20 <sup>th</sup> century Ontario vernacular commercial structure.

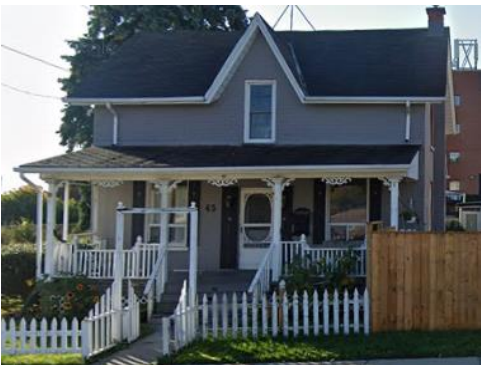
BHR-45	Residence	45 Albany Street, Oshawa	Identified during field review	The property contains a one and one-half storey residence. The residence has a side gable roof with a centre gable dormer. The exterior of the residence is painted brick with a brick voussoir above the upper storey window. The residence has modern windows and a wooden door. There is a full width covered front porch with decorative wooden elements and square wooden support columns. The porch also has wooden railing with finials. The foundation is obscured. The residence was likely constructed between 1911 and 1930 based on the fire insurance plan and topographic mapping. The residence has potential design value as a representative Gothic revival structure.

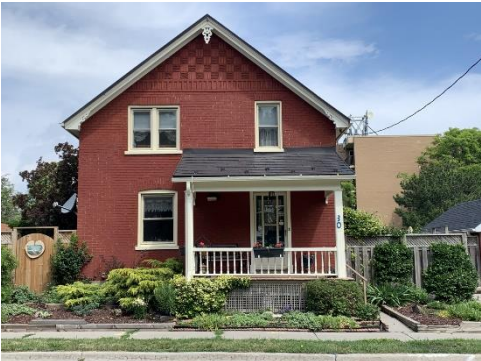
CHR Reference Number	Type of Property	Location	Previous Heritage Recognition	Description of Known or Potential CHVI	Photograph
BHR-46	Residence	30 Elena Avenue, Oshawa	Identified during field review	The property contains a one and one-half storey residence with front gable roof. There is a patterned brick design in the gable, an inverted finial at the peak and decorative wood elements in the corners of the gable. The windows and door are modern. There is one segmental arch window opening on the first storey and brick voussoirs above all window openings on the front façade. There is a half width covered front porch with square support columns and spindle railing. The foundation is obscured. The residence was likely built between 1900 and 1930 based on the style and topographic mapping. The residence has potential design value as a representative early 20 <sup>th</sup> century Ontario vernacular structure.

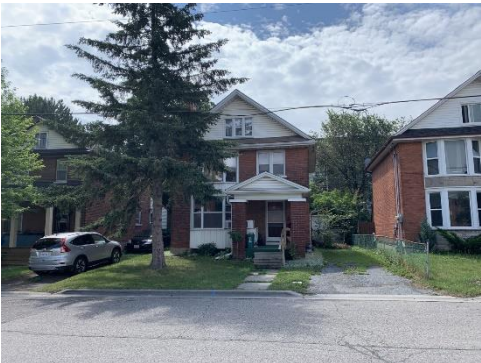
BHR-47	Residence	21 Elena Avenue, Oshawa	Identified during field review	The property contains a two and one and one-half storey residence with a front gable roof. There is siding in the gable. The exterior of the residence is red brick. The windows and doors are modern, including a bay window on both the first and second stories. There is a small porch at the front (north) entry covered with a triangular pediment and supported by square brick columns. There is a concrete block foundation. The residence was likely built between 1900 and 1930 based on its style and topographic mapping. The residence has potential design value as a representative early 20 <sup>th</sup> century Ontario vernacular structure.

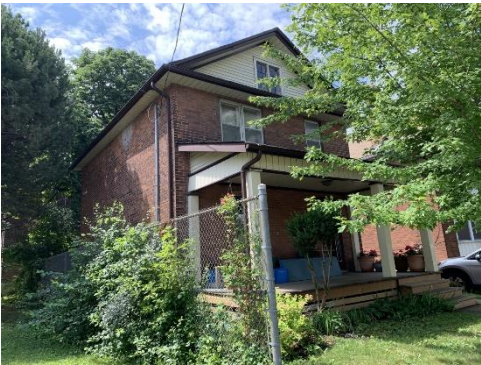
BHR-48	Residence	25 Elena Avenue, Oshawa	Identified during field review	The property contains a two and one and one-half storey residence with a front gable roof. There is siding and two six pane windows in the gable. The exterior is red brick. The front (north) façade also includes modern 1/1 windows, a wood frame segmental arch window, and a wood door. The foundation is poured concrete. The residence was likely built between 1900 and 1930 based on the style and topographic mapping. The residence has potential design value as a representative early 20 <sup>th</sup> century Ontario vernacular structure.

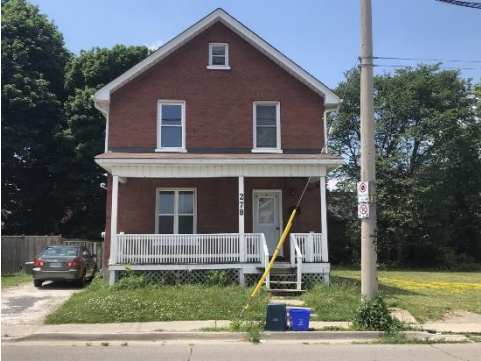
CHR Reference Number	Type of Property	Location	Previous Heritage Recognition	Description of Known or Potential CHVI	Photograph
BHR-49	Residence	278 Albert Street, Oshawa	Identified during field review	The property contains a two and one-half storey residence with a front gable roof. The exterior is red brick with matching brick voussoirs above the window and door openings. The windows and doors are modern. There is a full width covered front porch with plain square support pillars and plain railing. The foundation is poured concrete. The residence was likely built between 1911 and 1930 based on the fire insurance plan and topographic mapping. The residence has potential design value as a representative early 20 <sup>th</sup> century Ontario vernacular.

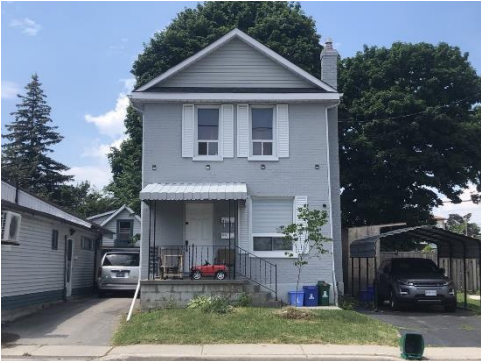
BHR-50	Residence	284 Albert Street, Oshawa	Identified during field review	The property contains a two storey residence with a front gable roof. There is modern siding in the gable. The exterior of the residence is brick. The windows and doors are modern. There is a half width porch on the front (east) façade with a corrugated metal roof and decorative metal support beams and railing. The foundation is poured concrete. The residence was likely built between 1911 and 1930 based on the fire insurance plan and topographic mapping. The residence has potential design value as a representative early 20 <sup>th</sup> century Ontario vernacular structure.

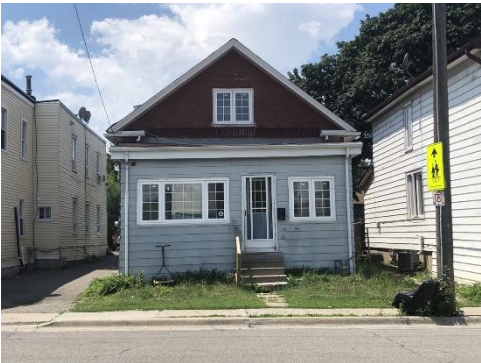
BHR-51	Residence	314 Albert Street, Oshawa	Identified during field review	The property contains a one and one-half storey residence with a front gable roof. There is a one storey addition on the front (east) façade that is clad in modern siding). The original residence has a red brick exterior with decorative brick banding across the bottom of the gable and a brick voussoir above the gable window. The windows and doors are modern. The foundation is poured concrete. The residence was likely built between 1911 and 1930 based on the fire insurance plan and topographic mapping. The residence has potential design value as a representative early 20 <sup>th</sup> century Ontario vernacular structure.
