**Addendum to Oshawa  
to Bowmanville Rail  
Service Extension:  
Cultural Heritage Report  
- Existing Conditions  
and Preliminary Impact  
Assessment**

**Final**

September 26, 2023

Project Number: 165011019

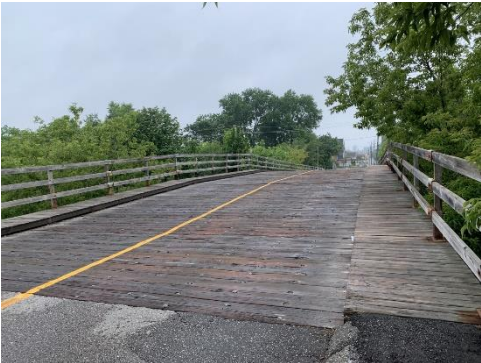
CHR Reference Number	Type of Property	Location	Previous Heritage Recognition	Description of Known or Potential CHVI	Photograph
BHR-52	Bridge	N/A—Albert Street Bridge over CPR tracks, Oshawa	Class A Listed Property on Heritage Oshawa Inventory	<p>The Albert Street Bridge over the CPR tracks is a wood and steel bridge. It contains sections of steel bracing and girders and sections of entirely wood construction. The bridge deck and railing are wood. The bridge was likely built <i>circa</i> 1912, when the CPR tracks were built through Oshawa. The bridge has potential design value as a rare surviving example of a wood and steel railway overpass. The distinctive wood deck and railing make the structure a landmark within the community.</p> <p>A CHER was completed for this bridge and determined the Albert Street Bridge is a hybrid bridge combining both the timber stringer bridge design and plate girder bridge design. The timber stringer sections of the bridge were likely built <i>circa</i> 1912 and the plate girder sections of the bridge were built <i>circa</i> 1957.</p>

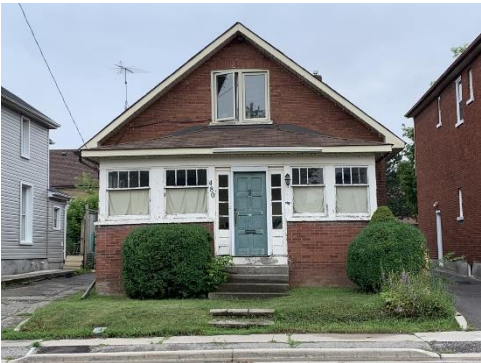
BHR-53	Residence	480 Albert Street, Oshawa	Identified during field review	<p>The property contains a one and one-half storey residence with a front gable roof and an enclosed front porch. The exterior of the residence is red brick with a matching brick voussoir above the segmental arch opening with a modern window in the gable. The enclosed porch on the front (east) façade has brick walls on the lower half with 4/1 wood frame windows on the upper half. There is a wooden door with four pane sidelight windows on either side. There is a shed roof dormer on the south façade. The foundation is poured concrete. The residence was likely built between 1900 and 1930 based on the style and topographic mapping. The residence has potential design value as a representative early 20<sup>th</sup> century Ontario vernacular structure.</p>

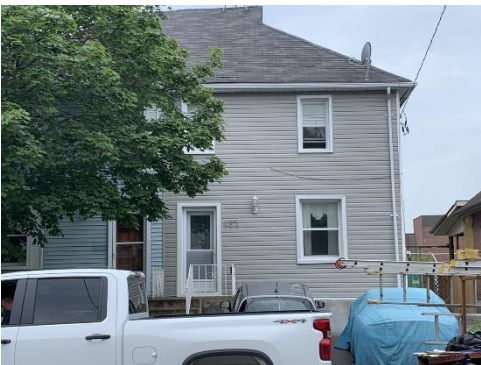
BHR-54	Residence	482 Albert Street, Oshawa	Class B Listed Property on the Municipal Heritage Register	<p>The property contains a two storey residence with a Dutch gable roof that is part of a duplex. The exterior is clad in modern siding and the residence has modern windows and doors. The foundation is poured concrete. According to the Heritage Oshawa Inventory, the residence was built in 1890. The residence has design value as a representative late 19<sup>th</sup> century Ontario vernacular structure.</p>

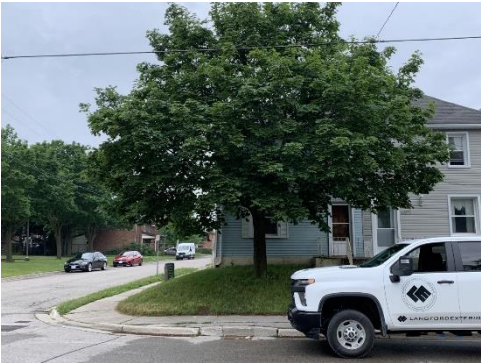
CHR Reference Number	Type of Property	Location	Previous Heritage Recognition	Description of Known or Potential CHVI	Photograph
BHR-55	Residence	484 Albert Street, Oshawa	Class B Listed Property on the Municipal Heritage Register	The property contains a two storey residence with a Dutch gable roof that is part of a duplex. The exterior is clad in modern siding and the residence has modern windows and a wooden door. The foundation is poured concrete. According to the Heritage Oshawa Inventory, the residence was built in 1890. The residence has design value as a representative late 19 <sup>th</sup> century Ontario vernacular structure.

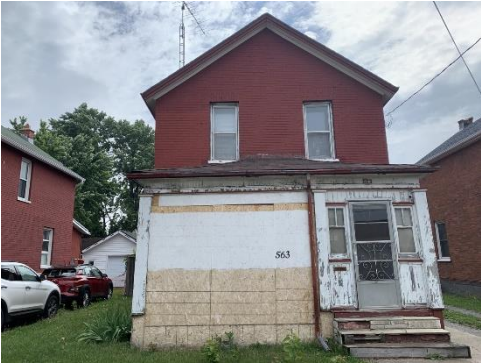
BHR-56	Residence	563 Albert Street, Oshawa	Identified during field review	The property contains a two storey residence with a front gable roof. The exterior or the residence is red brick with matching brick voussoirs above the upper storey windows. The front (west) façade has an enclosed porch supported by square columns. The walls of the porch are clad in wood with decorative trim and there are 2/1 side lights on either side of a modern screen door. The sides of the porch have 3/2 windows. The foundation is poured concrete. The residence was likely built between 1900 and 1911 based on the architectural style and fire insurance plan. The residence has potential design value as a representative early 20 <sup>th</sup> century Ontario vernacular structure.

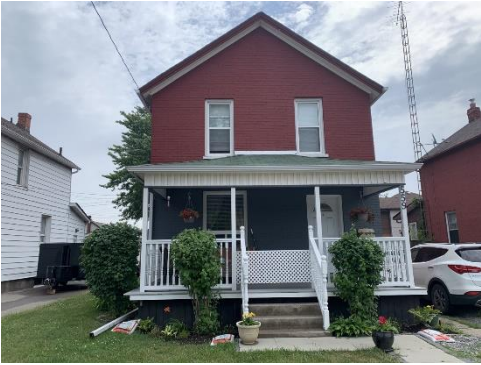
BHR-57	Residence	559 Albert Street, Oshawa	Identified during field review	The property contains a two storey residence with a front gable roof. The exterior or the residence is red brick with matching brick voussoirs above the upper storey windows. The front (west) façade has a covered porch with decorative trim below its roof, spindle railing, and plain square support beams. The windows and door are modern. The foundation is poured concrete. The residence was likely built between 1900 and 1911 based on the style and fire insurance plan. The residence has potential design value as a representative early 20 <sup>th</sup> century Ontario vernacular structure.

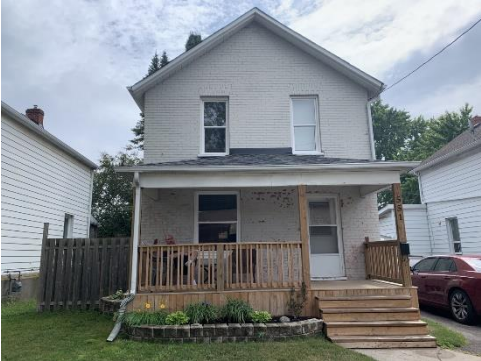
CHR Reference Number	Type of Property	Location	Previous Heritage Recognition	Description of Known or Potential CHVI	Photograph
BHR-58	Residence	551 Albert Street, Oshawa	Identified during field review	The property contains a two storey residence with a front gable roof. The exterior or the residence is painted brick with brick voussoirs above the upper storey windows. The front (west) façade has a covered porch with railing and supported by plain square columns. The windows and door are modern. The foundation is poured concrete. The residence was likely built between 1900 and 1911 based on the style and fire insurance plan. The residence has potential design value as a representative early 20 <sup>th</sup> century Ontario vernacular structure.

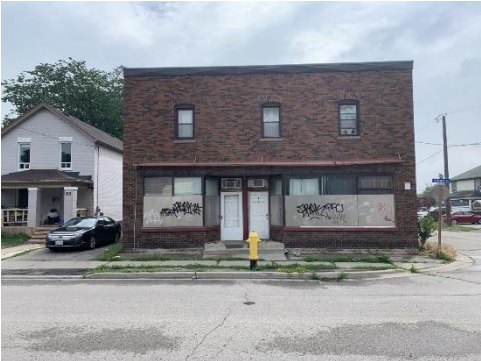
BHR-59	Commercial	539 Albert Street, Oshawa	Identified during field review	The property contains a two storey commercial building with a flat roof. The exterior of the building is red brick with matching voussoirs above segmental arch window openings in the upper storey. The front (west) façade has two recessed entrances between large shop front windows on the ground storey. The foundation is poured concrete. The structure was likely built between 1939 and 1954 based on topographic mapping and aerial photography. The structure has potential design value as a representative early to mid-20 <sup>th</sup> century Ontario vernacular commercial structure.

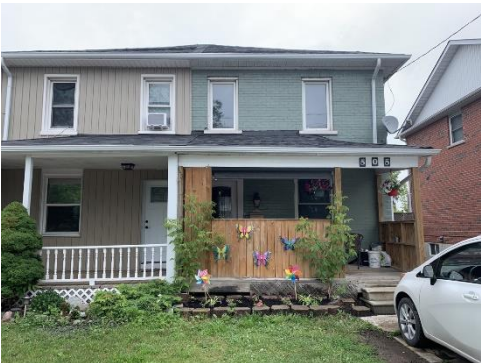
BHR-60	Residence	505 Albert Street, Oshawa	Identified during field review	The property contains a two storey residence with a pyramidal roof that is part of a duplex. The exterior is painted brick. The residence has modern doors and windows. There is a full width covered front porch with modern wooden support beams. The foundation is poured concrete. The residence was likely built between 1911 and 1930 based on the fire insurance plan and topographic mapping. The residence has potential design value as a representative early 20 <sup>th</sup> century Ontario vernacular structure.

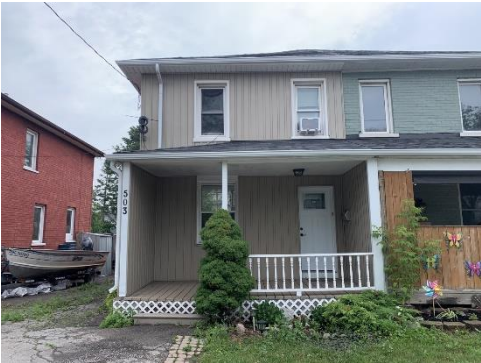
CHR Reference Number	Type of Property	Location	Previous Heritage Recognition	Description of Known or Potential CHVI	Photograph
BHR-61	Residence	503 Albert Street, Oshawa	Identified during field review	The property contains a two storey residence with a pyramidal roof that is part of a duplex. The exterior of the residence is brick and board and batten with the front (west) façade clad in board and batten siding and the north elevation clad in brick. The residence has modern doors and windows. There is a full width covered front porch with plain square support columns and a section of spindle railing. The foundation is poured concrete. The residence was likely built between 1911 and 1930 based on the fire insurance plan and topographic mapping. The residence has potential design value as a representative early 20 <sup>th</sup> century Ontario vernacular structure.

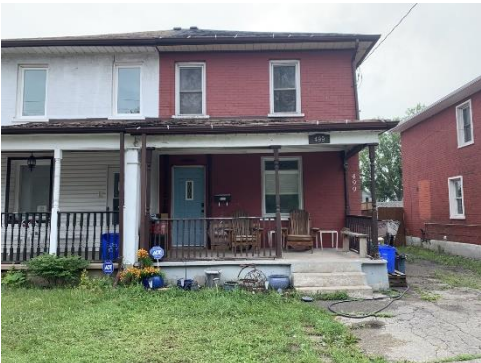
BHR-62	Residence	499 Albert Street, Oshawa	Identified during field review	The property contains a two storey residence with a pyramid roof that is part of a duplex. The exterior of the residence is brick. There is a stained glass rectangular transom window above the first storey window. The residence has a wood door and modern windows on the second storey. There is a full width covered front porch with spindle support columns. The foundation is poured concrete. The residence was likely built between 1911 and 1930 based on the fire insurance plan and topographic mapping. The residence has potential design value as a representative early 20 <sup>th</sup> century Ontario vernacular structure.

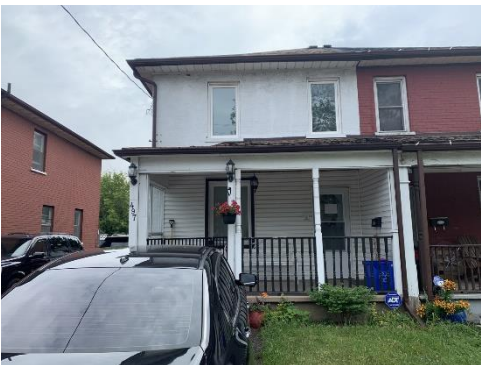
BHR-63	Residence	497 Albert Street, Oshawa	Identified during field review	The property contains a two storey residence with a pyramid roof that is part of a duplex. The exterior of the residence is painted brick with the first storey of the front (west) façade clad in modern siding. The windows and door are modern. There is a full width covered front porch with a combination of square and spindle support columns. The foundation is poured concrete. The residence was likely built between 1911 and 1930 based on the fire insurance plan and topographic mapping. The residence has potential design value as a representative early 20 <sup>th</sup> century Ontario vernacular structure.

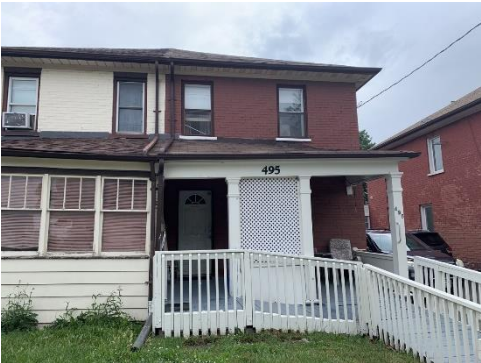
CHR Reference Number	Type of Property	Location	Previous Heritage Recognition	Description of Known or Potential CHVI	Photograph
BHR-64	Residence	495 Albert Street, Oshawa	Identified during field review	The property contains a two storey residence with a pyramid roof that is part of a duplex. The exterior of the residence is brick. The residence has a modern door and windows. There is a full width covered porch with square support columns. The foundation is obscured. The residence was likely built between 1911 and 1903 based on the fire insurance plan and topographic mapping. The residence has potential design value as a representative early 20 <sup>th</sup> century Ontario vernacular structure.

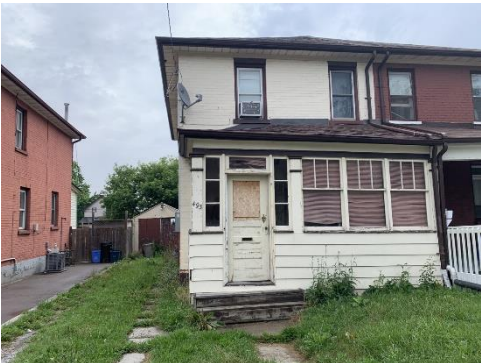
BHR-65	Residence	493 Albert Street, Oshawa	Identified during field review	The property contains two storey residence with a pyramid roof that is part of a duplex. The exterior of the residence is painted brick. There are modern windows on the second storey. There is an enclosed porch on the first storey of the front (west) façade with a wood door, side lights, rectangular transom window, and 3/1 windows. The porch is clad with siding. The foundation is obscured. The residence was likely built between 1911 and 1930 based on the fire insurance plan and topographic mapping. The residence has potential design value as a representative early 20 <sup>th</sup> century Ontario vernacular structure.

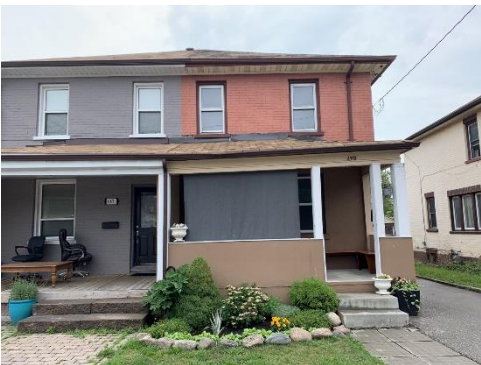
BHR-66	Residence	489 Albert Street, Oshawa	Identified during field review	The property contains a two storey residence with a pyramidal roof that is part of a duplex. The exterior of the residence is brick. The residence has a modern door and windows. There is a full width covered front porch with plain square support beams. The foundation is obscured. The residence was likely built between 1911 and 1930 based on the fire insurance plan and topographic mapping. The residence has potential design value as a representative early 20 <sup>th</sup> century Ontario vernacular structure.

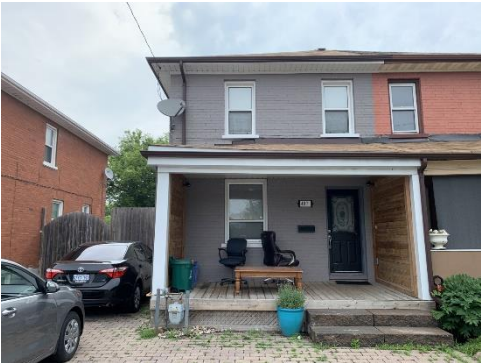
CHR Reference Number	Type of Property	Location	Previous Heritage Recognition	Description of Known or Potential CHVI	Photograph
BHR-67	Residence	487 Albert Street, Oshawa	Identified during field review	The property contains a two storey residence with a hip roof that is part of a duplex. The exterior of the residence is painted brick. There are modern windows and doors. The residence has a full width covered front porch with plain square support beams. The foundation is obscured. The residence was likely built between 1911 and 1930 based on the fire insurance plan and topographic mapping. The residence has potential design value as a representative early 20 <sup>th</sup> century Ontario vernacular structure.

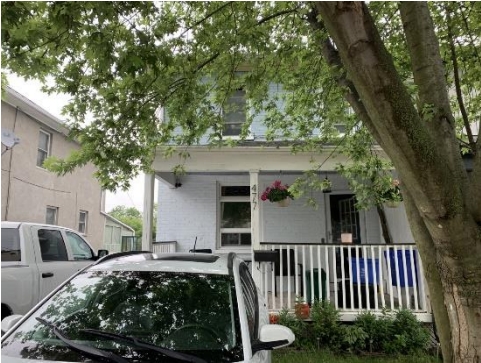
BHR-68	Residence	477 Albert Street, Oshawa	Identified during field review	The property contains a two storey residence with a hip roof that is part of a duplex. The exterior of the residence is painted brick. There is a stained glass transom above the first storey window and a full width covered porch with plain, square support beams and plain railing. The foundation is poured concrete. The residence was likely built between 1911 and 1930 based on the fire insurance plan and topographic mapping. The residence has potential design value as a representative early 20 <sup>th</sup> century Ontario vernacular structure.

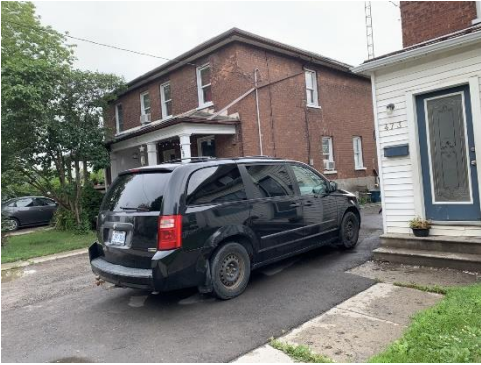
BHR-69	Residence	469 Albert Street, Oshawa	Identified during field review	The property contains a two storey residence with a hip roof that is part of a duplex. The exterior is red brick. There are modern windows in the upper storey and a modern door. The first floor window on the front (west) façade has a stained glass transom above it. The foundation is poured concrete. The residence was likely built between 1911 and 1930 based on the fire insurance plan and topographic mapping. The residence has potential design value as a representative early 20 <sup>th</sup> century Ontario vernacular structure.

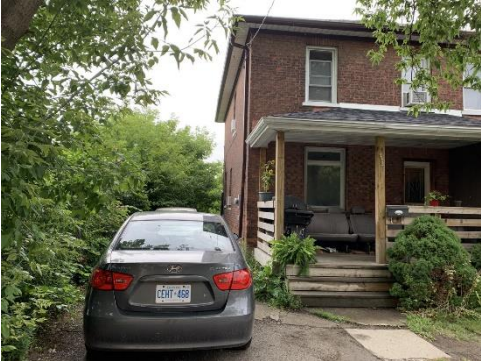
CHR Reference Number	Type of Property	Location	Previous Heritage Recognition	Description of Known or Potential CHVI	Photograph
BHR-70	Residence	467 Albert Street, Oshawa	Identified during field review	The property contains a two storey residence with a hip roof that is part of a duplex. The exterior is red brick. There are modern windows in the upper storey and a modern door. The first floor window on the front (west) façade has a stained glass transom above it. The foundation is poured concrete. The residence was likely built between 1911 and 1930 based on the fire insurance plan and topographic mapping. The residence has potential design value as a representative early 20 <sup>th</sup> century Ontario vernacular structure.

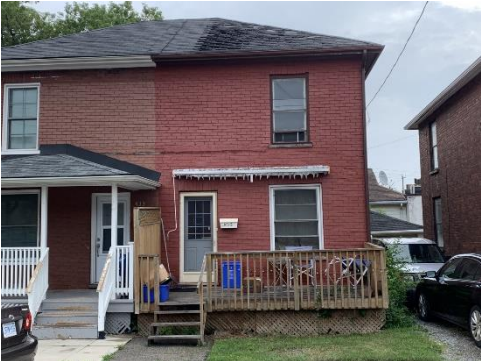
BHR-71	Residence	435 Albert Street, Oshawa	Identified during field review	The property contains a two storey residence with a hip roof that is part of a duplex. The exterior of the residence is painted brick. There are modern doors and windows. The full width covered porch has been removed on this structure and replaced with a retractable awning on this half of the duplex. The foundation is concrete block. The residence was likely built between 1911 and 1930 based on the fire insurance plan and topographic mapping. The residence has potential design value as a representative early 20 <sup>th</sup> century Ontario vernacular structure.

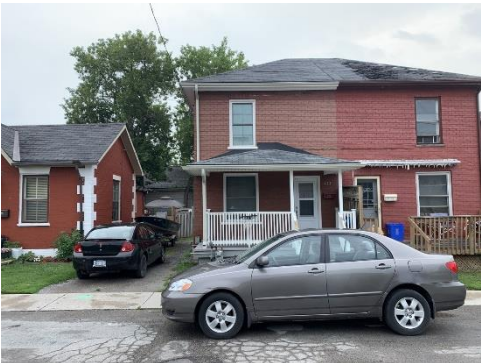
BHR-72	Residence	433 Albert Street, Oshawa	Identified during field review	The property contains a two storey residence with a hip roof that is part of a duplex. The exterior is brick. The residence has modern doors and windows. The full width covered porch has been removed on this structure and replaced with a half width covered porch with plain square support beams and railing on this half of the duplex. The foundation is concrete block. The residence was likely built between 1911 and 1930 based on the fire insurance plan and topographic mapping. The residence has potential design value as a representative early 20 <sup>th</sup> century Ontario vernacular structure.

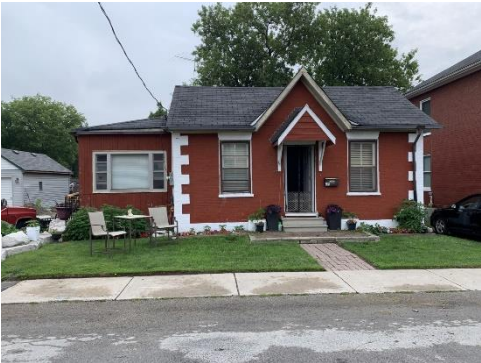
CHR Reference Number	Type of Property	Location	Previous Heritage Recognition	Description of Known or Potential CHVI	Photograph
BHR-73	Residence	431 Albert Street, Oshawa	Identified during field review	The property contains a one storey residence. It has a centre gable roof and a one storey hip roof addition on the north façade. The addition is clad in wood and has a concrete block foundation. The exterior of the original residence is brick with brick quoins. There is a triangular pediment above the entrance. The residence has 2/2 wood frame windows. The foundation is obscured. The residence was likely built between 1878 and 1911 based on the architectural style, historical mapping, and the fire insurance plan. The residence has potential design value as a representative Ontario vernacular structure with Gothic Revival design influence.

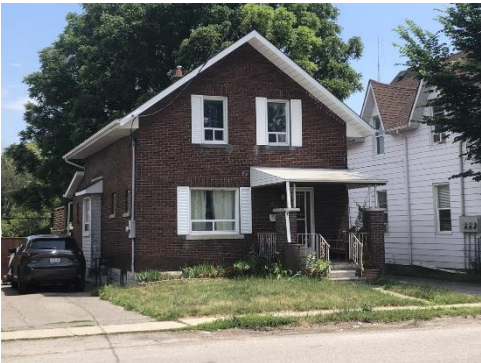
BHR-74	Residence	371 Albert Street, Oshawa	Identified during field review	The property contains a one and one-half storey residence with a front gable roof. The exterior of the residence is red/brown brick with matching brick voussoirs above the window openings. The doors and windows are modern. The residence has a half width covered porch with a metal roof and partial brick support pillars completed by decorative metal support posts. The porch also has decorative metal railing. The foundation is poured concrete with faux stone panels covering most of the foundation. The residence was likely built between 1911 and 1931 based on fire insurance mapping and city directories. The residence has potential design value as a representative early 20 <sup>th</sup> century Ontario vernacular structure.

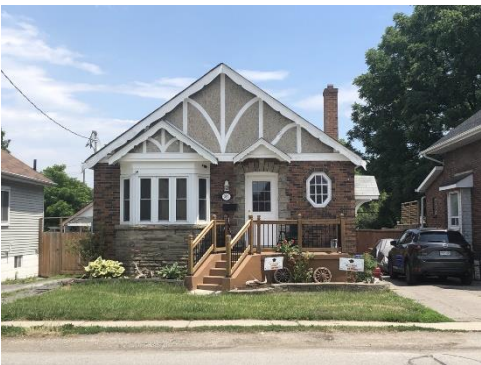
BHR-75	Residence	367 Albert Street, Oshawa	Identified during field review	The property contains a one storey residence with a front gable roof. There is bargeboard, half timbering, and pebble dash in the gable. The exterior of the residence is red brick. The front (west) façade has a bay window, a segmental arch door opening, and a wood frame octagonal window. There are stone accents around the door and under the bay window. The door has a triangular pediment with bargeboard and the bay window has a triangular pediment with bargeboard, half timbering and pebble dash. The foundation is poured concrete. The residence was likely built between 1939 and 1954 based on topographic mapping and aerial photography. The residence has potential design value as a representative mid-20 <sup>th</sup> century vernacular structure with Period Revival design influences.

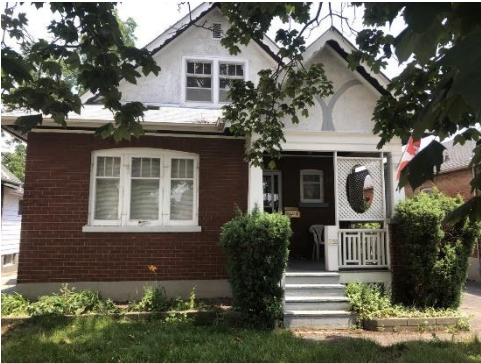
CHR Reference Number	Type of Property	Location	Previous Heritage Recognition	Description of Known or Potential CHVI	Photograph
BHR-76	Residence	355 Albert Street, Oshawa	Identified during field review	The property contains a one and one-half storey residence with a combination hip and front gable roof. There is bargeboard and stucco in the gable. There is a shed roof dormer on the south façade and a gable roof dormer on the north façade. The exterior of the residence is red brick with matching brick voussoirs above segmental arch window and door openings on the first storey. The residence has wood frame storm windows and 3/1 windows on the first storey and modern storm windows over 3/1 windows in the gable. The entrance on the front (west) façade has a covered porch with decorative railing and a gable roof supported by brick half pillars and square columns. The porch gable has bargeboard, half timbering, and stucco inside it. The foundation is concrete blocks. The residence was likely built between 1939 and 1954 based on topographic mapping and aerial photography. The residence has potential design value as a mid-20 <sup>th</sup> century vernacular structure with Period Revival design influence.

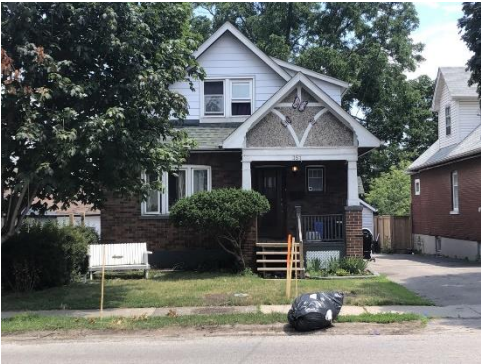
BHR-77	Residence	351 Albert Street, Oshawa	Identified during field review	The property contains a one and one-half storey residence with a combination hip and front gable roof. There is siding in the gable, a shed roof dormer on the south façade and a gable dormer on the north façade. The exterior of the residence is red brick with matching brick voussoirs above segmental arch window and door openings on the first storey. The residence has modern doors and windows, except for a small 3/1 wood frame window under the porch. The entrance on the front (west) façade has a covered porch with plain railing and a gable roof supported by brick half pillars and square columns. The porch gable has bargeboard, half timbering, and pebble dash inside it. The foundation is poured concrete. The residence was likely built between 1939 and 1954 based on topographic mapping and aerial photography. The residence has potential design value as a representative mid-20 <sup>th</sup> century vernacular structure with Period Revival design influence.

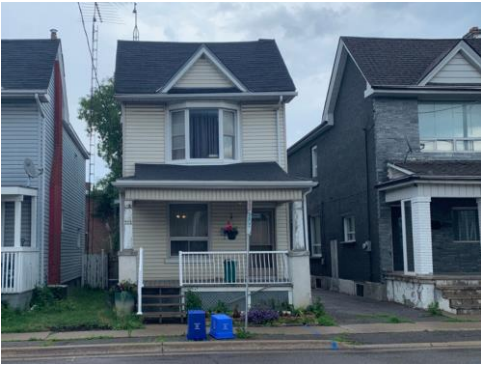
BHR-78	Residence	323 Albert Street, Oshawa	Class B Listed Property on the Municipal Heritage Register	The property contains a two storey residence with a side gable roof and gable peak. The exterior of the residence and the gable have been clad in siding. The windows and doors are modern. There are bay windows on the north and front (west) facades. The residence has a full width covered front porch with the roof supported by half pillars made of concrete and square columns. The foundation is poured concrete. According to the Heritage Oshawa Inventory, the residence was constructed in 1900. The residence has design value as a representative early 20 <sup>th</sup> century Ontario vernacular structure.

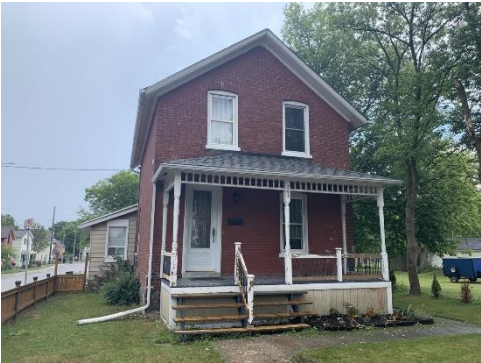
CHR Reference Number	Type of Property	Location	Previous Heritage Recognition	Description of Known or Potential CHVI	Photograph
BHR-79	Residence	263 Albert Street, Oshawa	Identified during field review	The property contains a one and one-half storey residence with a front gable roof. The exterior of the residence is red brick with matching brick voussoirs above segmental arch windows openings. The residence has modern windows and doors. There is a full width covered front porch on the front (west) façade with plain railing and turned support columns. There is a short row of spindles below the porch roof as well. The residence has a stone foundation. The residence was likely built between 1900 and 1911 based on the style and the fire insurance plan. The residence has potential design value as a representative early 20 <sup>th</sup> century Ontario vernacular structure.

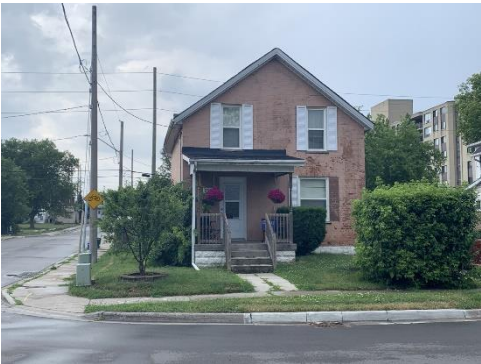
BHR-80	Residence	256 Court Street, Oshawa	Class B Listed Property on the Municipal Heritage Register	The property contains a one and one-half storey residence with a front gable roof. The exterior of the residence is brick with brick voussoirs above the window openings. The windows and doors are modern. There is a half width covered porch on the front (east) façade with turned supports, plain railing, and a rusticated concrete block base. The foundation is poured concrete. According to the Heritage Oshawa Inventory, the residence was constructed in 1905. The residence has design value as an early 20 <sup>th</sup> century representative Ontario vernacular structure.

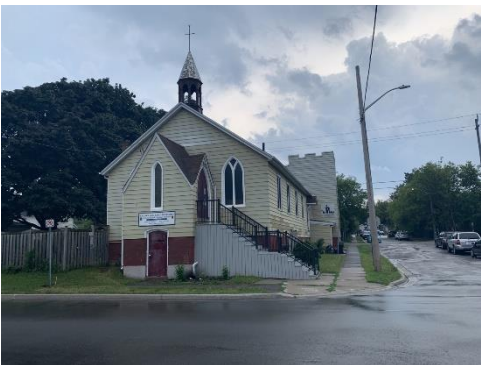
BHR-81	Church	300 Court Street, Oshawa	Class B Listed Property on the Municipal Heritage Register	The property contains a two storey church with a front gable roof. The exterior of the structure is red brick and modern siding. There is an enclosed entrance vestibule with a steeply pitched gable roof on the front (east) façade. The entryway has a segmental arch shaped door on the east side at the ground level and a pointed arch double door that enters the second storey on the north side of the entryway. The second storey on the front façade also has pointed arch windows. The central window, located in the entryway, is stained glass and the windows to each side of it have stained glass panes in the top section. There is a small octagonal bell tower on top of the main gable. The foundation is poured concrete. According to the Heritage Oshawa Inventory, the church was constructed in 1925. The church has potential design value as a representative early 20 <sup>th</sup> century church with Neo-Gothic influence and associative or historical value through its connection to the Church of the Good Shepherd and the community.

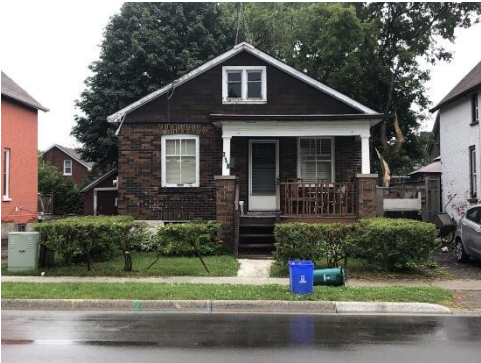
CHR Reference Number	Type of Property	Location	Previous Heritage Recognition	Description of Known or Potential CHVI	Photograph
BHR-82	Residence	113 Stacey Avenue, Oshawa	Identified during field review	The property contains a one and one-half storey residence with a front gable roof. There are shingles in the gable. The exterior of the residence is red brick with matching brick voussoirs above the segmental arch window openings. The residence has wood frame, 4 pane storm windows in front of 3/1 wood frame windows. The window in the gable is wood frame as well. There is a half width covered porch on the front (north) façade with brick half pillars and square columns. The porch has spindle railing. The foundation is rusticated concrete. The residence was likely built between 1921 and 1931 based on city directories. The residence has potential design value as a representative early 20 <sup>th</sup> century Ontario vernacular structure with Arts and Crafts influence.

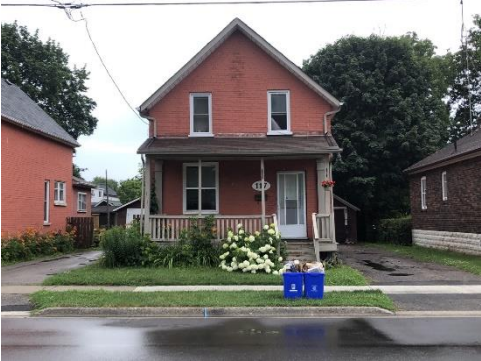
BHR-83	Residence	117 Stacey Avenue, Oshawa	Identified during field review	The property contains a one and one-half storey residence with a front gable roof. The exterior of the residence is brick with brick voussoirs above the windows. The windows and doors are modern. There is a full width covered porch with plain support beams and railings. The foundation is poured concrete. The residence was likely built between 1900 and 1911 based on the style and the fire insurance plan. The residence has potential design value as an early 20 <sup>th</sup> century Ontario vernacular structure.

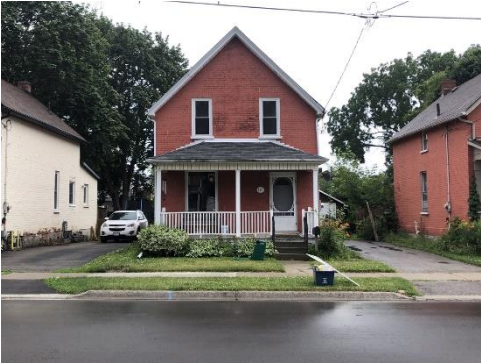
BHR-84	Residence	121 Stacey Avenue, Oshawa	Identified during field review	The property contains a one and one-half storey residence with a front gable roof. The exterior of the residence is brick with brick voussoirs above the windows. The windows and doors are modern. There is a full width covered porch with plain support beams and railings. The foundation is poured concrete. The residence was likely built between 1900 and 1911 based on the style and the fire insurance plan. The residence has potential design value as an early 20 <sup>th</sup> century Ontario vernacular structure.

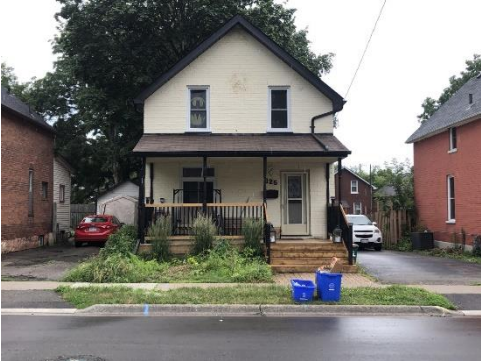
CHR Reference Number	Type of Property	Location	Previous Heritage Recognition	Description of Known or Potential CHVI	Photograph
BHR-85	Residence	125 Stacey Avenue, Oshawa	Identified during field review	The property contains a one and one-half storey residence with a front gable roof. The exterior of the residence is painted brick with brick voussoirs above the windows and door. The windows are modern. There is a stained-glass window in the door and a rectangular stained glass transom window above the first storey window on the front (north) façade. There is a full width covered porch with turned support beams and plain railings on the front façade. The foundation is poured concrete. The residence was likely built between 1900 and 1911 based on the style and the fire insurance plan. The residence has potential design value as an early 20 <sup>th</sup> century Ontario vernacular structure.

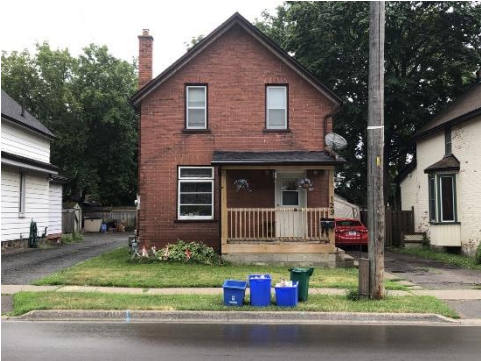
BHR-86	Residence	129 Stacey Avenue, Oshawa	Identified during field review	The property contains a one and one-half storey residence with a front gable roof and brick chimney. The exterior of the residence is red brick with brick voussoirs above the windows. The window and in the gable and the door are modern. There is a rectangular stained glass transom window above the first storey window on the front (north) façade. This window has wood frame storm windows covering a three paned window. There is a half width covered porch with pain, square support beams and railings on the front façade. The residence has a stone foundation. The residence was likely built between 1900 and 1911 based on the style and the fire insurance plan. The residence has potential design value as an early 20 <sup>th</sup> century Ontario vernacular structure.

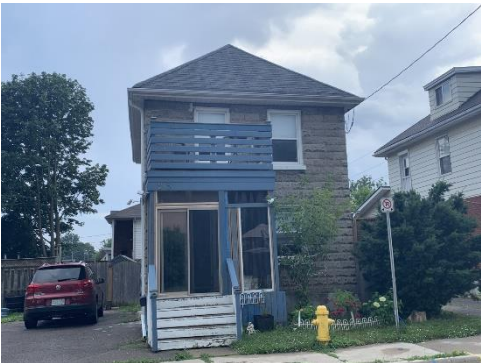
BHR-87	Residence	95 Wilkinson Avenue, Oshawa	Identified during field review	The property contains a two storey residence with a hip roof. The exterior of the residence is rusticated concrete block. The windows and door are modern. There is a wooden half width covered porch with an upper balcony added to the front (north) façade. The foundation is poured concrete. The residence was likely built between 1911 and 1928 based on fire insurance mapping and city directories. The residence has potential design value as a representative early to early 20 <sup>th</sup> century Ontario vernacular structure.

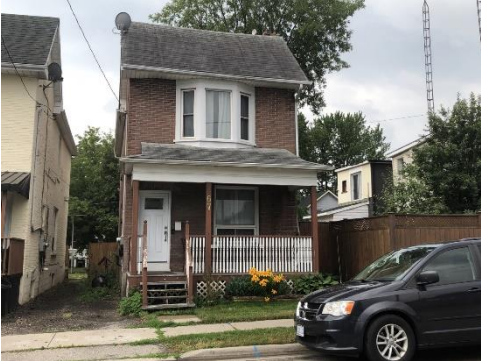
CHR Reference Number	Type of Property	Location	Previous Heritage Recognition	Description of Known or Potential CHVI	Photograph
BHR-88	Residence	67 Banting Avenue, Oshawa	Identified during field review	The property contains a one and one-half storey residence with a side gable roof. The exterior of the residence is red brick. The windows and doors are modern. There is a bay window on the upper storey of the front (north) façade. The front façade also has a full width, covered porch with plain square support beams and turned spindle railing. The foundation is poured concrete. The residence was likely built between 1912 and 1921 based on fire insurance mapping and city directories. The residence has potential design value as a representative early 20 <sup>th</sup> century Ontario vernacular residence.

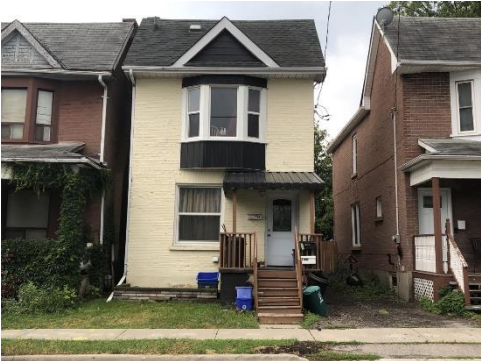
BHR-89	Residence	69 Banting Avenue, Oshawa	Identified during field review	The property contains a one and one-half storey residence with a centre gable roof. The gable has siding inside it. The exterior of the residence is brick. The windows and doors are modern. There is a bay window on the upper storey of the front (north) façade. The front façade also has a half width, covered porch with a metal roof and plain wood support beams and railing. The foundation is concrete with a stamped block design. The residence was likely built between 1912 and 1921 based on fire insurance mapping and city directories. The residence has potential design value as a representative early 20 <sup>th</sup> century Ontario vernacular residence.

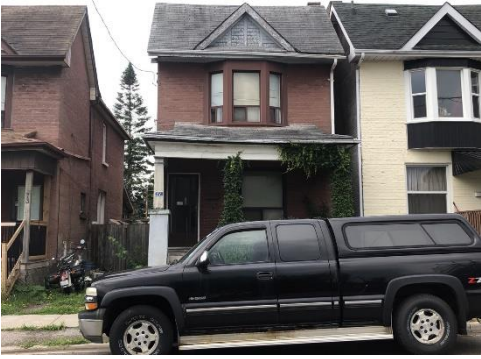
BHR-90	Residence	71 Banting Avenue, Oshawa	Identified during field review	The property contains a one and one-half storey residence with a centre gable roof. The gable has wood shingles and timbering inside it. The exterior of the residence is brick. The windows are wood frame ½ windows and the door is modern. There is a bay window on the upper storey of the front (north) façade. The front façade also has a full width, covered porch with half pillars made of concrete and square support columns. The foundation is concrete with a stamped block design. The residence was likely built between 1912 and 1921 based on fire insurance mapping and city directories. The residence has potential design value as a representative early 20 <sup>th</sup> century Ontario vernacular residence.

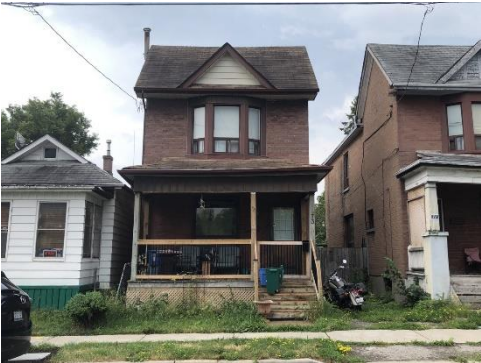
CHR Reference Number	Type of Property	Location	Previous Heritage Recognition	Description of Known or Potential CHVI	Photograph
BHR-91	Residence	73 Banting Avenue, Oshawa	Identified during field review	The property contains a one and one-half storey residence with a centre gable roof. The gable has siding inside it. The exterior of the residence is brick. The windows are wood frame 1:2 windows and a wooden door with a nine-pane window. There is a bay window on the upper storey of the front (north) façade. The front façade also has a full width, covered porch with square support beams and plain railing. The foundation is concrete. The residence was likely built between 1912 and 1921 based on fire insurance mapping and city directories. The residence has potential design value as a representative early 20 <sup>th</sup> century Ontario vernacular residence.

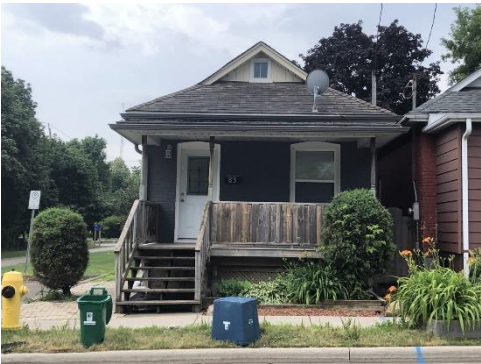
BHR-92	Residence	83 Banting Avenue, Oshawa	Identified during field review	The property contains a one storey residence with a Dutch gable roof that has board and batten siding in the gable. The exterior of the residence is brick. The window and doors, which are modern, are in segmental arch openings. The windows on the east façade have brick voussoirs. There is a full width covered porch with turned spindle supports and wooden railing. The foundation is poured concrete. The residence was likely built between 1912 and 1931 based on city directories. The residence has potential design value as a representative early 20 <sup>th</sup> century Ontario vernacular structure.

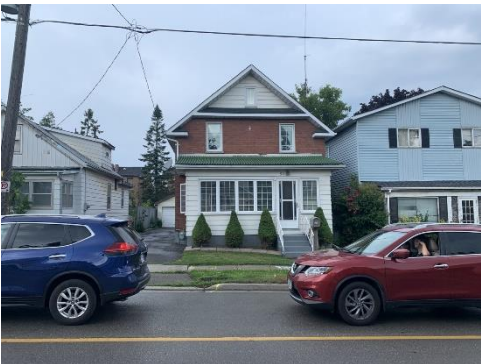
BHR-93	Residence	92 Olive Avenue, Oshawa	Identified during field review	The property contains a one and one-half storey residence with a front gable roof. There is siding in the gable. The exterior of the residence is red brick. The windows and doors are modern. The residence has an enclosed porch on the front (south) façade. The porch has a corrugated metal roof and the walls are clad in siding. The foundation is poured concrete. The residence was likely built between 1911 and 1930 based on the fire insurance plan and topographic mapping. The residence has potential design value as a representative early 20 <sup>th</sup> century Ontario vernacular residence.

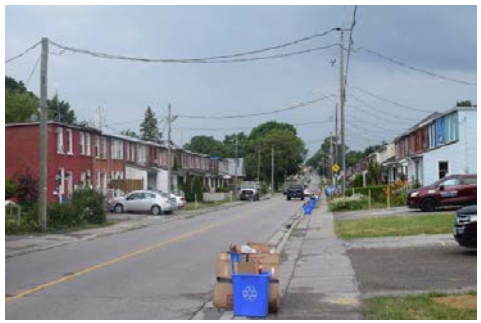
CHL-1	Residential Cultural Heritage Landscape	106 to 136; 142 to 168; 145 to 167.5 Olive Avenue, Oshawa	Class A Listed Property on the Municipal Heritage Register	These properties contain two storey row houses with flat rooflines. The exterior of the residences is brick with brick voussoirs above the window and door openings. The residences have a mixture of replacement and original windows and doors. The houses have full width front porches. Located on both sides of Olive Avenue and a rare example of row housing in downtown Oshawa, the structures give this section of Olive Avenue a distinct character. According to the Heritage Oshawa Inventory, the rowhouses were built circa 1910. The row houses contain potential design value as early 20 <sup>th</sup> century Ontario vernacular structures and are contextually linked to their surroundings and are landmark structures along Olive Avenue.

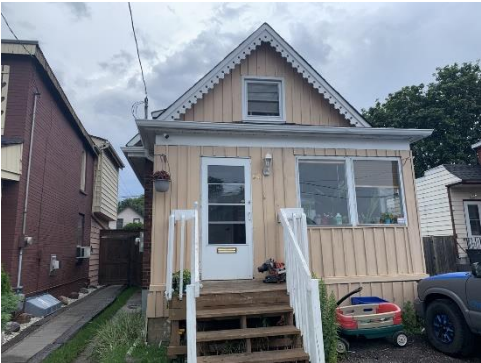
CHR Reference Number	Type of Property	Location	Previous Heritage Recognition	Description of Known or Potential CHVI	Photograph
BHR-94	Residence	140 Olive Avenue, Oshawa	Identified during field review	The property contains a one and one-half storey residence with a front gable roof. There is an enclosed, nearly full width porch on the front (south) façade. The exterior of the residence is red brick with board and batten siding in the gable and on the walls of the porch. The gable also has bargeboard. The windows and doors are modern. The foundation is concrete blocks. The residence was likely built between 1931 and 1951 based on city directories. The residence has potential design value as a representative mid-20 <sup>th</sup> century Ontario vernacular structure.

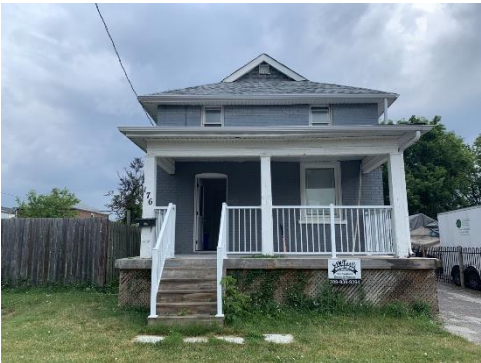
BHR-95	Residence	176 Olive Avenue, Oshawa	Identified during field review	The property contains a one and one-half storey residence with a Dutch gable roof. The exterior of the residence is brick. The windows and doors are modern. There is a full width, covered porch on the front (south) façade with plain square support columns and railing. There are dentils along the roofline of the porch. The foundation is obscured. The residence was likely built between 1900 and 1930 based on the style and topographic mapping. The residence has potential design value as a representative early 20 <sup>th</sup> century Ontario vernacular structure.

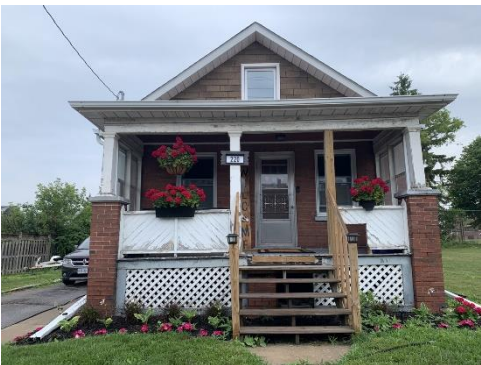
BHR-96	Residence	220 Olive Avenue, Oshawa	Identified during field review	The property contains a one and one-half storey residence with a front gable roof. The exterior of the residence is red brick with shingles in the gable and matching brick voussoirs above the window and door openings. The windows are modern and there is a wooden door. The residence has a full width, covered porch on the front (south) façade. The porch roof is supported by brick half pillars with square columns on top. The foundation is concrete block. The residence was likely built between 1900 and 1930 based on the style and topographic mapping. The residence has potential design value as a representative early 20 <sup>th</sup> century Ontario vernacular structure.

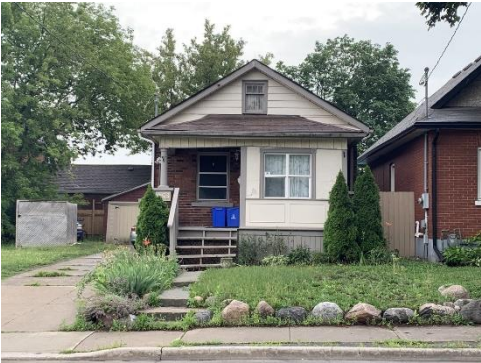
CHR Reference Number	Type of Property	Location	Previous Heritage Recognition	Description of Known or Potential CHVI	Photograph
BHR-97	Residence	253 Olive Avenue, Oshawa	Identified during field review	The property contains a one and one-half storey residence with a front gable roof. The exterior of the residence is red brick and there is siding and a 3/1 wood frame window in the gable. The rest of the windows are modern with wood surrounds. The residence has a full width, covered porch on the front (north) façade that is partially enclosed. The porch roof is supported by brick half pillars with round columns on top. The foundation is poured concrete. The residence was likely built between 1900 and 1930 based on the style and topographic mapping. The residence has potential design value as a representative early 20 <sup>th</sup> century Ontario vernacular structure.

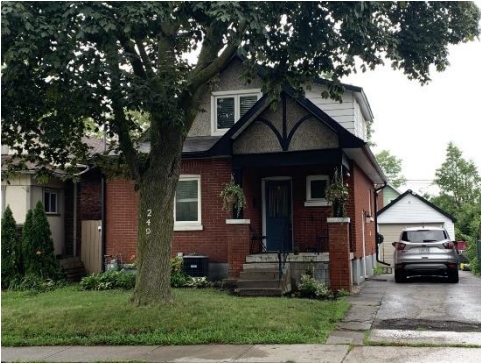
BHR-98	Residence	249 Olive Avenue, Oshawa	Identified during field review	The property contains a one and one-half storey residence with a combination hip and gable roof. The exterior of the residence is red brick with matching brick voussoirs above segmental arch window and door openings. There is a shed roof dormer on the side (west) façade. There is a half width covered front porch with a gable roof supported by brick half pillars with plain square columns on top. The gable of the porch is filled with pebble dash and half timbering and the gable of the house is also filled with pebble dash. The windows and door are modern. The foundation is concrete block. The residence was likely built between 1931 and 1951 based on city directories. The residence has potential design value as a representative mid-20 <sup>th</sup> century Ontario vernacular structure with Arts and Crafts design influence.

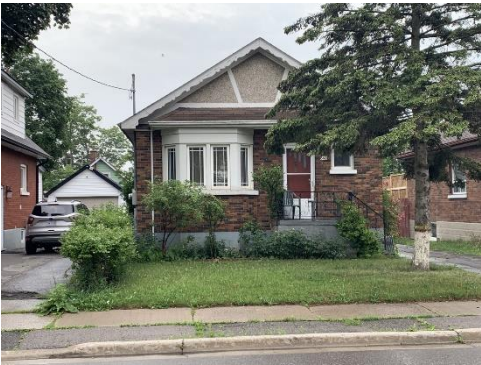
BHR-99	Residence	245 Olive Avenue, Oshawa	Identified during field review	The property contains a one storey residence with a front gable roof. The exterior of the residence is red brick with matching brick voussoirs above segmental arch window and door openings. The gable is filled with pebble dash and has half timbering and bargeboard. The front (north) façade has a bay window and a wooden door. The small window in the front façade has a diamond design in the pane. The foundation is poured concrete. The residence was likely built between 1931 and 1951 based on city directories. The residence has potential design value as representative mid-20 <sup>th</sup> century Ontario vernacular structure with Arts and Crafts design influence.

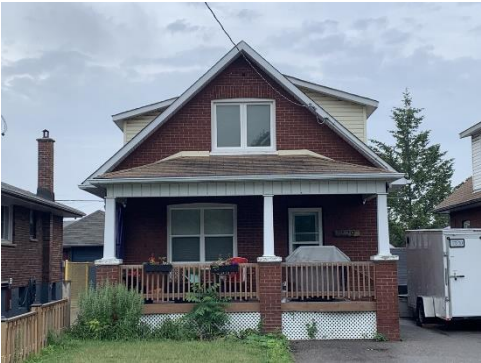
CHR Reference Number	Type of Property	Location	Previous Heritage Recognition	Description of Known or Potential CHVI	Photograph
BHR-100	Residence	229 Olive Avenue, Oshawa	Identified during field review	The property contains a one and one-half storey residence with a front gable roof and shed roof dormers on the east and west facades. The exterior of the residence is red brick with matching brick voussoirs above segmental arch window openings. The residence has modern windows. There is a full width, covered porch on the front (north) façade. The porch roof is supported by brick half pillars with plain square columns on top. The foundation is concrete block. The residence was likely built between 1931 and 1951 based on city directories. The residence has potential design value as a representative mid-20 <sup>th</sup> century Ontario vernacular structure.

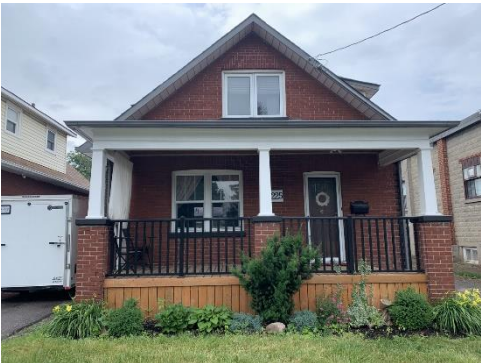
BHR-101	Residence	225 Olive Avenue, Oshawa	Identified during field review	The property contains a one and one-half storey residence with a front gable roof. There are shed roof dormers on the east and west facades. The exterior of the residence is red brick with matching brick voussoirs above segmental arch window and door openings. There are contrasting bricks at the corners of the front (north) façade. There is a wooden door and replacement 3/1 windows on the first storey. The residence has a full width porch on the front façade. The porch roof is supported by brick half pillars with plain square columns on top. The foundation is concrete block. The residence was likely built between 1931 and 1951 based on city directories. The residence has potential design value as a representative mid- 20 <sup>th</sup> century Ontario vernacular structure.

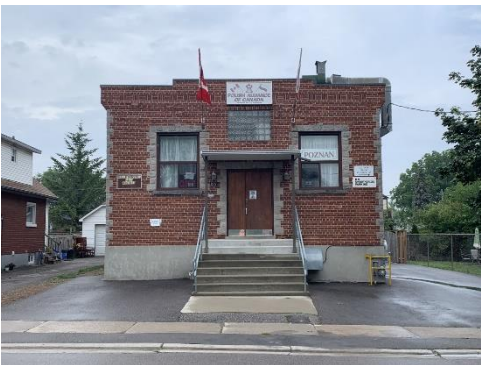
BHR-102	Civic	219 Olive Avenue, Oshawa	Identified during field review	The property contains a one storey civic building with a flat roof. The exterior of the building is red brick with a decorative brickwork band near the roof line. There are stone accents on the corners of the buildings and around the door and window openings. There are wooden, modern windows and one glass block window above the door. The foundation is poured concrete. The structure was likely built between 1900 and 1930 based on the style and topographic mapping. The building has potential design value as a representative early 20 <sup>th</sup> century Ontario vernacular civic structure. The property is historically associated with “GR.21 Związek Polaków w Kanadzie”, a Polish organization established in Oshawa in 1922 and is significant to the Polish community of Oshawa.

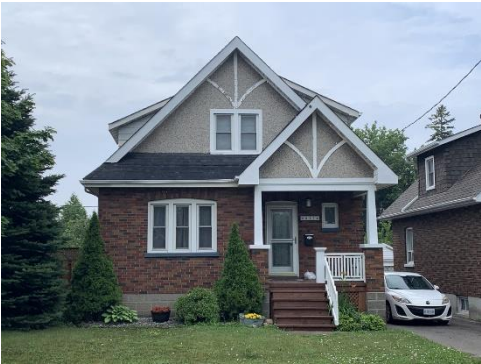
CHR Reference Number	Type of Property	Location	Previous Heritage Recognition	Description of Known or Potential CHVI	Photograph
BHR-103	Residence	217 Olive Avenue, Oshawa	Identified during field review	The property contains a one and one-half storey residence with a combination hip and gable roof. The exterior of the residence is red brick with matching brick voussoirs above segmental arch window and door openings. There are shed roof dormers on the east and west façades. There is a half width covered front porch with a gable roof supported by brick half pillars with plain square columns on top. The gable of the porch is filled with pebble dash and half timbering and the gable of the house is also filled with pebble dash. The windows and door are modern, with the exception of a small window under the porch on the front (north) façade that has a wood frame storm window. The foundation is concrete block. The residence was likely built between 1931 and 1951 based on city directories. The residence has potential design value as a representative mid-20 <sup>th</sup> century Ontario vernacular structure with Arts and Crafts design influences.

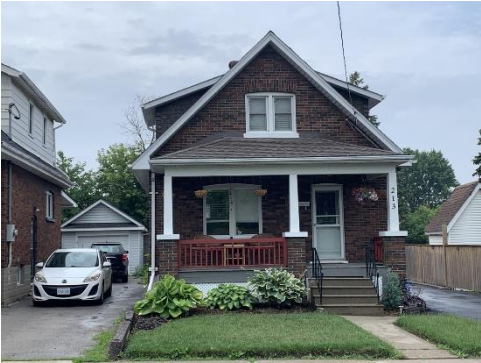
BHR-104	Residence	213 Olive Avenue, Oshawa	Identified during field review	The property contains a one and one-half storey residence with a front gable roof. The exterior of the residence is red brick with matching brick voussoirs above segmental arch window and door openings. There are shed roof dormers on the east and west façades. There is a full width covered front porch with the roof supported by brick half pillars with plain square columns on top. The windows and door are modern. The foundation is poured concrete. The residence was likely built between 1931 and 1951 based on city directories. The residence has potential design value as a representative mid-20 <sup>th</sup> century Ontario vernacular structure.

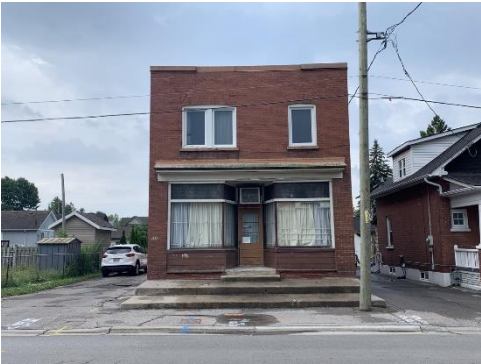
BHR-105	Commercial	183 Olive Avenue, Oshawa	Identified during field review	The property contains a two storey commercial structure with a flat roof. The exterior of the building is red brick with matching brick voussoirs above segmental arch window openings on the second story. The ground storey has large shop front windows with a wooden door and the upper storey windows are modern. The foundation appears to be brick with parging. The building was likely built between 1900 and 1930. The building has potential design value as a representative early 20 <sup>th</sup> century Ontario vernacular structure.

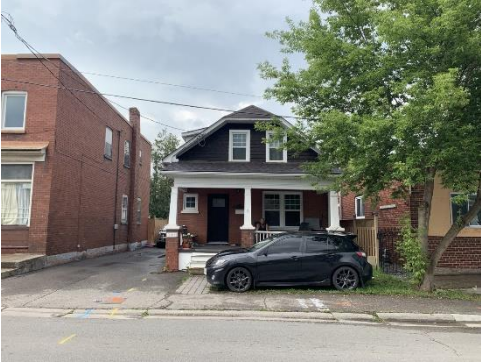
CHR Reference Number	Type of Property	Location	Previous Heritage Recognition	Description of Known or Potential CHVI	Photograph
BHR-106	Residence	181 Olive Avenue, Oshawa	Identified during field review	The property contains a one and one-half storey residence with a clipped gable roof. There are shingles in the gable. There is a shed roof dormer on the east façade. The exterior of the residence is red brick. There is a full width, covered porch on the front (north) façade with the roof supported by brick half pillars with square columns on top. There is a row of dentils along the porch roofline. There is a wooden door with modern windows. The foundation is obscured. The residence was likely built between 1900 and 1930 based on the style and topographic mapping. The residence has potential design value as a representative early 20 <sup>th</sup> century Ontario vernacular structure.
