**Addendum to Oshawa  
to Bowmanville Rail  
Service Extension:  
Cultural Heritage Report  
- Existing Conditions  
and Preliminary Impact  
Assessment**

**Final**

September 26, 2023

Project Number: 165011019

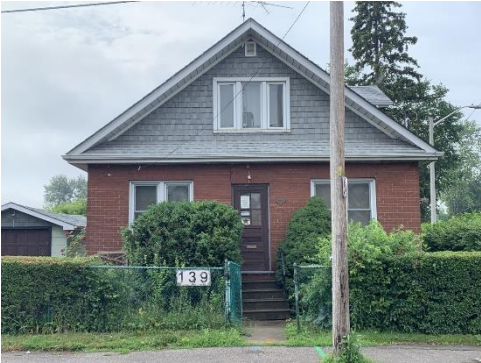
BHR-107	Residence	139 Olive Avenue, Oshawa	Identified during field review	The property contains a one and one-half storey residence with a front gable roof. There are shingles in the gable and a gable roof dormer on west façade. The exterior of the residence is red brick with matching brick voussoirs above the window and door openings. The residence has a wooden door with a four-pane window and modern windows. The foundation is poured concrete. The residence was likely built between 1900 and 1930 based on the style and topographic mapping. The residence has potential design value as a representative early 20 <sup>th</sup> century Ontario vernacular structure.

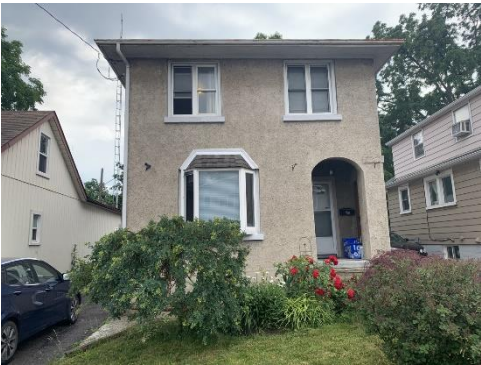
BHR-108	Residence	101 Olive Avenue, Oshawa	Identified during field review	The property contains a two storey residence with a hip roof. The exterior of the residence is clad with stucco. The windows and door are modern. There is a bay window on the front (north) façade and the entrance is recessed in an arched access. The foundation is poured concrete. The residence was likely built between 1900 and 1930 based on the style, city directories, and topographic mapping. The residence has potential design value as a representative early 20 <sup>th</sup> century Ontario vernacular structure.

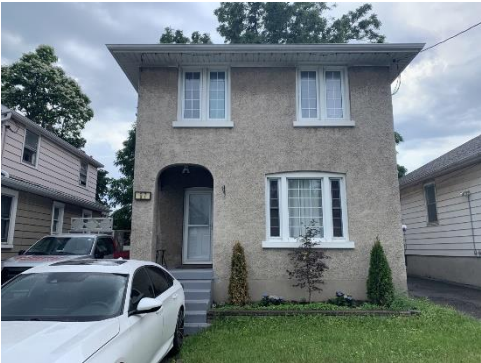
CHR Reference Number	Type of Property	Location	Previous Heritage Recognition	Description of Known or Potential CHVI	Photograph
BHR-109	Residence	97 Olive Avenue, Oshawa	Identified during field review	The property contains a two storey residence with a hip roof. The exterior of the residence is clad with stucco. The windows and door are modern. There is a segmental arch window on the front (north) façade and the entrance is recessed in an arched access. The foundation is poured concrete. The residence was likely built between 1900 and 1930 based on the style, city directories, and topographic mapping. The residence has potential design value as a representative early 20 <sup>th</sup> century Ontario vernacular structure.

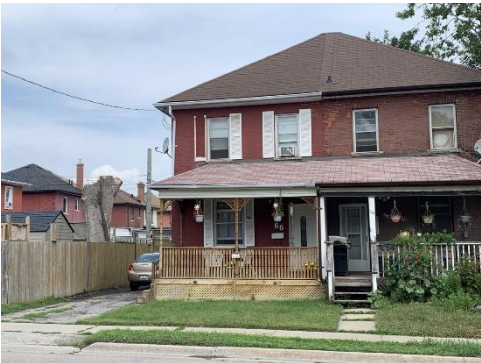
BHR-110	Residence	66 First Avenue, Oshawa	Identified during field review	The property contains a two storey residence with a pyramidal roof and is part of a duplex. The exterior of the residence is painted brick with brick voussoirs over the second storey windows. The residence has a modern door. There is a rectangular stained-glass transom above first storey window. There is a full width, covered porch on the front (south) façade with spindle support beams, decorative lattice corner pieces and spindle railing. The foundation is obscured. The residence was likely built between 1900 and 1911 based on the style and fire insurance plan. The residence has potential design value as a representative early 20 <sup>th</sup> century Ontario vernacular structure.

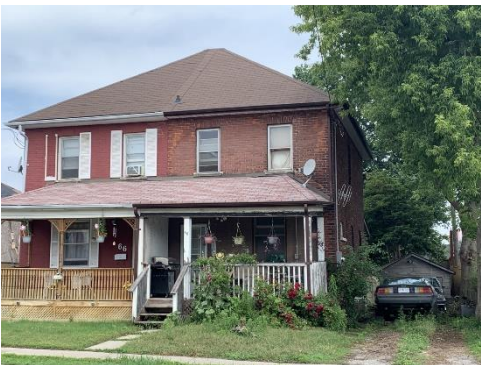
BHR-111	Residence	68 First Avenue, Oshawa	Identified during field review	The property contains a two storey residence with a pyramidal roof and is part of a duplex. The exterior of the residence is brick with brick voussoirs over the second storey windows. The residence has a wooden door with the contains a nine-pane window. There is a rectangular stained-glass transom above the first storey window. There is a full width, covered porch on the front (south) façade with plain square support columns and a section of railing. The foundation is obscured. The residence was likely built between 1900 and 1911 based on the style and fire insurance plan. The residence has potential design value as a representative early 20 <sup>th</sup> century Ontario vernacular structure.

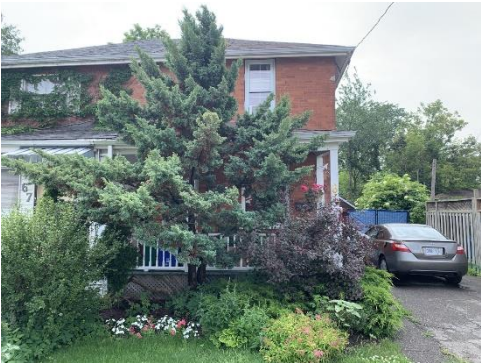
CHR Reference Number	Type of Property	Location	Previous Heritage Recognition	Description of Known or Potential CHVI	Photograph
BHR-112	Residence	65 First Avenue, Oshawa	Identified during field review	The property contains a one and one-half storey residence with a hip roof that is part of a duplex. The exterior of the residence is red brick. There is a stained-glass transom window on the first storey. The door is obscured by a large evergreen tree. The residence also has a full width, covered porch on the front (north) façade with the roof supported by plain square columns. The foundation is concrete. The residence was likely built between 1900 and 1911 based on the style and fire insurance plan. The residence has potential design value as a representative early-20 <sup>th</sup> century Ontario vernacular structure.

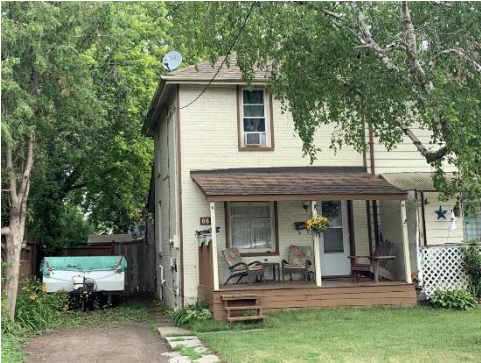
BHR-113	Residence	66 Second Avenue, Oshawa	Identified during field review	The property contains a one and one-half storey residence with a hip roof that is part of a duplex. The exterior of the residence is brick. The second storey has a modern window, with a four-pane wood frame window on the first storey. The residence has a full width, covered porch on the front (south) façade with the roof supported by plain square beams. The foundation is concrete. The residence was likely built between 1900 and 1911 based on the style and fire insurance plan. The residence has potential design value as a representative early-20 <sup>th</sup> century Ontario vernacular structure.

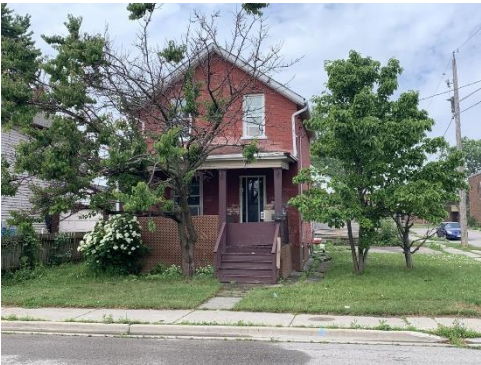
BHR-114	Residence	548 Front Street, Oshawa	Identified during field review	This property contains a residence. The residence is a one and one-half storey structure with a front facing gable roof and a brick chimney. The exterior is red brick and contains modern windows and a modern door. The residence has a full-width front porch and a poured concrete foundation. The residence was likely built between 1900 and 1911 based on the style and fire insurance plan. The residence has potential design value as a representative early-20 <sup>th</sup> century Ontario vernacular structure.

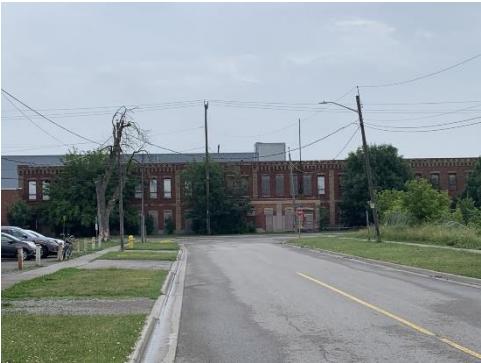
CHR Reference Number	Type of Property	Location	Previous Heritage Recognition	Description of Known or Potential CHVI	Photograph
BHR-115	Industrial	500 Howard Street, Oshawa	Class A Listed Property on the Municipal Heritage Register, Provincial Heritage Property of Provincial Significance	The property contains a historic factory with multiple additions surrounded by a large parking area. The historic portion of the building has two stories with a flat roofline. The exterior of the building is red brick with contrasting buff brick details. The buff brick details include voussoirs above the segmental arch windows openings, banding, and decorative brickwork below the roofline. The windows have been boarded up. The foundation is poured concrete. According to the Statement of CHVI contained in Appendix B, the building is divided into Part 1 and Part 2., Part 1 was built <i>circa</i> 1897 and expanded with an addition before 1910 by the Ontario Malleable Iron Company. The property is a Provincial Heritage Property of Provincial Significance and according to the prepared statement of CHVI the property contains design value through its intact brick architecture, its historic association with the Ontario Malleable Iron Co., and its contextual relationship with the surrounding railway and industrial area. These heritage attributes do not apply to Part 2 of the building, which is identified in the statement of CHVI as being adaptively reused by the Knob Hill Farms grocery store in 1981 (Metrolinx 2016; ERA 2022).

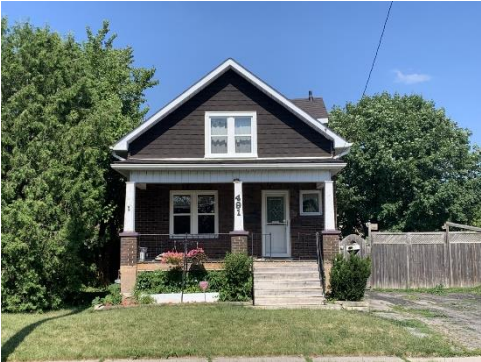
BHR-116	Residence	491 Howard Street, Oshawa	Identified during field review	The property contains a one and one-half storey residence with a front gable roof. There are shingles in the front gable and a gable dormer on the south façade. The exterior of the residence is red brick. The windows and doors are modern. The residence has a full width, covered porch on the front (west) façade with the roof supported by brick half pillars with square columns on top. The foundation is poured concrete. The residence was likely built between 1939 and 1954 based on topographic mapping and aerial photography. The residence has potential design value as a representative mid-20 <sup>th</sup> century Ontario vernacular residence.

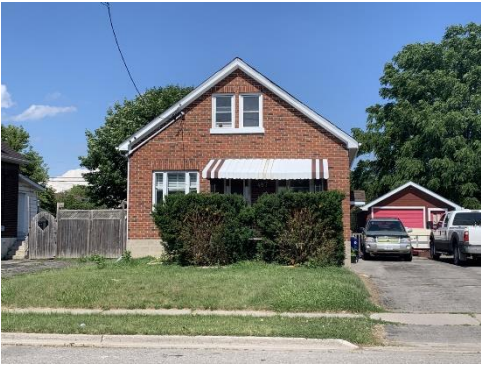
BHR-117	Residence	497 Howard Street, Oshawa	Identified during field review	The property contains a one and one-half storey residence with a front gable roof. The exterior of the residence is red brick with matching brick voussoirs above the window openings. The residence has modern windows and the door is obscured by a large evergreen bush. There is a metal roof over the door supported by decorative metal beams. The foundation is concrete blocks. The residence was likely built between 1939 and 1954 based on topographic mapping and aerial photography. The residence has potential design value as a representative mid-20 <sup>th</sup> century Ontario vernacular residence.

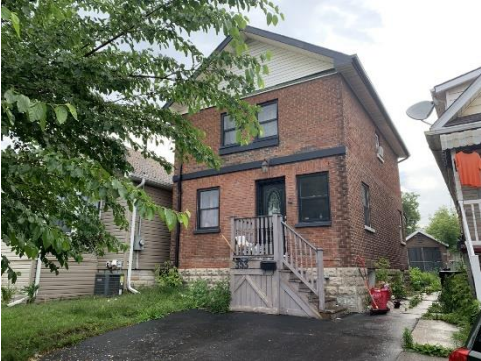
CHR Reference Number	Type of Property	Location	Previous Heritage Recognition	Description of Known or Potential CHVI	Photograph
BHR-118	Residence	353 Drew Street, Oshawa	Identified during field review	The property contains a two storey residence with a front gable roof. There is siding in the gable. The exterior of the residence is red brick with matching brick voussoirs above the window and door openings. The residence has a modern door and windows and partial width porch. The foundation is rusticated concrete block. The residence was likely built between 1939 and 1954 based on topographic mapping and aerial photography. The residence has potential design value as a representative mid-20 <sup>th</sup> century Ontario vernacular structure.

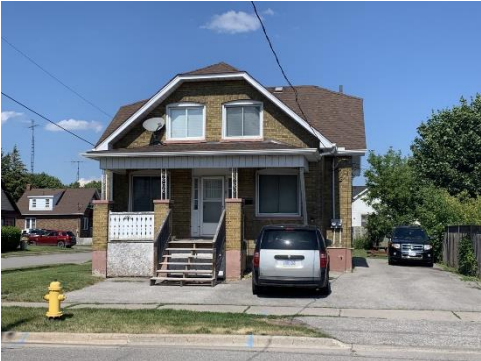
BHR-119	Residence	481 Drew Street, Oshawa	Identified during field review	The property contains a one and one-half storey residence with a crossed clip gable roof. The exterior of the residence is buff brick with matching brick voussoirs above segmental arch window openings. The front (west) entrance is a wooden door with a six pane window and three pane side lights on either side of the door. There is a full width, covered porch supported by brick half pillars with decorative metal columns on top. The foundation is poured concrete. The residence was likely built between 1900 and 1931 based on architectural style and city directories. The residence has potential design value as a representative early 20 <sup>th</sup> century Ontario vernacular structure.

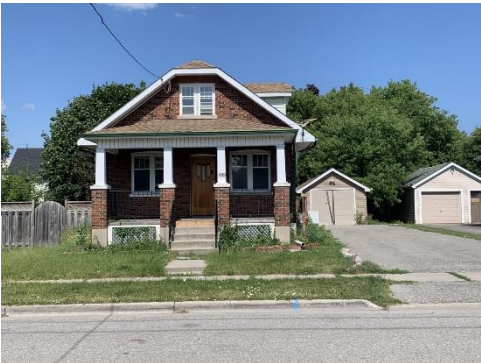
BHR-120	Residence	489 Drew Street, Oshawa	Identified during field review	The property contains a one and one-half storey residence with a clipped gable roof. There is a clipped gable dormer on the south façade. The exterior of the residence is red brick with matching brick voussoirs above segmental arch window and door openings. The windows are 3/1 pane and there is a wooden door. The residence has a full width, covered porch on the front (west) façade and the roof is supported by brick half pillars with plain square columns on top. The foundation is poured concrete. The residence was likely built between 1939 and 1954 based on topographic mapping and aerial photography. The residence has potential design value as a representative early to mid-20 <sup>th</sup> century Ontario vernacular structure.

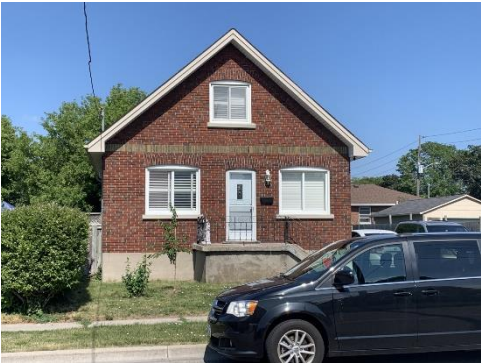
CHR Reference Number	Type of Property	Location	Previous Heritage Recognition	Description of Known or Potential CHVI	Photograph
BHR-121	Residence	497 Drew Street, Oshawa	Identified during field review	The property contains a one and one-half storey residence with a front gable roof. The exterior of the residence is red brick with a band of buff brick between the ground and upper stories. There are brick voussoirs above segmental arch window and door openings. The windows and door are modern. The foundation is concrete block. The residence was likely built between 1939 and 1954 based on topographic mapping and aerial photography. The residence has potential design value as a representative early to mid-20 <sup>th</sup> century Ontario vernacular structure.

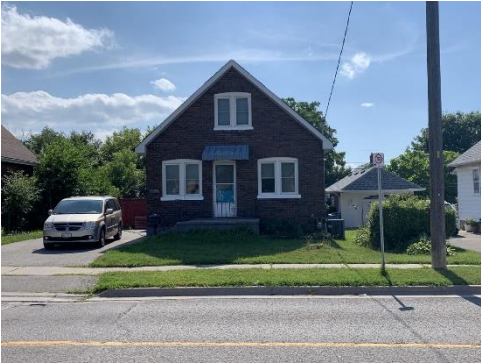
BHR-122	Residence	500 Drew Street, Oshawa	Identified during field review	The property contains a one and one-half storey residence with a front gable roof. The exterior of the residence is red brick. There are brick voussoirs above segmental arch window and door openings. The windows and door are modern. The foundation is concrete block. The residence was likely built between 1939 and 1954 based on topographic mapping and aerial photography. The residence has potential design value as a representative mid-20 <sup>th</sup> century Ontario vernacular structure.

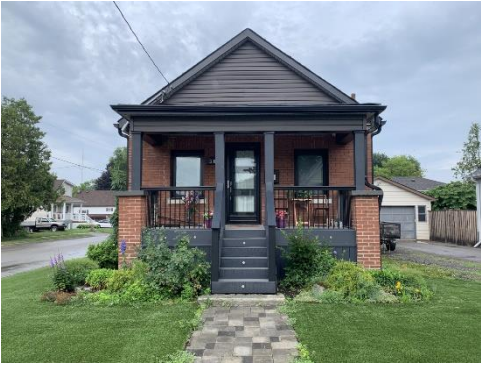
BHR-123	Residence	362 Drew Street, Oshawa	Identified during field review	The property contains a one storey residence with a front gable roof. The exterior of the residence is red brick. The windows are modern and there is a wooden door with three large windowpanes. There is a full width, covered porch on the front (east) façade. The porch roof is supported by brick half pillars with plain square columns on top. The foundation is poured concrete. The residence was likely built between 1900 and 1932 based on architectural style and city directories. The residence has potential design value as a representative mid-20 <sup>th</sup> century Ontario vernacular structure.

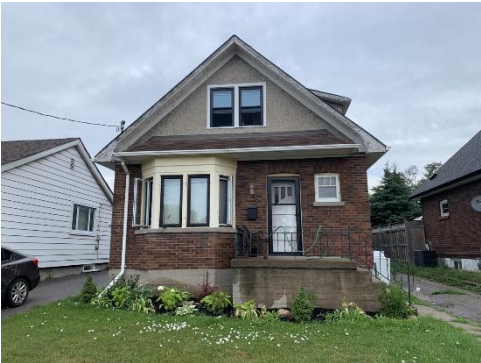
CHR Reference Number	Type of Property	Location	Previous Heritage Recognition	Description of Known or Potential CHVI	Photograph
BHR-124	Residence	242 Mitchell Avenue, Oshawa	Identified during field review	The property contains a one and one-half storey residence with a front gable roof. There is pebble dash in the front gable and a shed roof dormer on the east façade. The exterior of the residence is red brick with brick voussoirs above segmental arch window and door openings. There is a bay window with a wood surround on the front (south) façade and a small 3/1 wood frame window. The foundation is poured concrete. The residence was likely built between 1939 and 1954 based on topographic mapping and aerial photography. The residence has potential design value as a representative early to mid-20 <sup>th</sup> century Ontario vernacular structure.

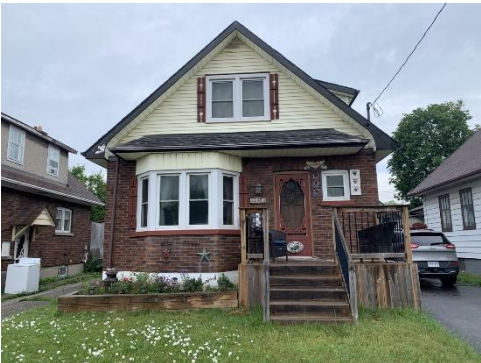
BHR-125	Residence	248 Mitchell Avenue, Oshawa	Identified during field review	The property contains a one and one-half storey residence with a front gable roof. There is siding in the front gable and a shed roof dormer on the east façade. The exterior of the residence is red brick with brick voussoirs above segmental arch window and door openings. There is a bay window on the front (south) façade and the residence has modern windows and shutters in the upper storey. The foundation is poured concrete. The residence was likely built between 1939 and 1954 based on topographic mapping and aerial photography. The residence has potential design value as a representative early to mid-20 <sup>th</sup> century Ontario vernacular structure.

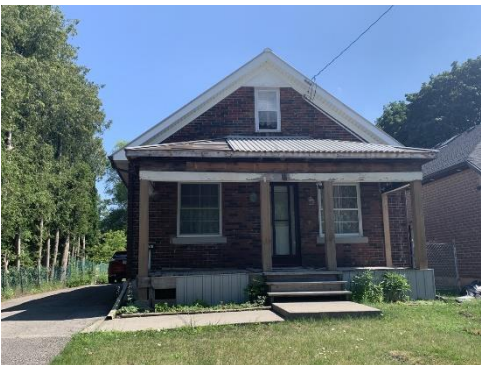
BHR-126	Residence	391 Mitchell Avenue, Oshawa	Identified during field review	This property contains a residence. The residence is a one and one-half storey structure with a steeply pitched front facing gable roof clad in metal. The exterior of the residence is red brick and contains bargeboard just below the gable peak of the front (north) façade. The residence has modern windows and doors and a full-width front porch. The foundation is poured concrete. The residence was likely built between 1900 and 1930 based on architectural style and topographic mapping. The residence has potential design value as a representative Ontario vernacular structure.

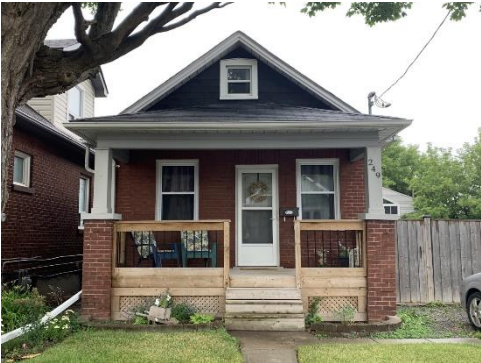
CHR Reference Number	Type of Property	Location	Previous Heritage Recognition	Description of Known or Potential CHVI	Photograph
BHR-127	Residence	249 Mitchell Avenue, Oshawa	Identified during field review	The property contains a one and one-half storey residence with a front gable roof. There are shingles in the gable. The exterior of the residence is red brick with matching brick voussoirs. There are modern windows and doors. The residence has a full width, covered porch on the front (north) façade and the roof is supported by brick half pillars with plain square columns on top. The foundation is poured concrete. The residence was likely built between 1900 and 1930 based on the style and topographic mapping. The residence has potential design value as a representative early 20 <sup>th</sup> century Ontario vernacular structure.

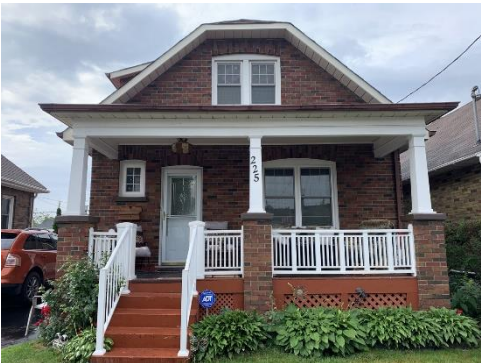
BHR-128	Residence	225 Mitchell Avenue, Oshawa	Identified during field review	The property contains a one and one-half storey residence with a clipped gable roof. There are shed roof dormers on the east and west facades. The exterior of the residence is red brick with matching brick voussoirs above segmental arch window openings. There is a modern door and modern windows. There is a full width, covered porch on the front (north) façade and the roof is supported by brick half pillars with plain white columns on top. The foundation is poured concrete. The residence was likely built between 1900 and 1930 based on the style and topographic mapping. The residence has potential design value as a representative early 20 <sup>th</sup> century Ontario vernacular structure.

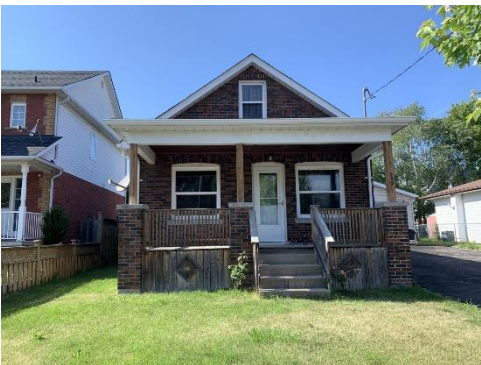
BHR-129	Residence	242 Graburn Avenue, Oshawa	Identified during field review	The property contains a one and one-half storey residence with a front gable roof. The exterior of the residence is red brick with matching brick voussoirs above segmental arch window and door openings. The windows and doors are modern. There is a full width, covered porch on the front (south) façade and the roof is supported by brick half pillars with wooden beam on top. The foundation is poured concrete. The residence was likely built between 1900 and 1930 based on the style and topographic mapping. The residence has potential design value as a representative early 20 <sup>th</sup> century Ontario vernacular structure.

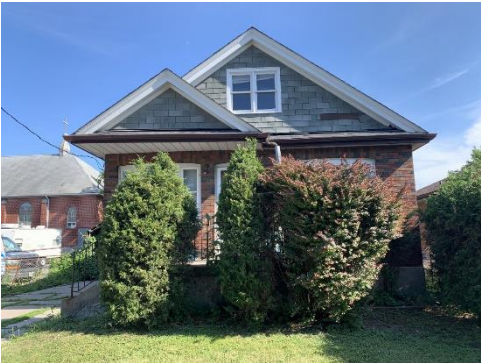
CHR Reference Number	Type of Property	Location	Previous Heritage Recognition	Description of Known or Potential CHVI	Photograph
BHR-130	Residence	255 Graburn Avenue, Oshawa	Identified during field review	The property contains a one and one-half storey residence with a front gable roof. The exterior of the residence is red brick with matching voussoirs above segmental arch window and door openings. The windows have wood frames. There is a triangular pediment above one of the windows and the door on the front (north) façade. Both the gable and the pediment have shingles inside them. The foundation is poured concrete. The residence was likely built between 1939 and 1954 based on topographic mapping and aerial photography. The residence has potential design value as a representative mid-20 <sup>th</sup> century Ontario vernacular structure.

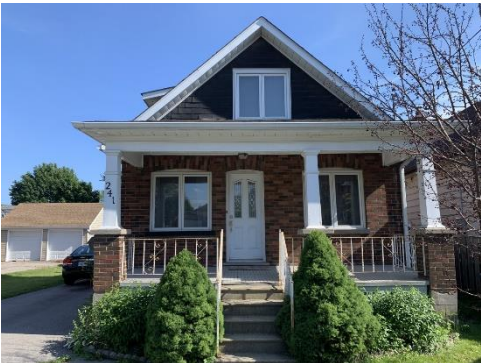
BHR-131	Residence	241 Graburn Avenue, Oshawa	Identified during field review	The property contains a one and one-half storey residence with a front gable roof. There are shingles in the front gable and a shed roof dormer on the east façade. The exterior of the residence is red brick with matching red brick voussoirs above segmental arch window and door openings. The windows and door are modern. There is a full width, covered porch on the front (north) façade and the porch roof is supported by brick half pillars with square columns on top. The foundation is concrete block. The residence was likely built between 1939 and 1954 based on topographic mapping and aerial photography. The residence has potential design value as a representative mid-20 <sup>th</sup> century Ontario vernacular structure.

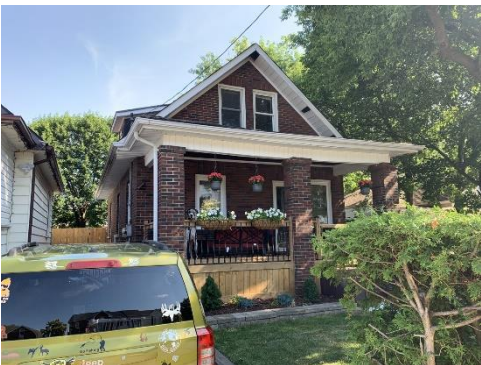
BHR-132	Residence	235 Graburn Avenue, Oshawa	Identified during field review	The property contains a one and one-half storey residence with a front gable roof. There are shingles in the front gable and a shed roof dormer on the east façade. The exterior of the residence is red brick with matching red brick voussoirs above the window and door openings. The windows and door are modern. There is a full width, covered porch on the front (north) façade and the porch roof is supported by brick pillars. The foundation is poured concrete. The residence was likely built between 1939 and 1954 based on topographic mapping and aerial photography. The residence has potential design value as a representative mid-20 <sup>th</sup> century Ontario vernacular structure.

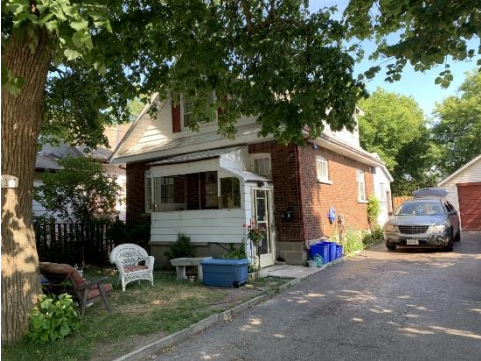
CHR Reference Number	Type of Property	Location	Previous Heritage Recognition	Description of Known or Potential CHVI	Photograph
BHR-133	Residence	217 Graburn Avenue, Oshawa	Identified during field review	The property contains a one and one-half storey residence with a front gable roof. There is siding in the gable and a shed roof dormer on the west façade. The exterior of the residence is red brick with matching brick voussoirs above segmental arch window openings. The windows are 3/1 wood frame windows. A partial enclosure has been added around the front (north) entrance which is clad in siding. The foundation is concrete block. The residence was likely built between 1900 and 1930 based on the style and topographic mapping. The residence has potential design value as a representative early 20 <sup>th</sup> century Ontario vernacular structure.

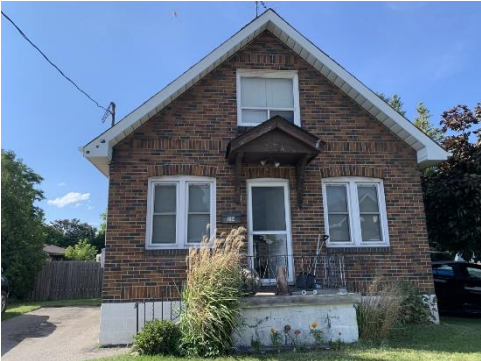
BHR-134	Residence	224 Beatty Avenue, Oshawa	Identified during field review	The property contains a one and one-half storey residence with a front gable roof. The exterior of the residence is red brick with brick bands along the top of the ground and upper stories and brick voussoirs above segmental arch window and door openings. The windowsills are also brick. The windows and door are modern. There is a triangular pediment above the door on the front (south) façade. The foundation is concrete block. The residence was likely built between 1939 and 1954 based on topographic mapping and aerial photography. The residence has potential design value as a representative early to mid-20 <sup>th</sup> century Ontario vernacular structure.

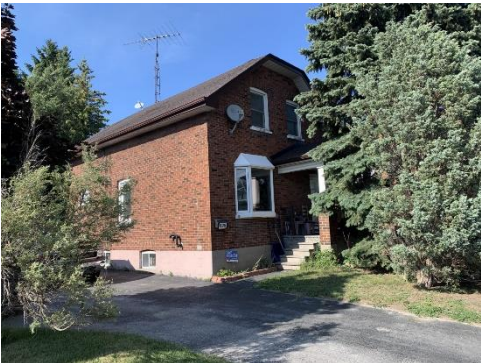
BHR-135	Residence	228 Beatty Avenue, Oshawa	Identified during field review	The property contains a one and one-half storey residence with a clipped gable roof. The exterior of the residence is red brick with matching brick voussoirs above segmental arch window openings. There is a bay window on the ground storey of the front (south) façade. The windows are modern. There is a half width, covered porch and the roof is supported by brick half pillars and square support columns. The door is obscured by a large evergreen tree. The foundation is concrete block. The residence was likely built between 1939 and 1954 based on topographic mapping and aerial photography. The residence has potential design value as a representative early to mid-20 <sup>th</sup> century Ontario vernacular structure.

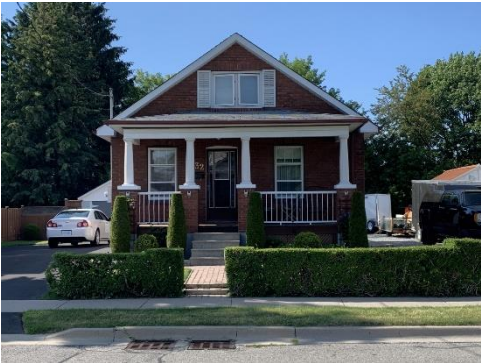
CHR Reference Number	Type of Property	Location	Previous Heritage Recognition	Description of Known or Potential CHVI	Photograph
BHR-136	Residence	232 Beatty Avenue, Oshawa	Identified during field review	The property contains a one and one-half storey residence with a front gable roof. The exterior is red brick with matching brick voussoirs above segmental arch window and door openings. The residence contains a combination of modern windows and 3/1 wood frame windows with shutters. There is a full width, covered porch on the front (south) façade and the roof is supported by brick half pillars with round columns on top. The foundation is concrete block. The residence was likely built between 1900 and 1930 based on the style and topographic mapping. The residence has potential design value as a representative early 20 <sup>th</sup> century Ontario vernacular structure.

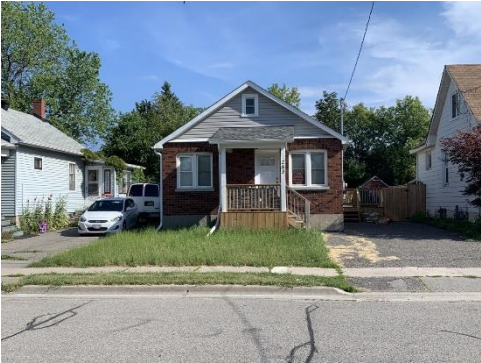
BHR-137	Residence	243 Beatty Avenue, Oshawa	Identified during field review	The property contains a one and one-half storey residence with a front gable roof. There is siding in the gable. The exterior of the residence is red brick with matching brick voussoirs above segmental arch window and door openings. The windows and doors are modern. There is a small porch and roof above the door on the front (north) façade supported by plain square columns. The foundation is poured concrete. The residence was likely built between 1939 and 1954 based on topographic mapping and aerial photography. The residence has potential design value as a representative early to mid-20 <sup>th</sup> century Ontario vernacular structure.

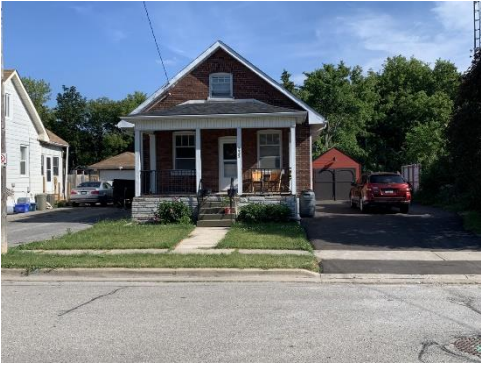
BHR-138	Residence	235 Beatty Avenue, Oshawa	Identified during field review	The property contains a one and one-half storey residence with a front gable roof. The exterior of the residence is red brick with matching brick voussoirs above segmental arch window and door openings. There is a wood door and 3/2 windows. The residence has a full width, covered porch on the front (north) façade and the roof is supported by plain square beams. The foundation is poured concrete. The residence was likely built between 1939 and 1954 based on topographic mapping, city directories, and aerial photography. The residence has potential design value as a representative early 20 <sup>th</sup> century Ontario vernacular structure.

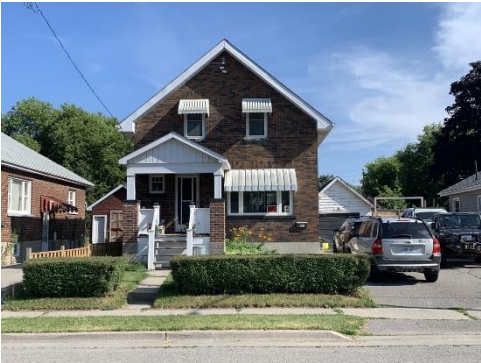
CHR Reference Number	Type of Property	Location	Previous Heritage Recognition	Description of Known or Potential CHVI	Photograph
BHR-139	Residence	225 Beatty Avenue, Oshawa	Identified during field review	The property contains a one and one-half storey residence with a front gable roof. The exterior of the residence is red brick with matching brick voussoirs above the window and door openings. The residence has modern windows with awnings, with the exception of a small, wood frame 3:1 window on ground storey of the front (north) façade. There is a half width porch with a gable roof over the front entrance. There is siding in the gable and the roof is supported by brick half pillars with plain square beams on top. The porch has a concrete block foundation and the house has a poured concrete foundation. The residence was likely built between 1939 and 1954 based on topographic mapping and aerial photography. The residence has potential design value as a representative early to mid-20 <sup>th</sup> century Ontario vernacular structure.

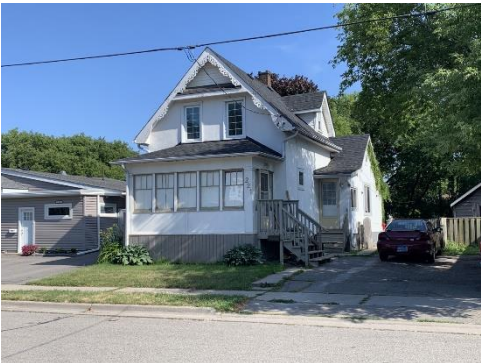
BHR-140	Residence	221 Beatty Avenue, Oshawa	Identified during field review	The property contains a one and one-half storey residence with a front gable roof. There is bargeboard in the gable. The exterior of the residence is covered with stucco. The residence has a combination of modern, sympathetic windows and wood frame windows. There is a full width, enclosed porch on the front (north) façade. The porch has 3/1 windows. The foundation is concrete block. The residence was likely built between 1900 and 1930 based on the style and topographic mapping. The residence has potential design value as a representative early 20 <sup>th</sup> century Ontario vernacular structure with Queen Anne design influence.

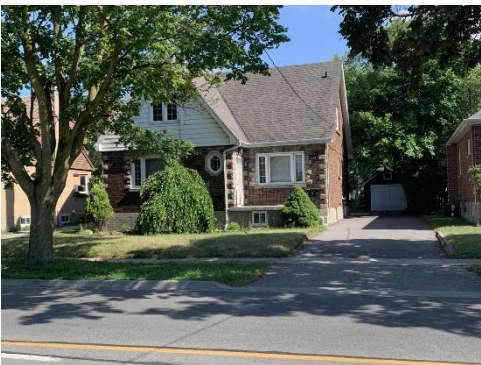
BHR-141	Residence	223 McNaughton Avenue, Oshawa	Identified during field review	The property contains a one and one-half storey residence with a cross gable roof. The front (north) facing gable has siding in it. The exterior of the residence is red brick with stone accents at the corner, around the windows, and around the door. The windows and door are modern but sympathetic. The foundation is concrete block. The residence was likely built between 1939 and 1954 based on topographic mapping and aerial photography. The residence has potential design value as a representative early to mid-20 <sup>th</sup> century Ontario vernacular residence with Period Revival design influence.

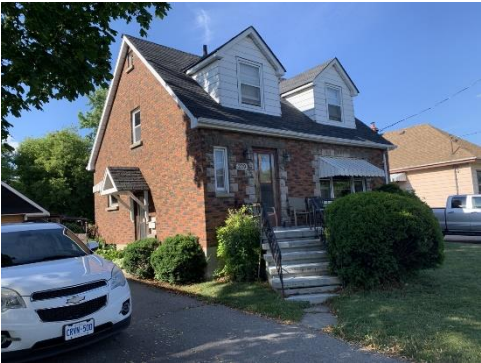
CHR Reference Number	Type of Property	Location	Previous Heritage Recognition	Description of Known or Potential CHVI	Photograph
BHR-142	Residence	220 Etna Avenue, Oshawa	Identified during field review	The property contains a one and one-half storey residence with a side gable roof. There are two gable dormers clad in siding on the front (south) façade. The exterior of the residence is red brick with stone accents around the door and windows. The picture window is covered by an awning. The foundation is concrete block. The residence was likely built between 1939 and 1954 based on topographic mapping and aerial photography. The property has potential design value as a mid-20 <sup>th</sup> century Ontario vernacular structure with Colonial Revival design influence.

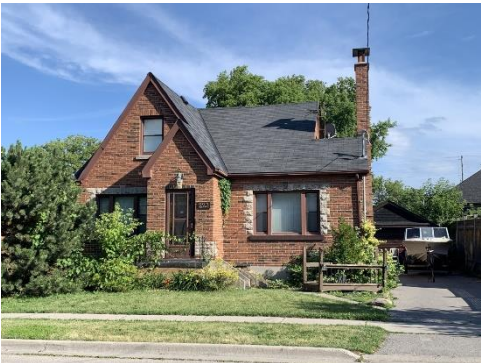
BHR-143	Residence	223 Etna Avenue, Oshawa	Identified during field review	The property contains a one and one-half storey residence with a cross gable roof. The exterior of the residence is red brick with a brick voussoir above the upper storey window and stone accents and keystones around the ground storey windows. The windows and door are modern. The foundation is poured concrete. The residence was likely built between 1939 and 1954 based on topographic mapping and aerial photography. The residence has potential design value as a mid-20 <sup>th</sup> century Ontario vernacular structure with Period Revival design influence.

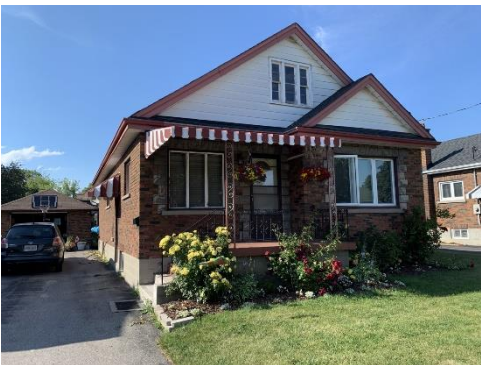
BHR-144	Residence	230 Etna Avenue, Oshawa	Identified during field review	The property contains a one and one-half storey residence with a front gable roof. There is a second, offset, protruding gable above a window on the ground storey of the front (south) façade. Both gables have siding in them. The exterior of the residence is red brick with stone accents and key stones around the ground storey window and door opening on the front façade. The windows and door are modern, with the exception of the wood frame window in the gable. There is a half width porch covered by a metal roof with decorative metal support beams and railings. The foundation is concrete block. The residence was likely built between 1939 and 1954 based on topographic mapping and aerial photography. The residence has potential design value as a representative early to mid-20 <sup>th</sup> century Ontario vernacular residence with Arts and Crafts design influence.

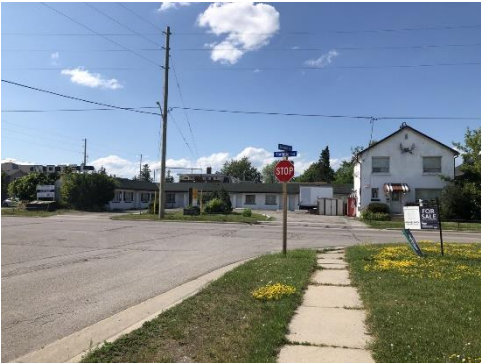
CHR Reference Number	Type of Property	Location	Previous Heritage Recognition	Description of Known or Potential CHVI	Photograph
BHR-145	Motel	214 Toronto Avenue, Oshawa	Identified during field review	The property contains a one and one-half storey heavily modified residence with a one storey u-shaped motel addition. The residence has a front gable roof, and the exterior is clad in stucco. The residence has modern windows and doors and there is no visible foundation. The hotel rooms also have a gable roof and are clad in stucco. The rooms have modern doors and windows as well. The residence was likely built between 1900 and 1930 based on the style and topographic mapping. The motel was likely built between 1939 and 1954 based on topographic mapping and aerial photography. The motel is functionally and historically linked with Highway 401, located just south of the motel. Lodgings oriented around car travel became popular in the postwar period as society emphasized the use of the car as a travel and leisure method.

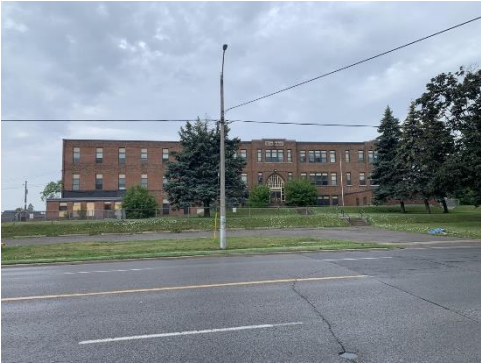
BHR-146	School	300 Ritson Road South, Oshawa	Class B Listed Property on the Municipal Heritage Register	The property contains a three storey school building with a flat roof line. The exterior of the building is red brick with decorative brickwork around a large, pointed arch at the main entrance on the building's east façade. The entrance contains a large, wooden double door with sidelights and a multipaned window filling the top section of the arch. The windows are modern. The building's foundation is not clearly visible from the public RoW. According to the Heritage Oshawa inventory, the school was built in 1928 and closed in 2012 by the Durham School Board. The building has design value as a representative Neo-Gothic structure. The building has potential design or associative value from its role in the community as an educational facility.

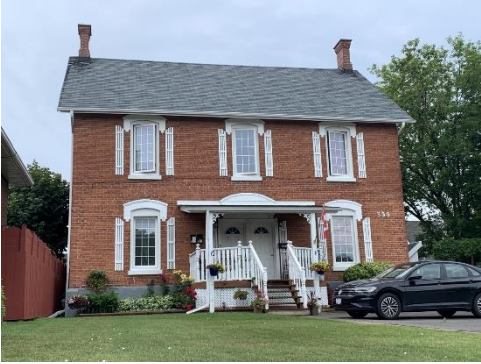
BHR-147	Residence	356 Ritson Road South, Oshawa	Class A Listed Property on the Municipal Heritage Register	<p>The property contains a two-storey residence with a side gable roof and large end-wall chimneys. The exterior of the residence is red brick. There are painted drip mould voussoirs above symmetrically spaced segmental arch window openings. The windows are modern and flanked by shutters. The main entrance on the front (east) façade has two doors with fan lights in a decorative wooden surround. The entrance has a small porch with a roof supported by plain square beams with decorative wooden brackets. The foundation has been parged with concrete, obscuring the original foundation. According to the Heritage Oshawa Inventory, the residence was built <i>circa</i> 1880. The residence has potential design value as a late 19<sup>th</sup> century Ontario vernacular structure with Italianate influences.</p> <p>A CHER was completed for the property determined the residence was likely built between 1862 and 1880. The residence at 356 Ritson Road South is an example of an Ontario vernacular structure that retains the balance and overall symmetry of a Georgian style structure and includes limited Italianate elements.</p>

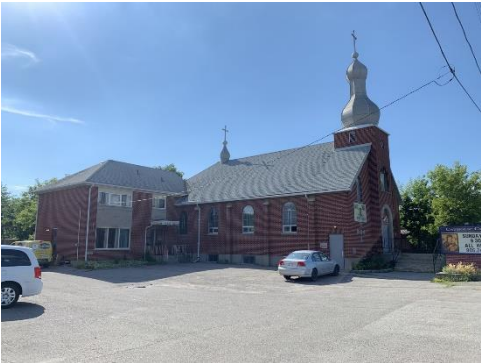
CHR Reference Number	Type of Property	Location	Previous Heritage Recognition	Description of Known or Potential CHVI	Photograph
BHR-148	Church	464 Ritson Road South, Oshawa	Identified during field review	<p>The property contains a one and one-half storey church building. The roof has a front gable with a square tower topped with a dome in the centre of the front (east) façade. The exterior of the building is red brick with stone accents in cross shaped in the front façade and in an arch around the door. The entrance has modern metal double doors with a semi-circular painting filling the top portion of the arch. The windows are stained-glass and have arched openings. The foundation is concrete. The church was blessed on October 2, 1955 (Eparchy of Ss. Cyril and Methodius of Slovaks of the Byzantine Rite in Canada n.d.). The building has potential design value as a mid-20<sup>th</sup> century church with Ukrainian design influences. The building also has potential historic and associative value through its connection to the Mother of God Parish and community.</p> <p>A CHER was completed for this property and determined the church was built in 1956 and is a vernacular structure with influences from eastern Christianity.</p>

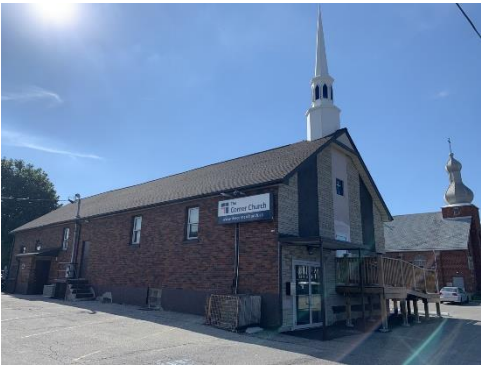
BHR-149	Church	470 Ritson Road South, Oshawa	Identified during field review	<p>The property contains a one and one-half storey church building. The building has a front gable roof with a spire near the front (east) façade. The exterior of the building is red brick with matching brick voussoirs above the windows on the side facades. The front façade has been clad in faux stone with vertical bands of stucco. The doors and windows are modern. The foundation is concrete. The church was likely built between 1939 and 1954 based on topographic mapping and aerial photography. The building has potential design value as a representative mid-20<sup>th</sup> century Ontario vernacular structure. The church has potential associative value as “The Corner Church”, an institution part of the community of Oshawa.</p> <p>A CHER was completed for this property and determined the structure at 470 Ritson Road South was built as The Slovak National Hall in 1939. The structure was modified to its present appearance in the late 20<sup>th</sup> century or early 21<sup>st</sup> century.</p>

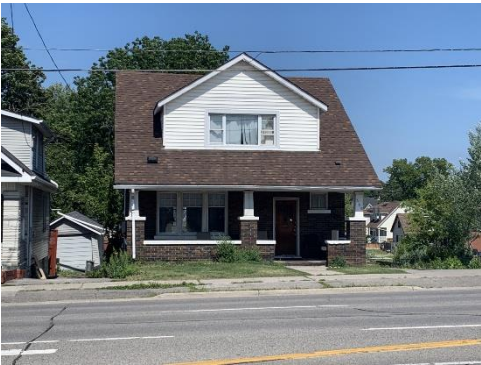
BHR-150	Residence	359 Ritson Road South, Oshawa	Identified during field review	<p>The property contains a one and one-half storey residence with a side gable roof. There is a large gable roof dormer on the front (west) façade w with a shed roof dormer on the rear façade. There is siding in the front dormer. The exterior of the residence is red brick. There is a wooden door and 6/1 wood frame windows on the ground floor. The residence’s roof provides an overhang for a front porch and is supported by brick half pillars with square columns on top and low brick walks between them. The foundation is poured concrete. The residence was likely built between 1900 and 1931 based on architectural style and city directories. The residence has potential design value as a representative early to mid-20<sup>th</sup> century Ontario vernacular residence with Craftsman influence.</p> <p>A CHER was completed for this property and determined the residence was likely built circa 1920 and is an example of Craftsman style architecture.</p>

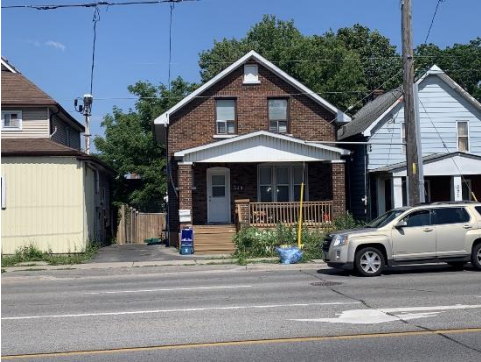
CHR Reference Number	Type of Property	Location	Previous Heritage Recognition	Description of Known or Potential CHVI	Photograph
BHR-151	Residence	349 Ritson Road South, Oshawa	Identified during field review	<p>The property contains a one and one-half storey residence with a front gable roof. The exterior of the residence is red brick with brick voussoirs above the window and door openings. The window and door openings on the ground storey of the front (west) façade are segmental arches. The windows and door are modern. There is a full width, covered porch on the front façade. The porch has a gable roof filled with siding and supported by brick pillars. The foundation is poured concrete. The residence was likely built between 1932 and 1950 based on city directories and architectural style. The residence has potential design value as a representative early to mid-20<sup>th</sup> century Ontario vernacular structure.</p> <p>A CHER was completed for this property and determined the residence was likely built between 1938 and 1941. The residence at 349 Ritson Road South is an example of an Ontario vernacular structure and is consistent with designs common in the early 20<sup>th</sup> century.</p>

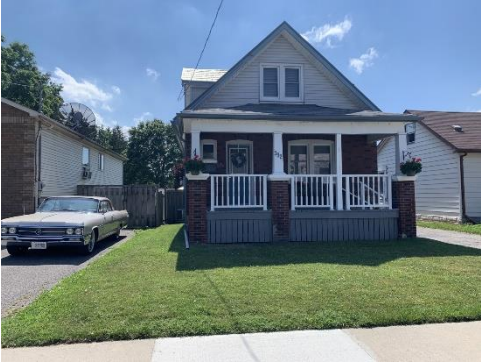
BHR-152	Residence	392 Oshawa Boulevard South	Identified during field review	<p>This property contains a residence. The residence is a one and one-half storey structure with a steeply pitched front facing gable roof with gable dormers on the west and east elevations. The exterior of the residence is clad in modern siding and red brick. The upper storey has modern windows and the first storey has modern windows in segmental arch window openings. The residence contains a full-width porch with wood columns and a modern door. The foundation is poured concrete. The residence was likely built between 1900 and 1930 based on architectural style and topographic mapping. The residence has potential design value as a representative early 20<sup>th</sup> century Ontario vernacular structure.</p>

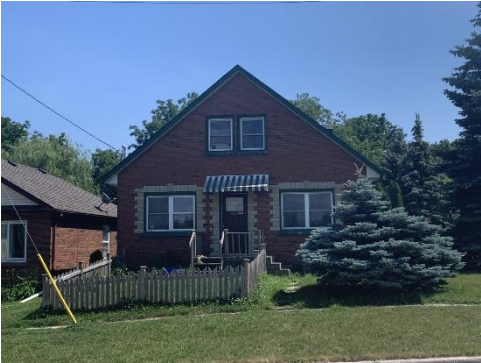
BHR-153	Residence	429 Crerar Avenue, Oshawa	Identified during field review	<p>This property contains a residence. The residence is a one and one-half storey structure with a steeply pitched front facing gable roof with a brick chimney and gable dormers on the east and west elevations. The residence is clad in red brick and the main (north) elevation contains rusticated concrete window and door surrounds on the first storey. The residence has a modern door and rusticated concrete block foundation. The residence was likely built between 1900 and 1930 based on architectural style and topographic mapping. The residence has potential design value as a representative early 20<sup>th</sup> century Ontario vernacular structure.</p>

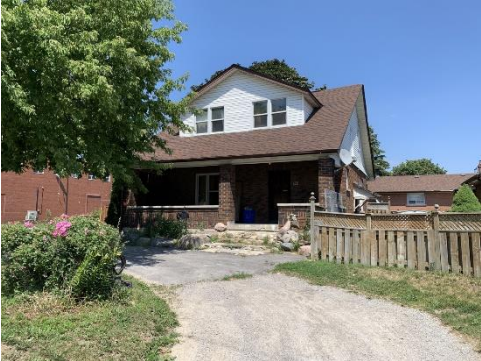
CHR Reference Number	Type of Property	Location	Previous Heritage Recognition	Description of Known or Potential CHVI	Photograph
BHR-154	Residence	393 Wilson Road South, Oshawa	Identified during field review	<p>This property contains a one and one-half storey residence with a side gable roof and a gable dormer on the front (west) elevation. The gables are clad in modern siding. The exterior of the residence is clad in red brick with matching brick voussoirs above the window openings. The residence has modern windows and doors and a full-width front porch. The foundation is poured concrete. The residence features Craftsman design elements including decorative brickwork on the porch surround and stone steps leading to the front entrance. Following a review of aerial photography, architectural style, and topographic mapping the date of construction of this residence cannot be determined. The architectural style is consistent with early 20<sup>th</sup> century Craftsman style architecture. However, aerial photography shows a vacant lot in 1954 and topographic mapping from 1968 indicates the presence of a building. The residence has potential design value as representative example of an early to mid-20<sup>th</sup> century Ontario vernacular structure with Craftsman design influence.</p>

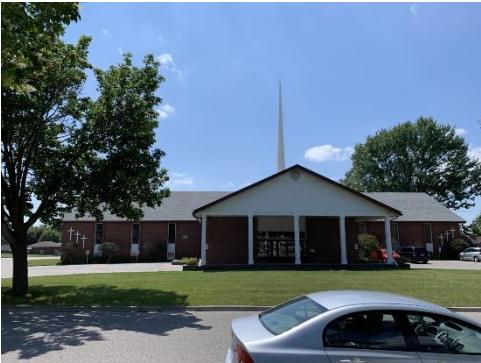
BHR-155	Church	374 Farewell Street, Oshawa	Identified during field review	<p>The property contains a one storey church building with a cross gable roof. The gables are clad in modern siding. The exterior is clad in red brick. The windows and doors are modern. The door on the front (east) façade has a large, three pane transom window above it. The front gable is supported by square columns and has a row of dentils above the columns. The building was likely built between 1954 and 1968 based on aerial photography and topographic mapping. The building has potential design value as a representative mid-20<sup>th</sup> century representative example of church design. The church has potential associative value as the Evangel Church.</p> <p>A CHER was completed for the property and determined that in 1966 the Evangel Pentecostal Church built a place of worship on Farewell Street which was converted into a daycare centre in 1979 when the present-day church was built. The church is an example of a modernist structure with a Colonial Revival port-cochere.</p>

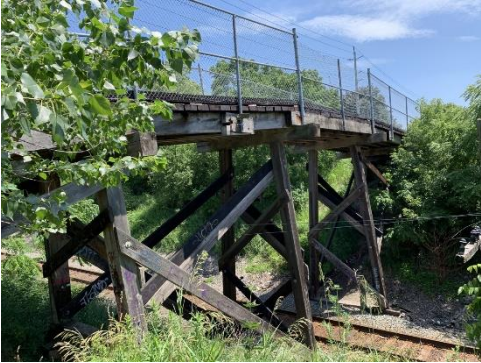
BHR-156	Bridge	N/A—Farewell Street Multi-Use Bridge over CPR tracks	Identified during field review	<p>The Farewell Street Multi-Use Bridge is a timber bridge which crosses the CPR tracks. The bridge contains timber bracing and piers which support a timber deck. The original railing has been replaced by chain-link fencing. The bridge was likely built in about 1912. The bridge is a rare example of a timber structure and its distinctive appearance and timber decking make it a landmark structure in an otherwise postwar suburban neighbourhood.</p> <p>A CHER was completed for the bridge and determined the Farewell Street Multi-Use Bridge is a wood stringer bridge that was built <i>circa</i> 1912 when the Canadian Pacific Railway (CPR) was constructed through the present-day City of Oshawa. The bridge is a rare surviving example of a timber bridge within the City of Oshawa and Durham Region.</p>

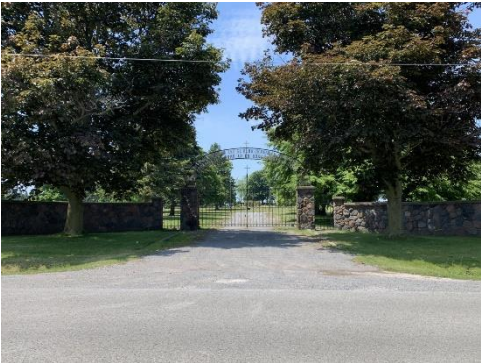
CHR Reference Number	Type of Property	Location	Previous Heritage Recognition	Description of Known or Potential CHVI	Photograph
BHR-157	Cemetery	N/A – St. Wolodymyr and St. Olha Ukrainian Cemetery, Clarington	Identified by Municipality of Clarington as a potential cultural heritage resource	<p>The property contains a cemetery. The cemetery has a row of mature trees on the east and south edges of the property. The main entrance is located on the eastern side. It has a metal gate with an arch bearing the name of the cemetery in English and Cyrillic atop stone pillars. There is also a curved section of stone wall on either side of the gate. The tombstones were obscured by distance from the RoW. The cemetery was associated with St. George the Great Martyr Ukrainian Catholic Church and according to the parish website, the cemetery was in operation from 1969 to 2019 (St. George the Great Martyr Ukrainian Catholic Church n.d.). The cemetery has historical or associative value from its connection to the St. George the Great Martyr Ukrainian Catholic Church and its connection to the community through its function as a burial ground.</p> <p>A CHER was completed for this property and determined the cemetery was established in 1969. The property contains a cultural heritage landscape with design value as a representative example of a 20<sup>th</sup> century cemetery.</p>

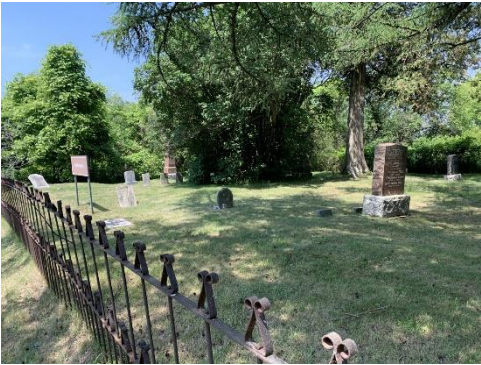
BHR-158	Cemetery	N/A—Trull Cemetery, Baseline Road, Clarington	Previously identified by Amec Foster Wheeler in 2018 in the CHSR for the Oshawa to Bowmanville Expansion, Identified as a potential cultural heritage resource by Municipality of Clarington	<p>The property contains a cemetery. The cemetery is a small family burial ground surrounded by a decorative wrought iron fence. There are several mature trees scattered throughout the cemetery. The gravestones are a mixture of materials and styles, including flat markers, arched and square upright limestone markers and more substantial upright granite markers. The burials range from 1856 to 1946 (Billion Graves 2021). The cemetery has potential historical or associative value from its connection to the Trull family, who were among the first families that settled in Courtice (Ontario Genealogy n.d.). Captain Trull also led a group of local settlers in a march during the Mackenzie Rebellion in 1837 (Ontario Genealogy n.d.).</p>
