**Addendum to Oshawa  
to Bowmanville Rail  
Service Extension:  
Cultural Heritage Report  
- Existing Conditions  
and Preliminary Impact  
Assessment**

**Final**

September 26, 2023

Project Number: 165011019

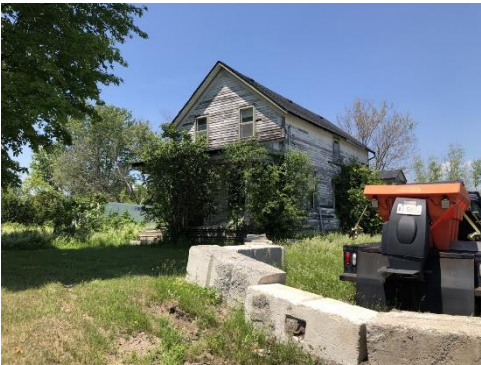
BHR-159	Residence	1558 Baseline Road, Clarington	Identified as a potential cultural heritage resource by Municipality of Clarington	<p>The property contains a one and one-half storey residence with a front gable roof. The exterior of the residence is clad in wooden siding. Some of the windows appear to have wood frames. The door is obscured by vegetation. There is a full width, covered porch on the front (south) façade with square support beams holding up the roof and railing with square posts. The foundation is also obscured by vegetation. The residence was likely built between 1939 and 1954 based on topographic mapping and aerial photography. The residence has potential design value as a representative early to mid-20<sup>th</sup> century Ontario vernacular residence.</p> <p>A CHER was completed for this property and determined the residence was likely built <i>circa</i> 1900. The residence is a relatively modest vernacular structure that resembles Folk Houses built across the American Midwest and Northeast from the mid-19<sup>th</sup> to early 20<sup>th</sup> century.</p>

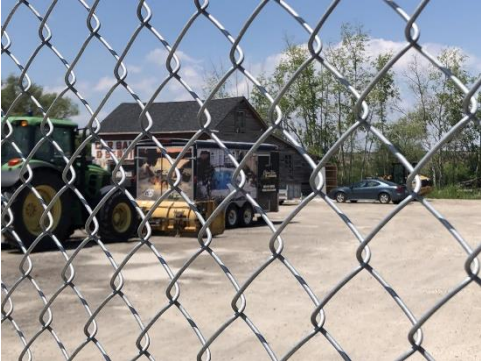
CHR Reference Number	Type of Property	Location	Previous Heritage Recognition	Description of Known or Potential CHVI	Photograph
BHR-160	Outbuilding	1580 Baseline Road, Clarington	Identified as a potential cultural heritage resource by Municipality of Clarington	<p>The property contains a one and one-half storey outbuilding with a saltbox roof. The exterior of the outbuilding is clad in wood siding. The windows have eight to ten panes and wooden frames. The front (south) façade of the outbuilding has two garage style doors. The foundation is obscured by distance and equipment. The structure was likely built between 1939 and 1954 based on topographic mapping and aerial photography. The structure has potential design value as a representative early to mid-20<sup>th</sup> century Ontario vernacular outbuilding.</p> <p>A CHER was completed for this property and determined the outbuilding was a vernacular early 20<sup>th</sup> century structure.</p>

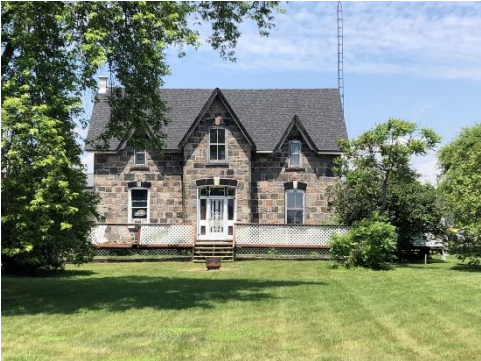
BHR-161	Residence	1598 Baseline Road, Clarington	Listed as a Primary Property on the Clarington Heritage Inventory <sup>5</sup>	<p>The property contains a one and one-half storey residence with a side gable roof that has three gable dormers. The exterior of the residence is stone. There are voussoirs with keystones above the segmental arch window and door openings. The windows have wood frames and there is a wood door behind a modern glass storm door. The door also has sidelights and a transom window. The foundation is obscured. The residence was likely built between 1830 and 1878 based on the style and historic mapping. The residence has potential design value as a representative 19<sup>th</sup> century Gothic Revival structure.</p> <p>A CHER was completed for this property and determined the residence was built in 1872. The residence at 1598 Baseline Road is an example of Gothic Revival style architecture.</p>

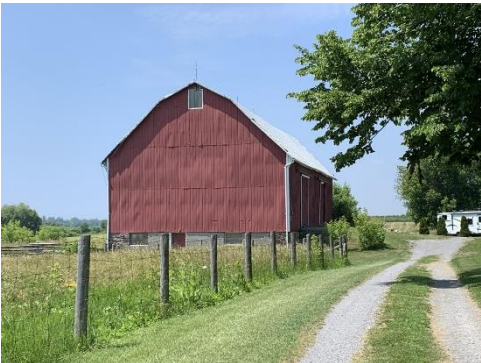
BHR-162	Barn	1218 Trulls Road, Clarington	Identified during field review	<p>The property contains a barn. The barn has a metal clad gambrel roof with the exterior of the structure clad in metal and an embankment on the north façade of the structure. The foundation is concrete blocks with stone quoins. Based on the barn's style and historical mapping, it was likely built in the late 19<sup>th</sup> century or early 20<sup>th</sup> century, sometime after 1878. The barn has potential design value as a representative late 19<sup>th</sup> to early 20<sup>th</sup> century Central Ontario barn. This style of barn is also known as a bank barn.</p>

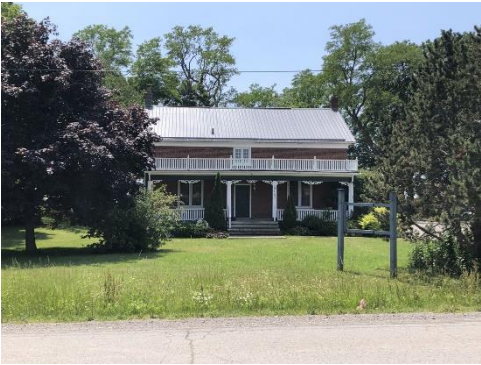
CHR Reference Number	Type of Property	Location	Previous Heritage Recognition	Description of Known or Potential CHVI	Photograph
BHR-163	Residence	1711 Baseline Road, Clarington	Listed as a Primary Property on the Clarington Heritage Inventory	This property contains a residence. The residence is a one and one-half storey structure with a metal clad side gable roof. The exterior is red brick. The residence has a full-width front porch with wooden railing, square support beams and decorative brackets. The upper story of the porch also has wooden railing with finials. The residence has modern windows and a modern door with a rectangular transom window above it. The foundation is obscured. The residence was likely built between 1860 and 1880 based on the style. The residence has potential design value as a representative 19 <sup>th</sup> century Ontario vernacular structure.

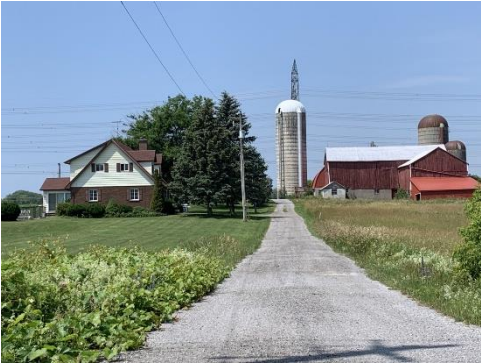
BHR-164	Barn	1108 Holt Road, Clarington	Identified during field review	This property contains two residences, a barn, and three silos. The residence closest to the RoW has been heavily modernized. The second residence is difficult to see from the RoW and an architectural style could not be determined. The barn has a cross gable roof clad in metal with four lightning rods. The exterior of the barn is clad in wood siding and there is an embankment on the north façade of the structure. The barn has a concrete foundation. The barn was likely built after 1900 or is a heavily modified barn that was built <i>circa</i> 1880. The barn has potential design value as a representative late 19 <sup>th</sup> century Central Ontario barn. This style of barn is also known as a bank barn.

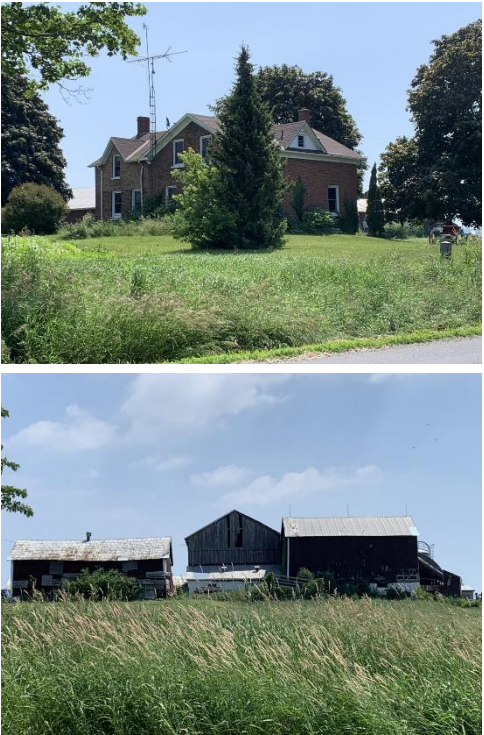
CHR Reference Number	Type of Property	Location	Previous Heritage Recognition	Description of Known or Potential CHVI	Photograph
BHR-165	Farmstead	1261 Holt Road, Clarington	Identified during field review	<p>This property contains a residence, two barns and multiple outbuildings. The residence is a one and one-half storey structure with an L-shaped gable roof. The roof also has multiple centre gable dormers. The exterior of the residence is red brick with matching flat arch voussoirs above the window openings. The residence has modern windows and the entrance on the west façade facing the road has been bricked in. The foundation is obscured. The residence was likely built between 1830 and 1861 based on the style and historical mapping.</p> <p>One of the barns has a gable roof, clad in metal with three lightning rods. The exterior of the structure has been clad in metal. The foundation is stone. There is an embankment on the west façade of the structure. The barn was likely built between 1878 and 1890 based on historical mapping and the style. The barn has potential design value as a representative late 19<sup>th</sup> century Central Ontario barn. This style of barn is also known as a bank barn. The second barn has a gable roof, clad in metal with three lightning rods. The exterior of the structure is clad in wood timbering. The foundation and potential presence of an embankment are obscured by distance, the other barn, and some of the additional outbuildings. This barn has potential design value as a representative gable roof barn, built in Ontario during the mid-19<sup>th</sup> to early 20<sup>th</sup> century.</p>

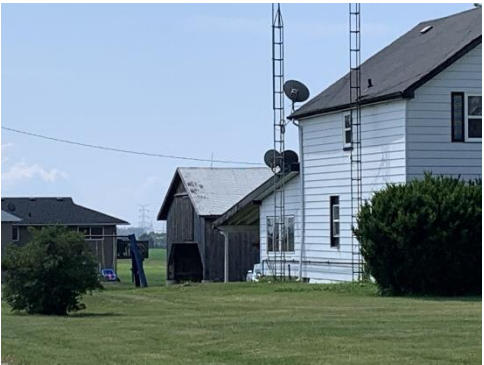
BHR-166	Barn	2185 Bloor Street, Clarington	Identified during field review	<p>The property contains a residence which has been heavily modified, modern outbuildings, and a barn. The barn has a metal clad gable roof. The exterior of the barn is clad in timber siding. The barn also has a breezeway and hay loft. The foundation is obscured by distance. The barn was likely built in the mid- to late 19<sup>th</sup> century based on the style. The barn has potential design value as a representative gable roof barn.</p>

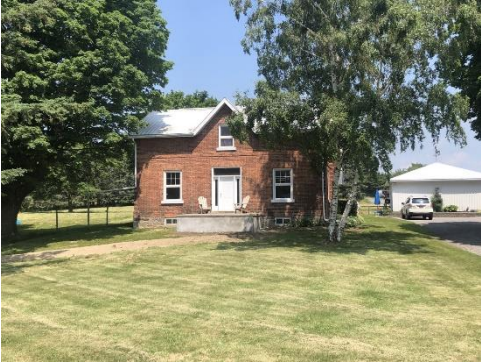
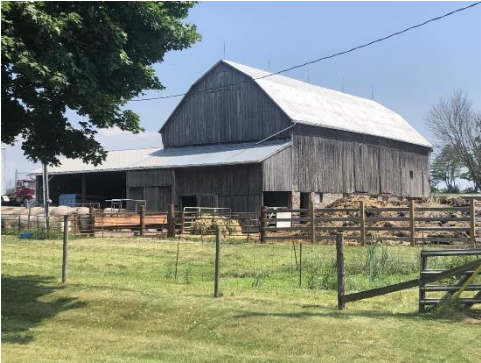
CHR Reference Number	Type of Property	Location	Previous Heritage Recognition	Description of Known or Potential CHVI	Photograph
BHR-167	Farmstead	2228 Baseline Road, Clarington	Listed on Municipal Heritage Register	<p>The property contains a residence, a barn, and several outbuildings. The residence is a one and one-half storey structure with a centre gable roof. The exterior of the residence is red brick with matching brick voussoirs above the window and door openings. The entrance on the front (south) façade has two side lights and a rectangular transom window. The foundation is stone. The residence was likely built between 1830 and 1878 based on the style and historical mapping. The residence has potential design value as a representative 19<sup>th</sup> century Ontario vernacular structure with Gothic Revival design influences.</p> <p>The barn has a gambrel roof clad in metal with five lightning rods. The exterior of the barn is clad in timber siding. The foundation is stone. The barn was likely built <i>circa</i> 1880 based on historical mapping and the style. The barn has potential design value as a representative late 19<sup>th</sup> century Ontario vernacular structure.</p> <p>A CHER was completed for this property and determined the residence at 2228 Baseline Road was likely built between 1847 and 1861. Based on the gambrel roof shape, the barn would have been a latter addition to the property likely added sometime after 1880. The residence is an example of a mid-19<sup>th</sup> century example of an Ontario vernacular residence with limited Gothic Revival design influences. The barn is a representative example of late 19<sup>th</sup> to early 20<sup>th</sup> century barn design in Ontario.</p>

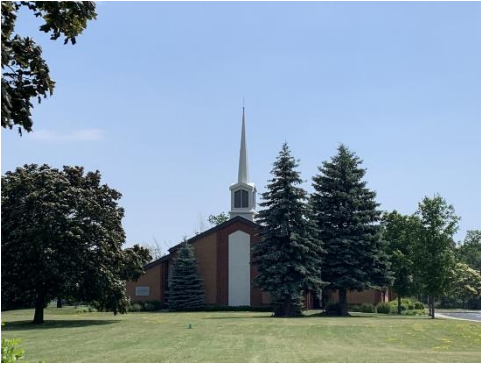
BHR-168	Church	7 Pethick Street, Bowmanville	Identified during field review	<p>The property contains a church. The building has an outshot gable roof. There is a spire in the centre of the west façade. The exterior of the building is clad in three colours of stucco. The windows and doors are modern. The foundation is obscured by distance. The church was likely built <i>circa</i> the late 1970s based on the style. The church has potential design value as a representative mid-century modern structure. The church is historically associated with the Church of Jesus Christ of Latter Day Saints.</p>

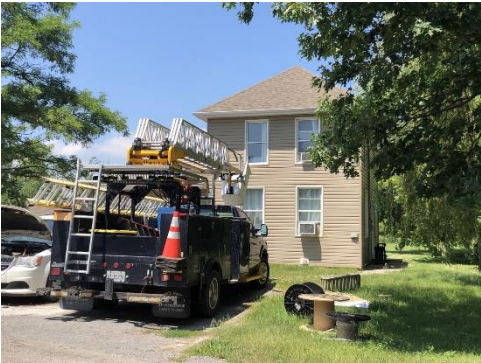
CHR Reference Number	Type of Property	Location	Previous Heritage Recognition	Description of Known or Potential CHVI	Photograph
BHR-169	Residence	1490 Baseline Road West, Clarington	Identified for consideration by municipal staff	<p>The property contains a residence. The residence is a two storey structure with a hip roof. The exterior of the residence is clad in siding. The residence contains modern sliding windows in rectangular openings. The foundation was not visible. There is a one storey gable roof wing of the residence on the west elevation that was not visible from the public RoW. The residence was likely built between 1900 and 1930 based on style and historical mapping. The residence has potential design value as a representative example of an early 20<sup>th</sup> century Ontario vernacular residence.</p> <p>A CHER was completed for this property and determined the residence was likely built between 1912 and 1916. The residence contains a massing consistent to early 20<sup>th</sup> century residential styles in Ontario, particularly the Edwardian style.</p>

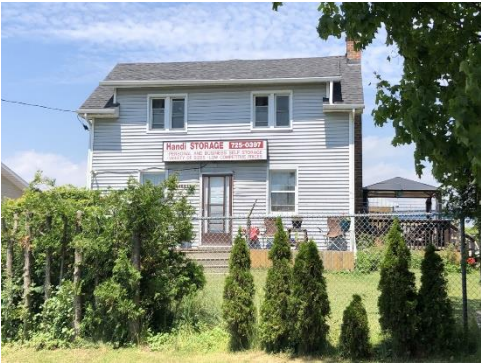
BHR-170	Residence (converted to commercial)	1660 Baseline Road West, Clarington	Identified for consideration by municipal staff	<p>The property contains a residence. The residence is a one-and-one half storey structure with a cross-gable roof and a T-shaped plan. The exterior is clad in siding and the residence has a red brick chimney on the east elevation. The residence has a large shed roof dormer on the front (south) elevation. The residence contains modern sliding windows in rectangular openings and a modern composite door. The foundation is obscured. The residence was likely built between 1900 and 1930 based on style and historical mapping. The residence has potential design value as a representative example of an early 20<sup>th</sup> century Ontario vernacular residence.</p> <p>The property also contains modern storage locker facilities which do not have potential CHVI.</p>

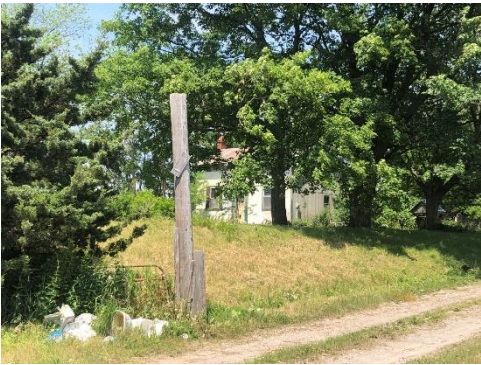
BHR-171	Farmstead	1766 Baseline Road West, Clarington	Identified for consideration by municipal staff	<p>The property contains a residence, a barn, and one outbuilding. The residence is a one storey structure with a side gable roof. The exterior of the residence is clad in stucco. The residence contains modern sliding windows. The main entrance on the front (south) elevation has a decorative door surround. The foundation was not visible from the public RoW. The residence was likely built between 1900 and 1930 based on the style and historical mapping. The residence has potential design value as a representative example of an early 20<sup>th</sup> century Ontario vernacular residence.</p> <p>The barn is a gable roof structure which is not visible from the public RoW due to heavy, mature tree coverage.</p> <p>A CHER was completed for this property and determined the residence had since been demolished. The barn at 1766 Baseline Road contains a gable roof and concrete foundation. The combination of the gable roof and concrete foundation suggests the barn was built between approximately 1900 and 1930 or was heavily modified to its approximate present-day appearance during this timeframe.</p>

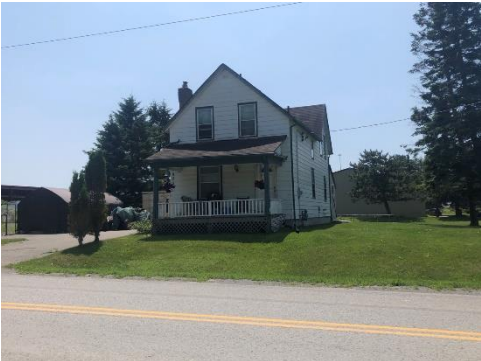
CHR Reference Number	Type of Property	Location	Previous Heritage Recognition	Description of Known or Potential CHVI	Photograph
BHR-172	Residence/Commercial	1825 Baseline Road West, Clarington	Identified for consideration by municipal staff	<p>The property contains a residence, a commercial building, and two outbuildings.</p> <p>The residence is a one-and-one half storey structure with a cross-gabled roof and a T-shaped plan. There is a red brick chimney on the east elevation. The exterior of the residence is clad in siding. The residence contains modern sliding windows and a modern composite door. There is a bay window on the east elevation. The residence has a full-width, shed roof porch with round support posts on the front (north) elevation. The residence's foundation is parged in concrete. The residence also has a one storey, shed roof addition on the rear (south) elevation. The residence was likely built between 1900 and 1930 based on style and historical mapping. The residence has potential design value as a representative example of an early 20<sup>th</sup> century Ontario vernacular residence.</p> <p>The commercial building and two outbuildings are modern and do not have potential CHVI. They are modern structures not present on topographic mapping from 1976.</p>

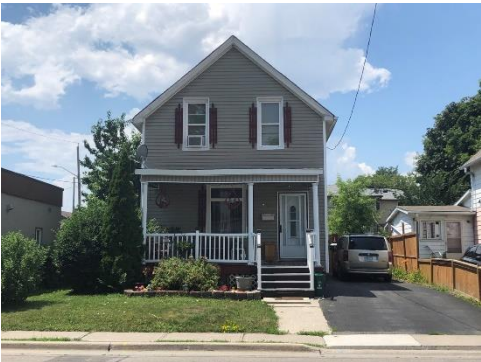
BHR-173	Residence	334 Albert Street, Oshawa	Listed (Class A Property)	<p>The property contains a residence. The residence is a one-and-one half storey structure with a front gable roof. The exterior of the residence is clad in siding. The residence contains modern sliding windows in rectangular openings on the upper storey of the front (east) elevation and the side elevations. There is a large single pane window with a rectangular transom on the first storey of the front elevation and the residence contains a modern door. The residence has a full-width, flat roof porch on the front elevation with round support posts and square railings. The foundation is stone. The residence has a one storey, shed roof addition on the rear (west) elevation. The residence was likely built between 1900 and 1930 based on style and historical mapping. The residence has potential design value as a representative example of an early 20<sup>th</sup> century Ontario vernacular residence.</p>

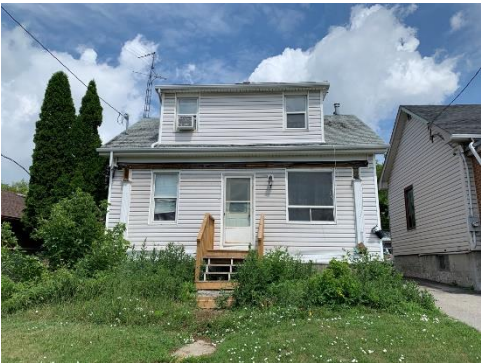
BHR-174	Residence	24 Mill Street, Oshawa	Listed (Class B Property)	<p>The property contains a residence. The residence is a one-and-one half storey structure with a side gable roof and shed roof dormers on the front (south) and rear (north) elevations. The exterior of the residence is clad in siding. The residence contains modern sliding windows. There is evidence that a full-width porch has been removed from the front elevation. The foundation is parged in concrete. There is a one storey, shed roof addition at the rear of the residence. The residence was likely built between 1900 and 1930 based on style and historical mapping. The residence has potential design value as a representative example of an early 20<sup>th</sup> century Ontario vernacular residence.</p>

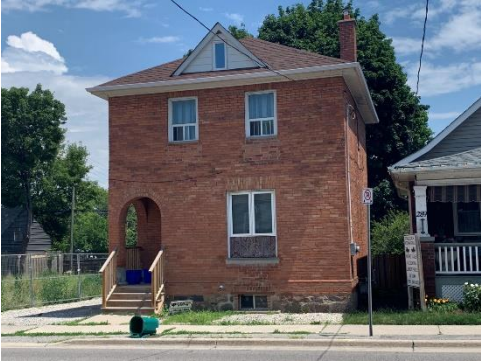
CHR Reference Number	Type of Property	Location	Previous Heritage Recognition	Description of Known or Potential CHVI	Photograph
BHR-175	Residence	285 Celina Street, Oshawa	Listed (Class B Property)	The property contains a residence. The residence is a two-and-one half storey structure with a hip roof and gables dormers on the west and north elevations. The exterior of the residence is clad in red brick. There is a chimney on the south elevation. The residence contains modern windows in rectangular openings with red brick voussoirs. Arches with red brick drop molding located in the northwest corner of the residence provide access to the main entrance. The residence has a one storey, gable roof addition on the rear (east) elevation. The foundation is stone. According to the City of Oshawa heritage register, the residence was built in 1900. The residence has potential design value as an unusual example of early 20 <sup>th</sup> century Ontario vernacular architecture.

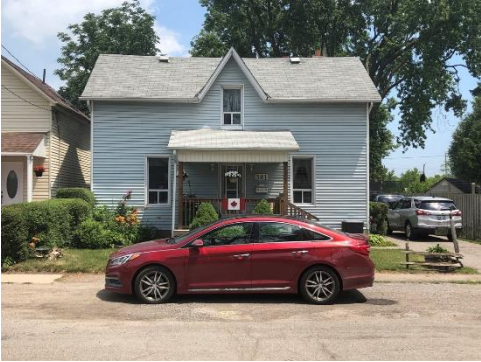
BHR-176	Residence	381 Celina Street, Oshawa	Listed (Class B Property)	The property contains a residence. The residence is a one-and-one half storey structure with a side gable roof and a central front gable. The exterior of the residence is clad in siding. The residence contains modern windows in rectangular openings and a modern door. The residence has a partial-width shed roof porch on the front (west) elevation centred over the principle entrance. The foundation is stone. The residence has a one storey, gable roof addition at the rear. According to the City of Oshawa heritage register, this residence was built in 1900. The residence has potential design value as a representative 19 <sup>th</sup> century Ontario vernacular structure with Gothic Revival design influences.
