## **Overview**

On February 2, 2026, at approximately 08:05, GO 3009 derailed at low speed while operating revenue service westbound near Mile 0.30, within the John Street Interlocking. One (1) coach and one (1) locomotive derailed. There were no injuries to passengers or crew and approximately 108 customers were safely transferred to a rescue train. The derailment caused significant disruption across the GO network during the morning peak rush hour service, with delays of up to 90 minutes.

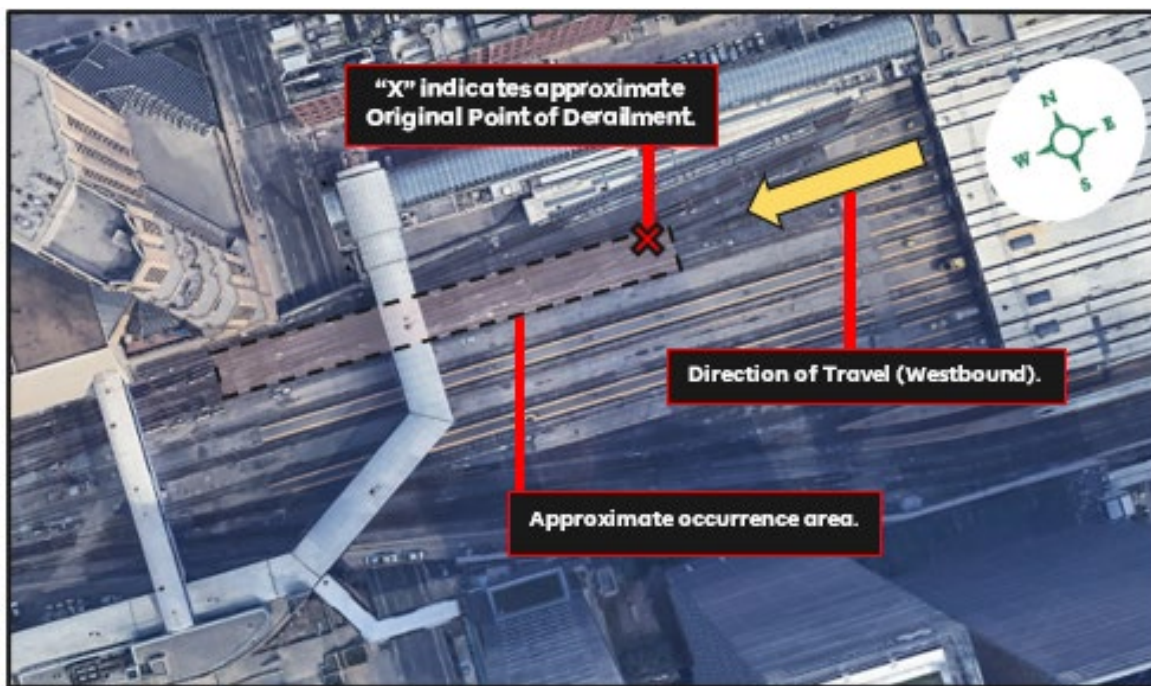
The derailment was caused by a loss of effective lateral rail fastening at the occurrence location. The rail fastening configuration did not meet the lag screw occupancy required by the Metrolinx Track Standard (MTS), as two (2) lag screws per plate were installed, where four (4) were required. Across nine (9) consecutive timber ties, the lag screws that were present were in a degraded condition - broken, loose, or missing.

With the fastening system unable to hold the rail in position under repeated train loading, the south rail shifted laterally by approximately  $1\frac{1}{8}$  inches, producing a wide gauge condition. This condition permitted the wheel to drop between the rails and the train to derail. Examination of wheel-contact markings placed the Original Point of Derailment (OPOD) near the insulated joints at Signal 662. The displaced wheelset then continued through the track layout until reaching the 664 double slip switch, where the wheel followed a diverging route and the derailment progressed.

**Figure 2: Aerial view of occurrence location at Mile 0.30 within the USRC. Image retrieved from Google Maps.**
